# St John the Baptist, Barnack

# Report on Archaeological Observation and Recording associated with New Heating Scheme

Archaeological contractor's Site Code: BCHS 19

Prepared by Jackie Hall for Barnack PCC October 2019

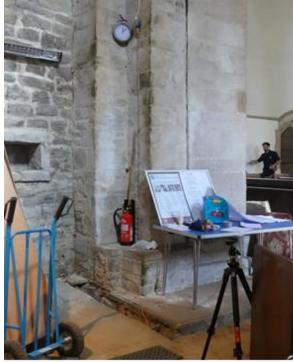
Figure 3: General location of duct in tower, looking north-east

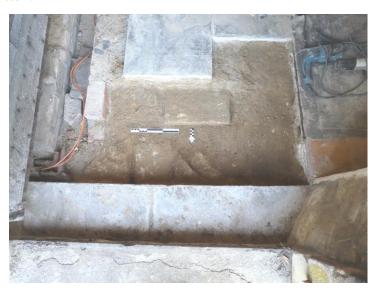
Figure 6: Area excavated for new duct in north aisle, immediately in front of step to north door, looking south (scale = 0.30m)

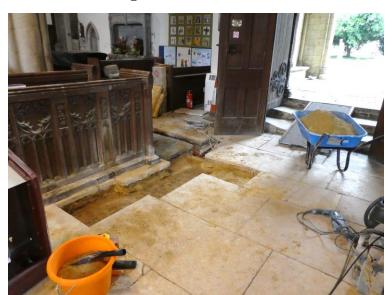
Figure 8: Trench for new duct in nave and south aisle. General view during excavation, looking south-east

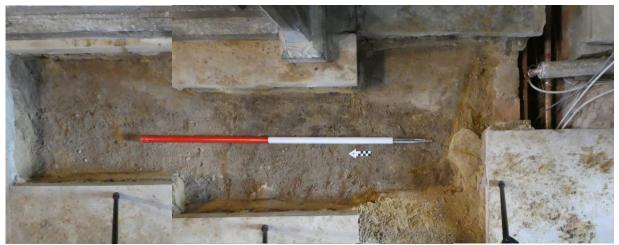
Figure 9: Trench in nave and south aisle, after excavation, looing east (scale = 1m)

below for inspection (Fig 9). While all the other slabs were bedded on sand, the floor slab edging the duct (south-east of trench) was bedded on a mixture of mortar and earth and a thin organic layer (decayed wood?) was visible just below the floor slab.

After removing the bedding, the bulk of the trench (northern three-quarters) came down onto a crumbly silty layer, with occasional small stones. A fragment of fine window glass was retrieved from the clean of this layer – it may have dated to the change in floors rather than the layer below; it is likely to be late medieval to early post-medieval (Appendix 2). Where this layer was not disturbed, it had a firm surface at 145–160mm below the current floor, (24.94m OD), possibly indicative either of a beaten earth floor, or of consolidation below a mortar or stone floor. It dipped from north to south.

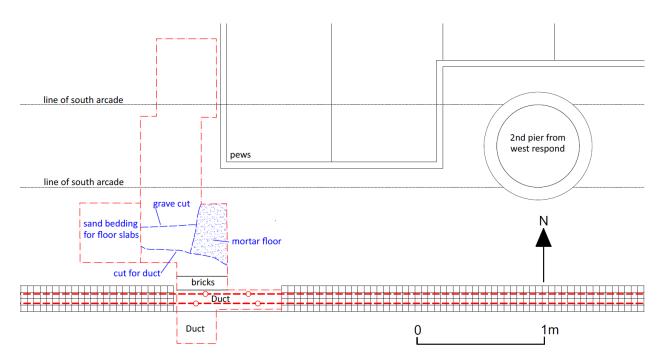
The south end of the trench was more complex, with three different features visible (Figs 10 and 11). Easiest to see was the sand-filled cut for the Victorian heating duct to the south, shown partially emptied on its north side. This cut into two earlier deposits: a loose deposit on the west, and a mortar surface on the east, which had been partly cut away by the builders. The loose deposit was very mixed: mainly silt with moderate chalk, moderate large lumps of clay, frequent small stones. Two fragments of disarticulated child's rib bone were found (subsequently reburied in the same place), and a fragment of rim from a mid-11th to mid-12th-century small jar (Appendix 1). Almost certainly, this is grave fill. On further investigation, the north side of the grave cut could be established c.0.50m from the Victorian duct to the south. Its east side probably cut through the mortar deposit, although this relationship could not be established for certain, within the constraints of the project and the trench.

The area of mortar had a very smooth upper surface, either indicative of a floor or the bedding layer for an earlier stone floor lower than the existing one; the surface was at 24.93m OD. An area was removed for examination (Fig 12), after the main excavation had been completed; it was seen to be lime-based, buff-coloured and even textured; it was not very hard. Below it was a second flat surface at 24.90m OD (Fig 11 and 12), which seemed to be a mixture of silt and mortar, with significant fine layering, including charcoal. This had the same uncertain relationship with the grave. These floors may have once been more continuous, with this area a fortuitous survival.

Unfortunately, there is little clear dating evidence for any of these features, except that they all pre-date the Victorian heating duct. Since the grave is cut into the principal deposit, the Saxo-Norman pottery found there must surely be residual, and the glass is also residual, found just below the bedding sand.

Figure 10: Plan of archaeological features in new duct south aisle-nave, plotted onto engineer's plan

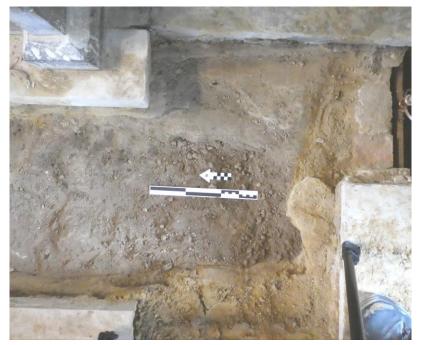
Figure 11: South end of south aisle-nave trench, after further investigation. Parts of mortar floors have been removed, and the loose grave fill can be seen. All of these are cut, on the south side, by the trench made to create the brick-lined duct (scale = 0.30m)

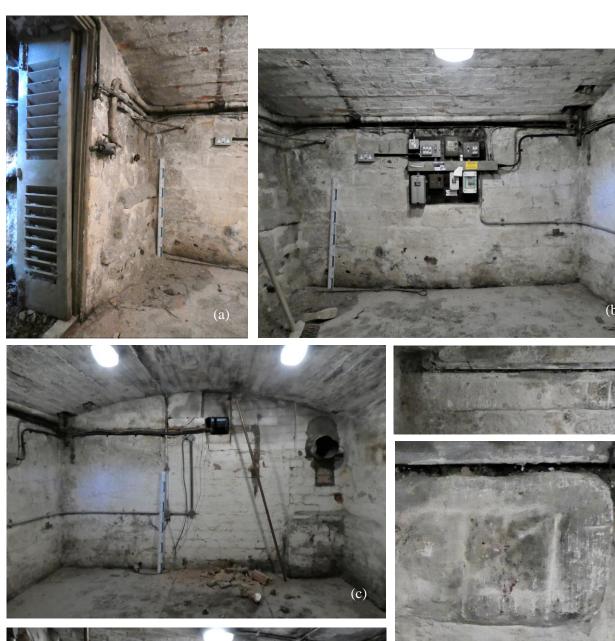
From an archaeological perspective, it is unfortunate that the whole chamber is whitewashed, since it is now impossible to comment on the geology of the ashlar walls. All the 14th-century work in the church is of Barnack stone, with the early 16th-century Lady Chapel being the first use of other building stone, also Ketton. Although the doorway, the brick vault, and various brick-lined insertions in the east wall are manifestly Victorian, or later, the same cannot be said of the stone walls themselves, especially in the lower sections, while whitewash obscures the relationship of the door jambs to the walls to each side. Apart from the stonework, the walls also have various unexplained plinths and other projections (e.g. a plinth in the south-west corner; a high ledge either side of the door including a possibly 11th-century grave cover (Fig 14e–f); and a partial plinth east of the door), all of which seem more in keeping with medieval techniques than 19th-century ones. The most likely medieval use of this space is either as a charnel house, or a crypt.

The probable gravecover is only c.115mm high (and more than 640mm long), has a roll-moulded edge on three sides, at least at one end, within which a small St Andrew's cross in incised. This is reminiscent of the much more ornate, and earlier (2nd half of the 10th century) mid-Kesteven covers, carved from Ancaster stone, which have decorative side panels (Everson and Stocker 1999, 36–46). If this is a correct

Figure 14: The boiler room. (a) northeast corner; (b) east wall; (c) south wall; (d) west wall and north-west corner; (e) and (f) probable reused 11th-century gravemarker in north wall.

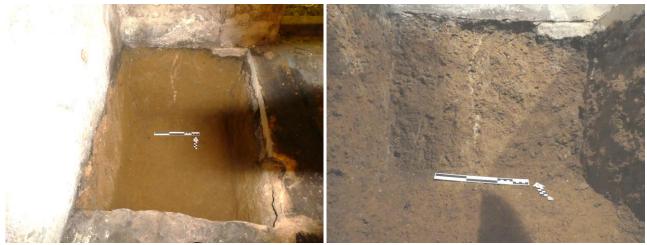
A pit for the new sump pump was cut into the north-west corner of the boiler room c.890mm north-south and 680mm east-west, to a depth of 530mm from the boiler room floor. The removed floor slabs (largest 225-330 x 780 x 70mm) were of a shelly oolitic limestone i.e. Barnack, if reused, or Clipsham if Victorian or later. This excavation (Fig 15) showed that both the walls and the floor slabs sit directly on natural, which, here, is a dark orange and gravel mixture, although there is a thin trampled layer at the top.

Figure 15: Pit for boiler room sump pump: (left) general view, looking north; (right) north section, showing solid sand and gravel (scale = 0.30m)

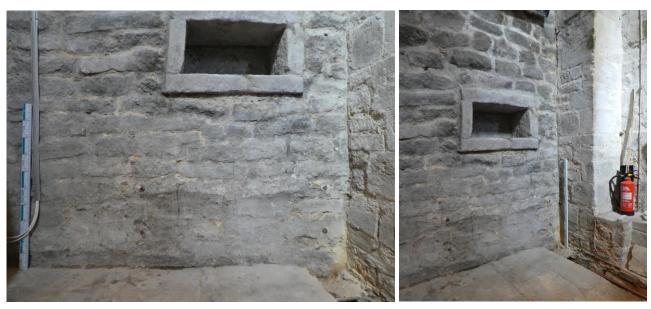
Figure 16: North wall of tower, temporarily exposed; 13th-century insertion at right hand side (scale = 1m)

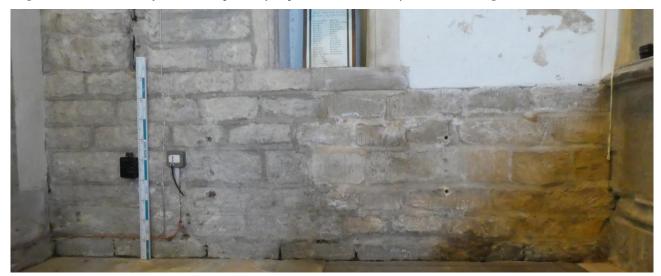
Figure 17: South wall of south aisle, temporarily exposed (scale = 1m)

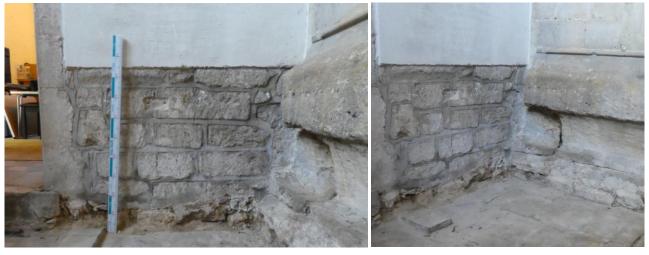
In the north chapel, the temporary exposure of the east wall revealed the top of the foundations (suggesting that the original floor level was higher than now); the relationship with the later east door; and the relationship with the south wall, which can clearly be seen as originally the exterior north wall of the chancel.

Figure 18: East wall of north chapel, temporarily exposed; foundations and earlier external wall of chancel can clearly be seen (scale = 1m)

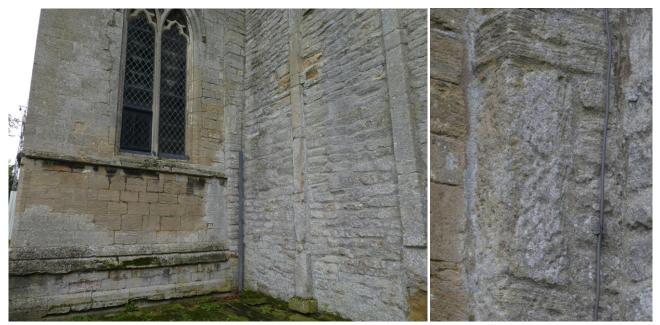
Purely by chance, a previously unseen item of Anglo-Saxon sculpture was identified, in the north-west quoin of the Anglo-Saxon nave, which can be seen at the exterior junction of the tower with the north aisle (Fig 19). It was identified by the strong textural difference between it and the much smoother long quoins and pilaster strips visible in the quoin and in the tower, and the sculpture is probably on two sides, with the right hand edge showing clear marks of retooling. It must pre-date the construction of the Anglo-Saxon nave, which is almost certainly contemporary with the tower. Unfortunately, the carving is very worn and the subject is difficult to make out; opinions have varied from a standing figure to a scroll. Further work on this piece requires specialist photography.

Figure 19: New sculpture in north-west quoin of Anglo-Saxon nave. Location is two stones above the cover to the lightening conductor, seen in the left hand picture
