Archaeological Report

Weirs and Channels East of the Lake,
Ragley Hall,
Alcester,
B49 5NJ.

Planning ref. 17/02593/FUL and 17/02594/LBC

Prepared by: Stephen Wass MA MCIfA, Polyolbion Archaeology

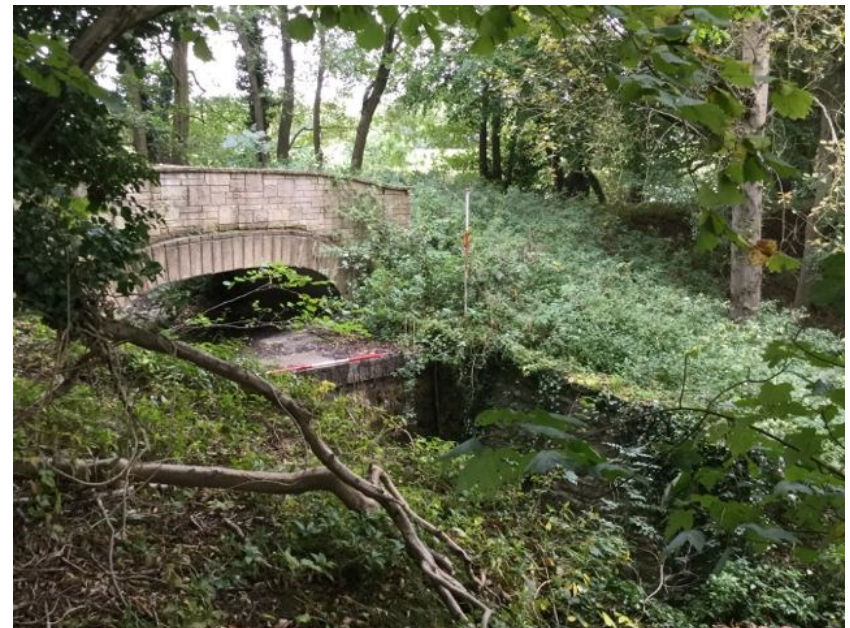
Fig 3 The bridge and the upper cascades before clearance, looking north west.

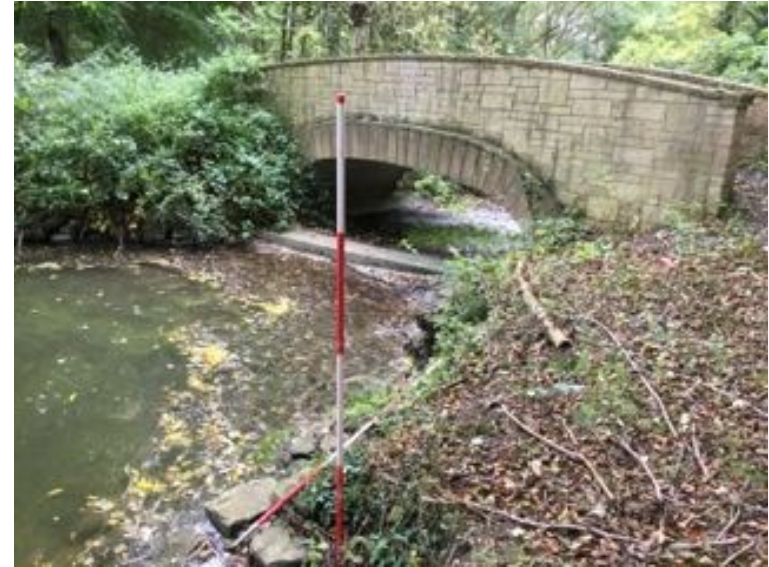
4.1.1 The intake from the lake to the west, the spillway and the bridge are twentieth-century constructions in concrete and reconstituted stone (Fig. 8) and are no doubt replacements for earlier features. The water is not drawn directly from the lake but through a small bay like harbour, oval in shape and roughly 20m (E – W) by 10m (N – S) entered through a narrow opening flanked by stone piers (Fig. 9). OS mapping shows a boathouse present here at least up until the 1920s and a few stone blocks to the south west of the bridge may be the remains of this.

Fig. 8 Twentieth century bridge and remains of boathouse looking north east.

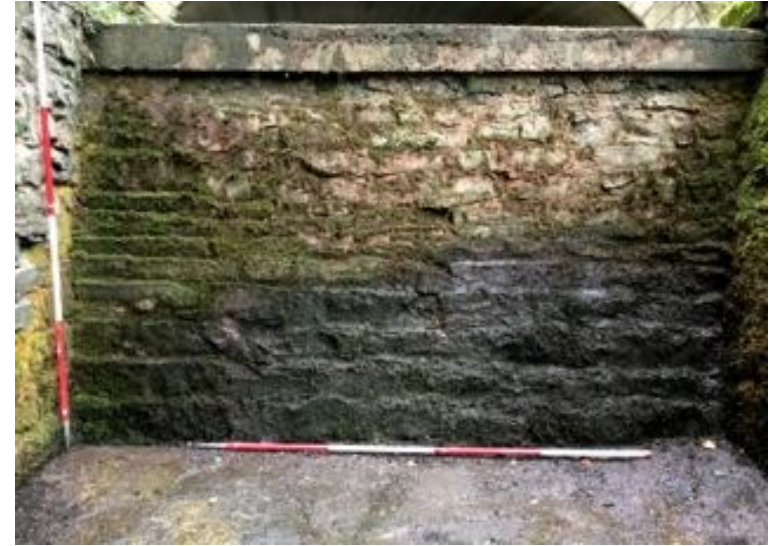
4.1.2 The first weir lies a couple of metres east of the bridge with a sloping face 3m wide and 2.1m high with a batter of 0.6m. the upper part of the stone face has clearly been rebuilt in less well coursed rougher stone blocks in a pinkish gritty mortar (Fig. 11) filling in a hollowed out profile suggesting a major episode of failure and erosion of the earlier fabric. The original face has regular diminishing courses.

Fig. 11 Weir 1 showing repair and diminishing courses of original work looking west.

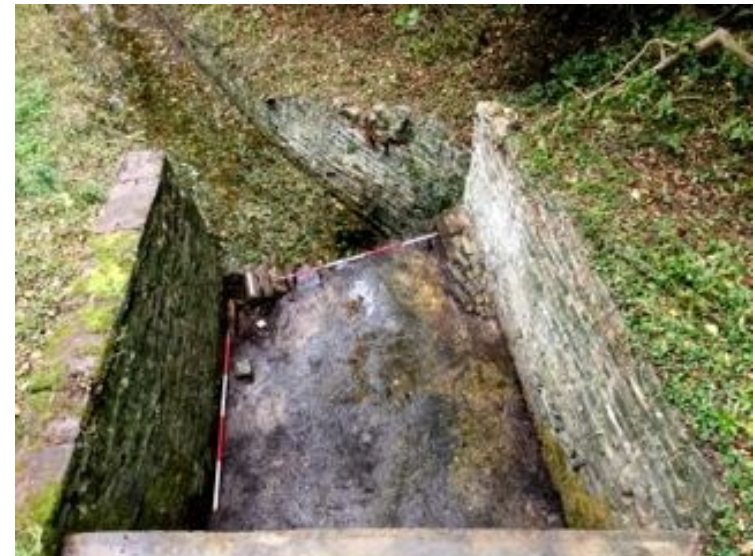
Most of the base of the channel between weirs 1 and 2 is concrete lined but the remains of a pitched stone surface rise at the edges immediately above the lip of weir two indicating a gently curved profile for the original base of the channel at this point (Fig. 12). The channel is edged by two high flanking walls, that to the east is capped by stone coping slabs linked with iron cramps.

Fig. 12 Channel approaching lip of weir 2 with flanking walls and remains of pitched stone base looking south east.

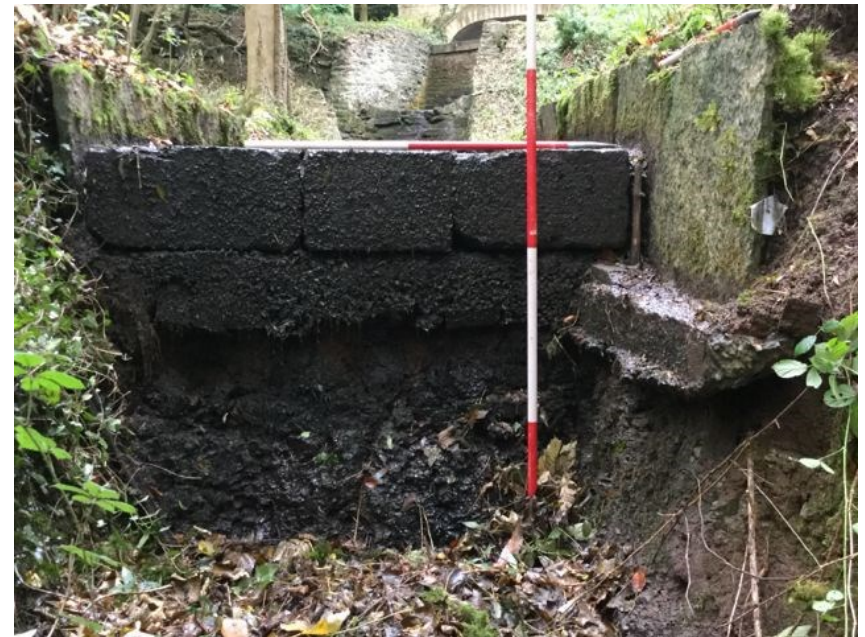
4.4.1 The east end of the brick lined channel is defined by a similar set of stone blocks to those which exist at the junction with the stone sets to the west. They are founded on a large block of concrete which extends on the north side indicating that the original fall to the next level of the channel was about 0.3m (Fig. 22), however, beyond this point structures have failed and erosion has taken out most of the base and lining of the channel deepening it by nearly a metre.

Fig. 22 Weir 3 looking west.

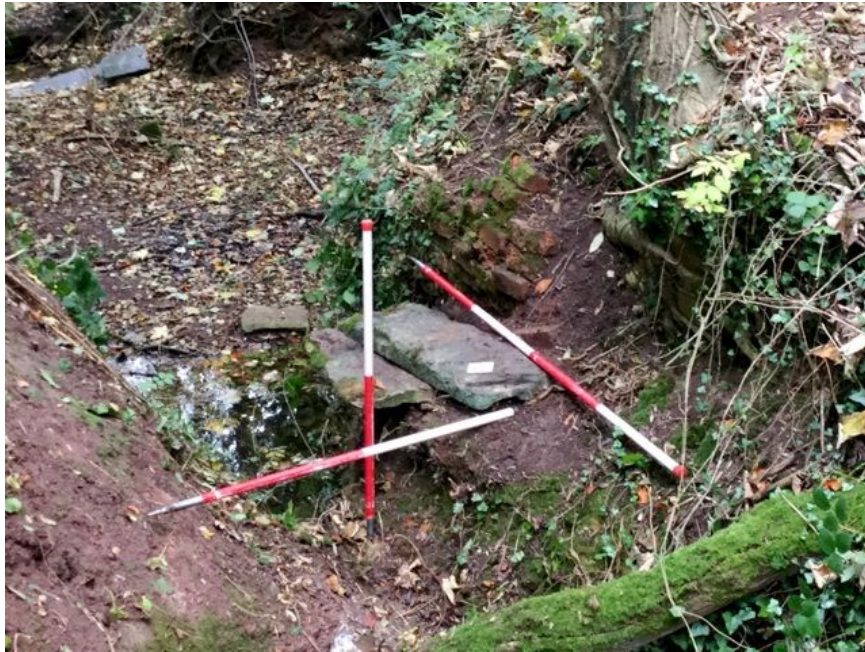
Fig. 23 Remains of stone slabbed base and brick lining above the site of weir 4, looking south east.

Around 5m downstream, on the south side of the channel are a pair of large stone slabs whilst above them the bank is revetted in brick (Fig. 23). Immediately beyond these remains the water plunged down almost 2.5m into deeply cut ravine (Fig. 24) which broadens out into a scoured pool measuring some 10m in length and 7m in width. The margins of this expose the red marly clay derived from the underlying mudstones.

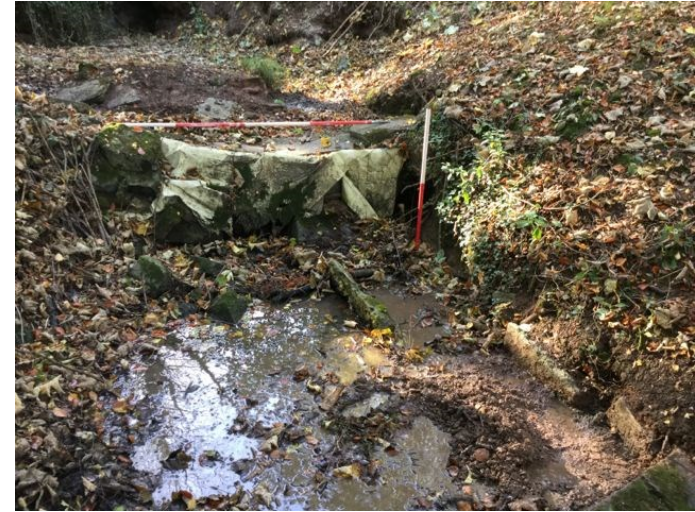
4.5.1 Weir 5 some 10m downstream from the site of weir 4 marks the end of the area of heavy scouring. The structure here was difficult to interpret on account of recent repairs with cement and plastic sheeting (Fig. 27). It seemed to consist of two or three courses of roughly shaped blocks of stone but several had been dislodged and there was a large quantity of rubble directly below the cascade so it may originally have been higher. During its demolition it was noted that some of the underlying structure was of brick set on a wooden beam above further plastic sheeting so the entire fabric could be a modern rebuild (Fig. 28). The channel below it and weir 6 was heavily silted and it was not possible to examine the base of the channel however it was lined with the same kind of vertical stone slabs as seen next to the brick base above weir 3.

Fig. 27 Weir 5 and channel looking south west.

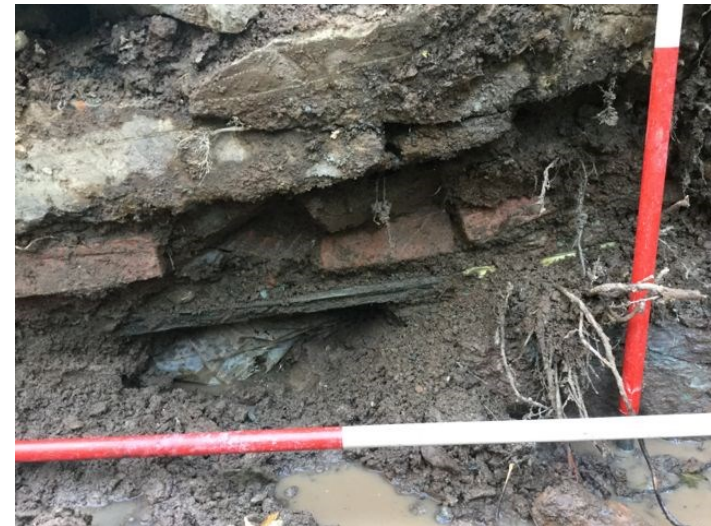
Fig. 28 Rear of weir 5 during demolition.

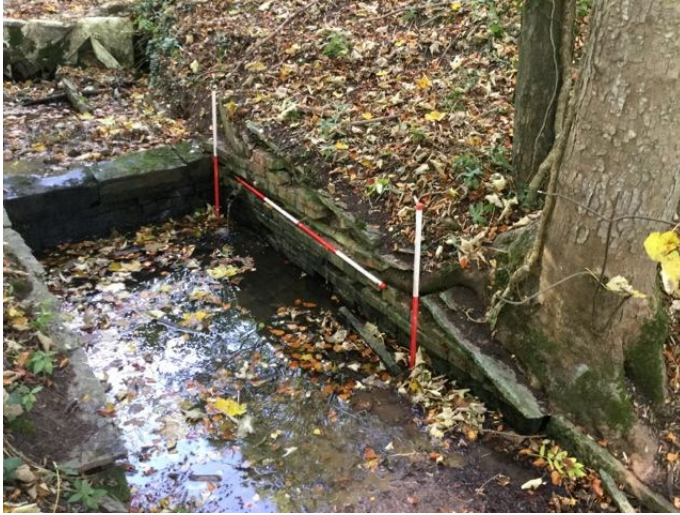
4.5.2 Weir 6, 4.5m beyond weir 5 was in a better state of repair and consisted of a single course of well shaped stone blocks above 5 or 6 courses of brickwork. This was carried round to edge the downstream channel for around 5m with flanking walls with stone coping slabs (Fig. 29). The channel at this point was water filled and heavily silted in places. The brick walling gave way to edging with vertical stone

Fig. 29 Weir 6 and brick lined channel looking west.

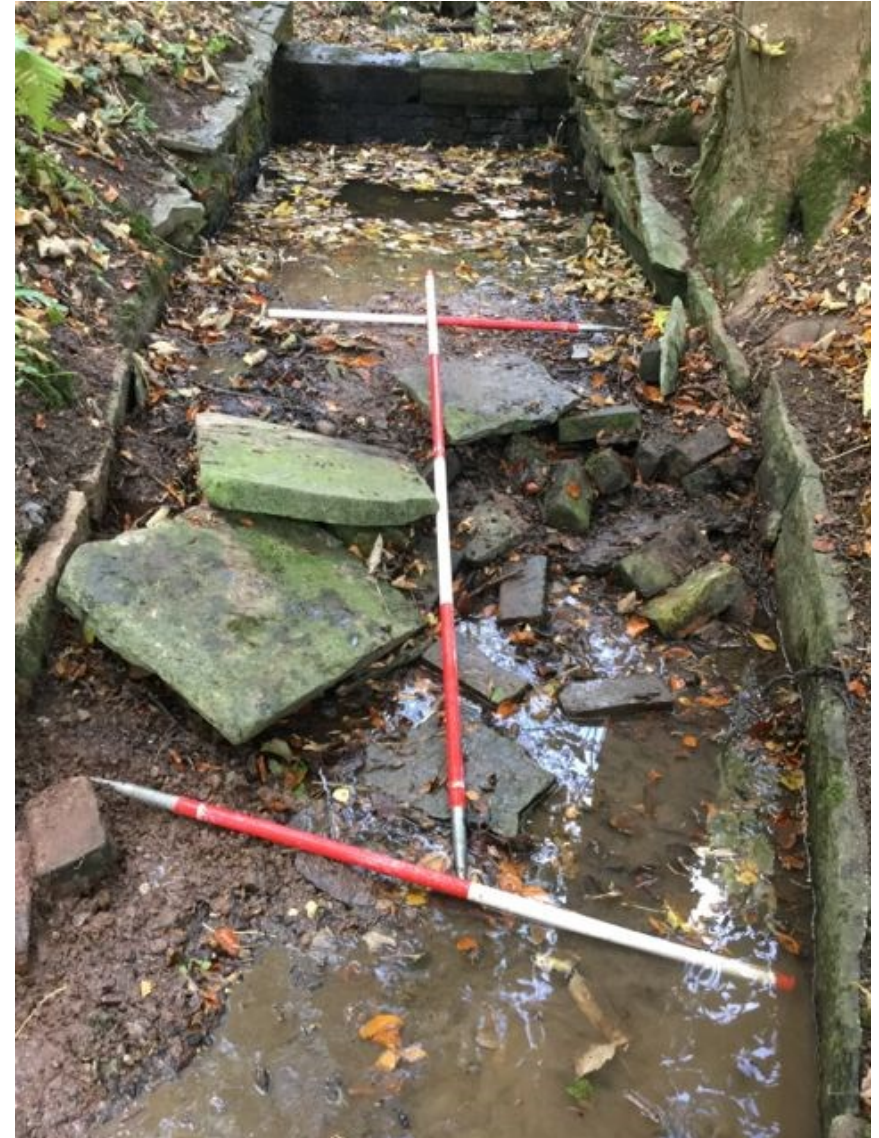
slabs at which point a series of stone slabs and tumbled bricks partially blocked the channel. White interpreted these as the remnants of another weir (HA 3.3).^{*} Examination of the remains revealed no trace of any structural integrity and the deposit could simply have been made up of material such as edging stones washed down from further upstream (Fig. 30).

Fig. 30 Stone slabs and brick rubble east of weir 6 looking south west.

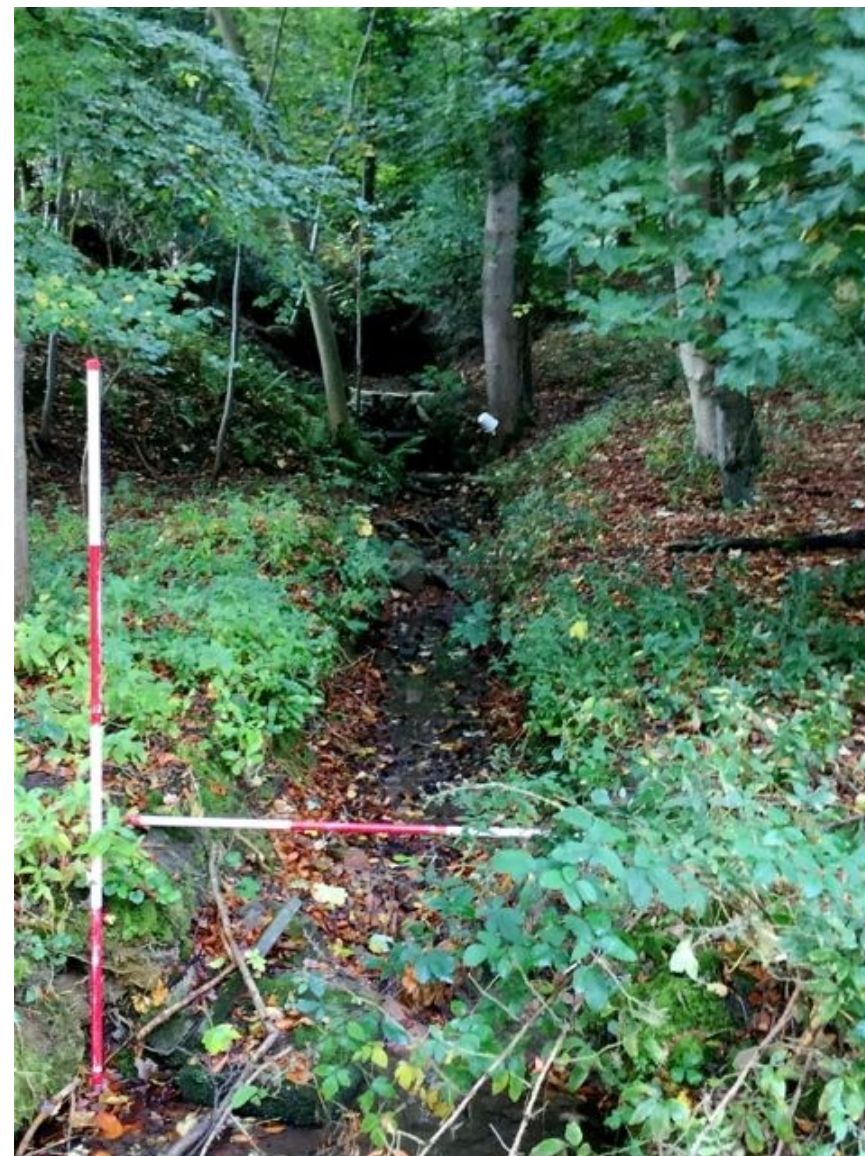
4.6.1 The remainder of the channel continued down the valley in a north easterly direction for just under 15m (Fig. 36). There was no evidence of stone or brick lining for any part of this although plenty of brick and stone fragments had accumulated within banks of silt. Small test pits were dug into the bank at three locations to confirm the lack of any structural elements. Indeed early OS mapping indicates that the original line of the out flowing channel appears to bend slightly to the south beyond weir 6 on a line today marked by a shallow dry ditch (Fig. 35). The present day channel finishes at a small, heavily silted up, pool south of a derelict brick pump house. At this point are the remains of what may have been another small weir consisting of a couple of stone blocks in situ and one larger one displaced into the pool to the north (Fig 32).

Fig. 32 Channel looking south west with possible remains of weir 7 in the foreground.

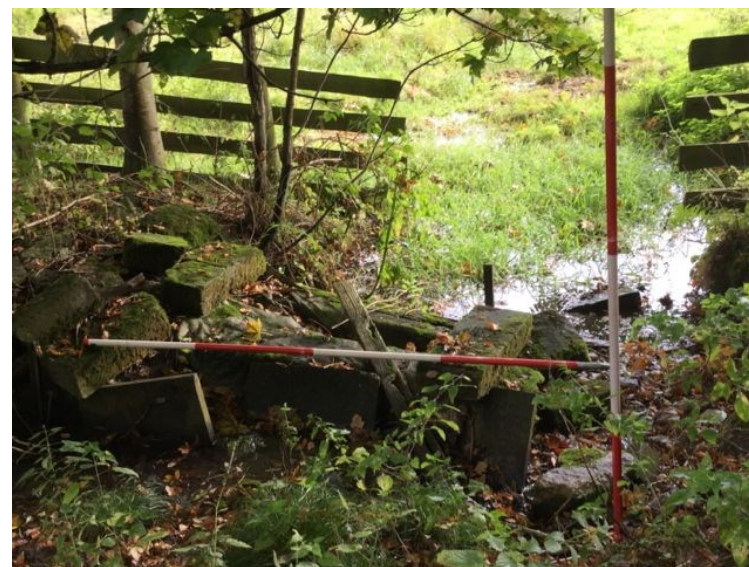
Fig. 35 Dam 8 looking north east.

of stone and concrete blocks with some timber and again appears to be quite recent (Fig. 35).

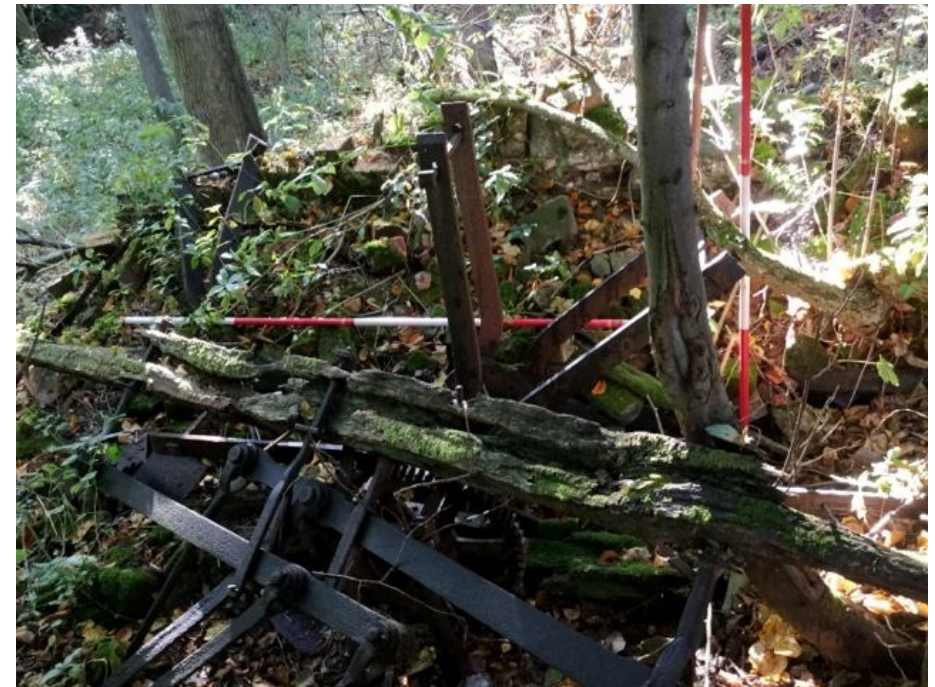
4.8.2 A demolished pump house with the remains of an iron water wheel and associated pumping mechanism lies on the eastern face of the dam roughly 30m from its northern end (Fig. 37). It is shown on the tithe map compiled between 1847 and 1853.^{xii} Presumably this was fed via a conduit underneath the dam and controlled by a lake side sluice, although the bank above the site was examined no trace could be seen of this mechanism.

Fig. 37 Remains of water wheel and pumping mechanism looking south.
