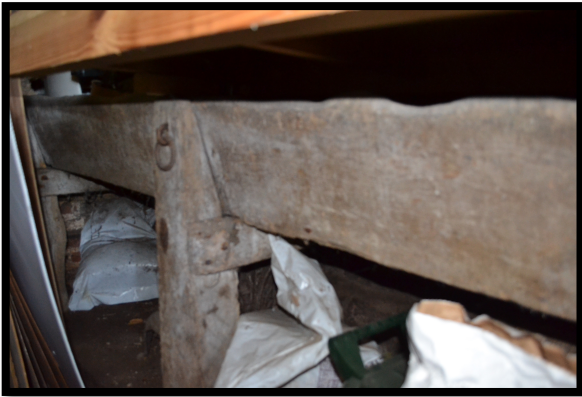
Plate 6. The Barn (Area 1), ground floor, north elevation - The manger still in situ under the modern workbench (facing north)

Below the rail two lengths of close boarding 9" & 6" (c.27 & 23cm) continues to create the back wall of the manger. A single board 10" (c.25cm) creates the base of the manger and a single piece of timber 11"x 2" (c.28cm x 6cm) creates the angled front wall. It is worn in two places in the second section from the west where the chin of the livestock rested while eating.

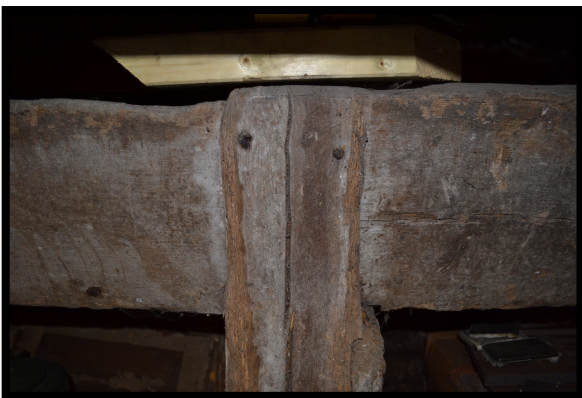
Plate 7. The Barn (Area 1) - Vertical supports to front of Manger

Five vertical supports 6"x 4" (c.15cm x 11cm) are rebated at the top to provide a support rest for the manger trough. A 3½" (c.9cm) horizontal brace is lap jointed by

1”(c.2.5cm) to the side of each support on the east side (except for the last timber to the east which is cut on the west side) and cut into the rear brick plinth. The far east and west support have an additional 4” (c.10cm) timber planted on to the outside edge. All except for the central support have an iron ring to the front to secure the livestock. All the timbers are chamfered to protect the livestock from damage. The manger would be for corn or cooked feed and the rack for fodder and is typical of the designs in farm books of that 19th Century. According to the owner, before its conversion to a garage, a central screen wall divided the stable area to create two stalls.

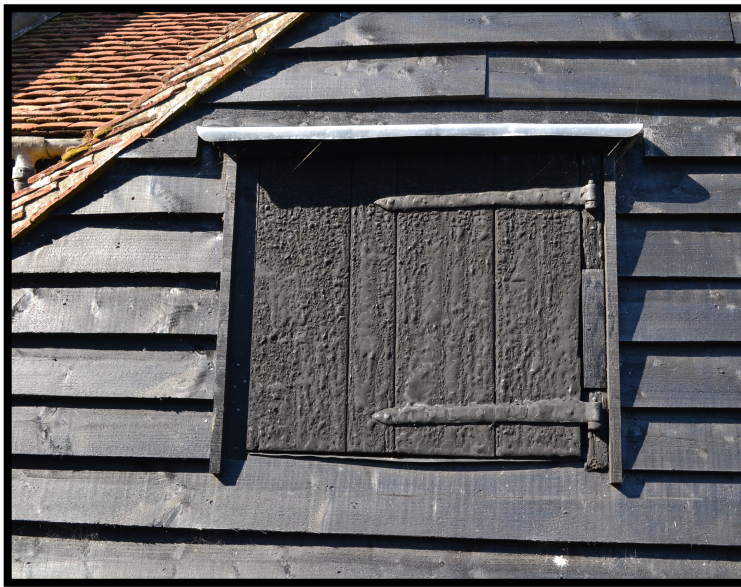
A pitching hatch, set between the Queen posts on the first floor of the north elevation is a later addition; the Queen posts have cuts for noggins. The tie beam acts as the cill trim and the collar as the head trim. However, there is no evidence of wear on the tie beam from use. The door is constructed from weatherboarding in a vertical composition with iron pin-hinges cut into the west Queen post; an iron hook and eye once secured it, but the hook is no longer in place.

Plate 8. The Barn (Area 1), ground floor, east elevation, external - Window/pitching hatch - probably a later addition (facing west)

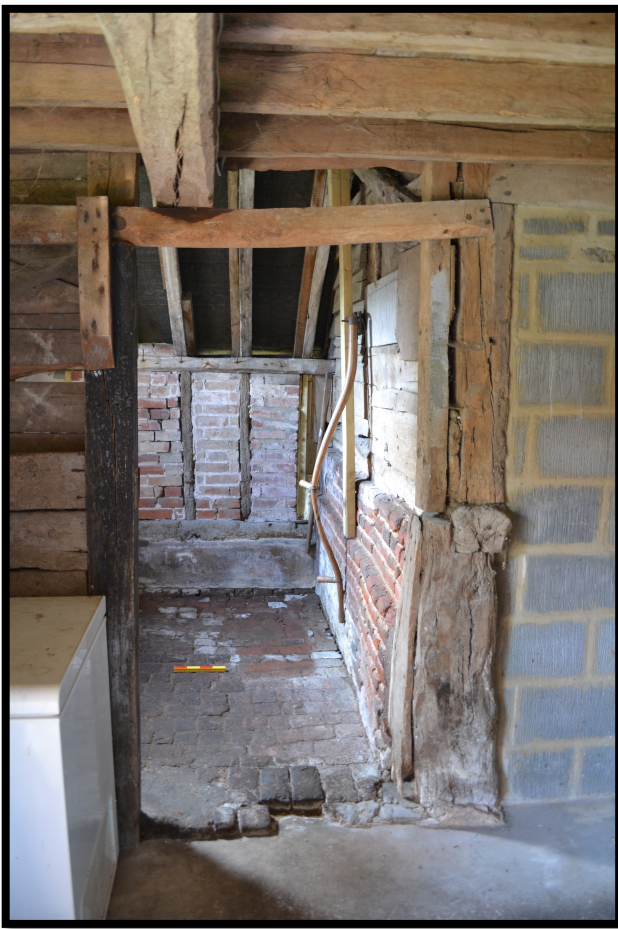
Plate 9. The Barn (Area 1), ground floor, facing south - Southeast room

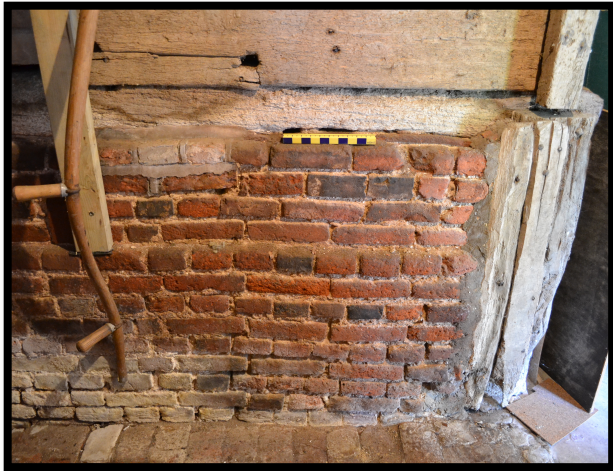
The east wall has the red brick plinth wall in English bond and is at the same height and on alignment with the plinth on the north side of the west elevation adjacent to the garage doors.

Plate 10. The Barn (Area 1), ground floor, facing east - East wall of southeast room

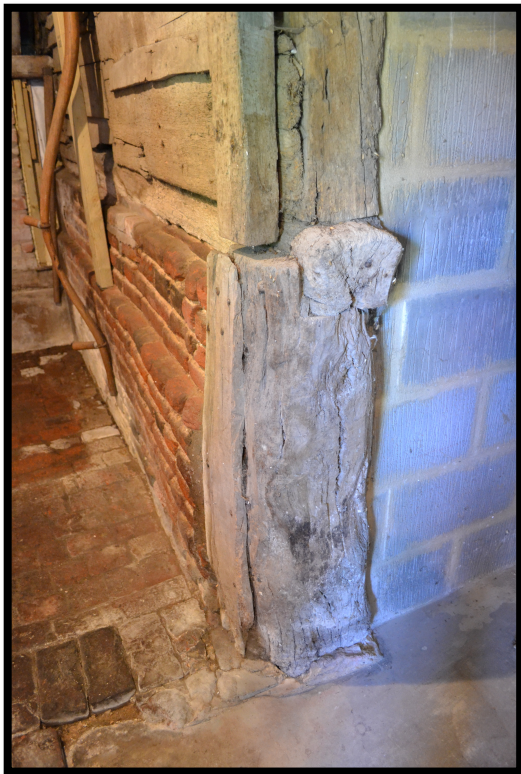
Plate 11. The Barn (Area 1), ground floor, facing south – Southeast room entrance

A wall plate rests on the wall and laps into the post at the end of the wall. The evidence suggests that this is the original outer wall. There is no evidence of jointing between the midstreys and the west elevation. In most cases the beams do not meet and the constructions are of a different style. The Ordnance Survey maps show that there was always a midstreys on the barn, but they also suggest that the barn was taken down in
