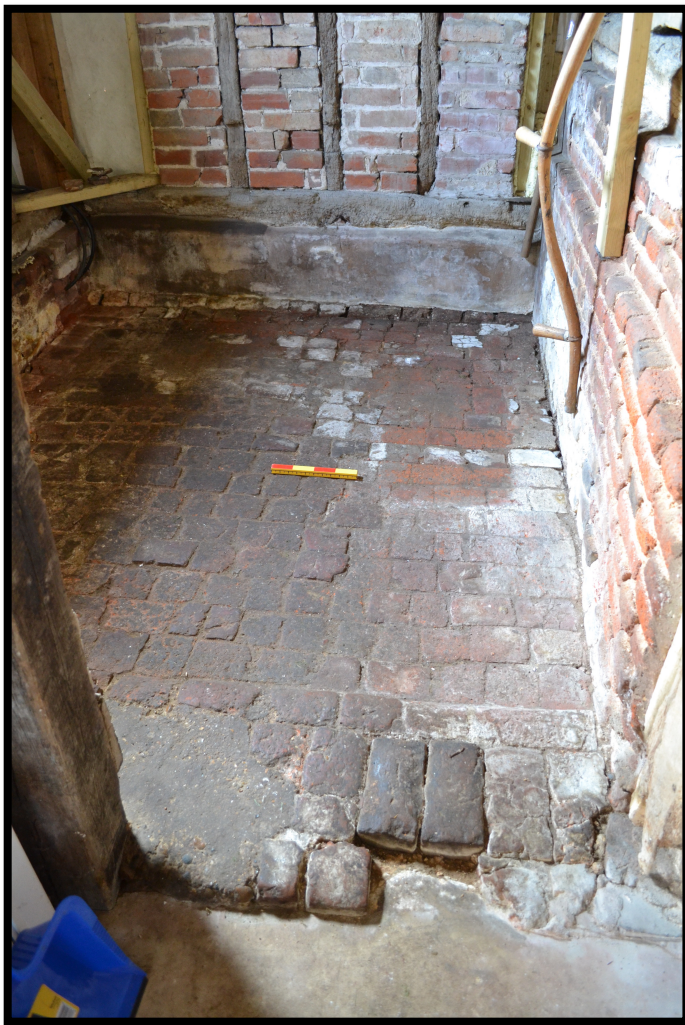
Plate 12. The Barn (Area 1), ground floor, facing south - Brick floor to southeast room

The floor is made of half brick with brick threshold and appears to be the same as the bricks used in the plinth.

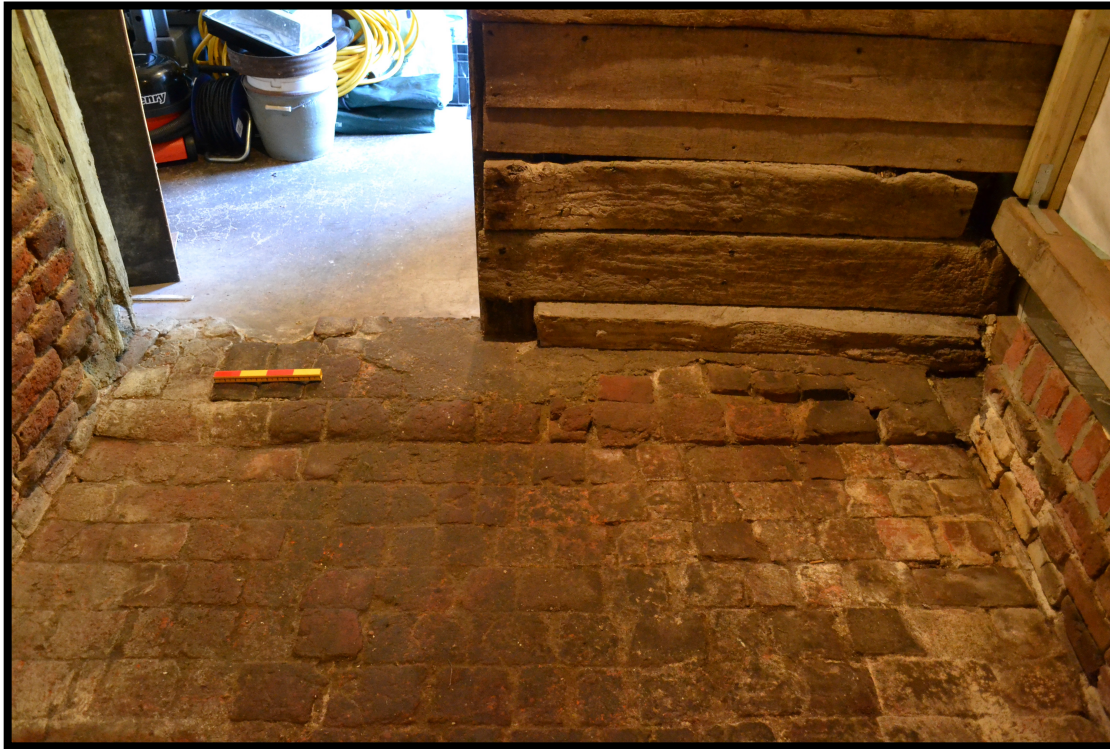
Plate 13. The Barn (Area 1), ground floor, southeast room, facing north - Threshold

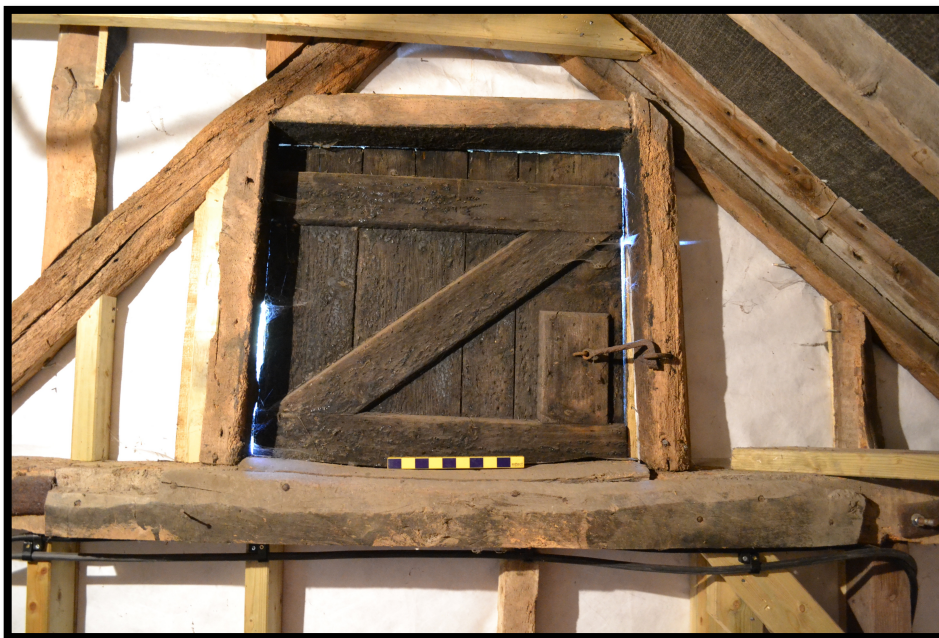
Plate 14. The Barn (Area 1), ground floor, southeast room, internal, facing east - Window pitching hatch

A second pitching hatch is at high level on the ground floor. The door is constructed from 7"/9" x 1" boards in a vertical composition with ledge and brace. A tapered long leaf iron pin-hinge is cut into the stud and an iron hook and eye once secures it. There is significant wear on the cross beam that creates the cill, either from the loading and unloading of stock or possibly from the chin of an animal resting on it (it is noted in books from that era that a brick floor is preferable for stables and the description of the farmyard notes further stabling beyond the barn) (*Parker Unknown, 193?*). Similar boards are used on the internal walls of the barn and the manger. On the first floor, a modern softwood double casement window is cut into the existing beam on the first floor of the east elevation. The midstrey has a catslide roof to the south.

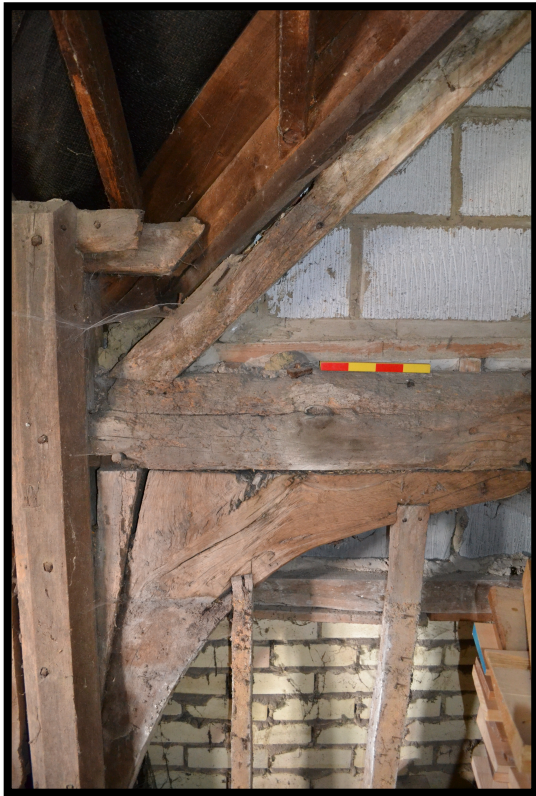
The south elevation of the Barn has been divided from Strelley Barn with modern blockwork; therefore, the original construction is no longer visible. However, with the kind invitation of the neighbours I was able to view the southern end of the Barn and take photographs. It is similar construction to the north elevation of the Barn.

Plate 15. The Barn (Area 1), 1<sup>st</sup> floor, South elevation, internal - modern partition to Strelley barn behind
