Type FW3/23 Pillbox, Wet Dock Knuckle, Port of Boston

Level 2 Historic Building Recording

October 2021

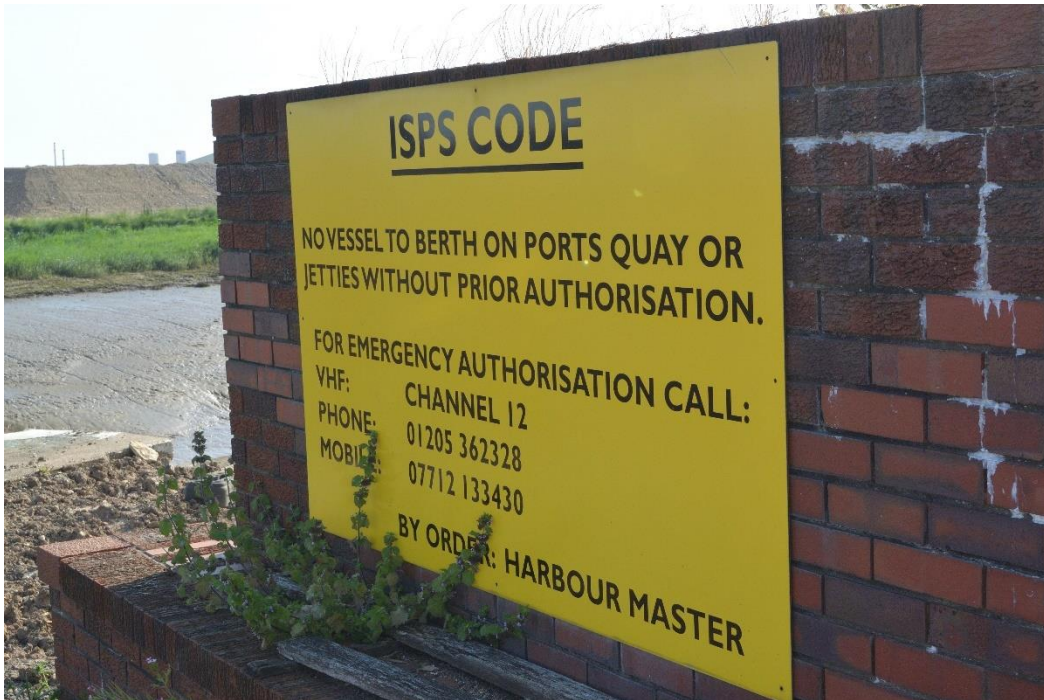
Photo 3.3: Photo of structure before removal of bricks and Port of Boston Signage (eastern end of structure)

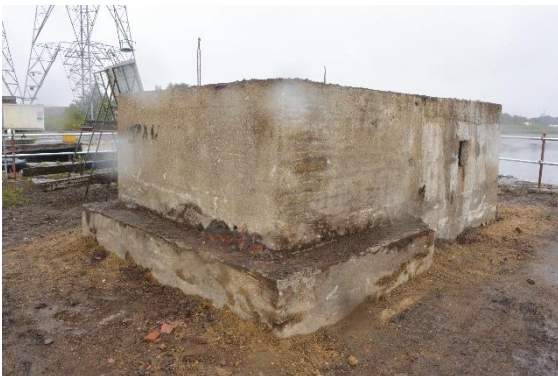
Photo 4.1: Western and southern elevation of the pillbox. Showing step around open chamber.

The lip/step around the outside of the unroofed chamber does not seem to be present on surviving FW3/23 pillboxes, in the wider area. Due to the absence of an external door (not uncommon among this type of pillbox), it is possible this was put in to help egress.

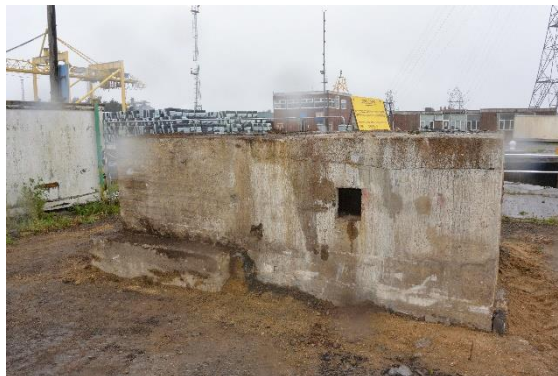
Photo 4.2: Southern elevation. Showing southern embrasure and step round open chamber.

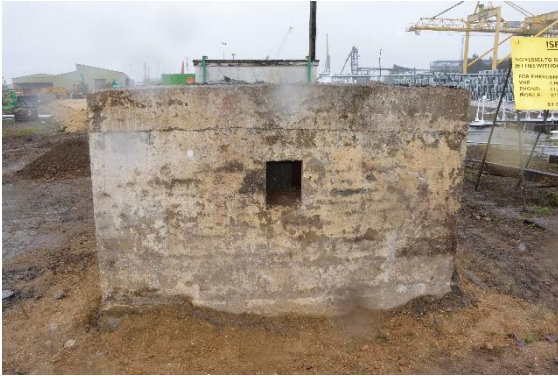
Photo 4.3: Eastern elevation. Showing eastern embrasure.

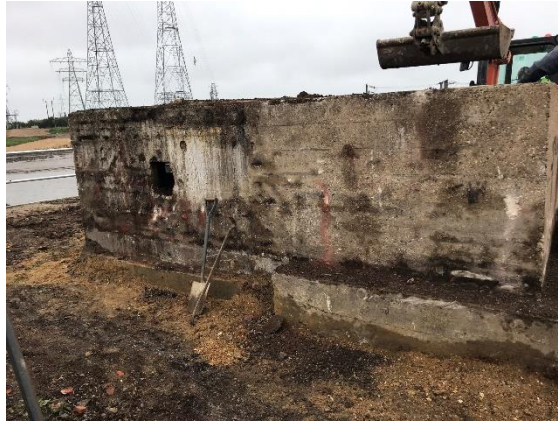
Photo 4.4: Northern elevation. Showing step and northern embrasure.

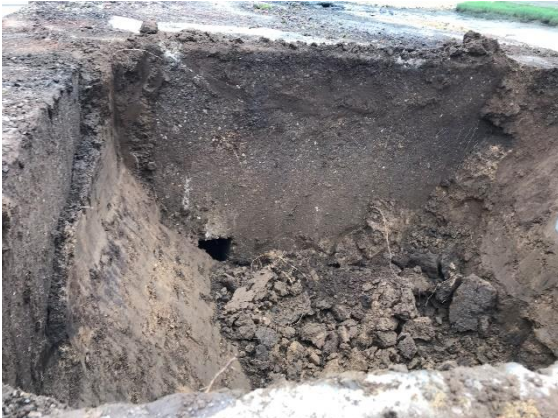
Photo 4.5: Top of open chamber, with infill partially removed. Top of doorway to roofed chamber partly shown.

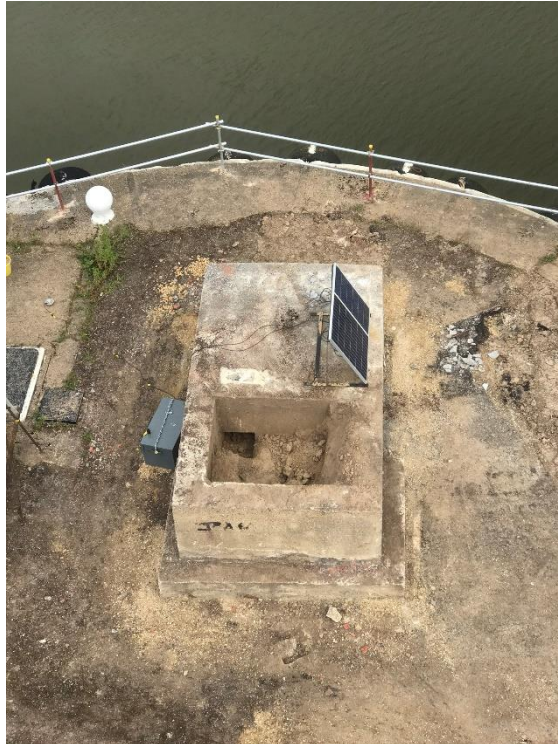
Photo 4.6: Overhead view of pillbox.

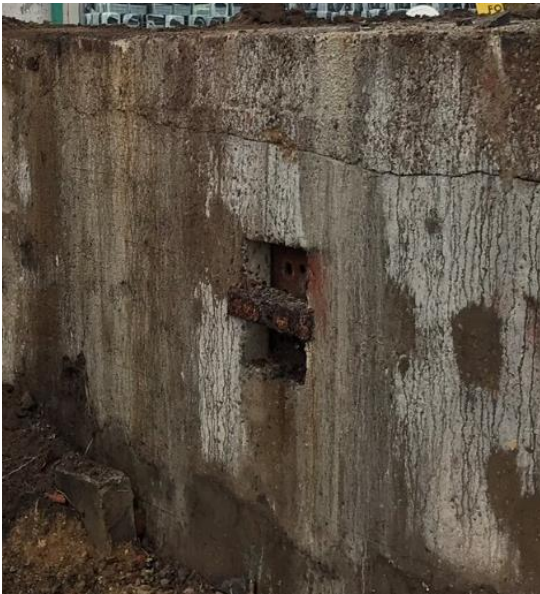
fitted in the past with an internal wooden frame and covered in a mesh and then blocked with a metal plate (possibly done as part of the bricking up process). These were removed during the removal of the bricks.

Photo 4.7: Fixed plate within southern embrasure.

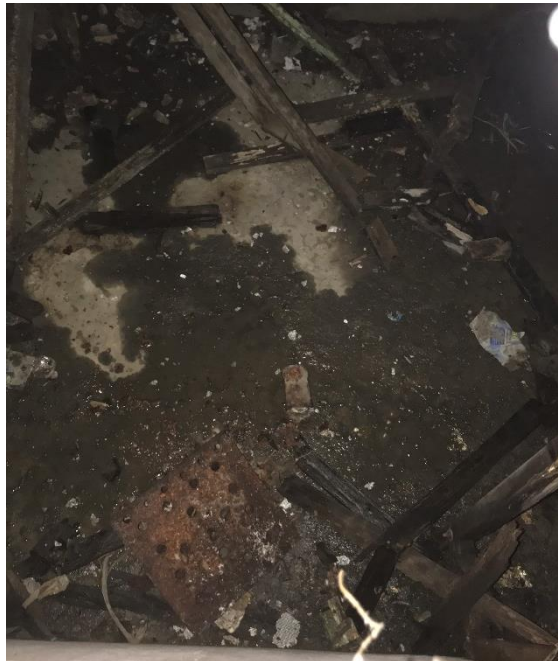
Photo 4.8: Embrasure plate on floor of pillbox and remains of wooden/metal frames.

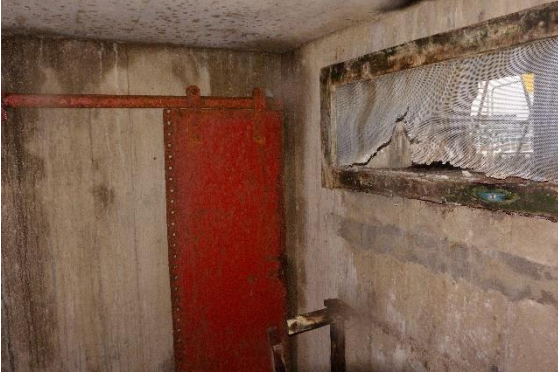
Photo 4.9: Taken through eastern embrasure. Internal door, northern embrasure and top of wood/metal frame.

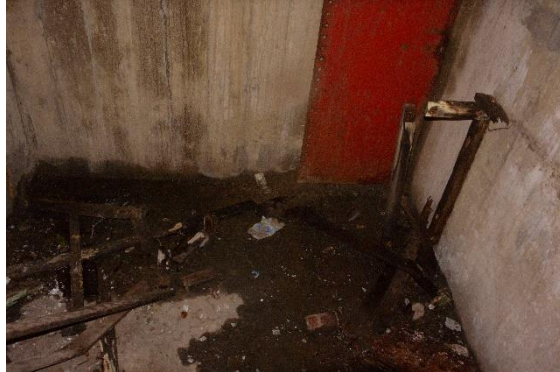
Photo 4.10: Floor of pillbox showing water and soil ingress.

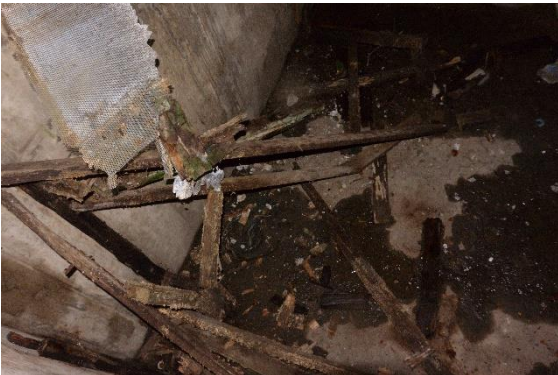
Photo 4.11: Remains of wood/metal frame.

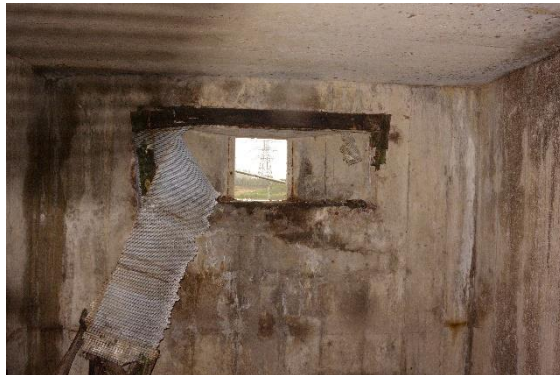
Photo 4.12: Taken through the northern embrasure. Showing the southern embrasure.
