# **Barn at 2 Lodge Lane, Cronton, Knowsley**

Level 2 Historic Building Record

661544

**JULY 2018**

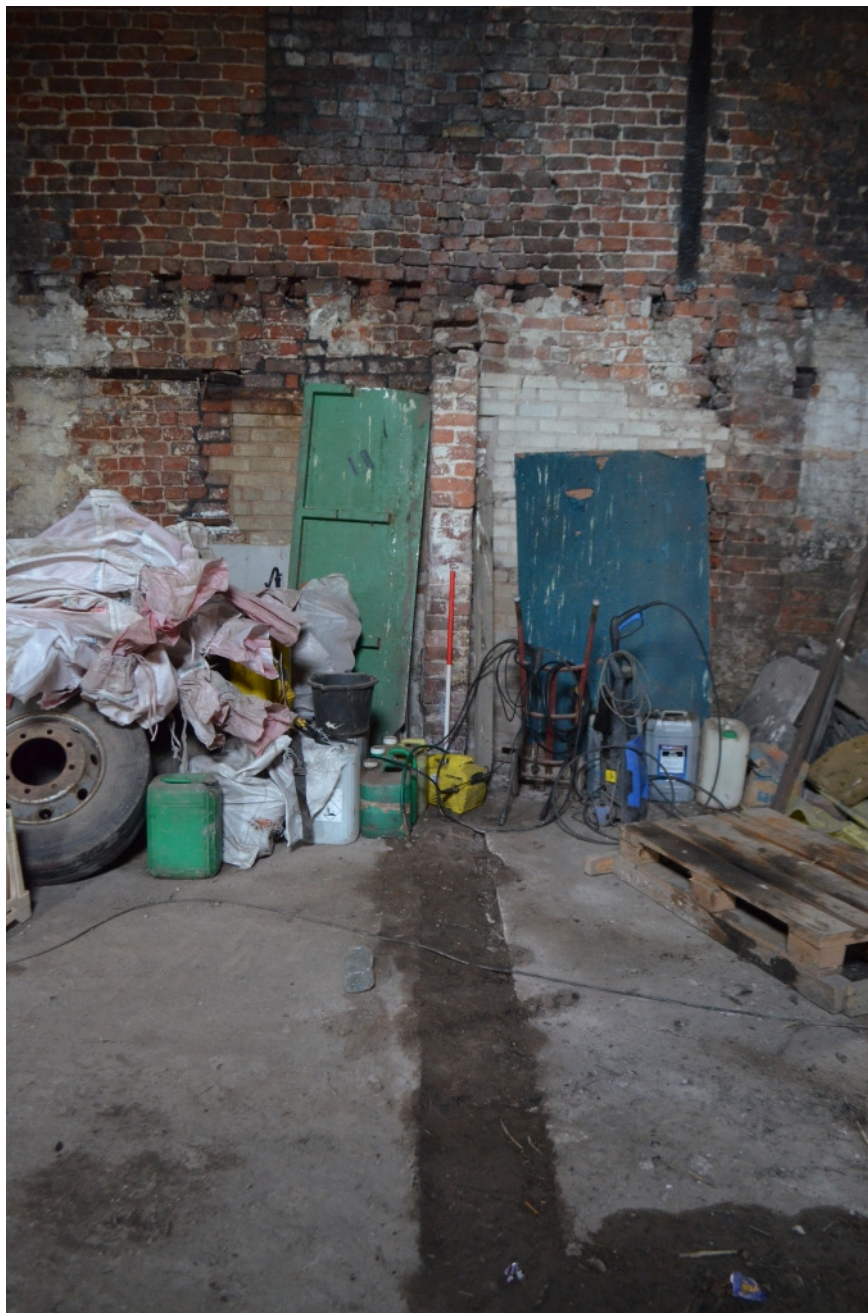
Report 661544: Barn at 2 Lodge Lane, Cronton: Level 2 Historic Building Record		Photographic Survey
Client: Mr P. Walton	Photo No. <b>019</b>	Date: 09.03.18	Direction Taken: NW

**Description:** Door D5 blocking sequence and decorative brick arch above

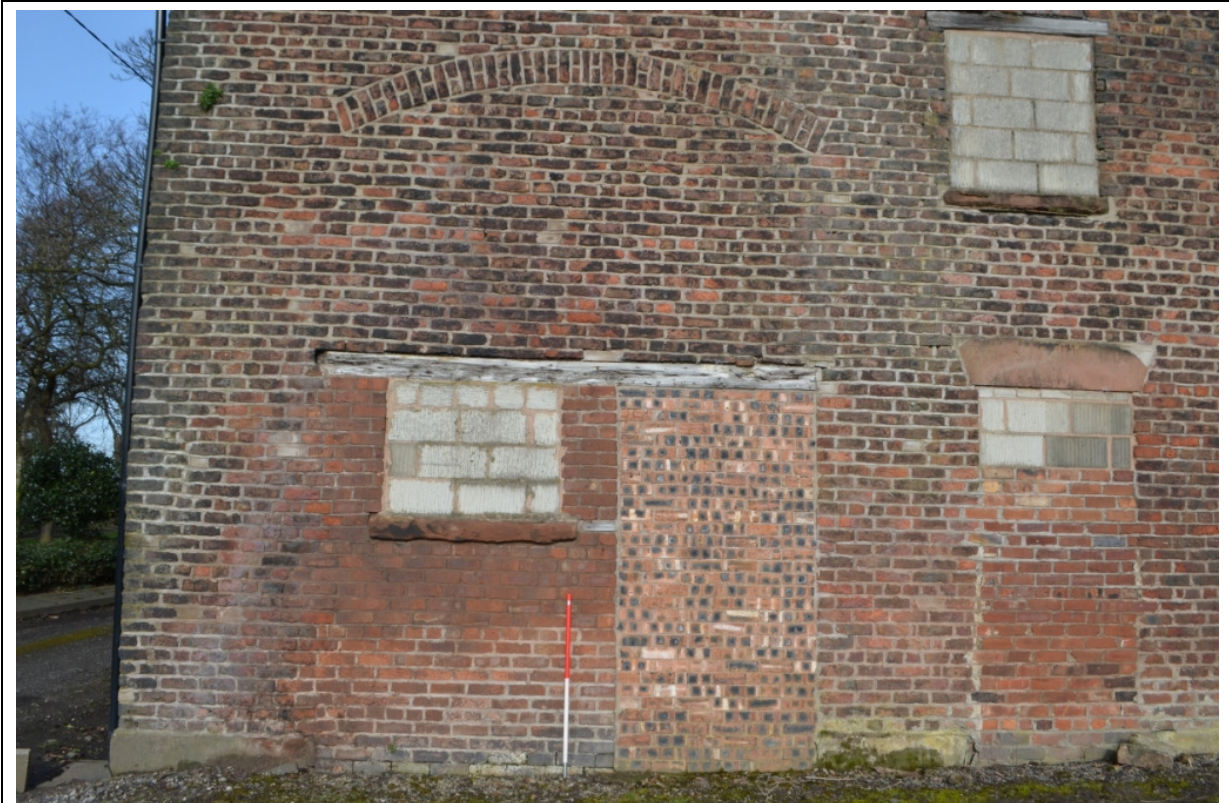
Report 661544: Barn at 2 Lodge Lane, Cronton: Level 2 Historic Building Record		Photographic Survey
Client: Mr P. Walton	Photo No. <b>020</b>	Date: 09.03.18	Direction Taken: SE

**Description:** Blocked door D6 to Room 1 integrated cart shed

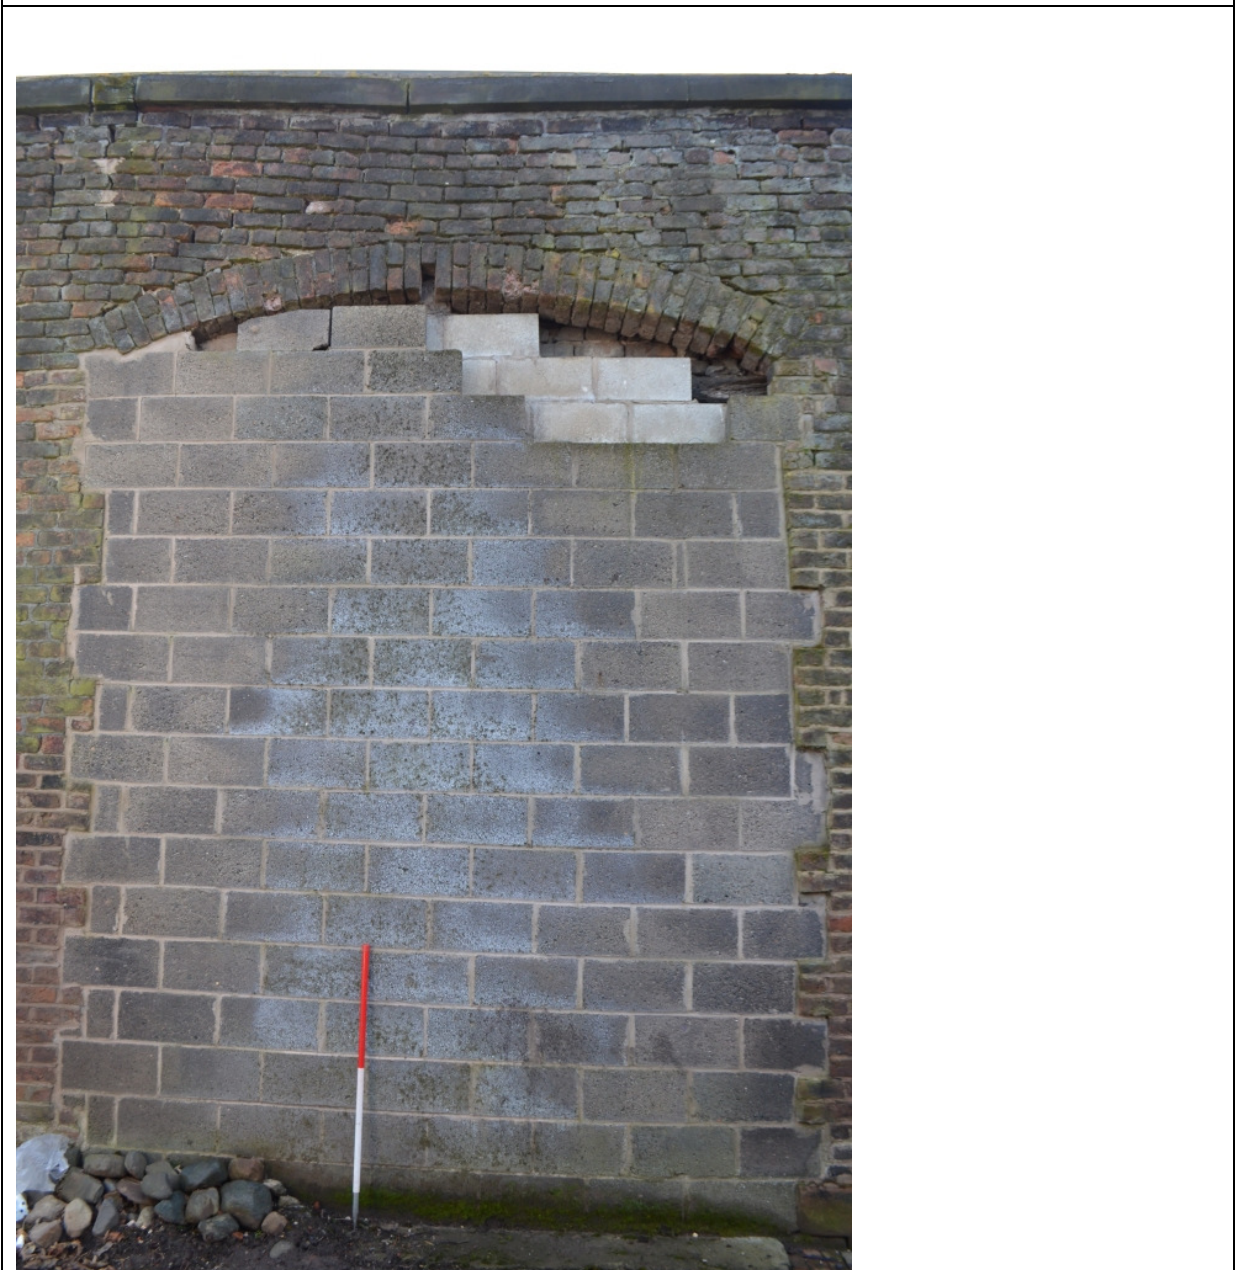
Report 661544: Barn at 2 Lodge Lane, Cronton: Level 2 Historic Building Record		Photographic Survey
<b>Client:</b> Mr P. Walton	<b>Photo No.</b> <b>021</b>	<b>Date:</b> 09.03.18	<b>Direction Taken:</b> SW

- 6.28 Door D7 remains open and has a modern UPVC door and frame below a red sandstone lintel. Within this is a two part timber door. Doors D8 and D9 have been blocked with late 20<sup>th</sup> century brickwork/concrete block and the original lintel above D8 removed. All of these doors have worn red sandstones steps at their base (Photo 021).

**Description:** Example work sandstone threshold (D8)
