## PETERBOROUGH CATHEDRAL: THE TRANSEPT CEILINGS

**Record of Treatment and Additional Investigations  
following a fire in the Cathedral on 22 November 2001.**

**JULY - OCTOBER 2002**

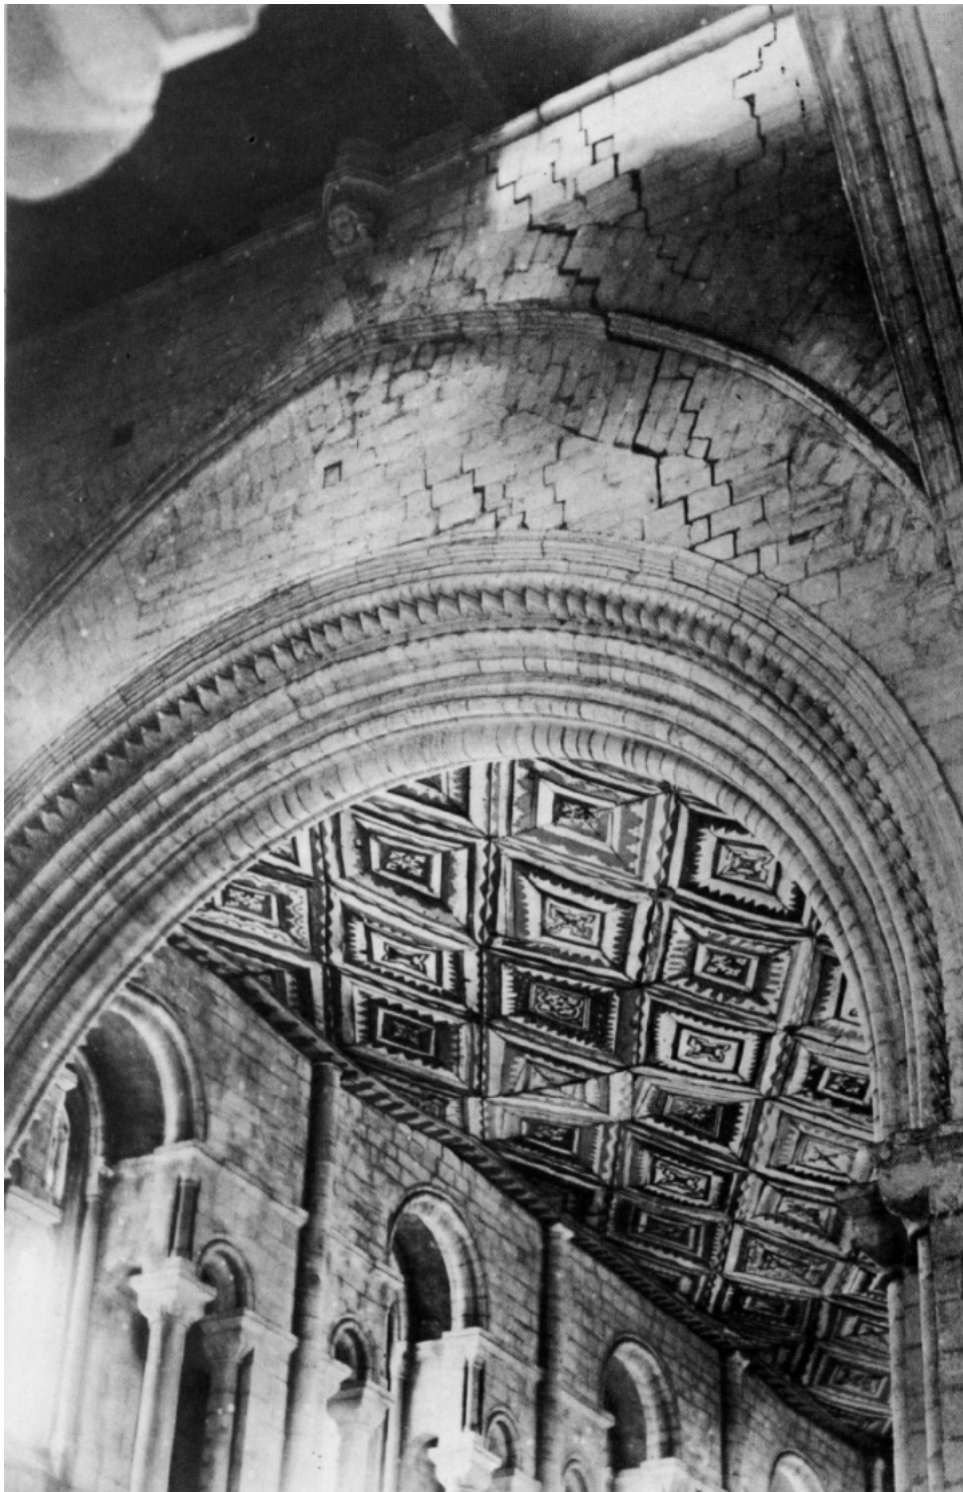
**Figure 4.** *Pre-1880s photograph showing a section of the North Transept Ceiling as well as significant structural cracks in the north crossing arch wall.<sup>9</sup> Evidence suggests the ceiling painted decoration is significantly different from the thirteenth-century linear design. It is probable the alterations were made in the 1740s and that scheme was simply repainted in the 1830s.*

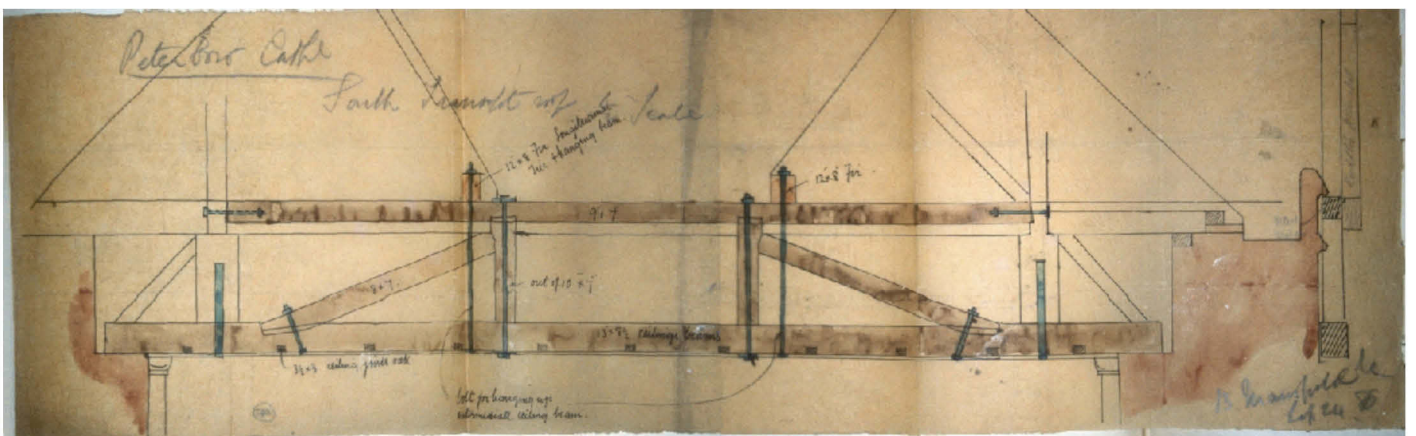
**Arch Draw 8.** North Transept - J.T. Irvine's drawing showing Blore's roof structure shown yellow with the Robert de Lindsey ceiling beams suspended from a softwood longitudinal beam shown yellow hung from the post tie beams. Note Irvine's curious inclusion of what appears to be an upper layer of ceiling boarding above the noggin's. This is probably a mistake in interpretation.

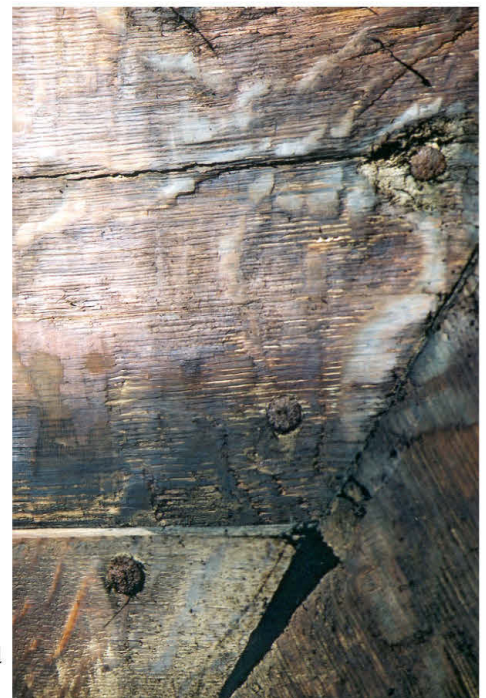
Plate 5. Detail of an area of the on the edge of an 1890s board. Samples were obtained for analysis from this area (Sample 2).

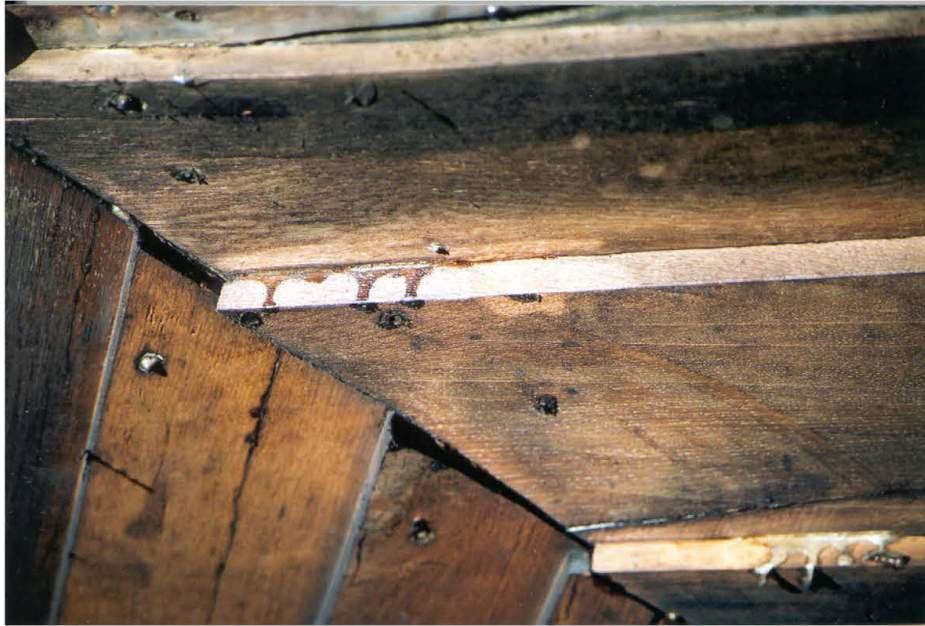
Plate 6. (right) Detail of a weathered original board showing possible residue of a preparatory layer within the grain. Samples were obtained for analysis from this area for comparison with the light ground/coating found on some 1890s boards (Sample 3).

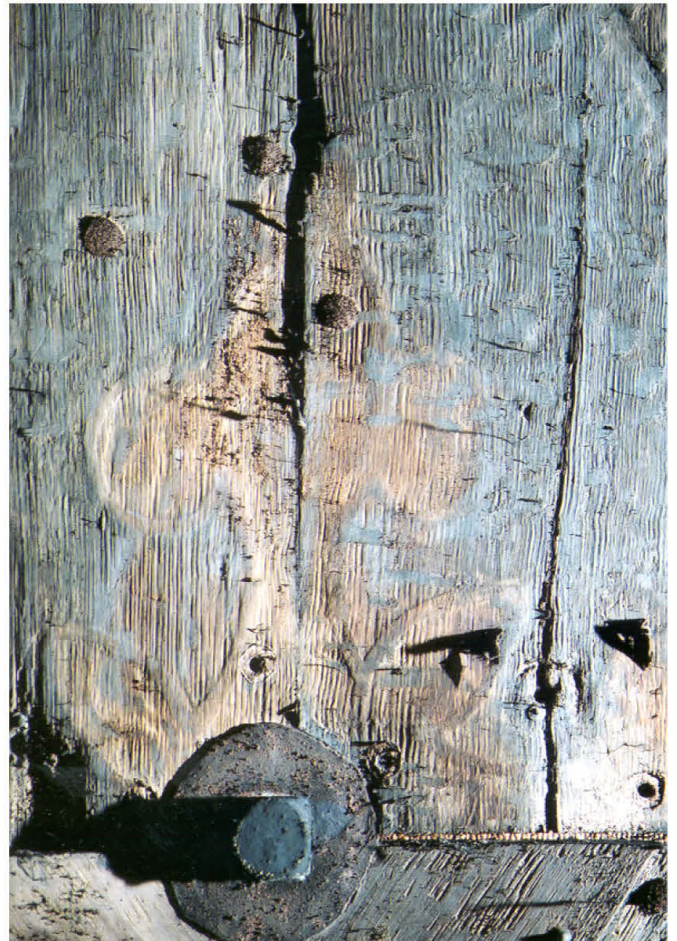
Plate 7. Detail of glue drips on the edge of 1890s boards. Removal tests indicate the glue may be removed by swabbing with warm water. On drying the underlying wood appears slightly lighter than if it were cleaned with wishabs only.

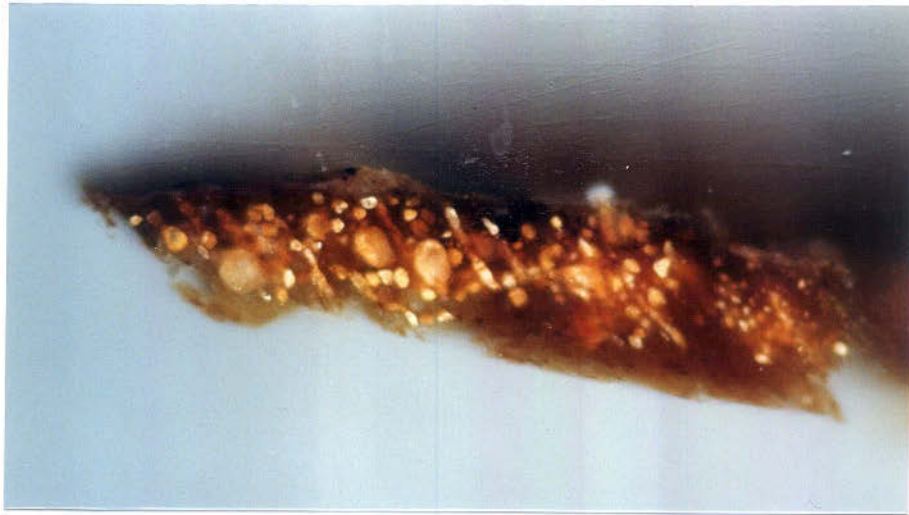
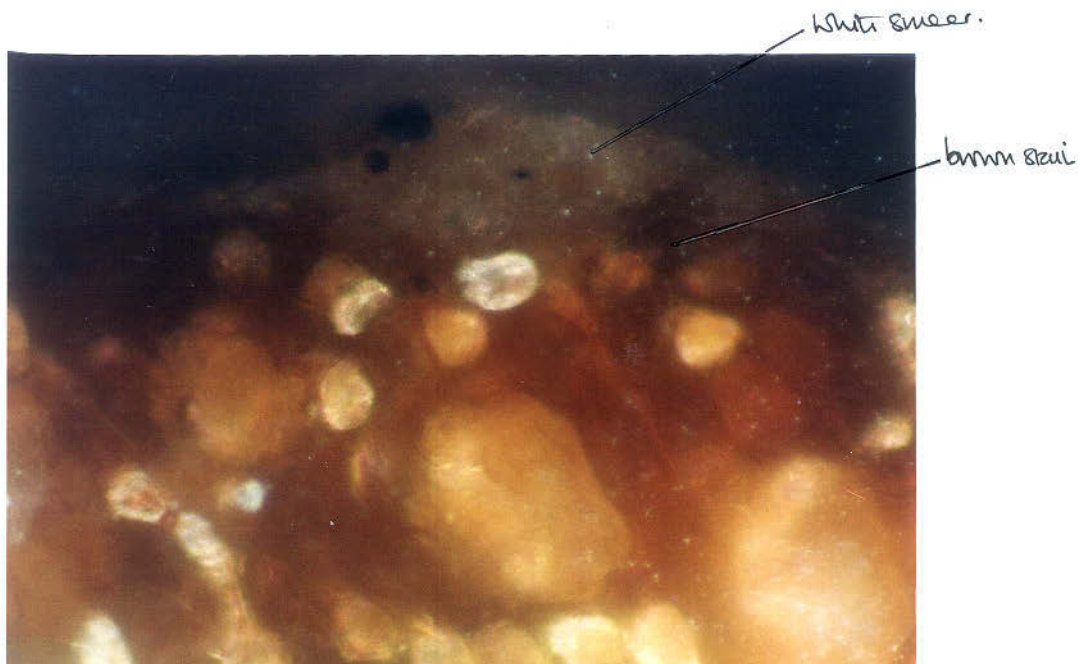
**SAMPLE 2**  
White coating

The white does not sink into the wood cells, but rests on top of the dark-stained surface.

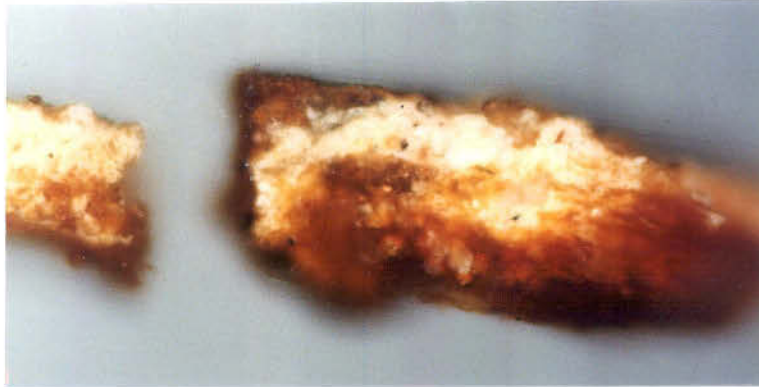
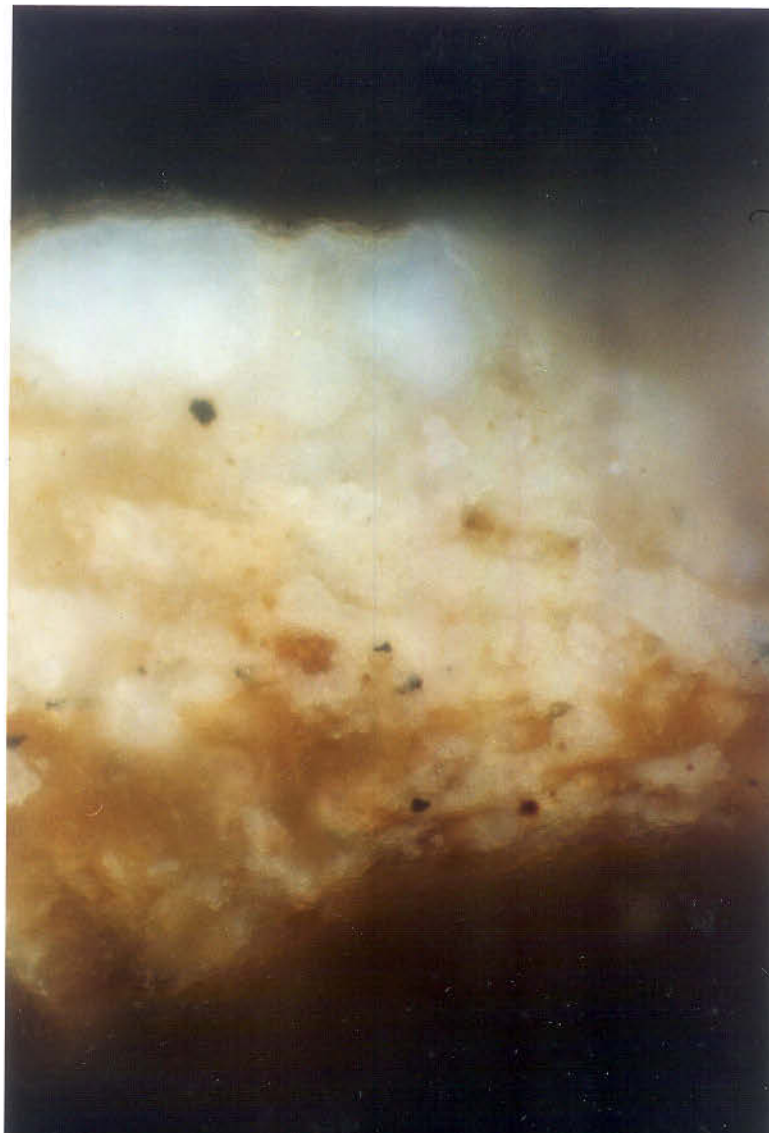
**SAMPLE 3**

The white penetrates the clean wood surface, and is therefore contemporary with it. The opaque brown layer over the top is seen in all the fragments from sample3, whether they are a thick layer of white or just a white smear, and is probably a combination of degraded lead paint and dirt.

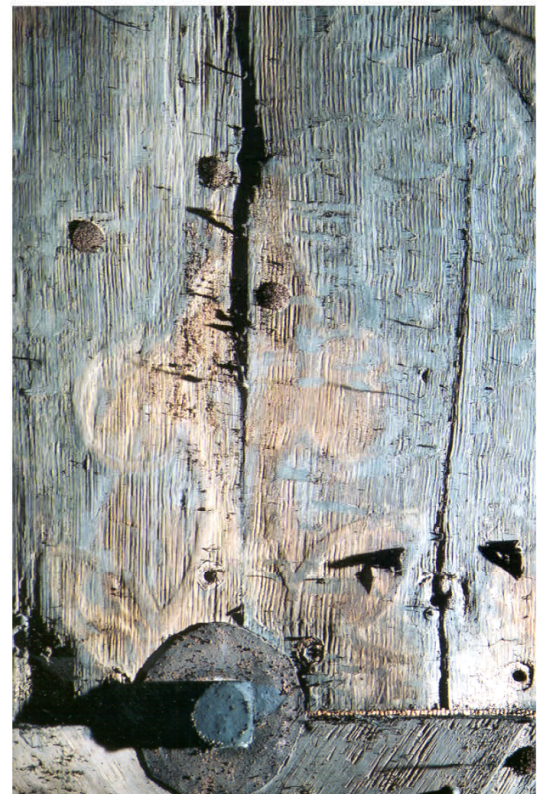
Raking light details showing some of the original painted decoration now showing as relief within the weathered timber surface.
