K1010 Condition Report

Catalogue number: 475

K1010 is a Gold fragment, possibly a partial hilt collar, with interlaced beaded wire, granule rosettes, and C-shaped filigree and four rivet holes.

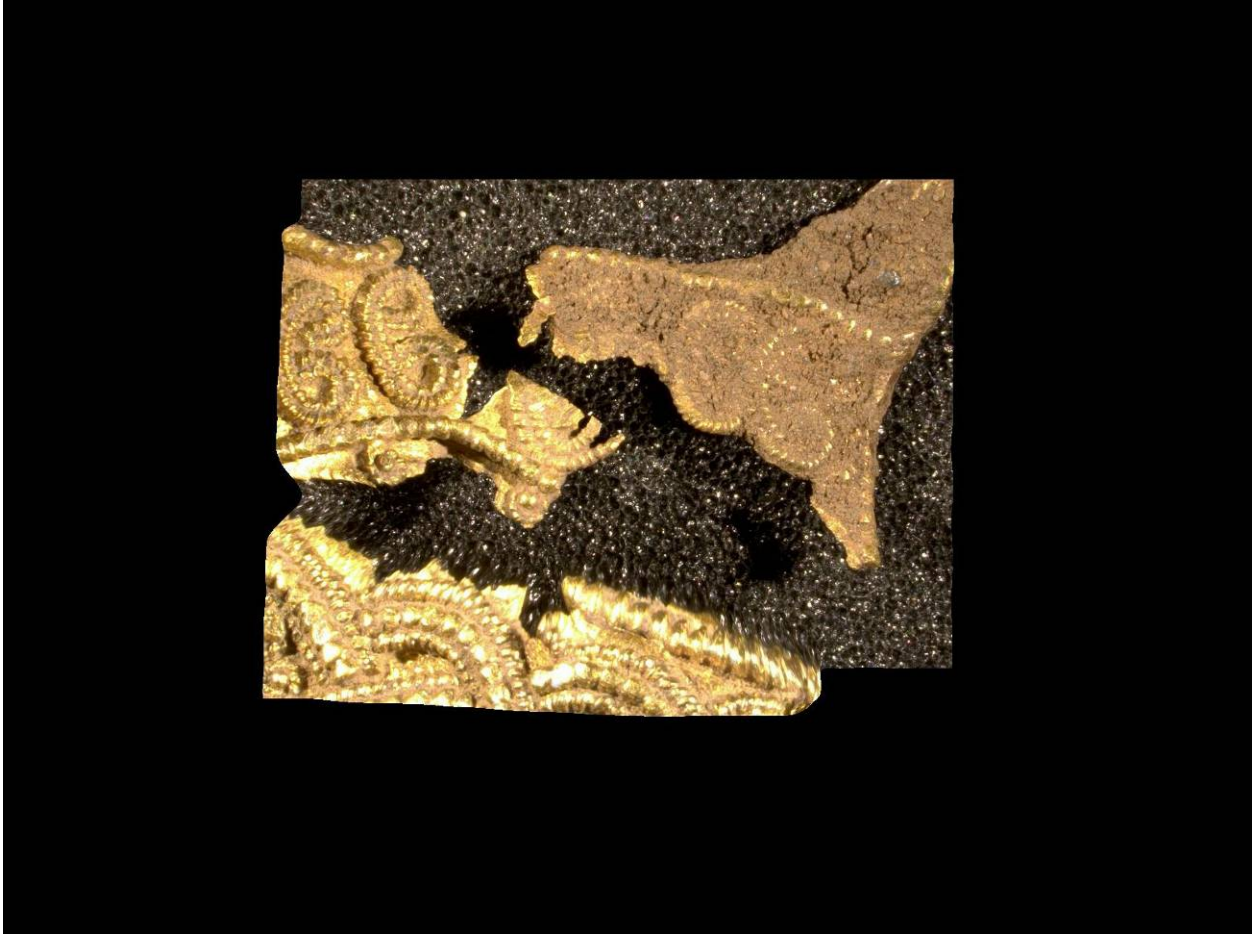
K1010 AT join to K71 BT 20x

Associated Objects: Join to K0071. Same C-shaped filigree and pointed corner.

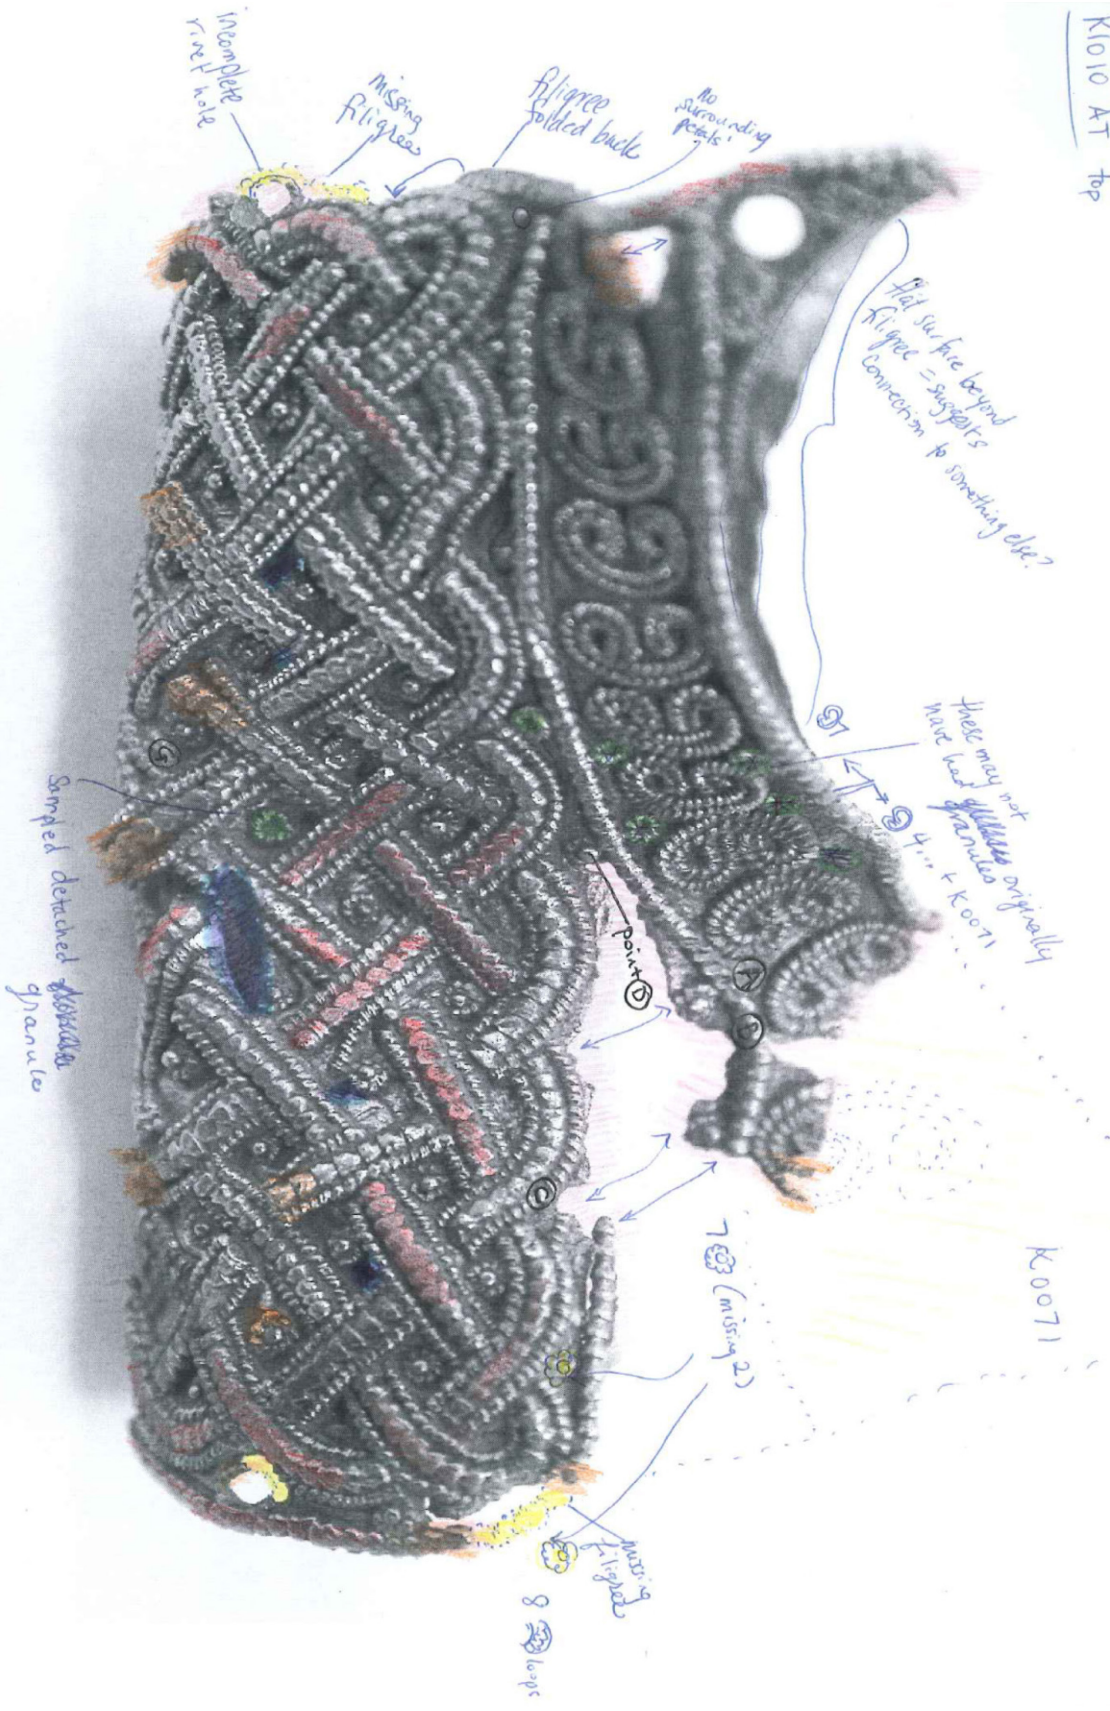
-   dark tarnish
-   missing pieces
-   fitting figure (inverted)
-   missing granule
-   flat and filigree
-   Tom sheet
-   snag possible / rough edge

incomplete rivet hole

missing filigree

filigree folded back

no surrounding peaks

flat surface beyond filigree - suggest's connection to something else?

these may not have had granules originally

sampled detached granule

missing filigree
8 loops

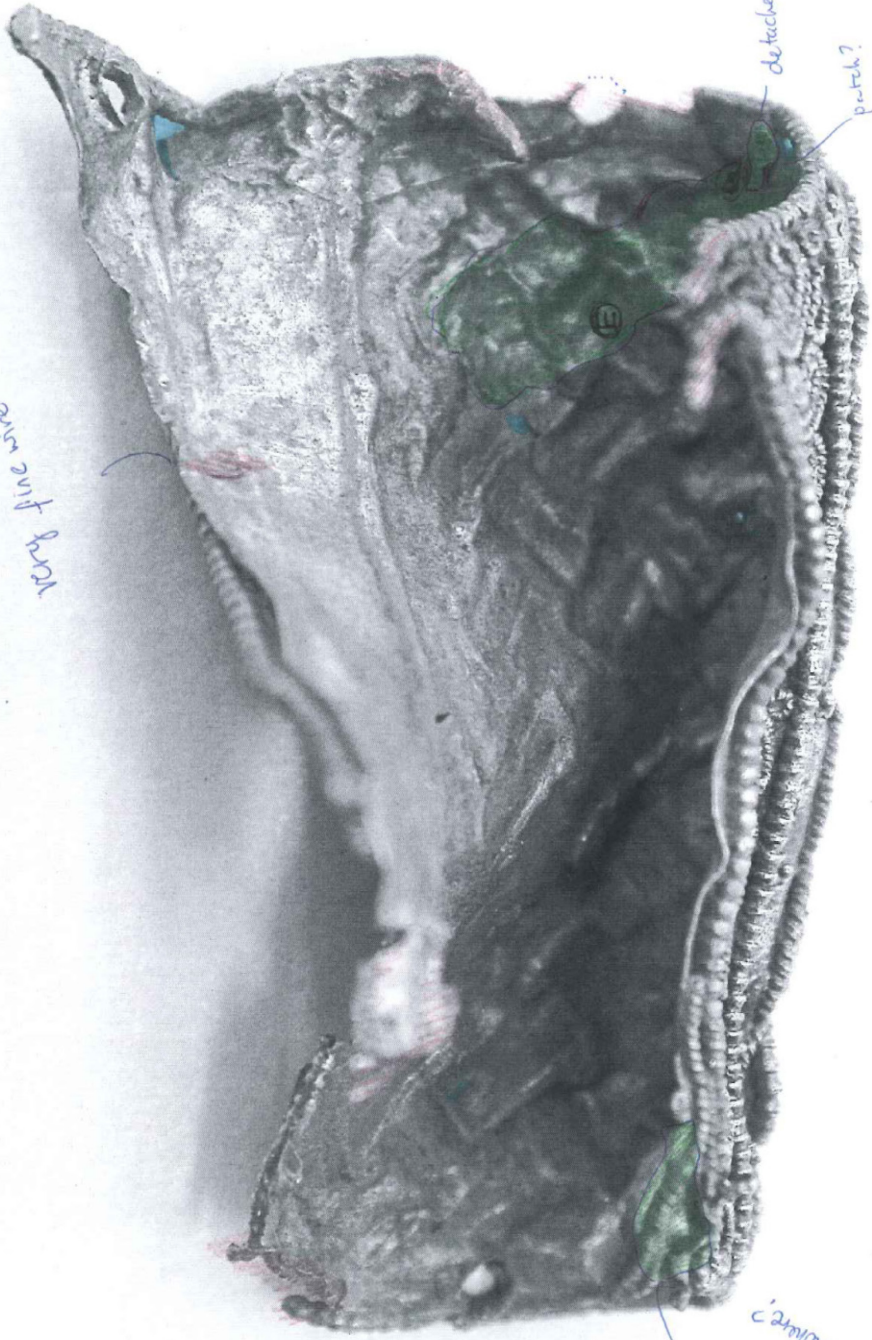
K1010 AT inner

Patch?
detached
from
sheet?
(bleach?)?

detached?
patch?

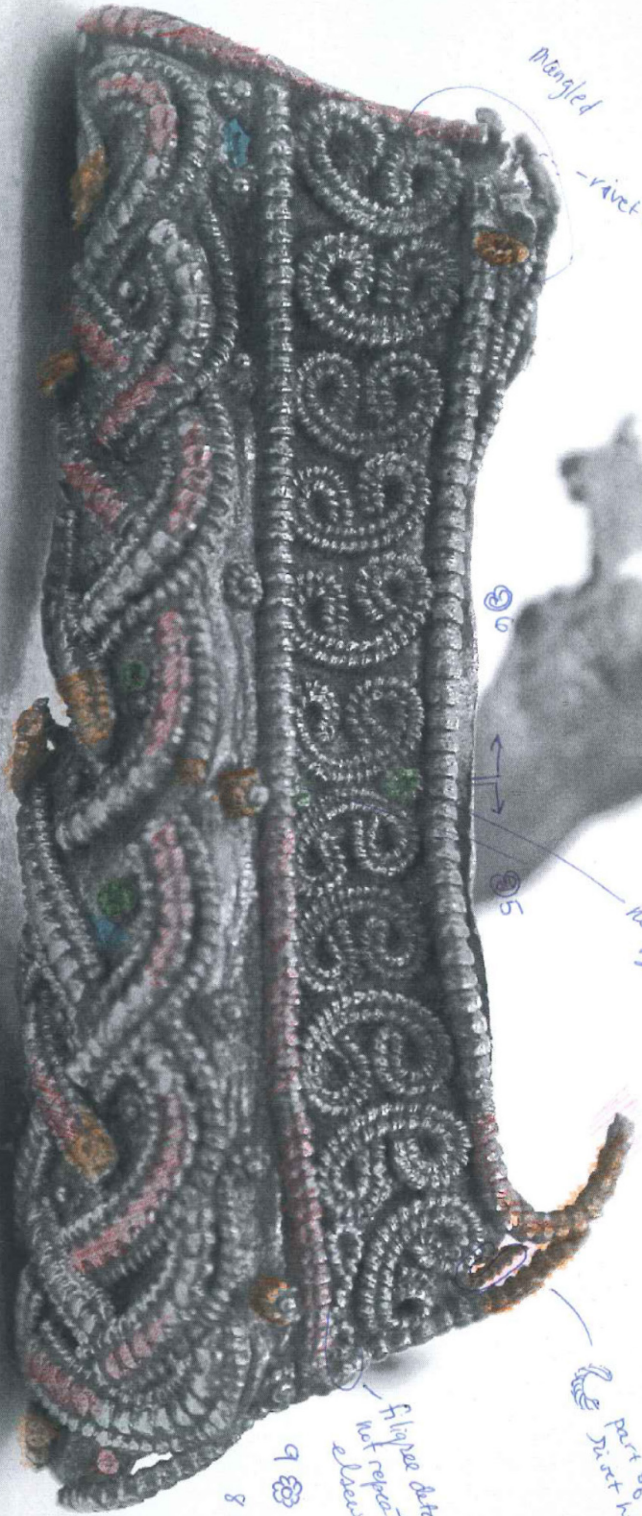
K1010 AT bottom

Rivet holes have fringe flaps around them.

Mangled

- rivet hole?

no Maltese granules

part of rivet hole?
