K1014 Small gold snake

Conservation started: 20.01.11
Conservation finished: 24.01.11
Time: 8.5 hrs
Conservator's initials: DLM

Dimensions: (L) 50 mm (W) 25 mm (Thickness) 3 mm
Weight before treatment: 4.51g
Weight after treatment: 4.47 g
Catalogue number: 530

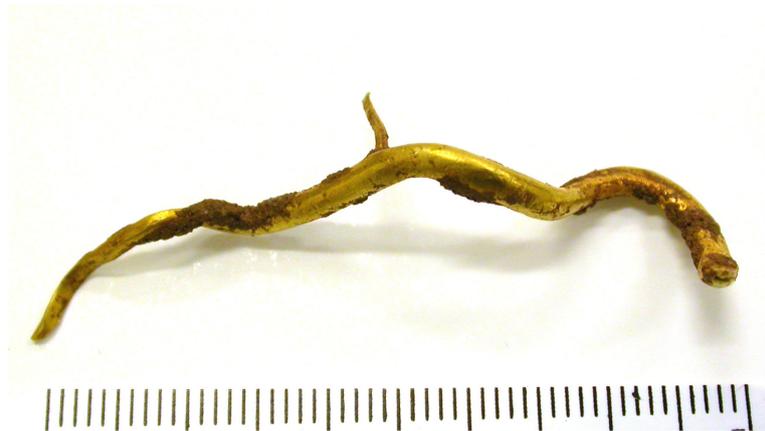
K653 photo before treatment

Deposits of compact soil closely adhered to the metal surface partially cover the object, which is whole and structurally stable. Presumably it featured a protruding tongue, which has now broken off and is lost. Only one of the four fixings on its underside survives in situ. The body has been twisted and distorted so that head and tail do not lie on the same plane. There are no remains or evidence of other materials associated with this object which, judging by the even, bright yellow colour must have a considerable Au content; the marks left by the sharp blade indicate a relatively soft metal. Please see the micro photographs within K1014 image file for evidence of cuts. Generally, the damage on this object's surface has occurred at a microscopic

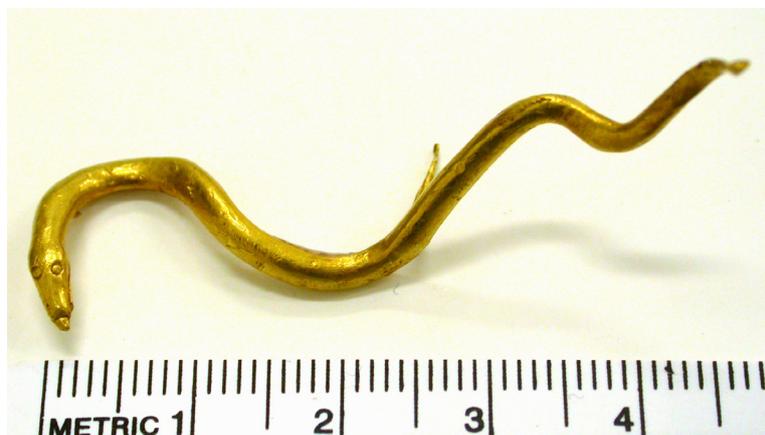
K653 photo after treatment

Method: Standard wet: Softening of soil with solvent; dislodging of soil with thorn and/or cocktail stick, removal of particles with brush; cleaning of surface with solvent in cotton swab
