K 1226: Small gold rectangular plate or fitting with cloisonné garnets and blue enamel glass inlay
Conservation Report

Conservation started: 21.9.10

Finished: 23.9.10

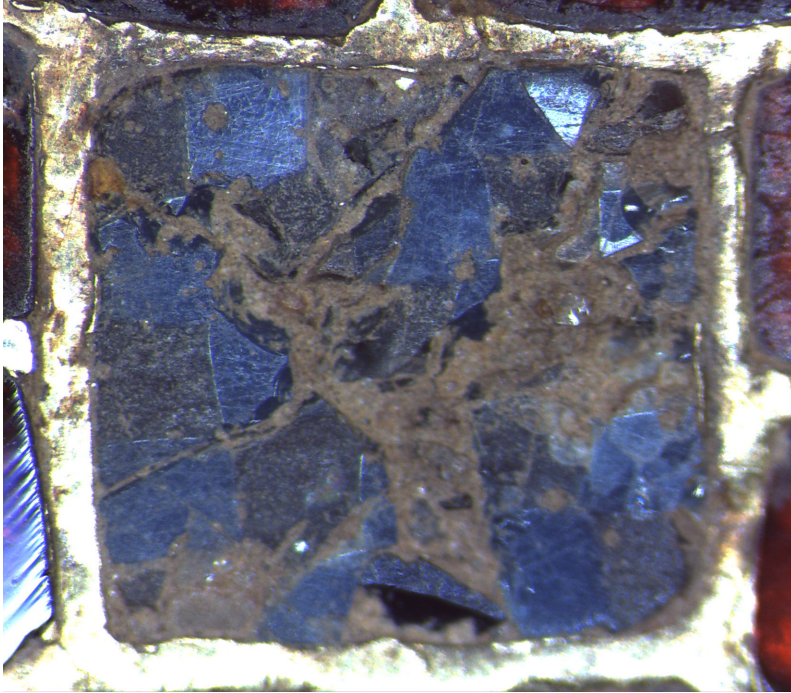
When Deborah Cane examined the gold fitting after the investigative cleaning in an inverted position and using the Meiji Techno RZ stereo microscope with fibre optic lights, rather than the Leica microscope with the LED lights that was used to treat the fitting, she noticed that the different coloured blue inlay fragments may form a checker board pattern. See the photo below showing the blue inlay cell inverted, with the dark blue fragment at the lower edge rather than the upper edge. The differences in the colour of the blue inlay may therefore be due more to an intentional pattern in the inlay than the deterioration process.
