K131: U-Shaped Slotted Gold Strip with Cloisonné Garnet and Gold Filigree Decoration
Conservation Report

Conservation started: 17.11.2010

Finished: 10.12.2010

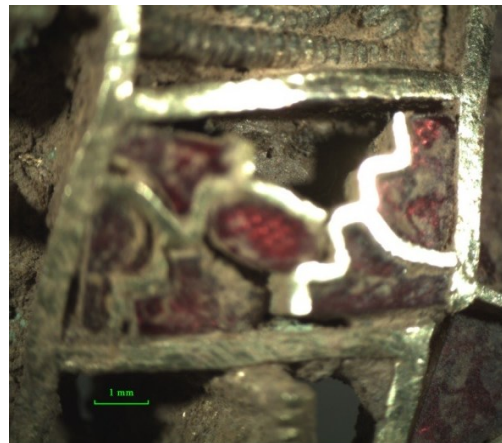
Close up of cell for garnet # 1

Damaged cell for garnet # 1 – cell wall pushed out

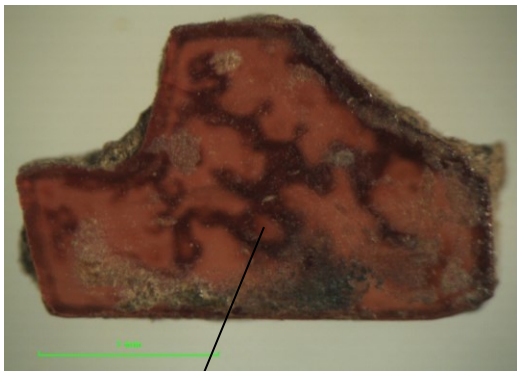
Garnet # 1: Upper surface

Upper surface of garnet # 1 with the brown adhesive-like material visible through the garnet

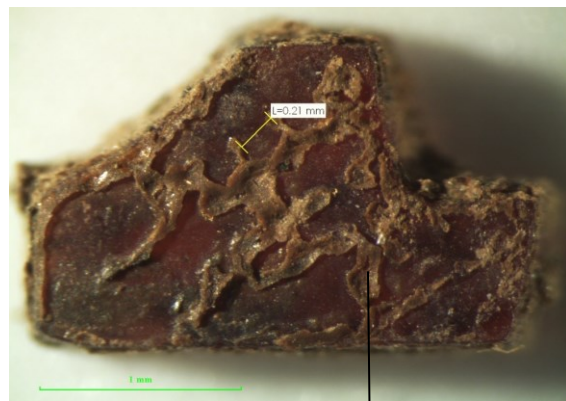
Garnet #1: Lower surface

Lower surface of garnet # 1 with brown adhesive-like material retaining the impression of the gold foil surface

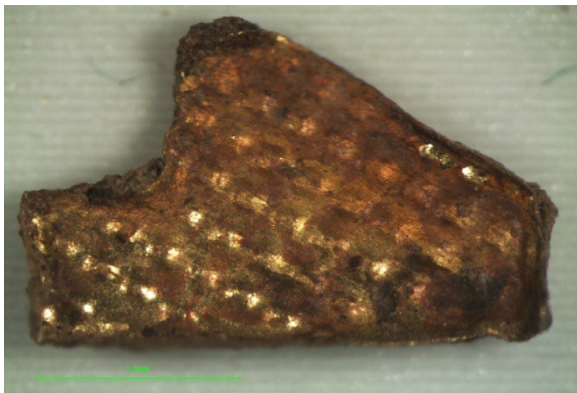
Gold foil for garnet # 1: Upper surface

Upper surface of gold foil for garnet # 1 with traces of the brown material

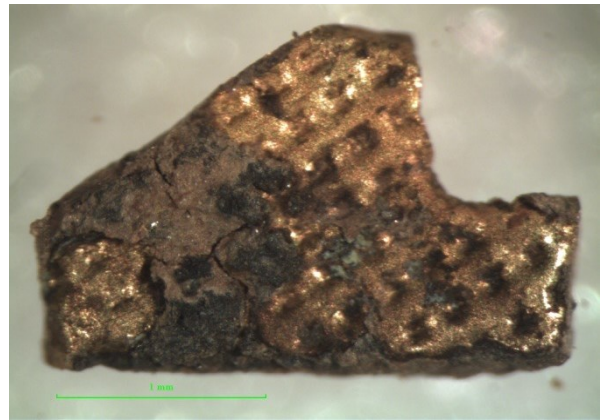
Gold foil for garnet # 1: Lower surface

Lower surface of the gold foil for garnet # 1 with a dark grey, inorganic-looking material

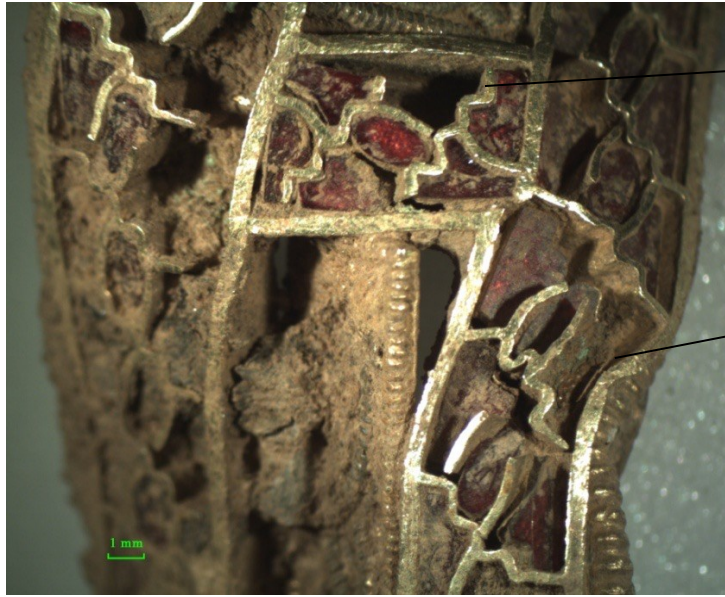
Location of cells for garnet # 1 and # 2

2: Loose garnet # 2 with gold foil backing. The garnet/gold foil no longer fits in the cell due to the damage to the cell walls.

Damaged cell for garnet # 2 – cell wall pushed in

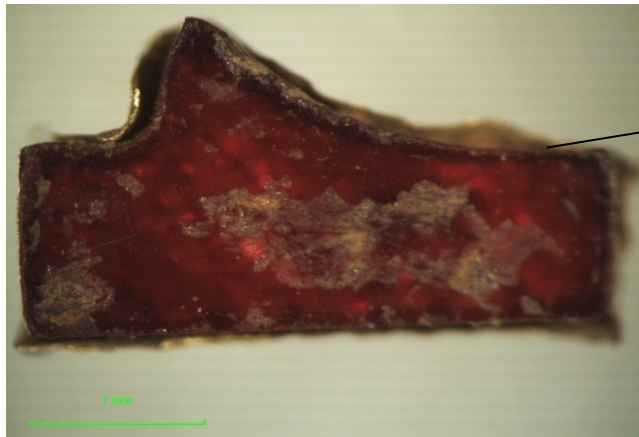
Garnet # 2: Upper surface

Garnet # 2 with gold foil backing wrapped around the sides

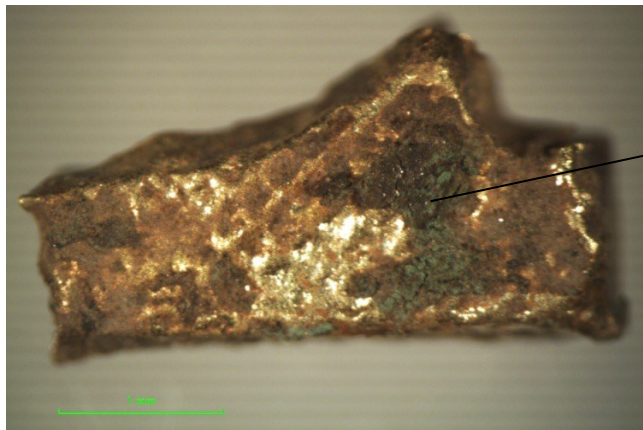
Garnet # 2: Lower surface of gold foil backing

Lower surface of gold foil backing for garnet # 2 with traces of grey inorganic-looking material and green deposit – possibly copper corrosion
