## K1548 Condition Report

**Conservator:** Deborah Magnoler

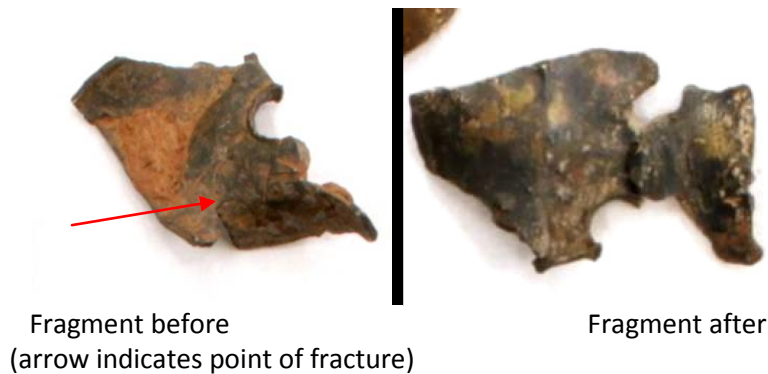
There is minimal amount of soil, as well as black and iridescent form of discolouration on the silver gilt fragments. All the pieces are incomplete. Most pieces are torn and bent. Several of the smaller silver

sheet metal fragments are brittle and have a patchy tarnish and a form of grainy silver corrosion on the surface; they appear to be mineralised.

**Post-Conservation Condition/Findings:** One of the fragments housed in the foam which was particularly brittle, broke in tow on removal of soil during conservation. See images below.

The granular soil on the front and back was mechanically removed or reduced where possible using a fine thorn tip secured in a pin vice and a small pure bristle brush. IMS was used to soften the soil to facilitate removal. Loose particles of soil were then removed with a small swab of IMS.

Possible corrosion products were left in situ; corrosion was not active and can be further cleaned or stabilised at a later date.
