K1663 Condition Report 2010

Conservation started: 02/12/2010
Conservation finished: 08/12/2010
Time taken: 6 Hours
Conservator's initials: MCG

Dimensions: (L) 30mm (W) 12mm (D) 5mm (Th) sheet 0.25mm
Weight after: 1.42 g
Catalogue number: 462

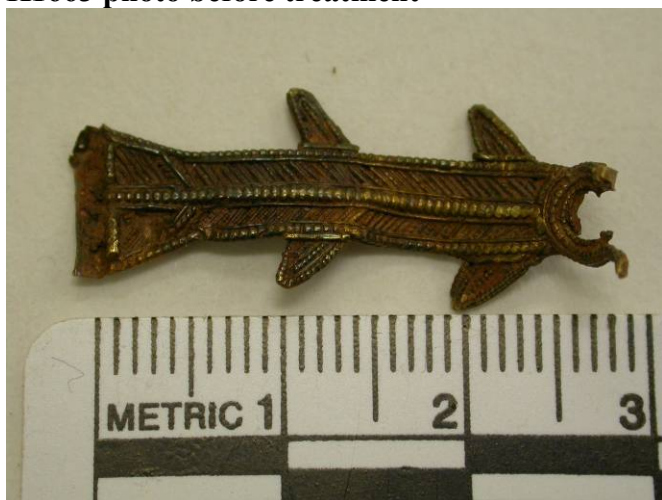
K1663 photo before treatment

The front surface has an encrusted mud layer especially in the indentations of the filigree. This consists of a brown soil with many orange mineral inclusions. The back is fairly clear of soil. Both sides, but especially the back, are tarnished with a rainbow/blackened appearance which may suggest heating. There are several pieces of burnt wood present around the tail area on the front of the mount.

The front surface shows minor surface scratching all over. The head itself has been bent upwards and is also twisted out of shape. The sideways profile is also distorted by the lower second fin. There is a large gouge with parallel scratches on the back of this fin. Another area of gouging is present on the front by the lower section of the tail. On the back there are many light, bright scratch marks running parallel to those present in the fin gouge. There are several circular holes on the back which look similar to blow holes that can form when casting metal. There is a tear in the back plate that makes up the back fin on one edge. Another small tear is present a few centimetres along from this.
