Prudhoe Hospital

Prudhoe, Northumberland

Historic Building Recording : August 2016

Gentoo Homes Ltd

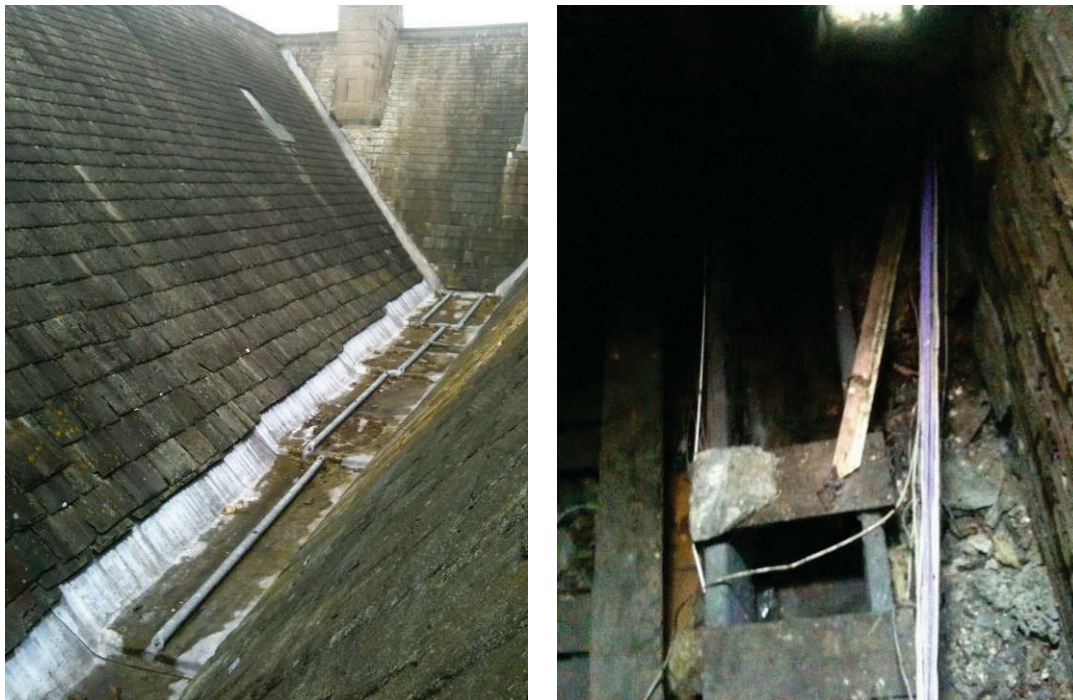
Figure 33 The lead-lined valley between the inward-facing pitches, over the 1870s core of the hall. It falls to the west, and water passes into the west pitched roof, through a lead-lined box channel, and into a rain-water hopper on the tower, at the centre of the south garden façade.

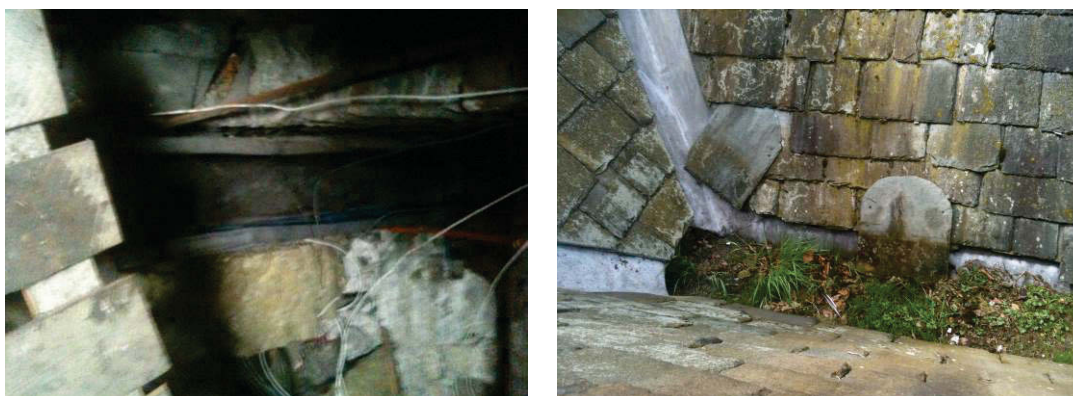
Figure 34 The lead-lined internal channel on the left, with the valley on the right, showing it blocked with debris, weeds and slipped slates.

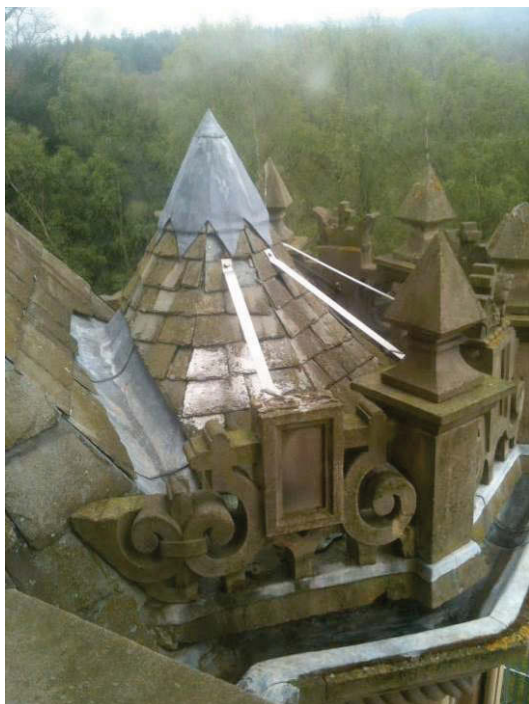
Figure 35 Corner tower roof, over dining room, which has lost its finial.

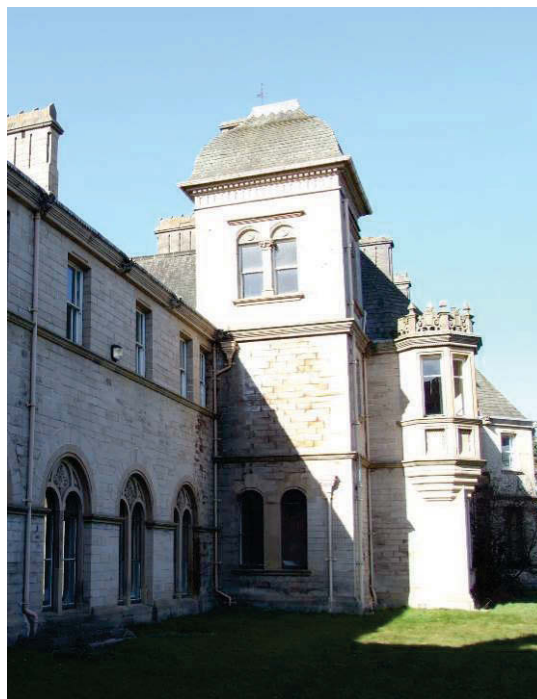
Figure 36 Central tower which has lost its brattishing.

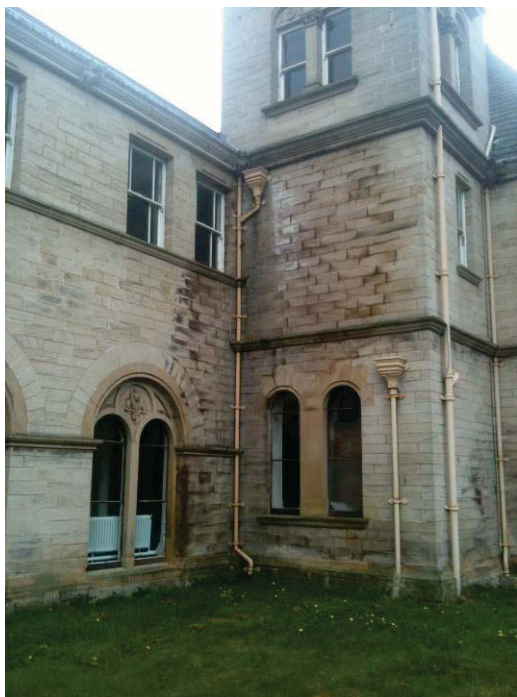
Figure 37 South façade, angle between central tower and 1870s former chapel corridor showing water-damaged masonry. This damage is caused by inadequate 1870s rainwater goods, and there is evidence of dry rot fruiting bodies internally.

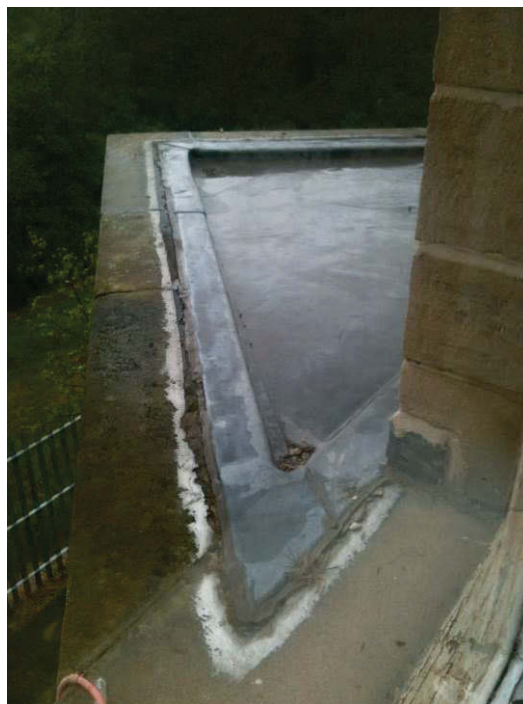
Figure 38 Roof to the south-west square bay-window. It is a poor piece of leadwork and is damaged. There is water damage internally.

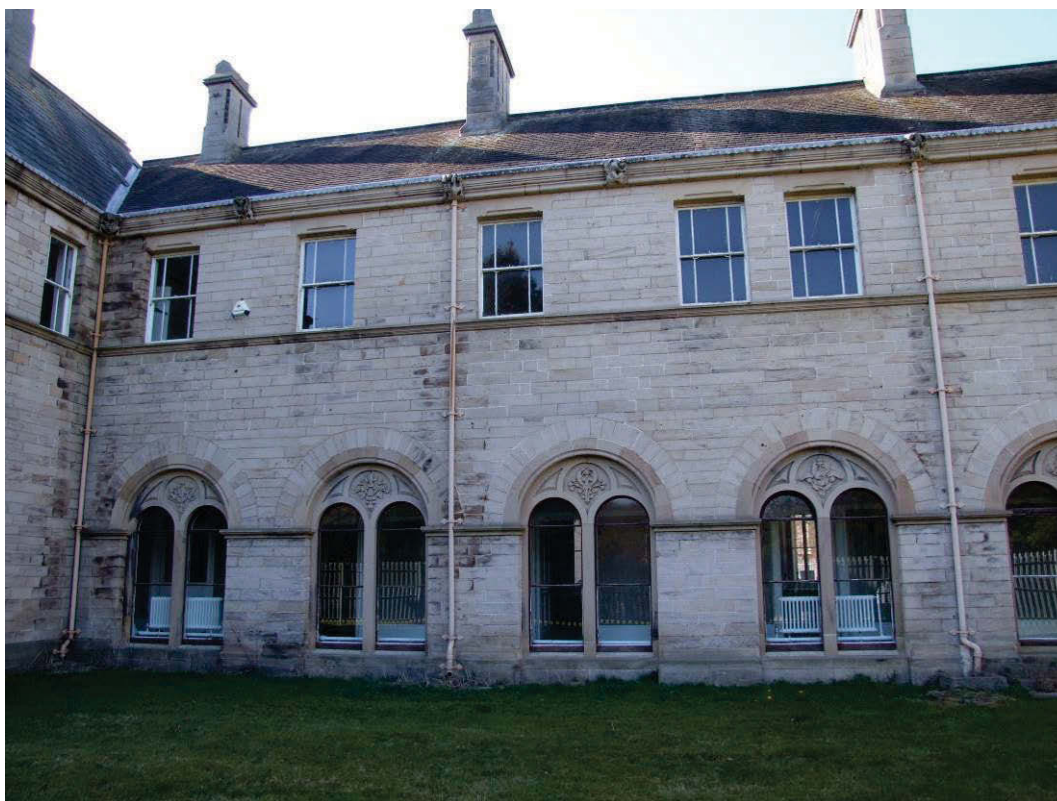
Figure 39 South elevation to terrace garden, showing leaking downpipes, and damage at west angle.

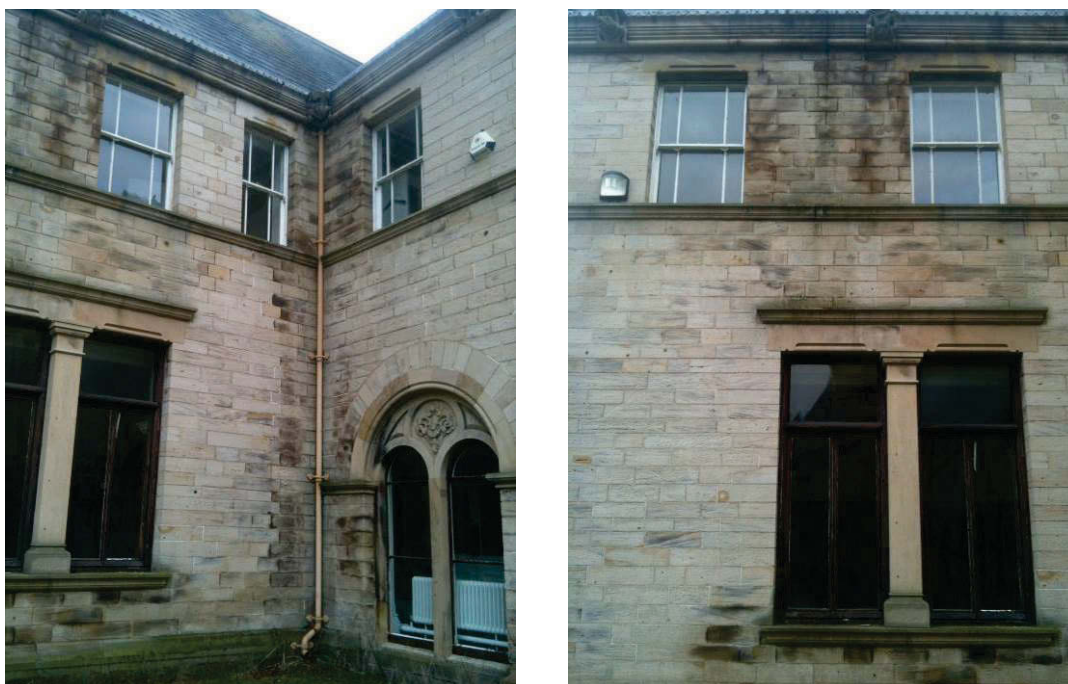
Figure 40 South façade, angle between former billiards room and 1870s former chapel corridor showing water-damaged masonry.

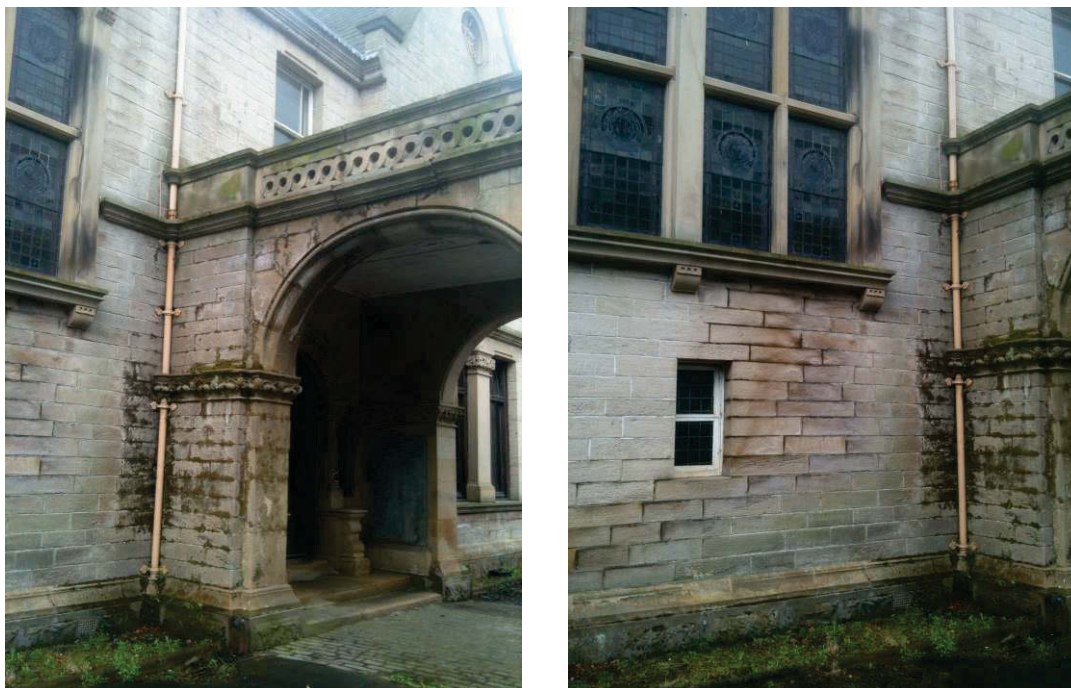
Figure 41 Ground storey, north entrance façade, *porte-cochère*, showing water-damaged masonry and slipping voussoirs.

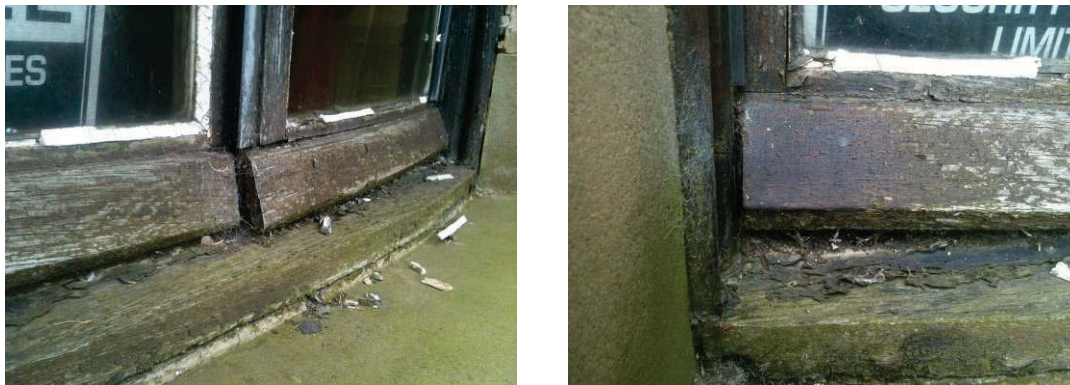
Figure 42 Ground storey casement window showing failing cills.

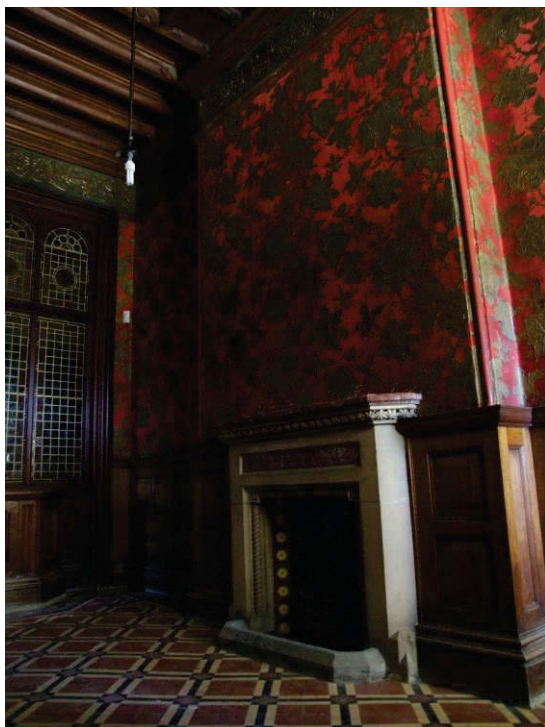
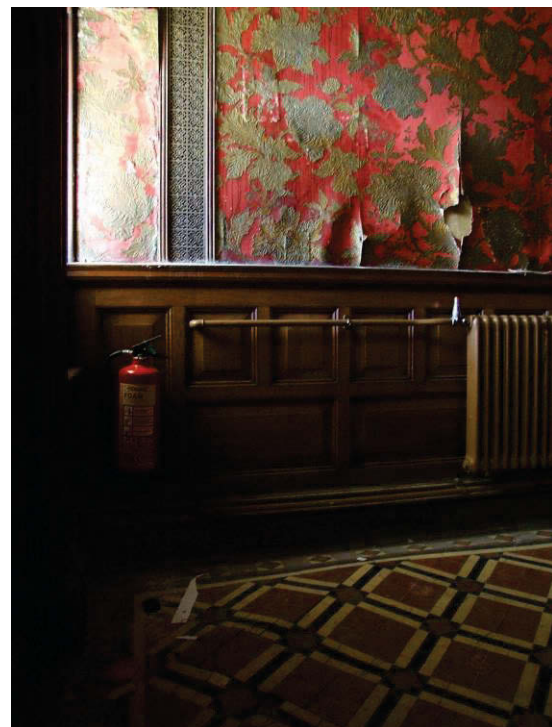
Figure 44 The entrance hall. On the right is the damaged area of wall and swelling floor.

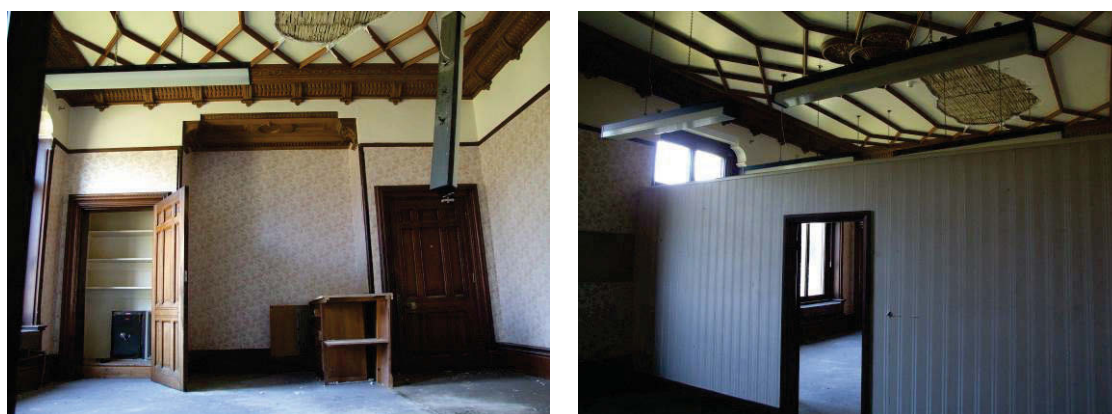
Figure 57 Dining room, with buffet-table recess on the left and partition on the right. The fallen area of the plaster ceiling is clear.

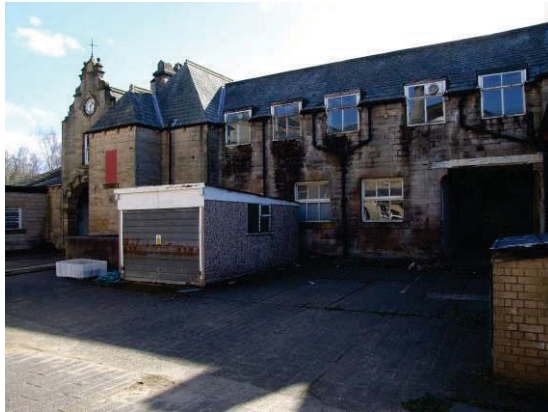
Figure 73 The 1870s stable range, altered several times, with the 1889 enclosed bridge to the church, relocated on the left, and a 1970s garage in front. The dormer windows have been inserted with little consideration for rainwater shedding.

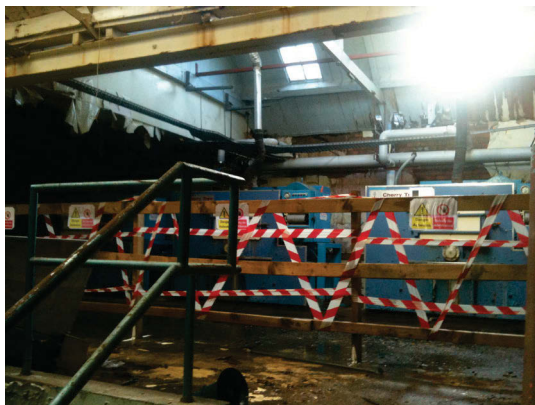
Figure 75 Interiors in poor condition with former laundry machinery.

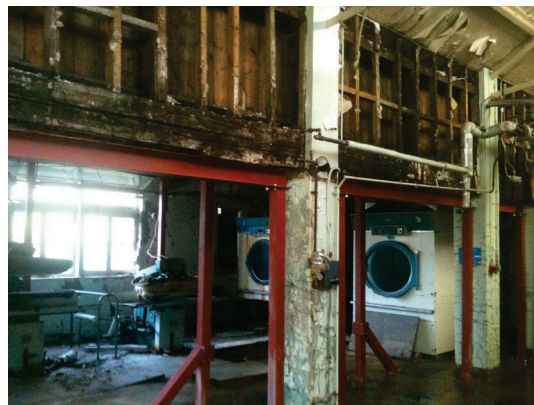
Figure 76 Looking south, under propped timber lintols, into the former carriage shed. Laundry machinery beyond.
