**NO.10 LINCOLN ROAD,
WELTON, WEST LINDSEY,
LINCOLNSHIRE.**

**HISTORIC BUILDING
SURVEY**

Site Code: WERD 11
NGR: TF 0109 7957
Planning Ref: 126997
LCCM Acc No: LCNCC 2011.91

June 2011

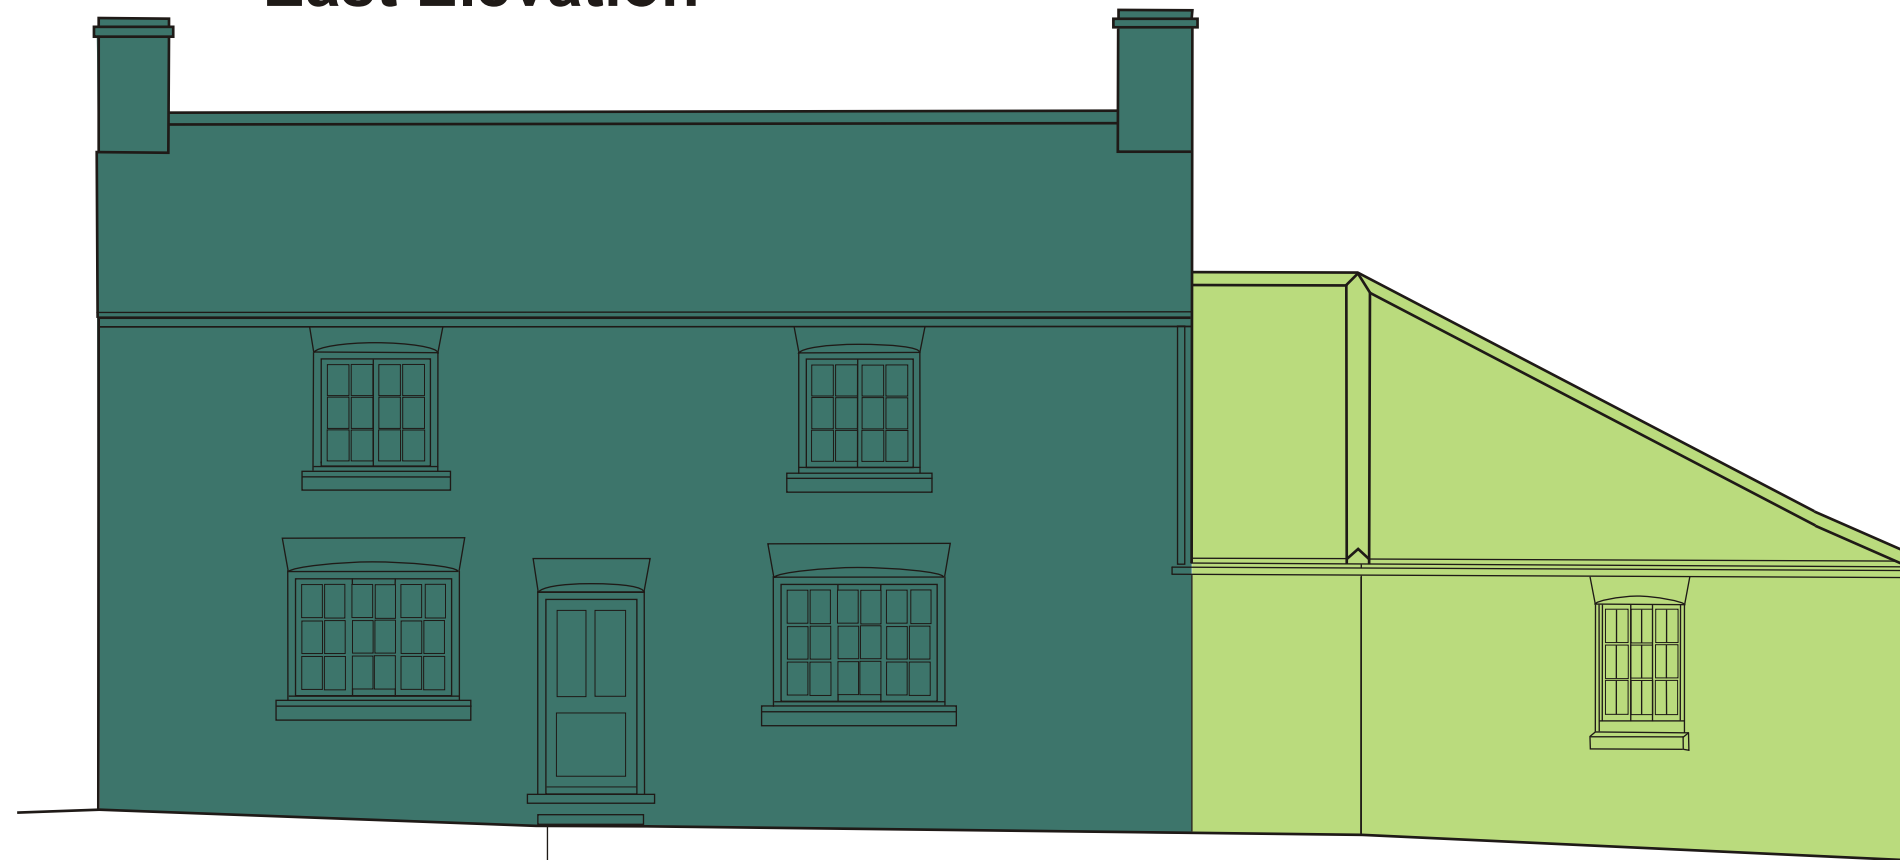
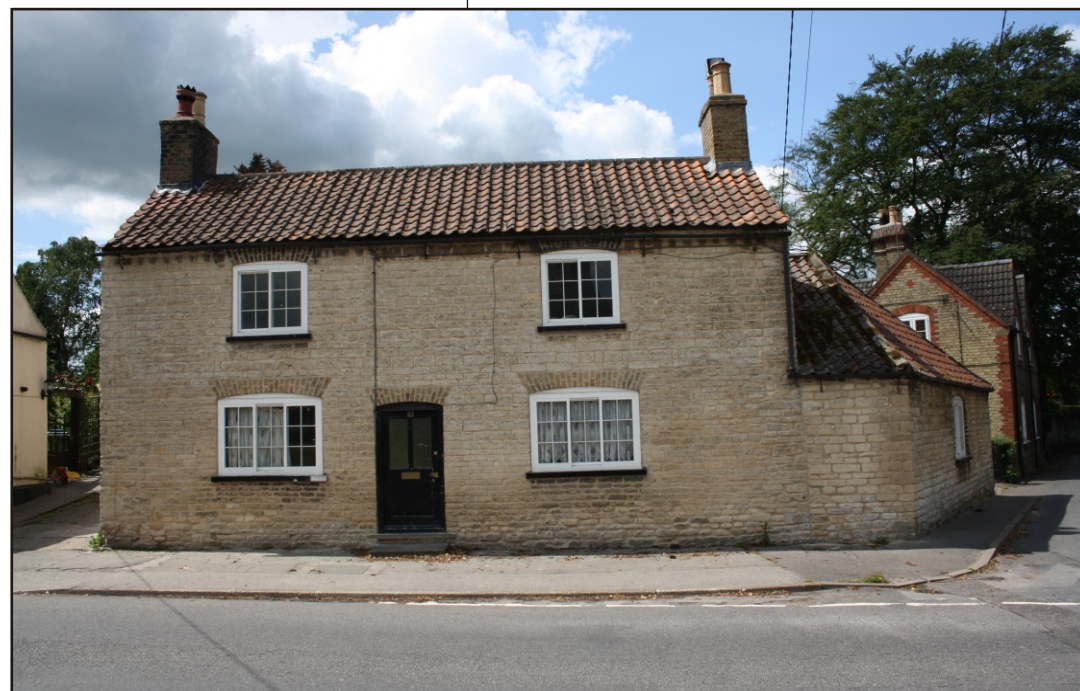
The main structure of this building comprises of the East Elevation with a latter addition of a Stable building projecting from the north gable wall. **see above**

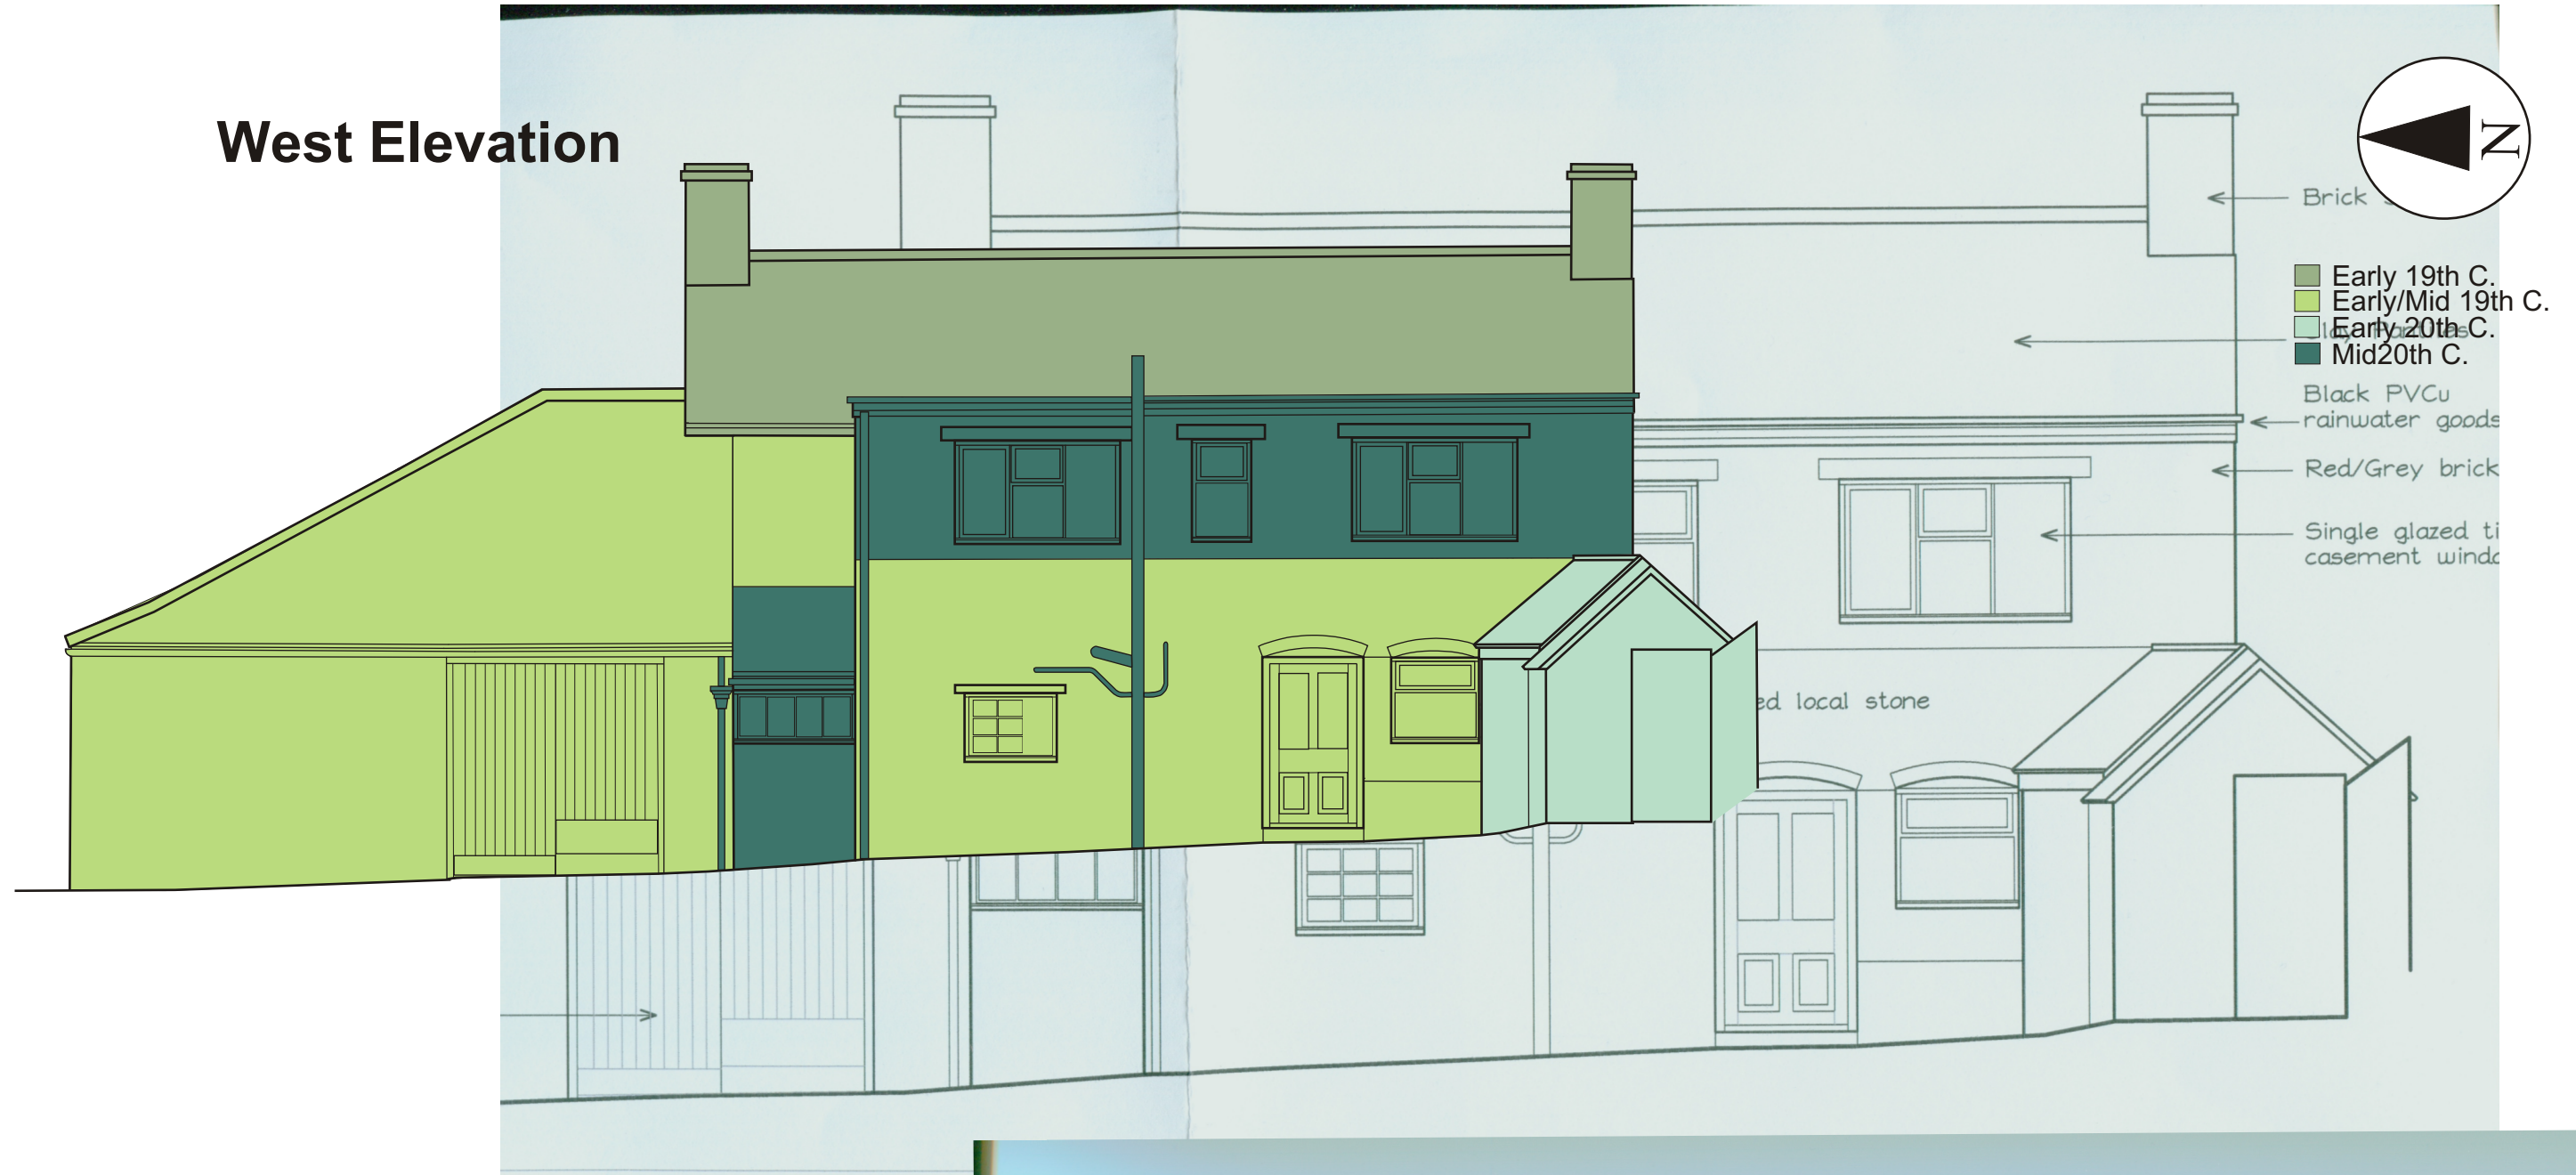
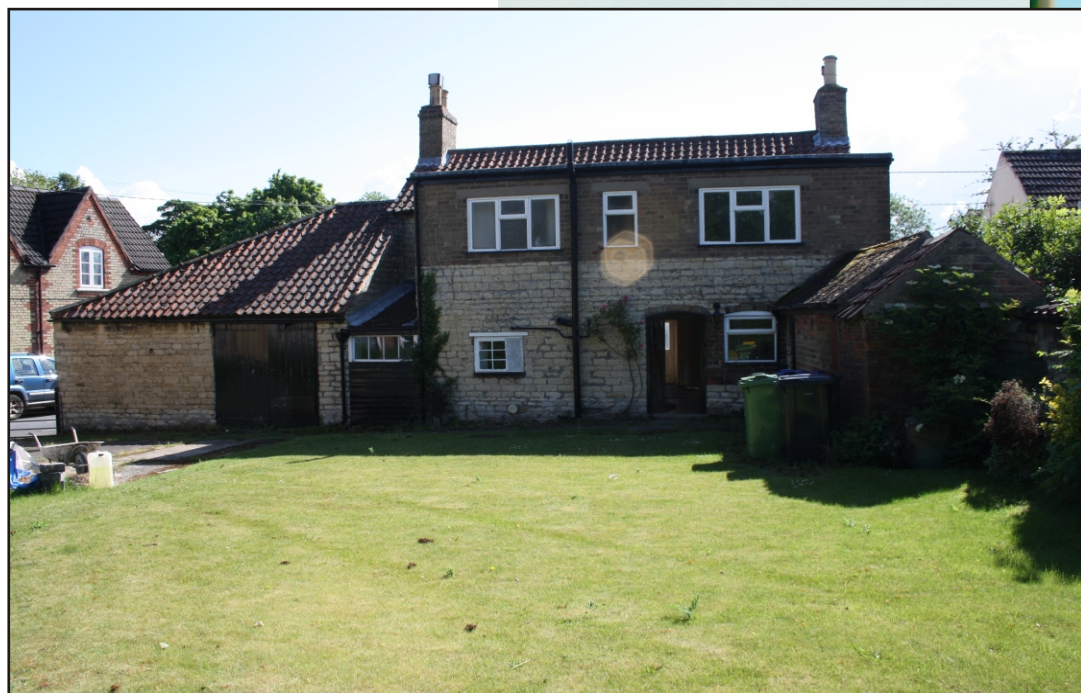
This latter window sits awkwardly in this elevation, with the area around it and that to the immediate right of the doorway being built of late 19th/early 20th Century brick and which appears to constitute an alteration or even repair to this area of the outshut (fig. 8).

The West Elevation reveals much about the development of this building. Although there has been some major and minor alterations to the building's original design, much still remains of this 19th Century fabric. *see left*

The stable is believed to be slightly later than the outshut, its awkward setting and the fact that two of the outshut's windows immediately face onto it to the north would suggest that it was an afterthought.

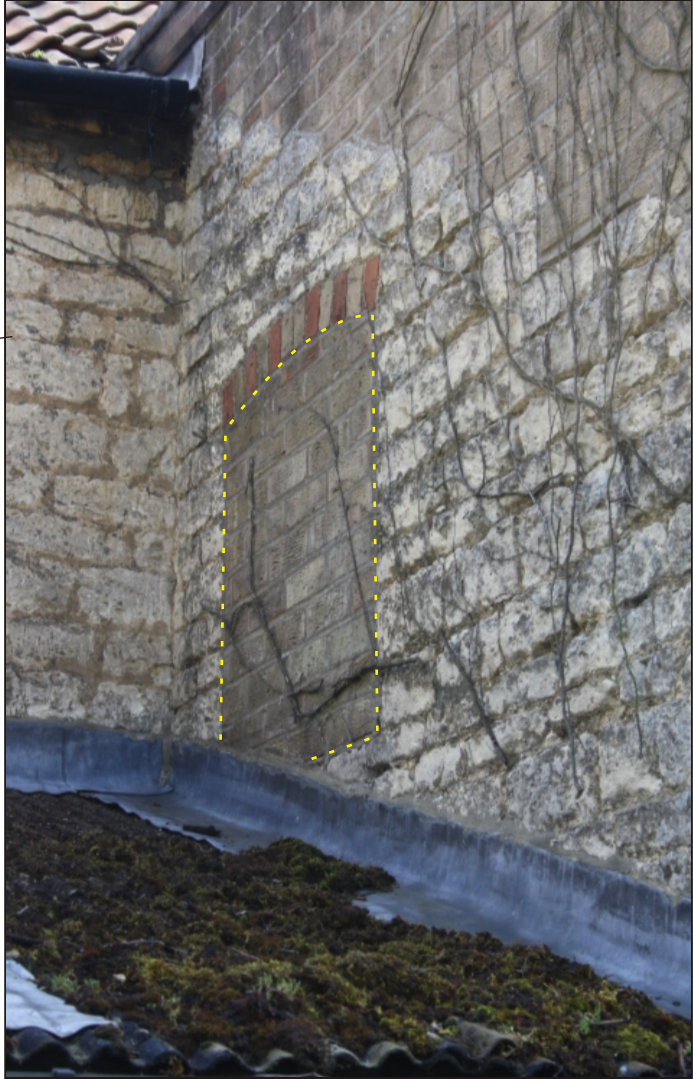
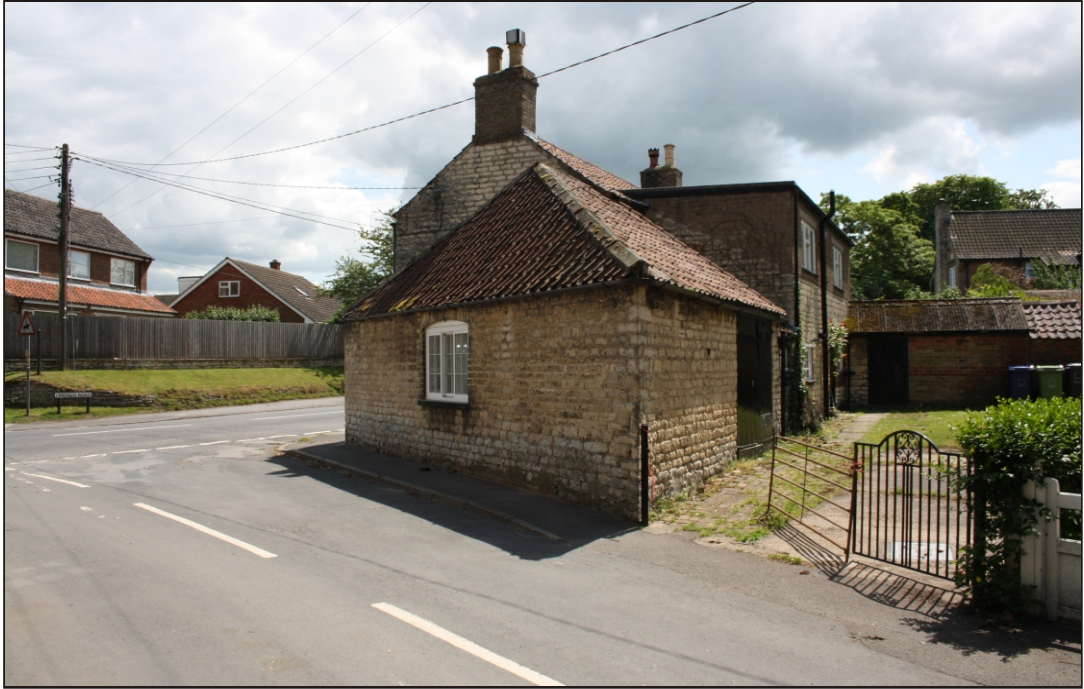
North Elevation

The overlooking 'blocked' upper window to the outshut, blocked with brick identical to the 1960's extension. *see above right*

The outbuildings leading from the south/west corner of the outshut, with the remains of a possible former stone structure to the immediate left of the door. *see right*

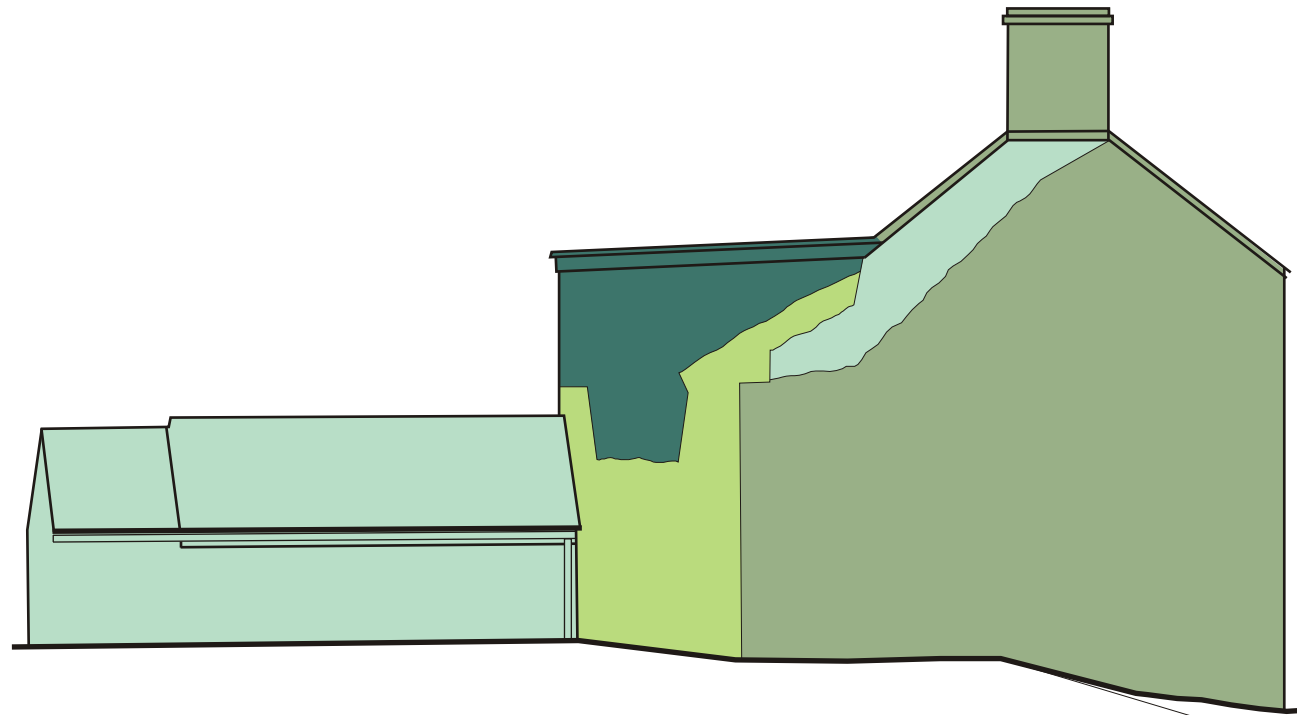
South Elevation

In this elevation the stone built outshut is clearly visible as a separate building phase and it is clear that along with the main structure it has at some point undergone an area of repair. The repair forms a long scar of brick infill leading from eaves level of the outshut and to the base of the chimney stack. The bricks used are very similar and match well to those of the stack; although it is not possible to accurately date this repair it is likely to have taken part during the late 19th-early 20th C.

The very obvious addition of a mid 20th C brick storey to the outshut is also clearly visible and can be seen to have been 'roughly' toothed into the existing structure. Constructed of modern brick in Flemish Bond pattern it has a flat felted roof (fig.10).

The alteration and repair to the building can be further identified with this elevation.

The differentiating build line of the rear of the main structure with that of the outshut 'extension' is clearly illustrated. *see above and right*

The brick repair running up at eaves level within the gable of the original structure, interestingly has part of a stringer course towards the middle of it, in a different brick, although it is unclear to why this should be. *see right*

The south facing stone wall of the outbuilding can just be made out projecting slightly south of No.10 and could possibly be an earlier outbuilding or structure, *see right*

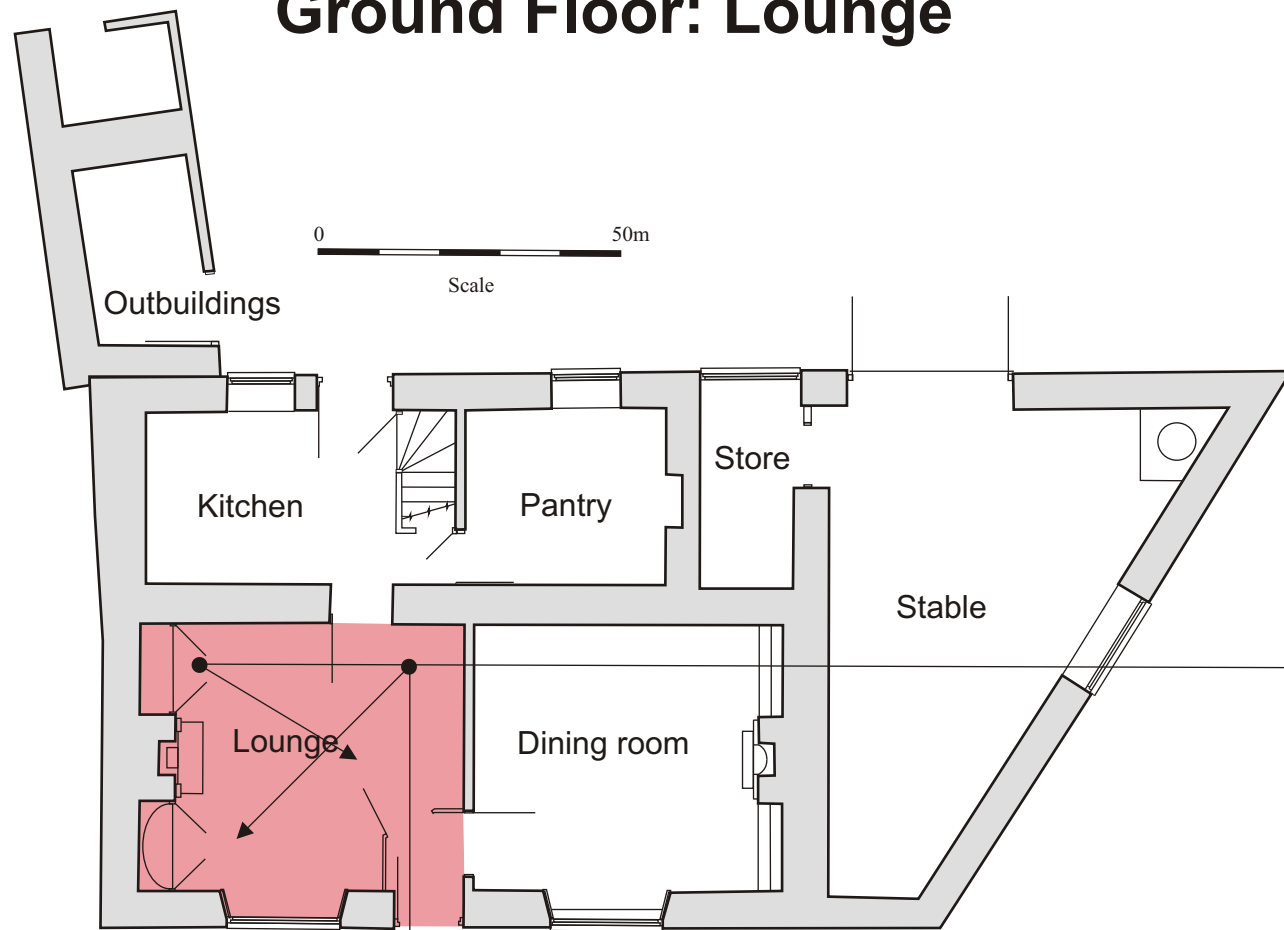
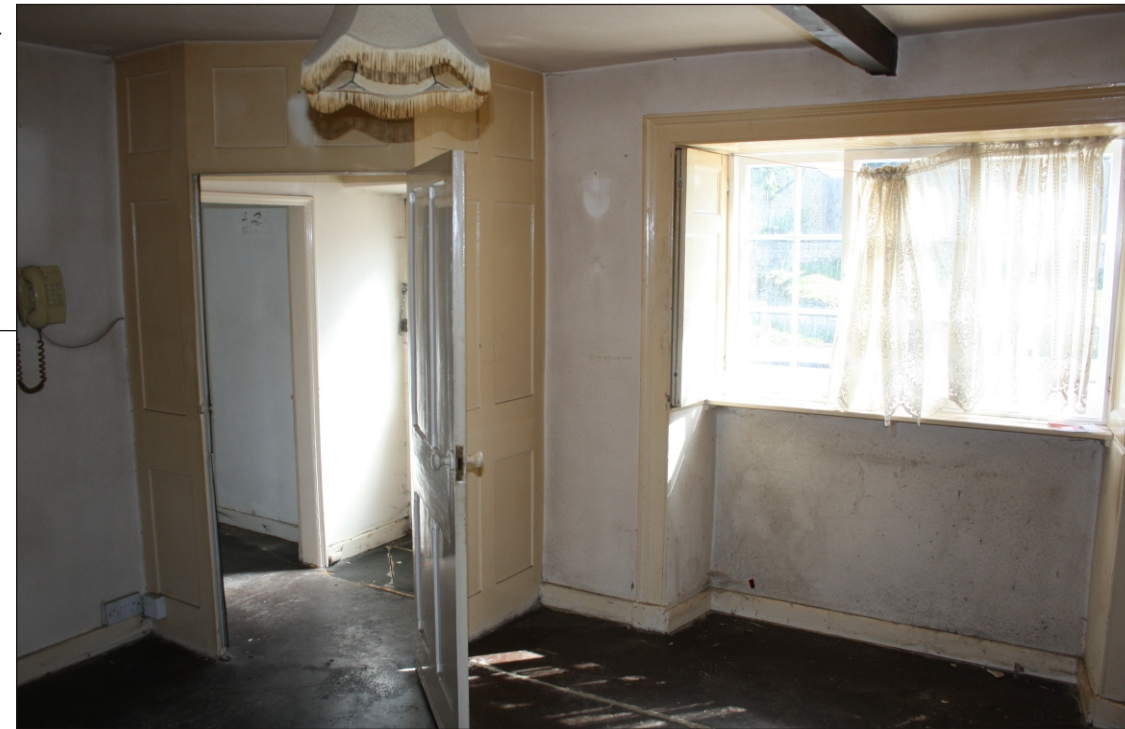
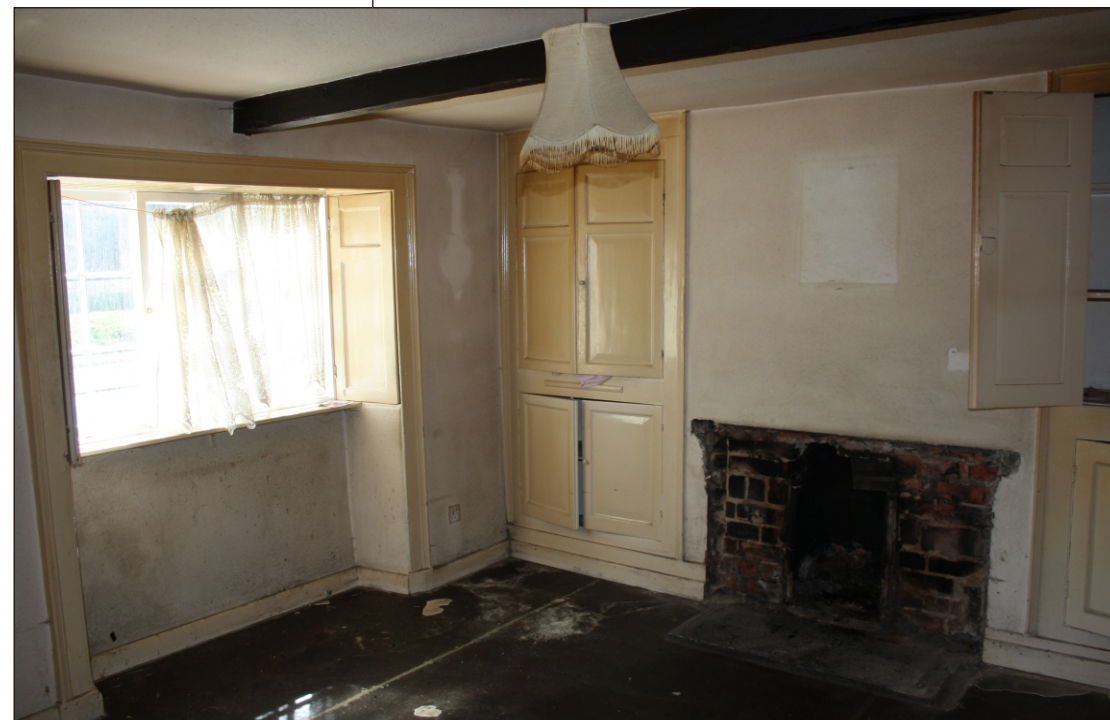
Ground Floor: Lounge

The central hearth within the southern gable is missing its insert and there are fitted cupboards both top and bottom either side of the chimney breast (fig. 12).

A hearth is present in the south gable wall, although its insert is missing, there are fitted cupboards both top and bottom either side. **see left**

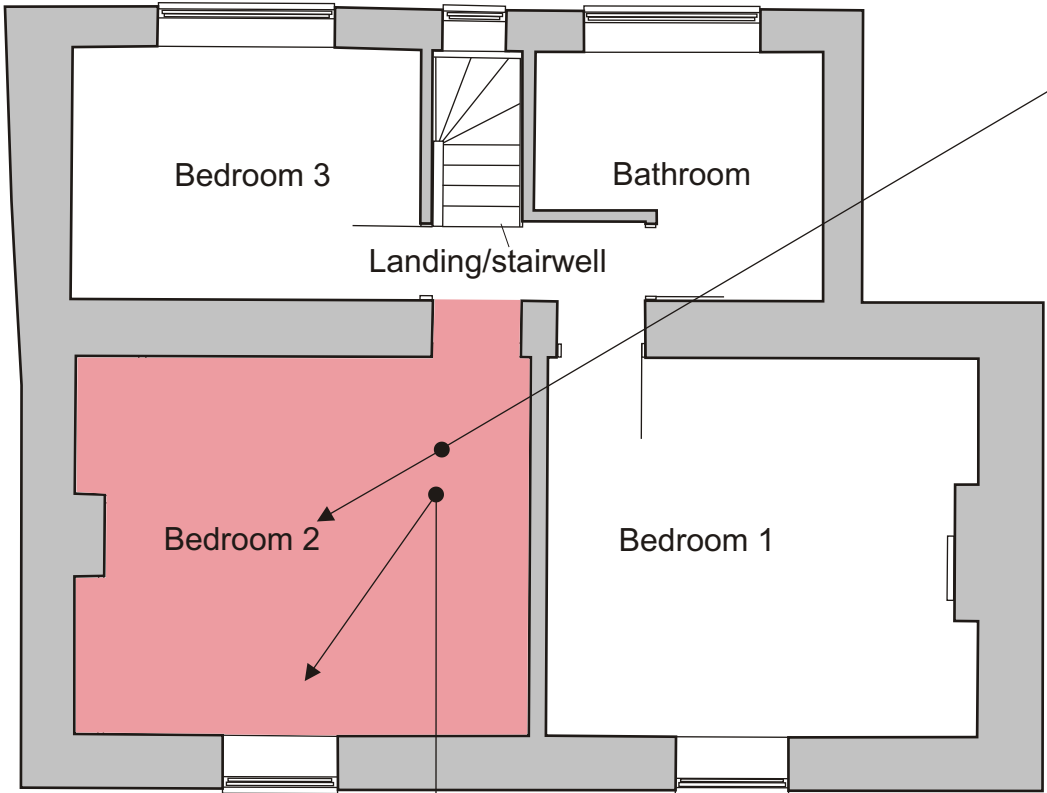
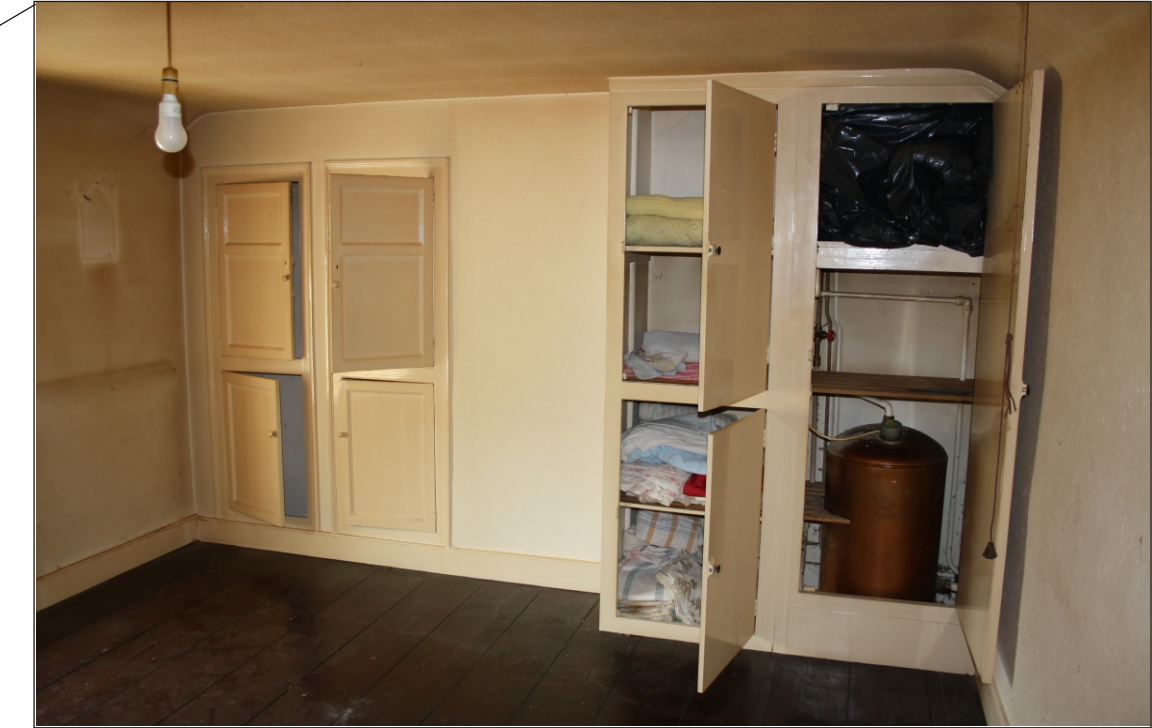
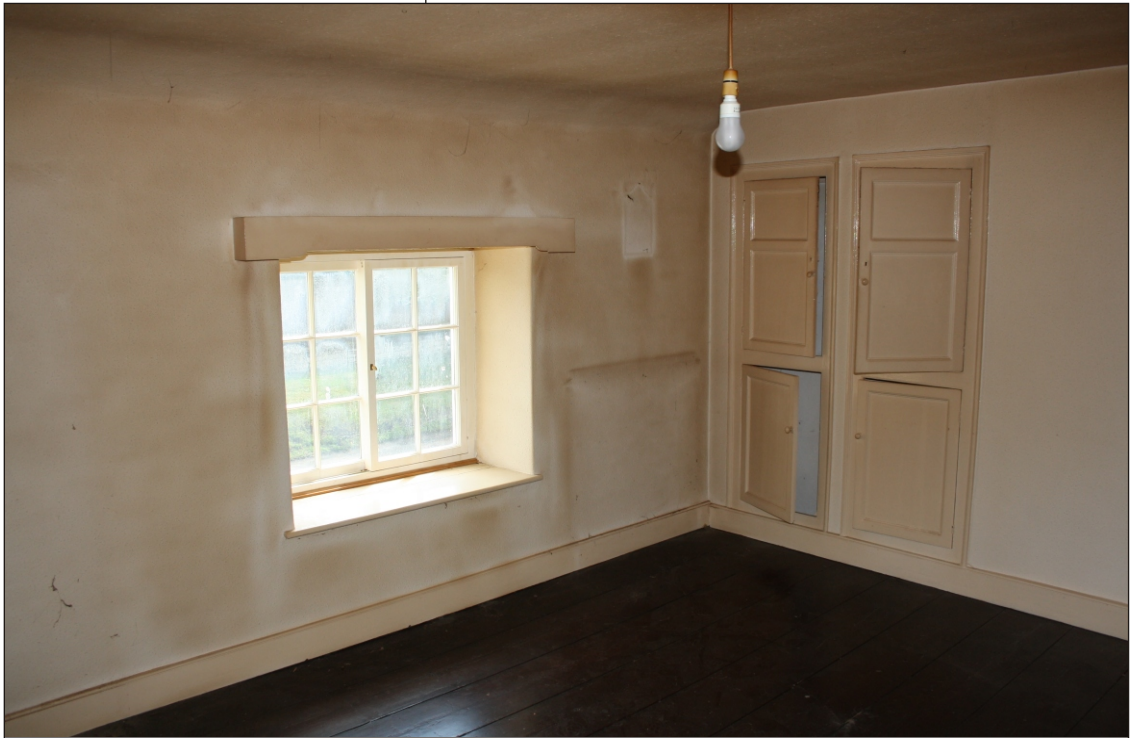
Ground Floor: Bedroom Two

The fireplace has been boarded over in this room, the area in part being replaced with fitted cupboards, there are cupboards within the left side alcove and a central heating boiler to the right. **see bottom left and above.**
