14 Hilgrove Street, St Helier, Jersey

Archaeological Appraisal

**Archaeological appraisal of the suitability of 14 Hilgrove Street to be
considered for designation as an
Archaeological Site**

August 2010

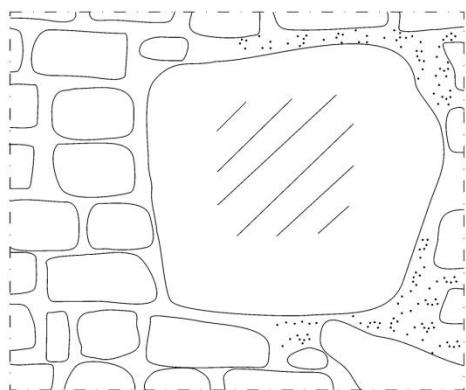
9.2 Detail of East Facing Cellar Wall, Showing Brick Bond Incorporating Roughly

- 5.2.6** The brickwork is specific to the east facing cellar wall. The material is badly degraded and as such the bond is difficult to distinguish. A rough header bond may be the closest match to the evident pattern; however individual bricks hardly overlap at all in some areas. The brickwork both incorporates and consolidates the granite material which makes up the majority of the cellar walling. Perhaps the brickwork is used here to face up an existing wall in need of repair, rather than to provide a structural role. The need for a buttress in this area confirms the inadequacy of the brick coursing.

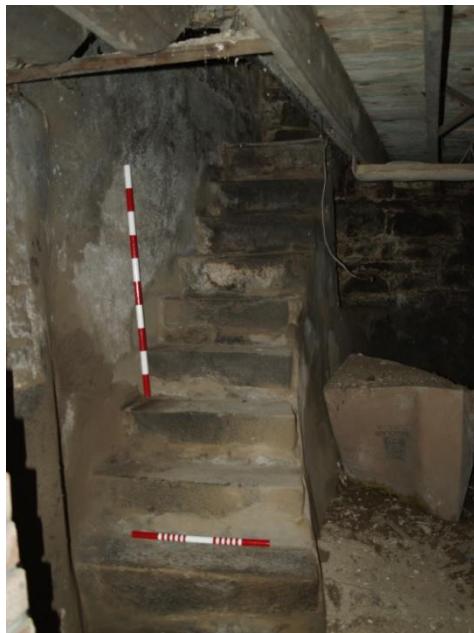
Photo 1: Cellar Stairway Scales 1 x 1m & 1 x 500mm

- 5.2.1** The cellar is accessed through an internal doorway leading down from the rear, NW corner of the ground floor of 14 Hilgrove Street. A set of 11 dressed grey granite steps (measuring 80mm rise x 750mm clear width) make up the original stairway. The stairs lead to a cellar, with a clearance height of 1.82m from the floor to the underside of the ground floor. The staircase follows the line of a clear anticlockwise curve in the render, sealing the east facing wall of the cellar, against which the

granite steps are set (Photo 1). The staircase construction respects this orientation, although there is no evidence from the rectangular plan of the main structure to propose a reason for this. It is suggested here that the staircase perhaps continues to a greater depth and that the floor surface has been gradually raised to combat the damp.

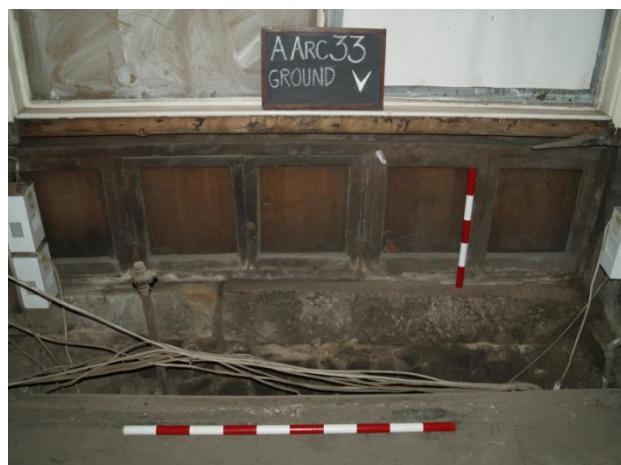
Photo 2: Coal Chute Scales 1 x 1m & 1 x 500mm

- 5.2.2** The coal chute empties into the cellar and is accessed from timber shutters at street level (Hilgrove Street). The Granite chute, measuring 2.4m in length x 700mm in width, represents another original feature, contemporary with the original use of the premises (Photo 2). The chute is lined, at street level, with large dressed rectangular granite blocks. This material makes up the upper course of the random coursed north facing cellar wall.

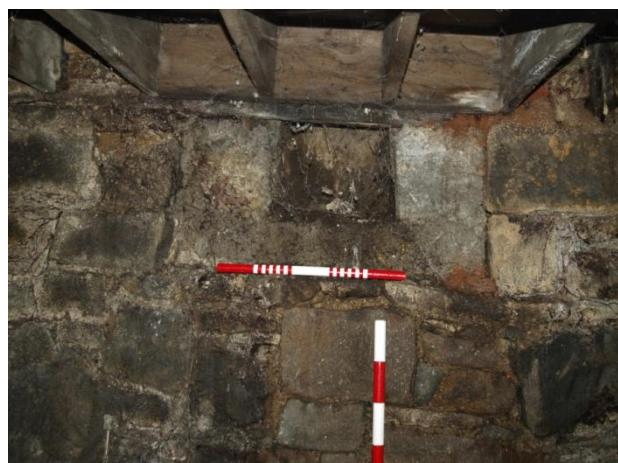
Photo 3: Drain in Cellar Scales (vertical) 1 x 1m & 1 x 5

- 5.2.3** The remains of a drain inlet can be seen, contemporary with the south facing wall of the cellar. In the 19th century, well appointed premises were fitted with external guttering to allow for the collection of rainwater from the roof to be transferred via an external drain, to a built in holding tank in the cellar (Photo 3). This would have been used for the purpose of washing, with water being drawn from the tank using a hand pump. No remnants of the holding tank were identified at the time of the inspection; however the floor and wall were only partially visible at the time of the visit. A large area of the drain has now been cemented in (20th century), presumably with the intention of reducing the flow. However 300mm (w) of the drain remains open and still allows water into the cellar. An area below the inlet appears to have been patched up with random granite stonework, to match the random uncoursed 19th century wall. The documentary evidence identified the culverted Douet running beneath the adjoining property (number 12 Hilgrove Street). Despite the proximity of No 14 to the water source, there was clearly a requirement for additional capture and storage at the time of construction.

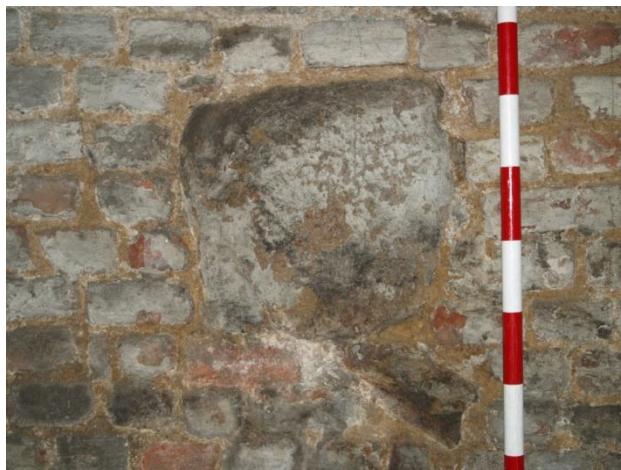
Photo 4: East Facing Elevation, Cellar Scale 1 x 1m

- 5.2.5** The contemporary cellar construction exhibits a piecemeal design, with a mix of random uncoursed granite walling, comprising roughly hewn granite blocks and 19th century brickwork elevations, incorporating roughly hewn granite (Photo 4). The bricks show evidence of extensive damage from the rising damp. To combat the problem, the lower c. 900mm of the cellar walling is sealed with thick cement, which appears to be covering lower courses of roughly hewn granite building material.

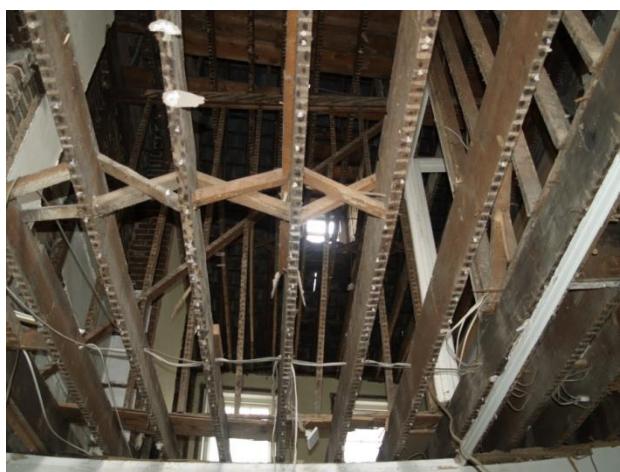
Photo 5: View of Floor Joists from Ground

- 5.3.2** The majority of floorboards have been taken up and ceiling material removed to expose a complete set of original floor joists for the first and second floors (Photo 5). The first floor timbers are jointed to the lintel to the front of the building. In contrast, on the opposite wall, the joists can be seen to be only partially jointed into the lintel and partially keyed into the random uncoursed granite load bearing wall, above the beam. Original joist spacers remain in situ, between the first and second floor timbers. Occasional samples of the original floor boards remain in areas where access is still required. Examples include the stair landings and areas around the second floor fireplaces.

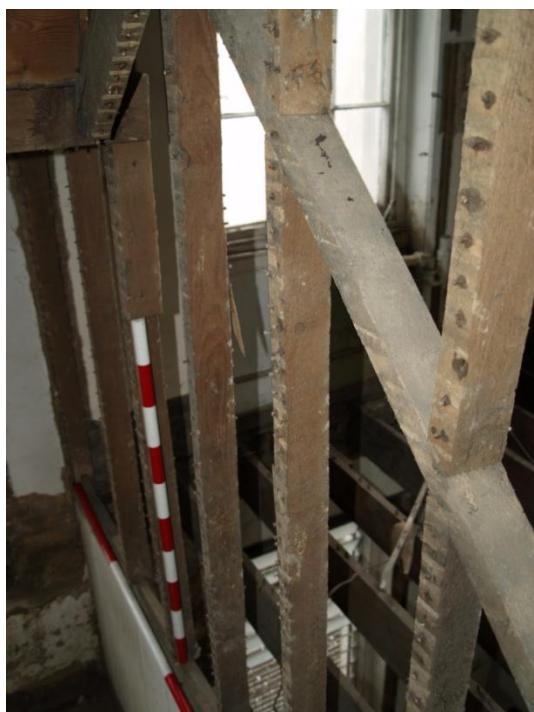
Photo 6: Partition Beams with Evidence of Lath and Plaster Scales 1 x 2m & 1 x 1m

- 5.3.4** At the time of the inspection, the frames of the partition walls on the first and second floors were exposed. The door frames remain, although the doors have been removed. The internal divisions comprised simple timber frames consisting of horizontal beams joined to the floor joists above and below. The beams are given strength from single diagonal timbers, supporting each frame. Vertical beams are jointed to the diagonal, above and below, to hold the lath (for lath and plaster) in place (Photo 6). Although now only the bare struts are visible, there is clear

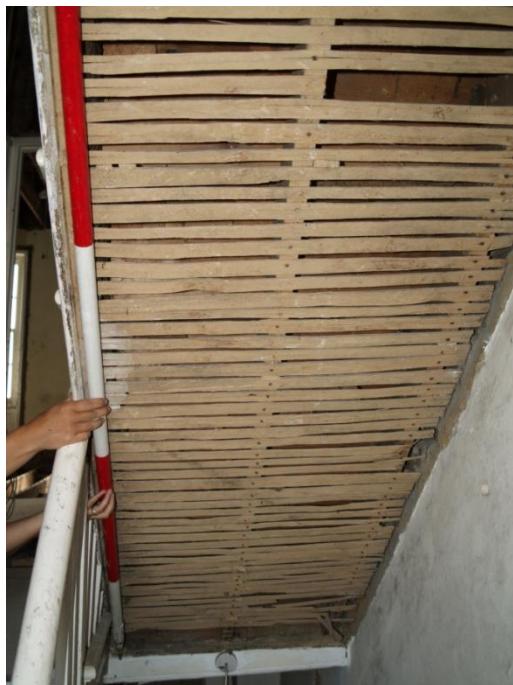
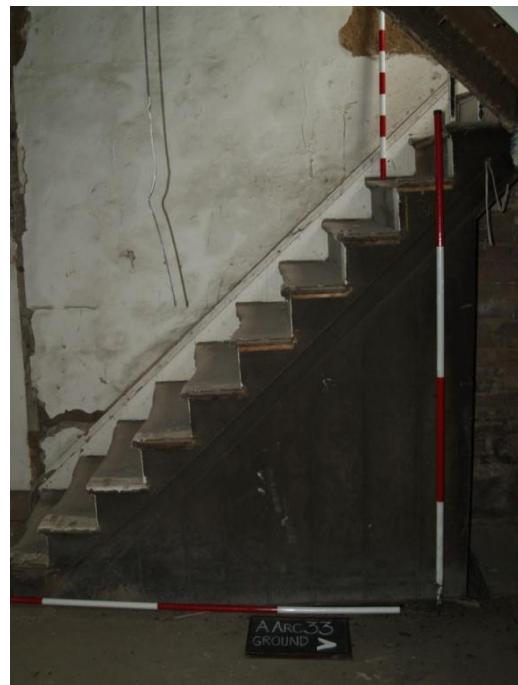
**Photo 7 & 8: Main Stairway Left = Underside with Preserved Lath Scale 1 x 2m
Right=Ground Floor Elevation Scales 2 x 2m**

- 5.3.3** The half landing staircase, enabling access to the first and second floors of the property, rises from the rear NW corner of the ground floor. Original materials make up the first three flights (to the second half landing). However, it should be noted that the staircase has been substantially destabilised as a result of the recent alterations and is no longer suitable for use.

evidence that the partitions were previously consolidated with lath and plaster, which is still visible on the underside of the staircase (lath only) (Photo 7).

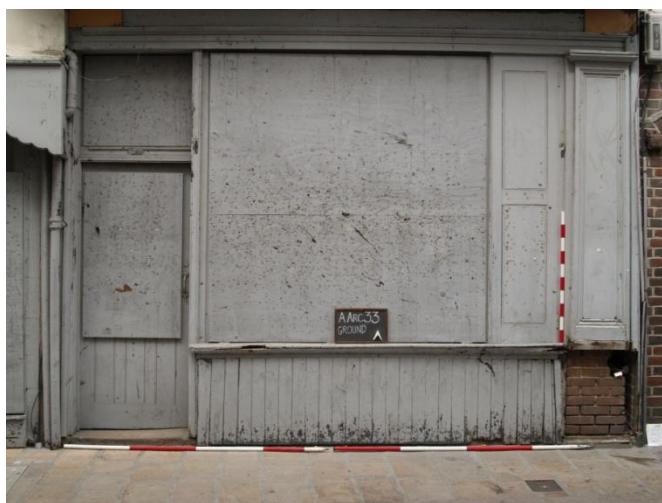
Photo 9: Façade of 14 Hilgrove Street, St Helier Scales 1 x 2m & 1 x 500mm

- 5.4.1** An inspection of the property revealed that the exterior was not affected by the recent alterations to the building and therefore has not changed since the 2002 report (Photo 9). Therefore it will suffice here to note that the majority of the timber facing remains in keeping with the 19th century use of the building. Although alterations were noted to have taken place in this period, they can be considered in keeping with the historic development of the site. For example, Carey notes the insertion of a line of ‘glazed opening lights’ that can be seen to span the width of the shop window (Carey 2002), giving street side access to the coal chute. Although dated to the late 19th/early 20th century, the lights appear in keeping with the fabric of the building and add historical interest to the story of 14 Hilgrove Street. Major alterations to the face of 14 Hilgrove belonging to the 20th century, consist primarily of alterations to the door leaf and glazing (see Carey 2002).

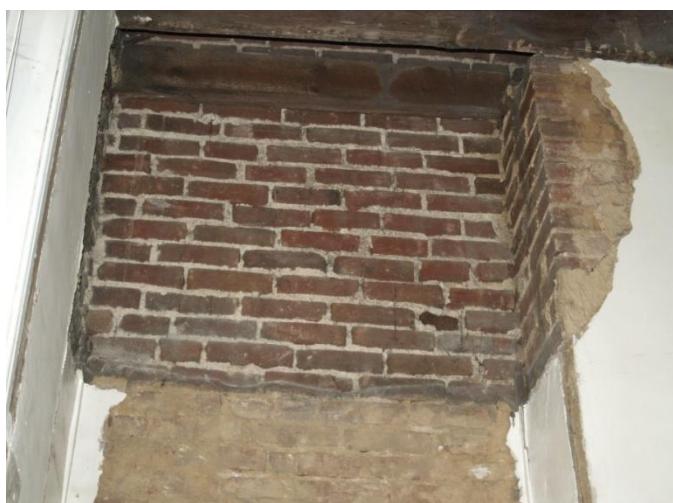
**Photo 10: First Floor Revealed
Stretcher Bond**

- 5.4.3** A limited inspection of the fabric of the internal walls was carried out, where the brick and stonework was revealed. The east and west facing walls are worked in brick, with evidence of bonding timbers through the lower floors (evident in a gap in the modern plasterboard on the ground floor east facing elevation). The bond was visible on the first floor, west facing elevation, where a basic stretcher bond is evident (Photo 10). An inspection of the main load bearing walls (north and south facing) was limited by the lack of revealed materials and the absence of floorboards, preventing a closer investigation of the north facing elevation. However, it is clear that the outer walls of the building, supporting the pitch of the roof and housing the fenestration is constructed from a combination of random

uncoursed rubble with brick consolidation around the openings. Timber lintels remain visible in most instances and it is clear that 80/90% of the structural material is original (belonging to the early 19th century construction of 14 Hilgrove Street).
