**GREENBANK BARN, GRINDLETON,
LANCASHIRE**

HISTORIC BUILDING RECORDING

Planning ref. 3/2019/0140

July 2019
Revised October 2019

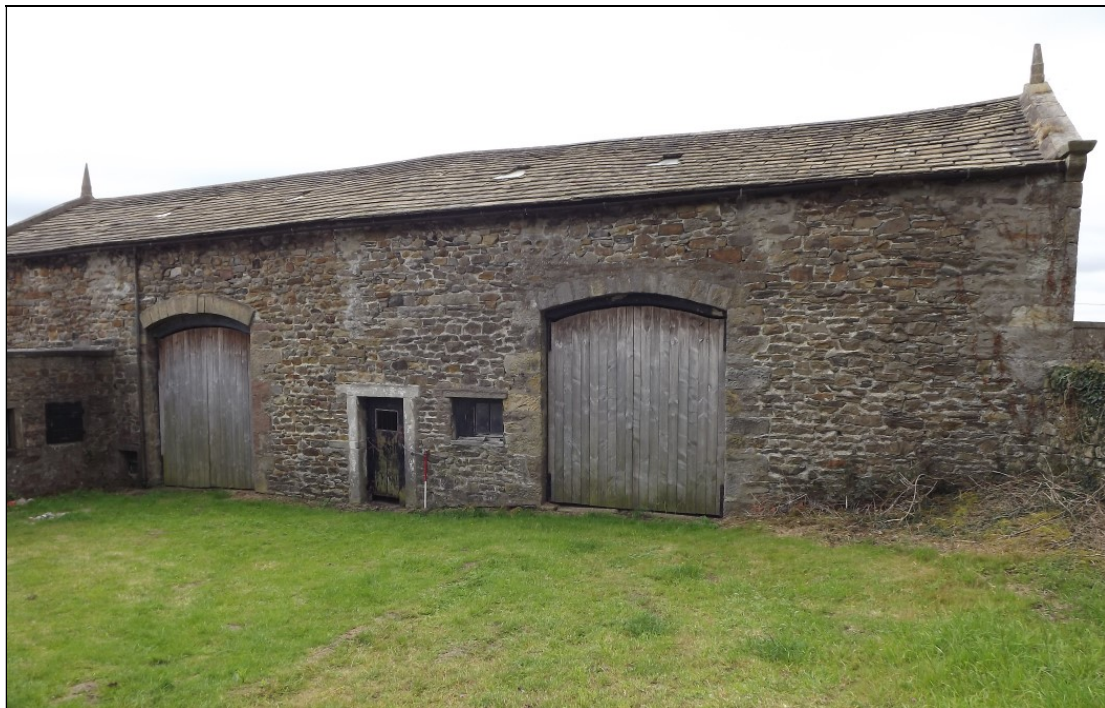
Plate 1. Rear (northern) elevation, looking south, scale 1m

- 4.4 The barn had been built on a modest man-made terrace cut into the south facing slope of the hillside. The rear (north) elevation (Plate 1) contained two large cart doors along with a single, centrally located doorway and window.

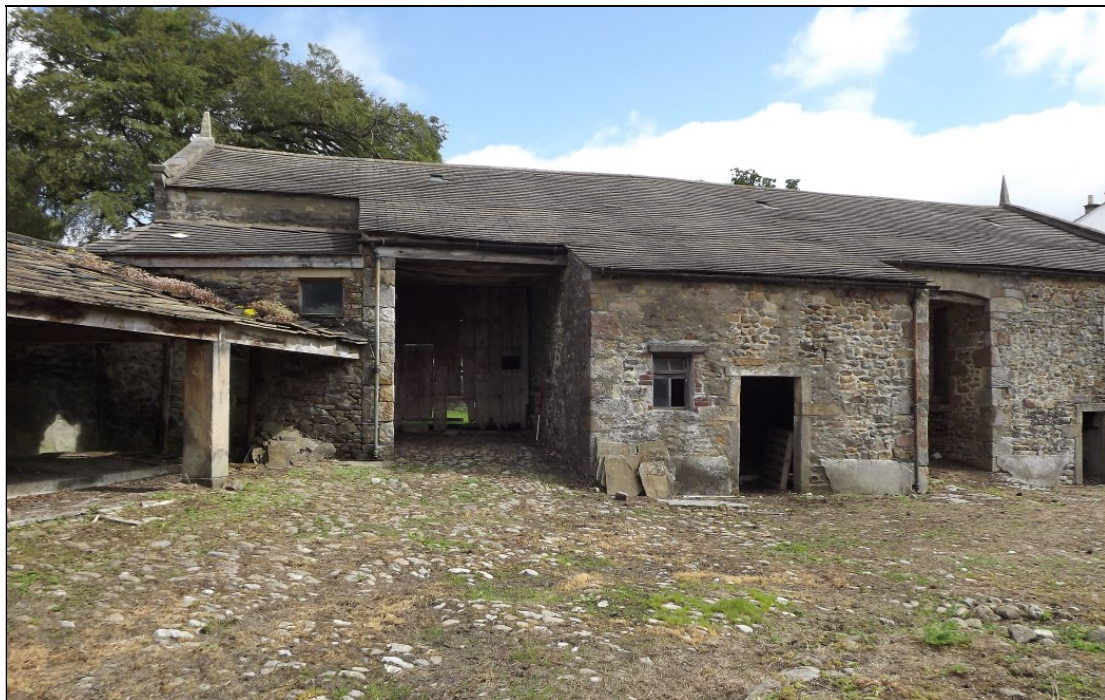
Plate 2. Front (southern) elevation, looking north, scale 1m

- 4.5 The southern elevation (Plate 2) had a similar arrangement with two large cart doors directly opposite the ones in the northern elevation. There were a number of small doors leading to a variety of small rooms which appear to have been added to this elevation over time.

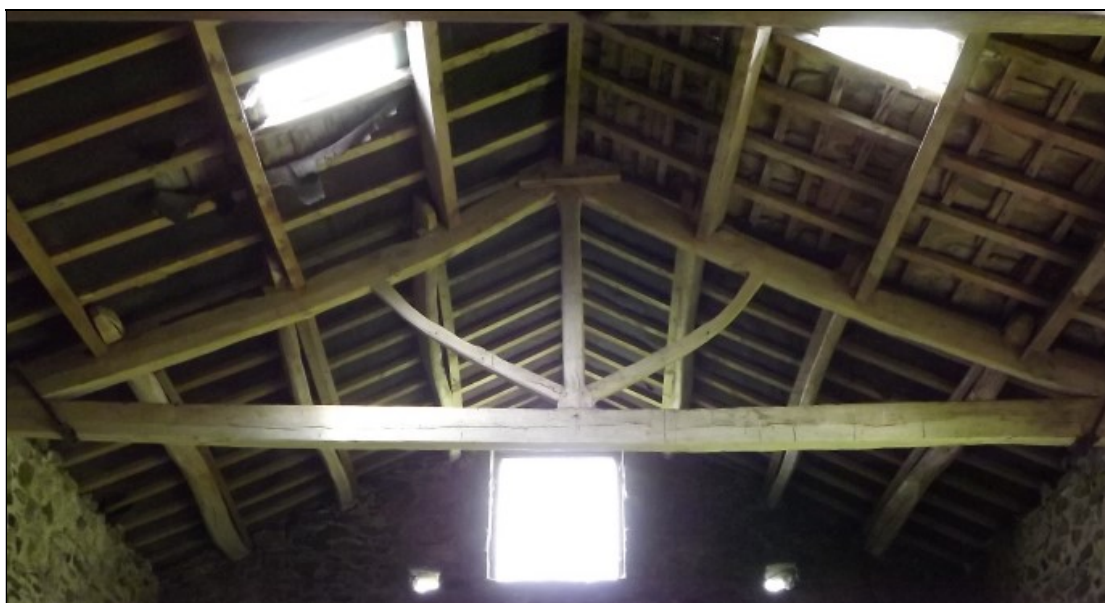
Plate 3. King post truss with curved braces at west end of the barn, looking W

- 4.8 The date of the original construction of the barn is uncertain and, as seen in the historic mapping above, it appears to be in place in its current form by the mid 19th century. An earlier origin is indicated by a number of surviving architectural features including a king-post truss of hand-cut timber which has curved braces (Plate 3). This suggests an 18th century date.

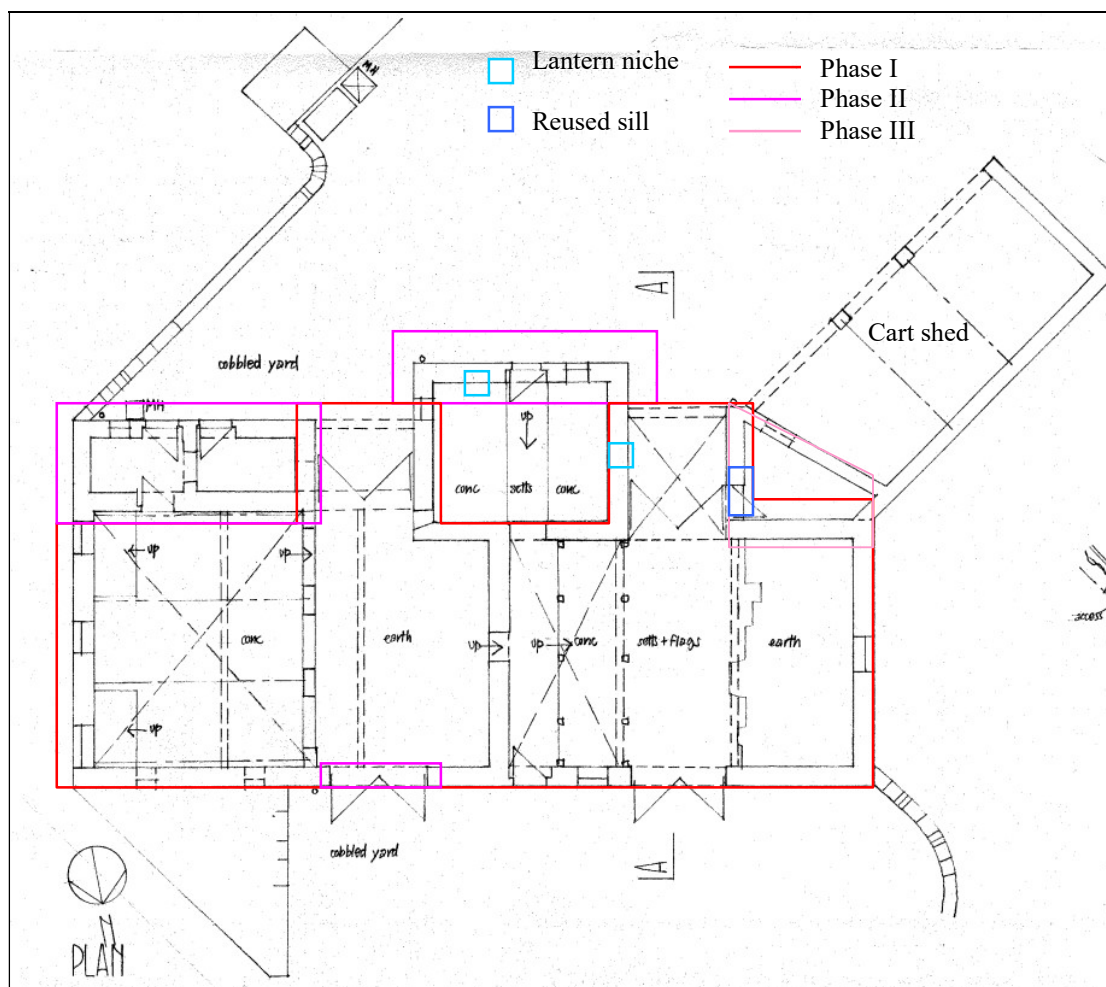
Figure 9. Ground floor plan

- 4.11 The dated key stone in the cart door at the eastern end of the northern side of the barn probably marks first phase of extensive alterations to the building (Plate 8). The arch appears to be re-built as it is out of keeping with the wall that it is inserted in and the springers at either end do not join properly to the jambs. This phase of activity can be seen in the infilling of the area between the two cart porches on the southern side and the addition of a further two rooms on the south-eastern corner (Figure 9).

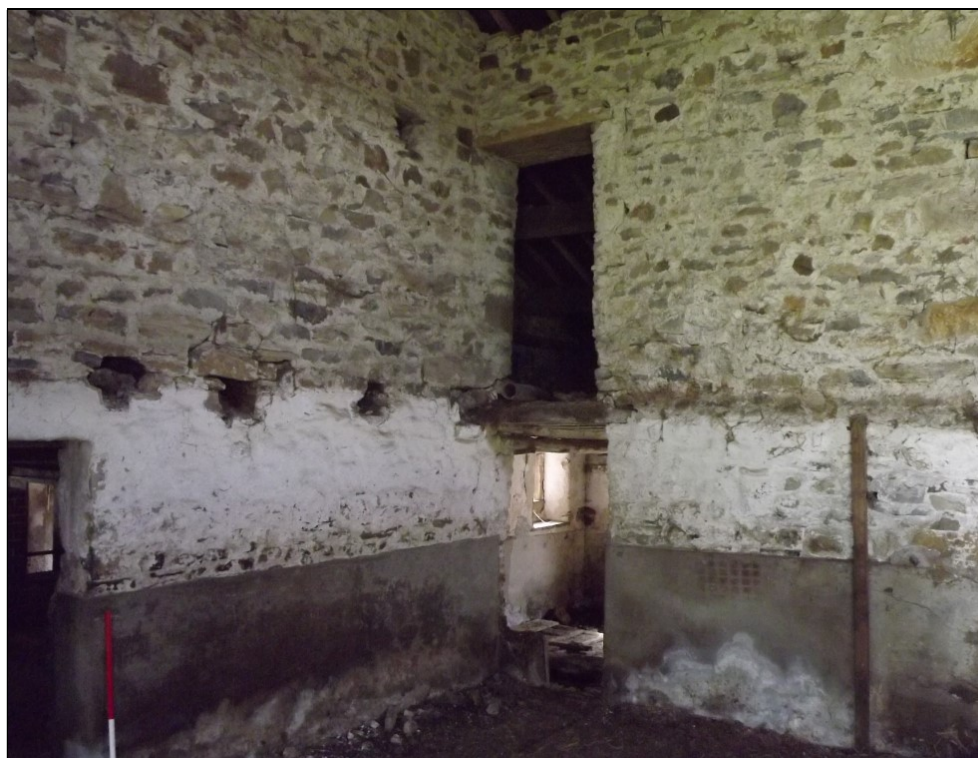
Plate 4. Joist holes and 'tide mark' showing hayloft, looking SE, scale 1m

- 4.9 The original configuration of the barn appears to have been as a large hay barn with two cart porches on the southern side with matching doors on the northern side. The size and location of these doors would have allowed for threshing to have taken place as an additional activity. A row of joist holes in the dividing wall between the two parts of the barn attest to a hayloft (Plate 4). A further possible indication of a hayloft, or possibly even a granary, is a line of large staggered stones in the north-eastern side of the barn (Plate 5 & Figure 7). These stones could be the remains of a flight of external steps to a loft of some form, however due to lack of any blocked doorway associated with them and their spacing this suggestion remains purely speculative.

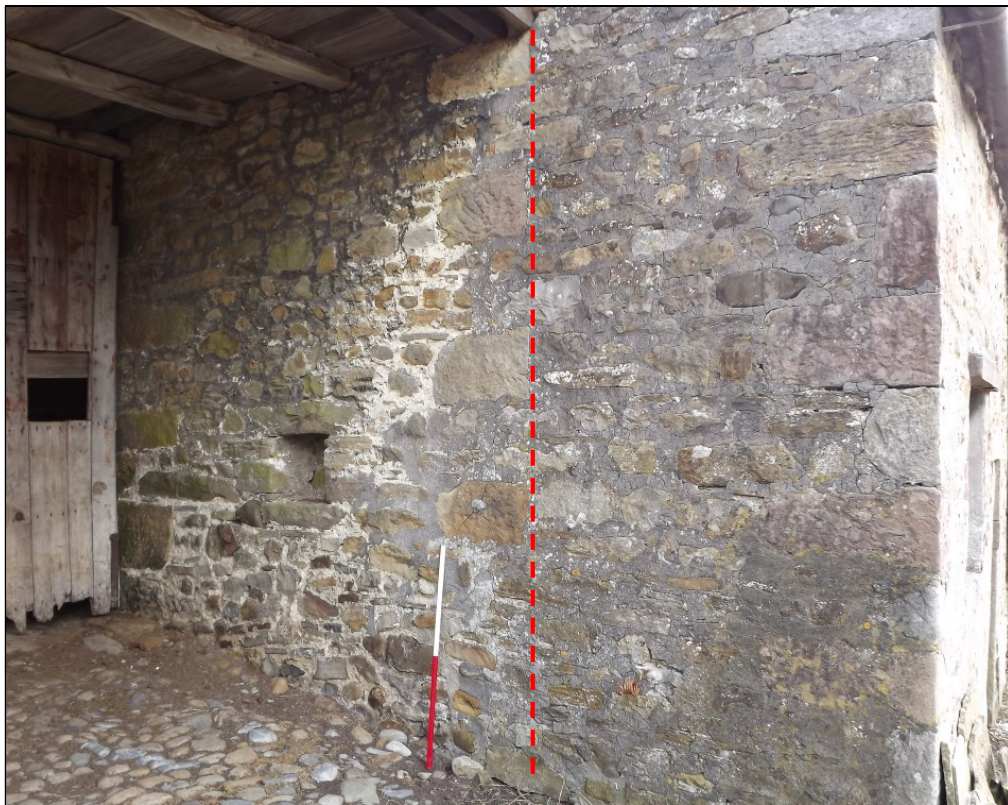
Plate 6. Lantern niche & butt join of Phase II extension, looking NE, scale 1m

- 4.10 The western cart porch retained a lantern niche on its eastern side (Plate 6), a similar one would be expected in the eastern cart porch but later alterations have probably removed it (Plate 7). The cart doors in all four entrances were harr-hung which probably reflects their original configuration; the current doors are a mixture of repairs and additions with no heritage significance.

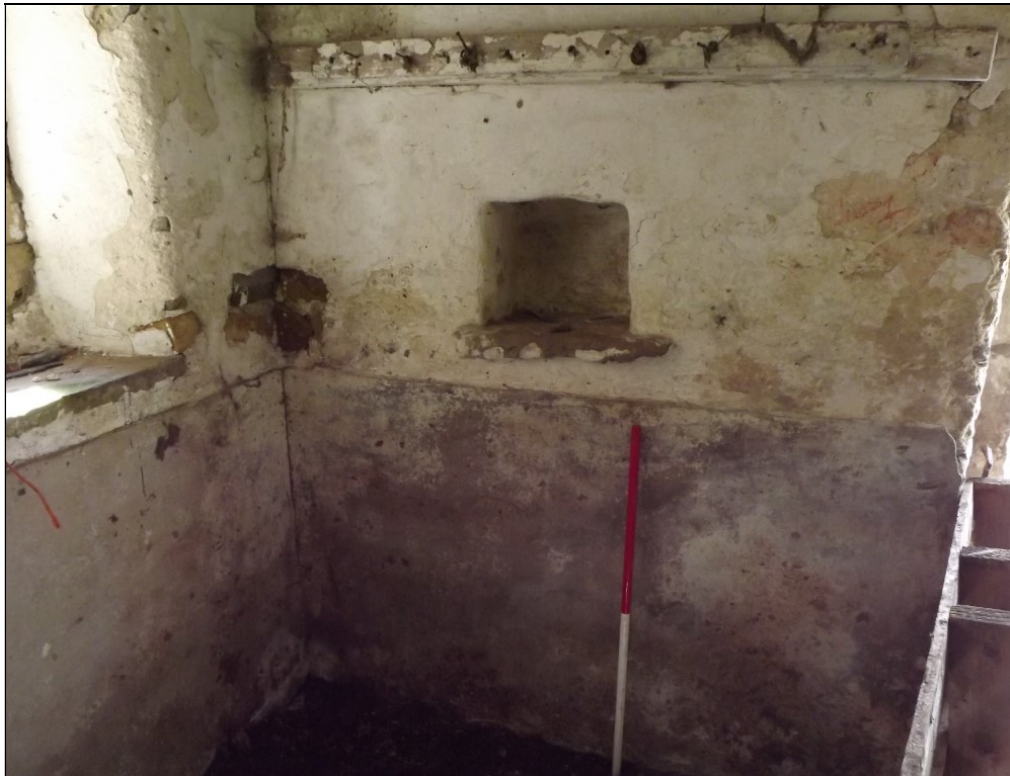
Plate 10. Lantern niche, looking south-east, scale 1m

- 4.12 The infill between the cart porches was used for livestock, as seen by the lantern niche in the southern wall (Plate 10) and the collapsed boskins. The ceiling timberwork for this room contained a number of reused elements which may have derived from the reconfiguration of other parts of the building.

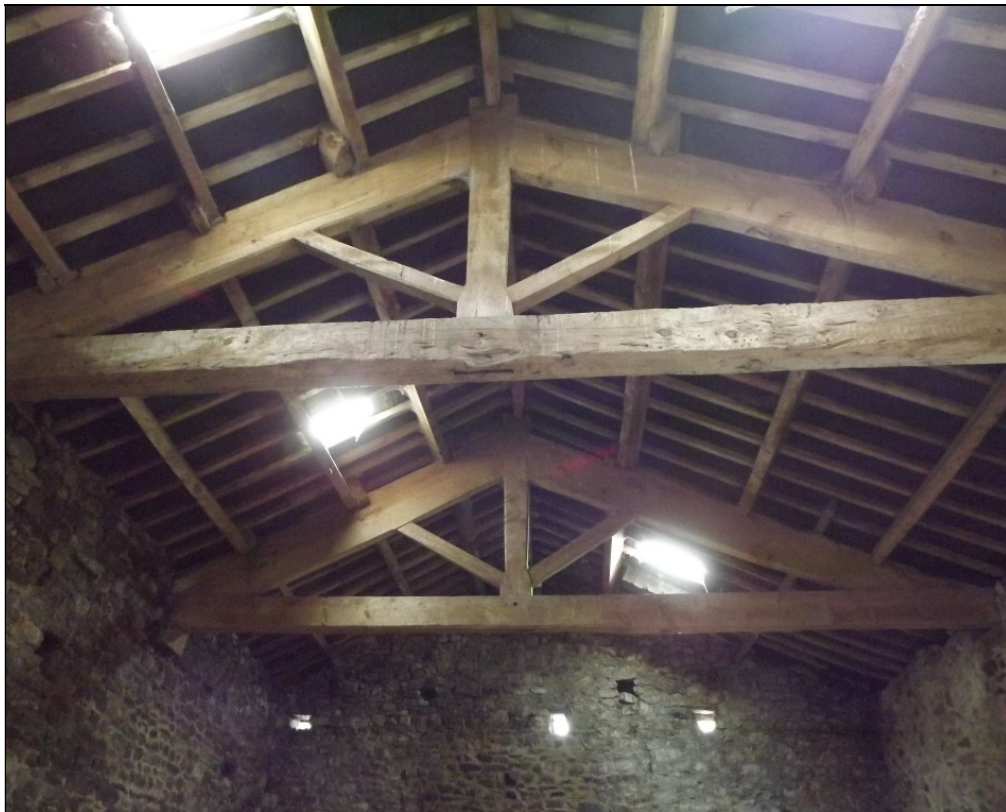
Plate 11. Later, pegged trusses at the eastern end of the barn, looking east

- 4.15 It would seem probable that the early 19th century changes also saw the replacing of the original/earlier trusses with the more substantial ones seen

today (Plate 11). The current trusses are simply lodged on the top of the walls with no obvious wall plate and no corbel.

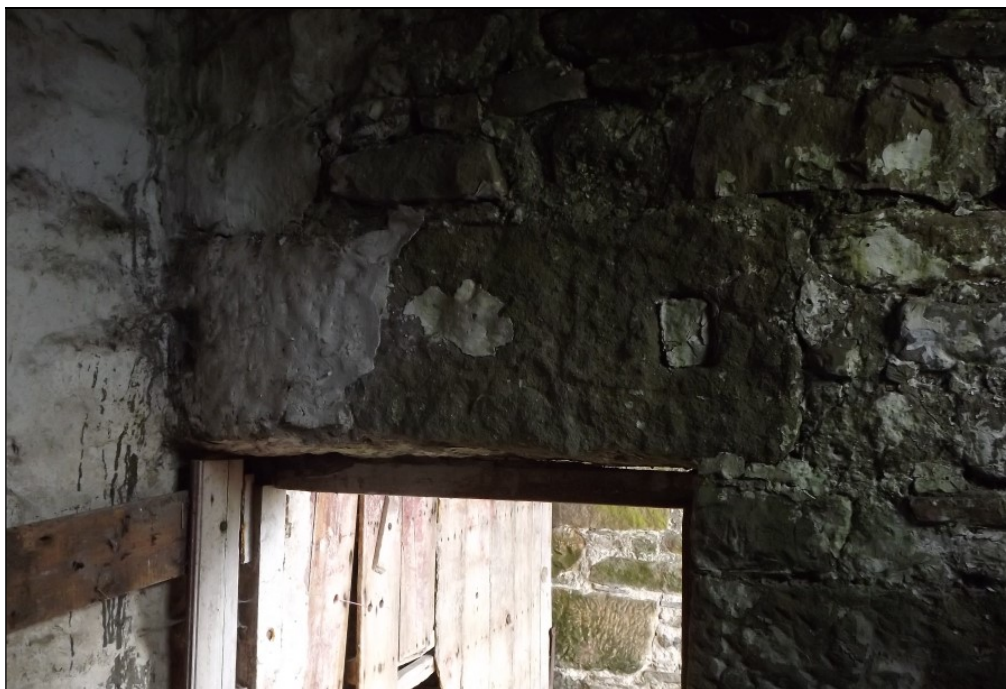
Plate 12. Reused door sill as a jamb, looking east.

- 4.16 The last significant change to the building that can be identified is the infilling of the gap between the cart shed to the west and the western end of the barn. From historic mapping (Figs 6&7) this would seem to be between 1890 and 1908. The only notable feature of this room was the reused door sill as a lintel over the door, as seen by the holes for door jambs (Plate 12).
