**Roebuck Barracks
Acaster Malbis
North Yorkshire**

Archaeological Building Recording Level II

LS Archaeology

January 2015

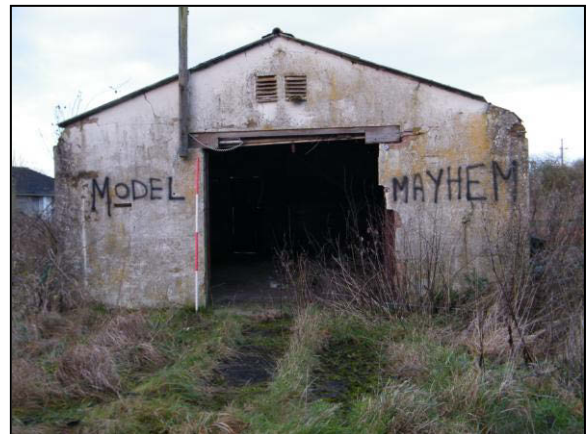
Plate 1: Building 1 looking southwest

Building 1; consists of a rectangular shape in plan brick and cement walls, concrete floor, cast iron window frame, with an iron frame roof and asbestos tiles. A small wood door located at the south west corner of the west wall. A large vertical sliding door was fitted at the east.

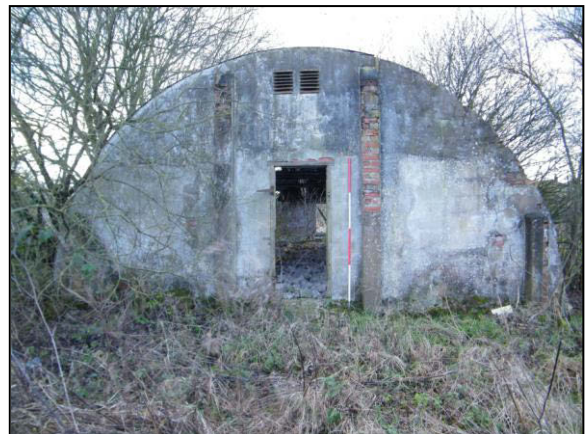
Plate 7: Building 3 looking south

Nissen hut, with brick walls at each north and south end, and corrugated iron roof. The hut appears to be in a poor state of preservation.

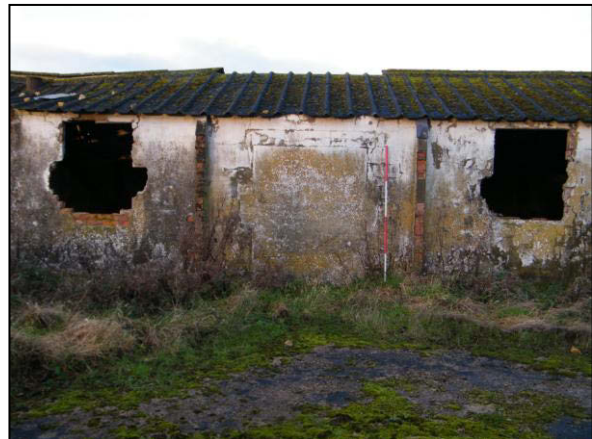
Plate 11: Building 4 looking east

Rectangular shape in plan building with walls made of bricks and mortar, an iron frame roof with asbestos tiles. All windows have been removed, and new opening for modern large door are visible along the east wall. The interior is filled with debris from the collapsing walls and roof. This building has been deemed unsafe to enter.

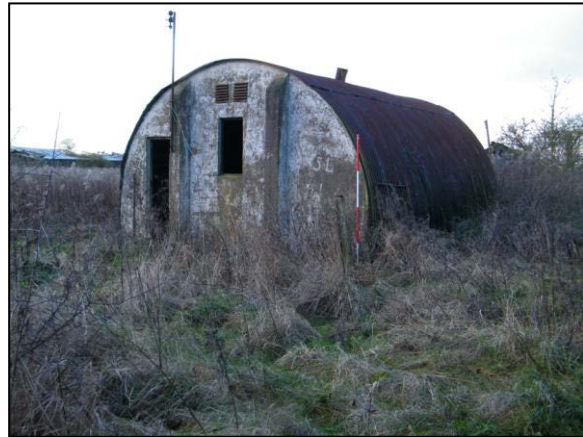
Plate 13: Building 5 looking south west

Nissen hut, with brick walls at each north and south end, and corrugated iron roof. The hut appears to be in a better state of preservation than hut 3. Inside two side walls made with concrete bricks have been added when the hut was converted for piggery use.

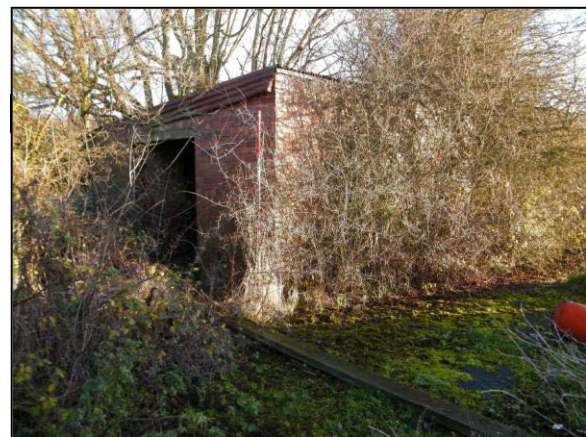
Plate 16: Building 6 looking north east

Building 6 is a small building, the walls are of brick and mortar and it has a flat roof with corrugated iron cover. Due to heavy overgrown vegetation and collapsed interior this building has been regarded as unsafe to enter.

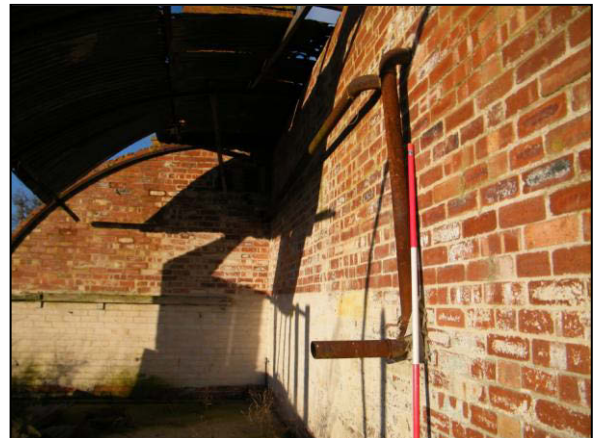
Plate 19: Building 8 interior

Nissen hut, which has internal partition brick and mortar walls, and a brick and mortar build tower at the west end. The east end of this dwelling has not survived and so is most of the corrugated iron roof and structure.

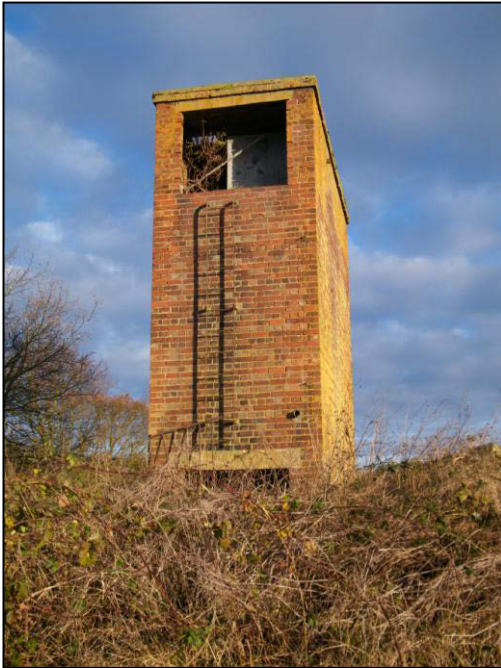
Plate 22: Building 9 looking north east

Building 9 is a rectangular brick and mortar built tower, with access to the south. A substantial amount of derides has been deposited around this building creating a mound which made access to the tower difficult and unsafe.

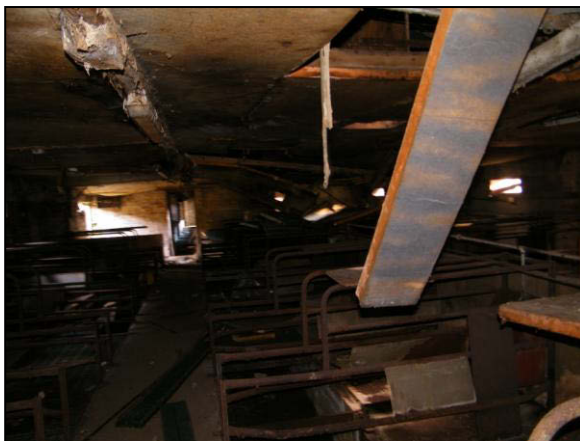
Plate 24: Building 10 interior

cover consists of asbestos corrugated tiles. At the south end it has a metal silos. Inside this building alterations made for the piggery are visible although a good part of the ceiling has collapsed making the access to this building unsafe. A tall brick and mortar square tower rise at the center of this building, the access to this part of the building is restricted due to falling ceiling.

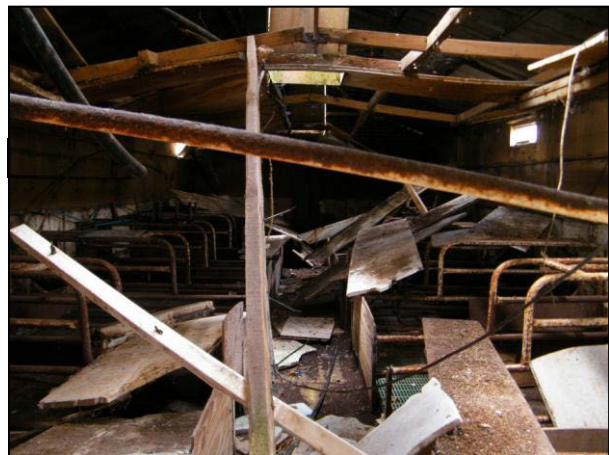
Plate 28: Building 11 interior

cover consists of asbestos corrugated tiles. Inside this building alterations made for the piggery are visible although a good part of the ceiling has collapsed making the access to this building unsafe. A tall brick and mortar square tower (shorter than the tower of building 10) rise at the center of this building, the access to this part of the building is restricted due to falling ceiling.

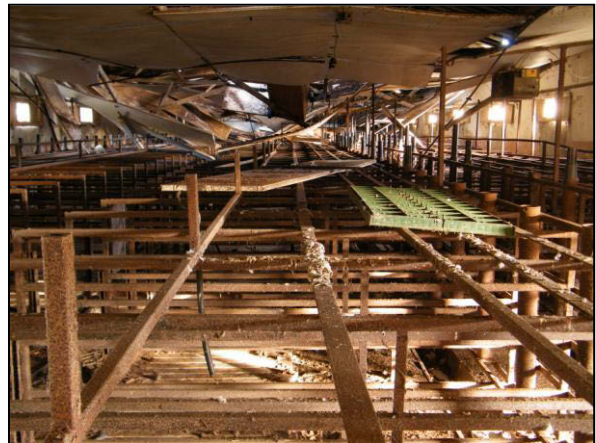
Plate 29: Building 12 interior

This building is of a rectangular shape in plan, built with bricks and mortar, and orientated on a north northeast to south southwest alignment, located at the east of Building 11. The roof cover consists of asbestos corrugated tiles. At the north east end it has a metal silos. Inside this building alterations made for the piggery are visible although a good part of the ceiling has collapsed making the access to this building unsafe.

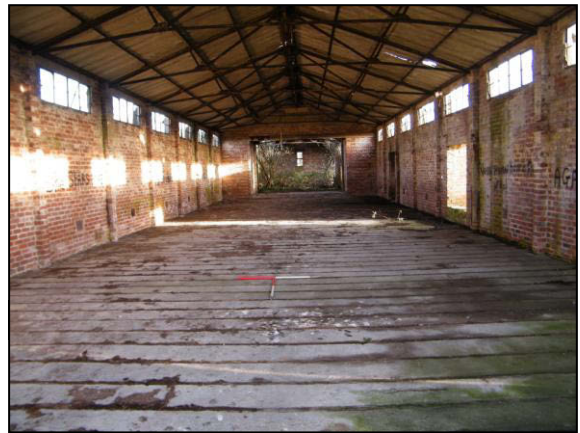
Plate 50: Building 19 interior

for large machinery. Along the south wall at the western end, two square cubicles built with bricks and mortar and flat roof have been added to the main building, most likely to be associated with the farming activity. All in all the building is in a relatively good condition of preservation, although the eastern end of this building appears in a very poor state of preservation, with the roof nearly all collapsed.

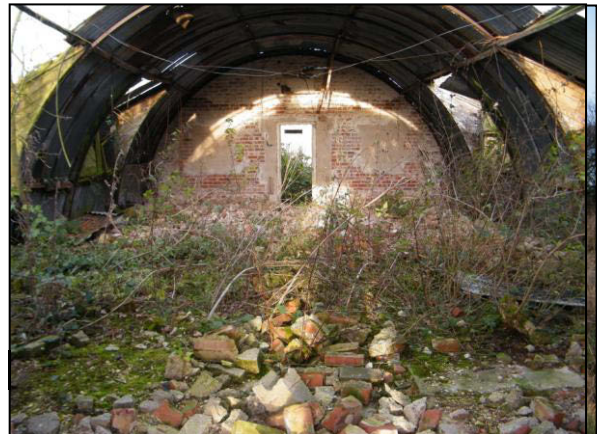
Plate 58: Building 23 looking north east

Building 23 is another Nissen hut, orientated on a north northeast to south southwest alignment, with brick walls at each north and south end, and corrugated iron roof. The hut appears to be in a very poor state of preservation, where most of the central part of the roof has disappeared or collapsed inside the structure. The floor consists of overgrown vegetation and derides. Overgrown vegetation also surrounds this

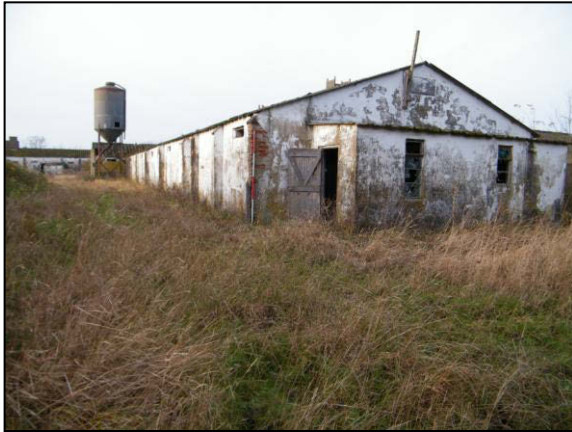
Plate 60: Building 24 looking north west

This building is of a rectangular shape in plan, built with bricks and mortar, and orientated on a north northwest to south southeast direction, located at the north east end of site. The roof cover consists of asbestos corrugated tiles. At the north westt end it has a metal silos. Inside this building alterations made for the piggery are visible although a good part of the ceiling has collapsed making the access to this building unsafe.

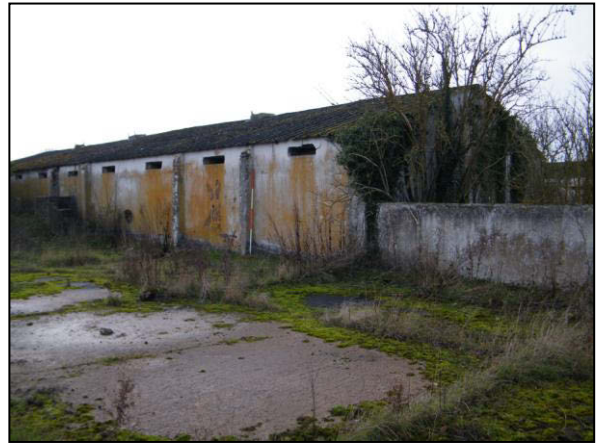
Plate 64: Building 25 looking south west

Similar to building 24 in construction, building 25 is located at the northwest end of building 24 and orientated on a north northeast to south southwest direction. Access to this building is through building 24 which in itself appears to be unsafe, as consequence no assessment of the building 25 interior was made.

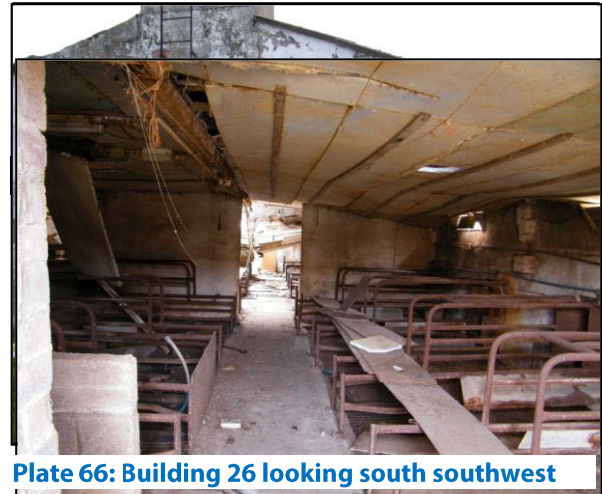
Plate 66: Building 26 looking south southwest

Building 26 is of a rectangular shape in plan, built with bricks and mortar, and orientated on a north northeast to south southwest alignment and it is located between Buildings 24, 25 and 27. The roof cover consists of asbestos corrugated tiles. At the north east end it has brick and mortar tower. Inside this building alterations made for the piggery are visible although a good part of the ceiling has collapsed making the access

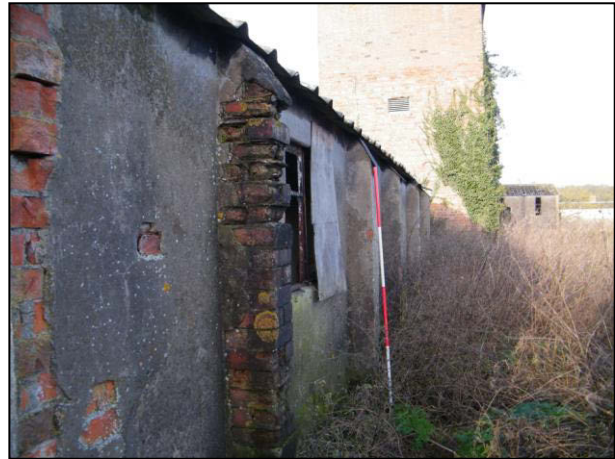
Plate 76: Building 30 looking north west

This building of a rectangular shape in plan, is located immediately south of building 29. It appears in a very poor state of preservation, and deemed unsafe to enter. The structure is of bricks and mortar with asbestos roof tiles.

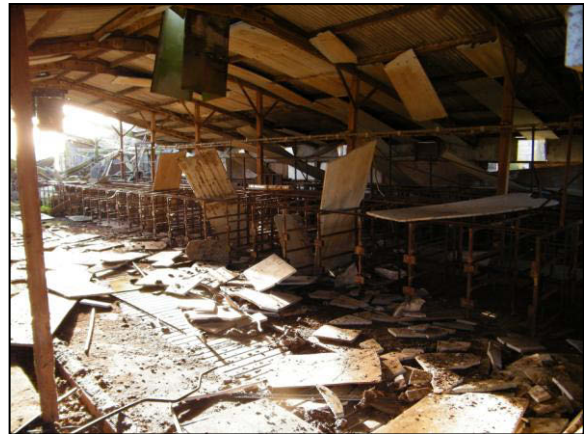
Plate 78: Building 31 interior

Building 31 is a modern steel frame shed and wood panels outside. Partitions for poultry farm use still in place. Orientated on north to south direction this building of a rectangular shape in plan is adjacent to building 32 (east side). It appears in a very poor state of preservation and deemed unsafe to enter.

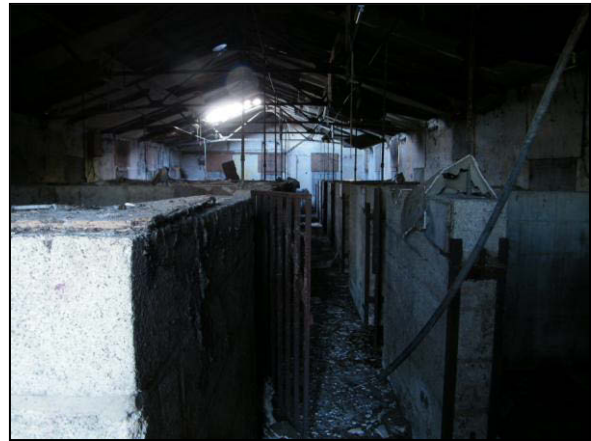
Plate 86: Building 33 interior

This building located to the near east of the building complex 32, has a brick and mortar structure with a metal frame roof covered with asbestos tiles. The interior has been converted for piggery use, with concrete bricks partitions. Building 33 is in a very poor state of preservation deemed unsafe to enter.

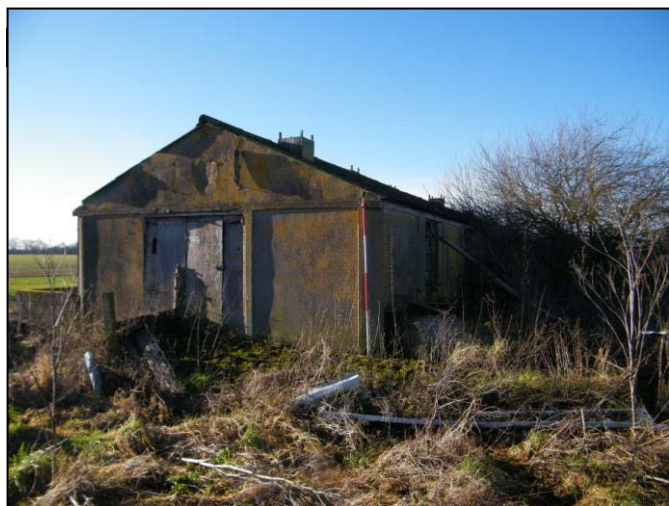
Plate 93: Building 38 looking south west

These buildings are a set of six buildings (buildings 38, 39, 42, 43, 44 and 45) all orientated on an east to west direction, set at an equal distance of each other, are located towards the south west end of the site. Of a rectangular shape in plan, all have a concrete floor, and walls made of bricks and mortar. The roof like all the other rectangular structures consisted of the principal and common rafter, hammer beam, hammer brace and pendant post made of cement, while the ridge pole consists of a long iron bar bolted at each end. The roof cover consists of asbestos-cement undulated tiles. All of these buildings have been converted for piggery use, and appears in a very poor state of preservation deemed unsaved to access.

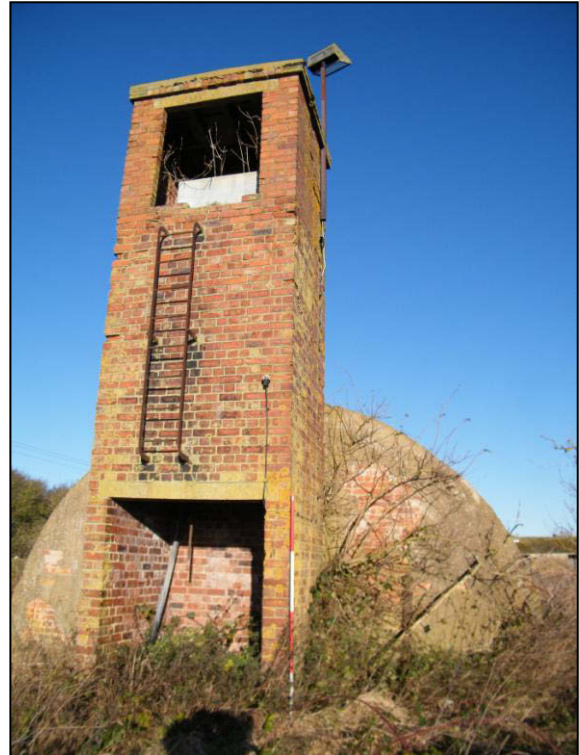
Plate 110: Building 41 tower block looking north east

Building 41 are the remains of what once was a Nissen hut. Only the south wall and tower are still standing, both of bricks and mortar. This building is located at the far south west corner of the site.

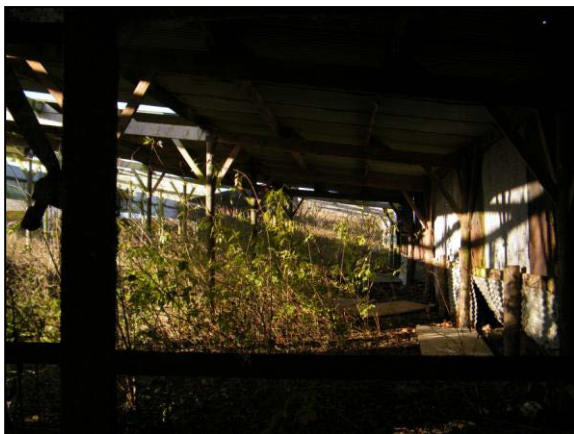
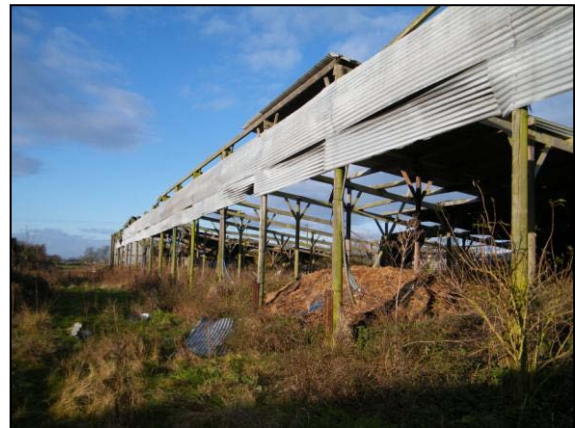
Building 47 is a modern wood frame shed associated either with the poultry farm or piggery. Located at the center west of the site, adjacent to building 13, it appears in a very poor condition of preservation.
