Iain Soden Heritage Services Ltd

33 and 37 Main Road Crick

A Heritage Asset Survey

March 2014

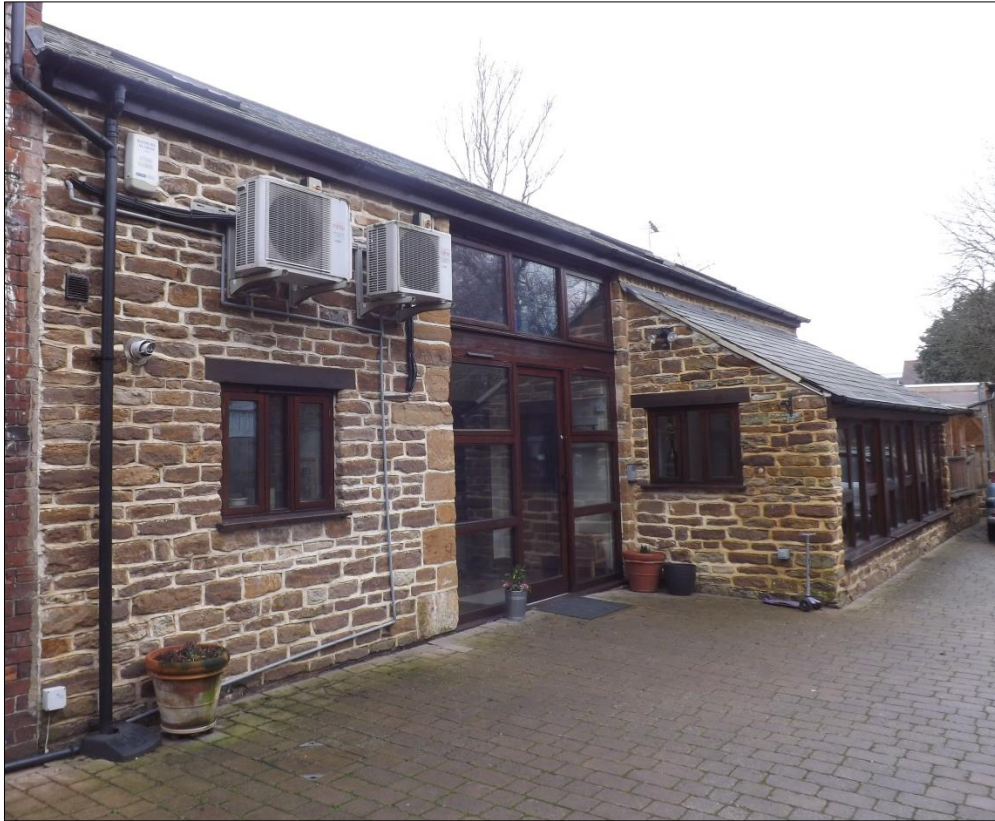
the outside, no historic fabric is visible anywhere in the building. This is the building which on the 1953 sale notice is described as being let out at that time as a garage to Northamptonshire County Council (confirmed by checking the distinctive measurements given).

Fig 11: Detached barn, converted into a nursery and extended in the last decade.

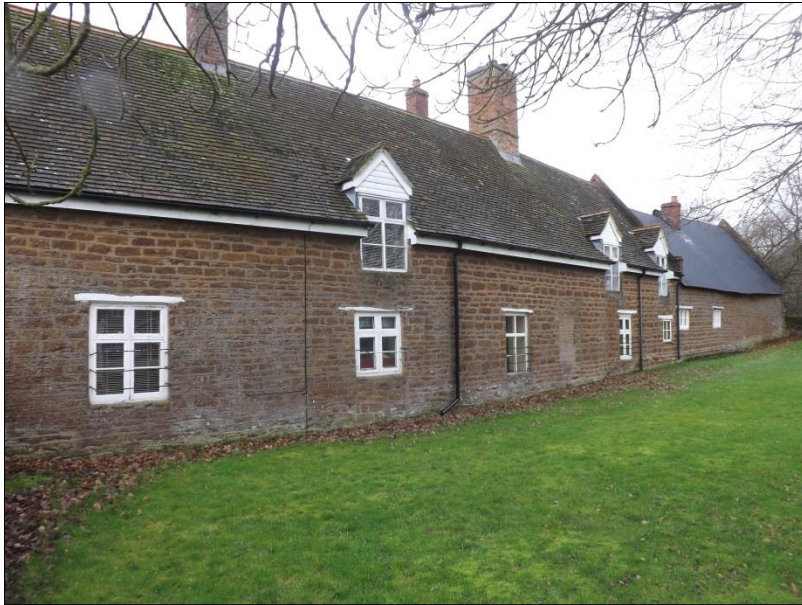
Fig 13: The outside (east face) of the house and the barn beyond. The first floor window locations are no older than later 19th century. The original eaves were probably lower, with a first floor much more constrained and not specifically for bedrooms, but rather combined with general storage.

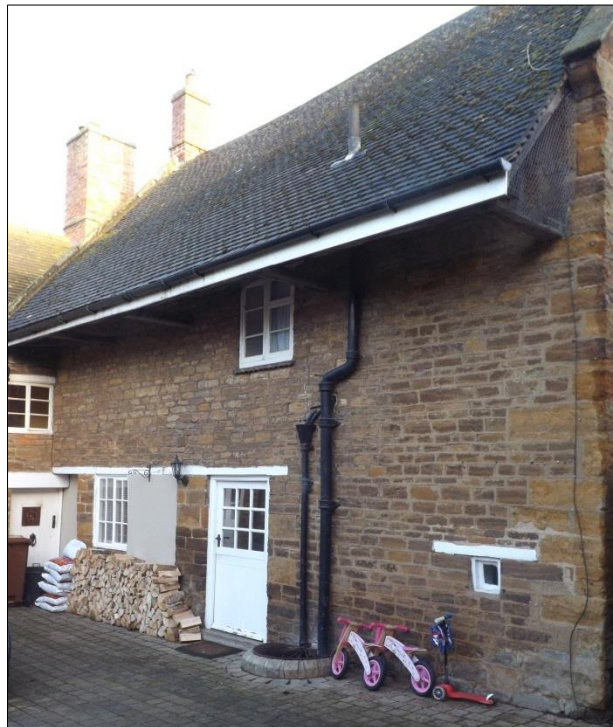
Fig 14: The rear of the 18th-century addition; much of the long wall beneath the extravagantly-overhanging eaves-drip appears to have been re-built

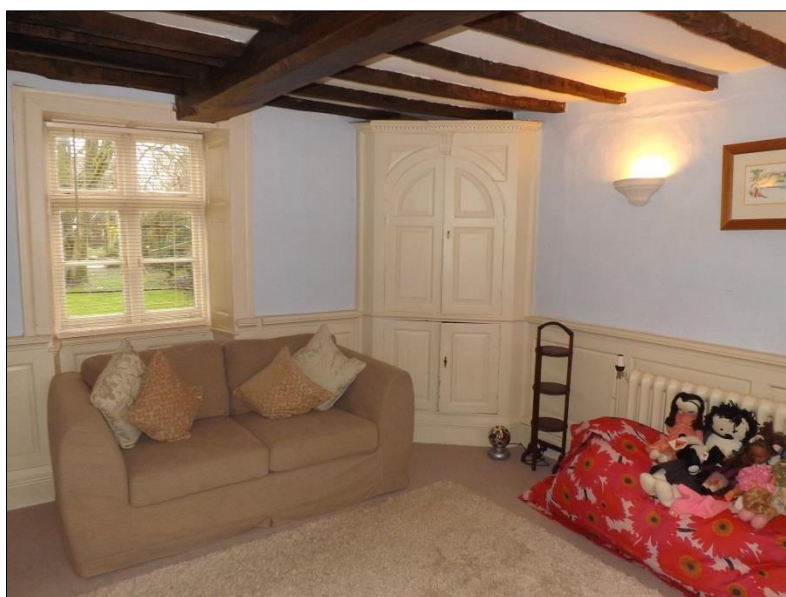
G2 A relatively 'high-status' interior. It has a stop-chamfered axial beam between later and widened-out Victorian windows. There is a simple skirting and dado (chair rail) with raised and fielded panelling between, probably of the middle of the 18th century (EH 1993). No panelling above the dado. The window-surrounds and reveals are panelled in keeping with the room, but are later alterations. There is a corner china cabinet, a 19th century fire surround and mantel surround with a modern-tiled fireplace. The former wallpapering above the dado post-dates the 'modern' removal of the ceiling. There is a 6-panel stripped door and a flagged floor. The ceiling plaster has been removed from the underside of the joists in a modern practice which completely undermines the high-status of this 'best-room'. Only the chamfered axial beam should be visible.

Fig 16: The high-status panelled interior of room G2.

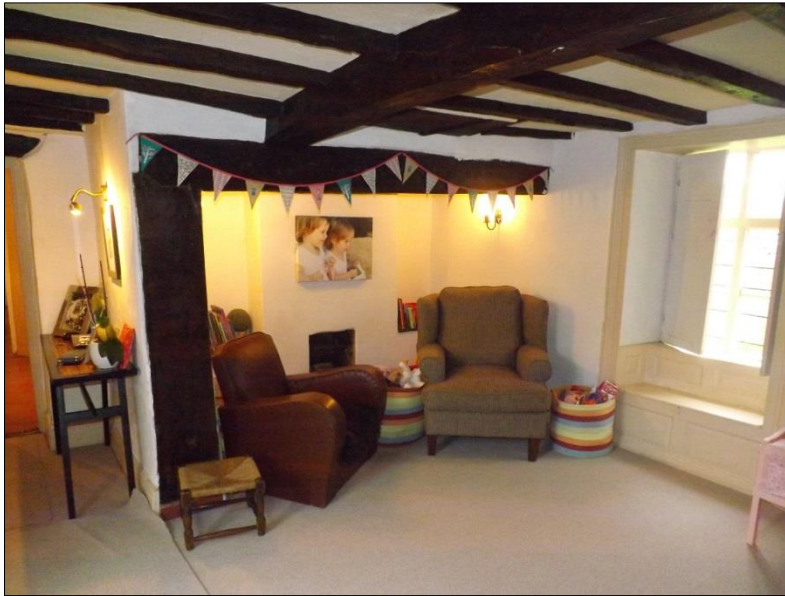
G3 A sitting room with a large inglenook, originally open to G1 and G1a, except perhaps via a flimsy partition. Windows to front and back. Front has privacy-shutters (no top-leaf), covering the lower two thirds and having raised and fielded panels. The back has full security shutters folding back into shutter-boxes, again raised and fielded. The inglenook has a blocked fire-window on the north (the blocking visible on the exterior) and a C19th century chimney breast has been inserted into the inglenook. The ceiling has been taken down to reveal the joists in the usual modern reversal of what was usually intended, in search of 'character'. Only the chamfered axial beam was intended to be visible.

Fig 17: Sitting room G3 inglenook, note full shutters to right. A fire-light window has been blocked behind the armchair.

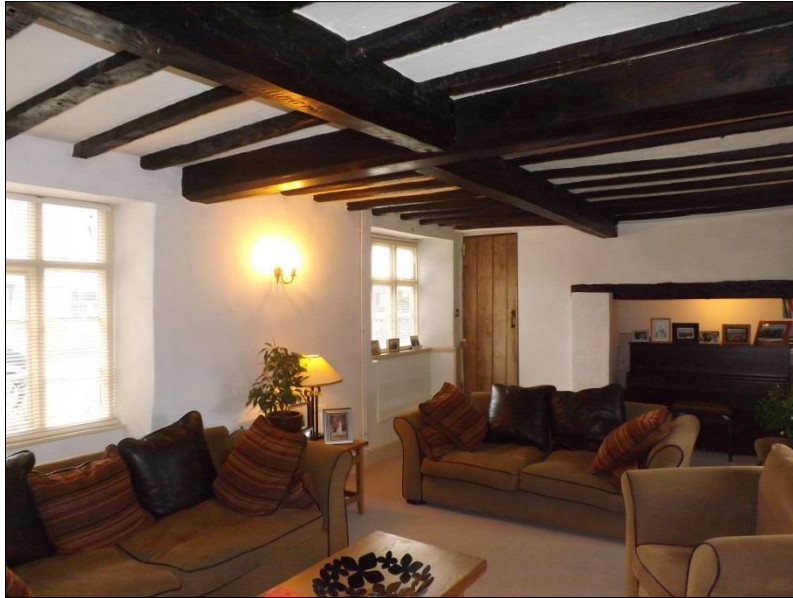
There was originally a wall between G5 and G5a. This has been removed and the remains at ceiling level boxed in. Axial beams run east-west in both rooms, and are stop-chamfered. The joists were not intended to be seen. G5a has a large inglenook with stair around its back and a spice cupboard. There is a tiny fire window looking north.

Fig 18: Looking from G5a across G5. An original partition wall is missing from left to right.

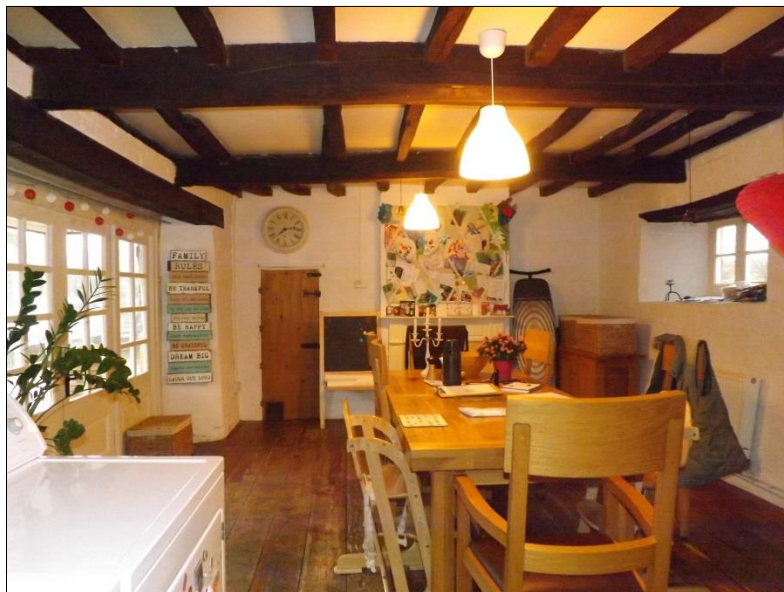
G6. Now used as the dining room, this is formerly the scullery, created out of an agricultural outbuilding, probably in the early 20th century and serving G4. To create it windows were put into the north wall and three axial beams were inserted into a new ceiling, which show previous joist-socket configurations relating to their original places of use, perhaps not even in this property. The room has been lined with brick deliberately laid on edge (in a notably very frugal method of use of the material), partly to achieve ease of ongoing cleanliness, partly to maximise heat, perhaps suggesting that the creation of the room dates to after 1926 when coal was in desperately short supply and The Great Depression really began. The chimney breast is similarly an insertion at the same time as the lining of the walls as part of the scullery, which as a type was probably a short-lived room. Most did not remain in use after the 1960s, with the spread of modern kitchen appliances.

Fig 19: G6 Dining room; formerly a scullery. Originally a fully agricultural space.

The room was shortened by about 1.5m at the south-east end when the kitchen was extended to its present dimensions. This resulted in the awkward position of the more southerly of the two rear windows, with its skewed reveal.

A battered and non-functioning louvered ventilator window just under the eaves lights the roof-space, which is currently unused. The window may have been designed to ventilate above the scullery and prevent build-ups of condensation. It is of 20th century date.

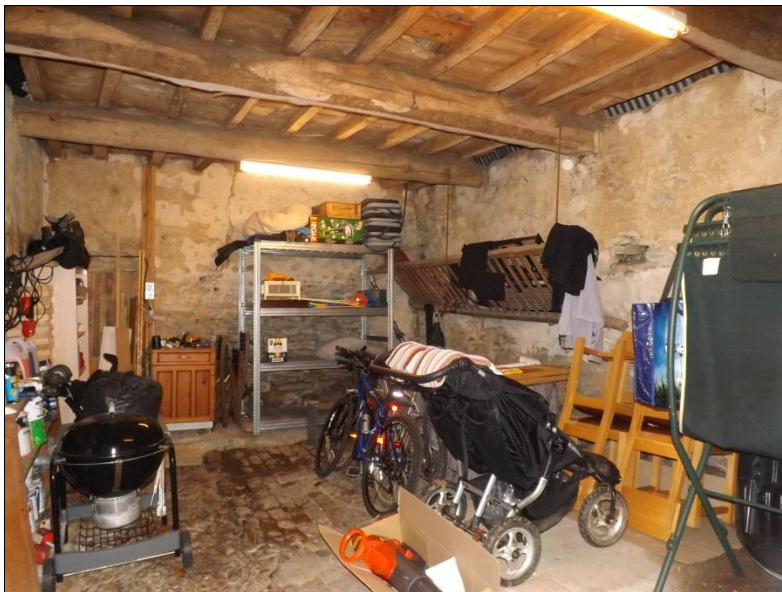
G7 The former stable is now used as a store. It has waney-edged unfinished axial beams supporting a boarded ceiling with a hay-loft space above. The south-west wall has a blocked large doorway and there is an adjacent stable door. The north-east wall has been re-built, perhaps after a total collapse (it is also possible it was once open-fronted on that side). There is a blocked doorway in the end wall.

The floor is of worn cobbles and stone, with expanses of brick, typical of stables. Although no stalls are evident, parts of a hayrack survive and some saddle/collar hooks are affixed over the barn-door blocking. Patches of earth-plaster survive.

Fig 20: G8, formerly a stable, now a store. Hay rack on right, harness peg on far left

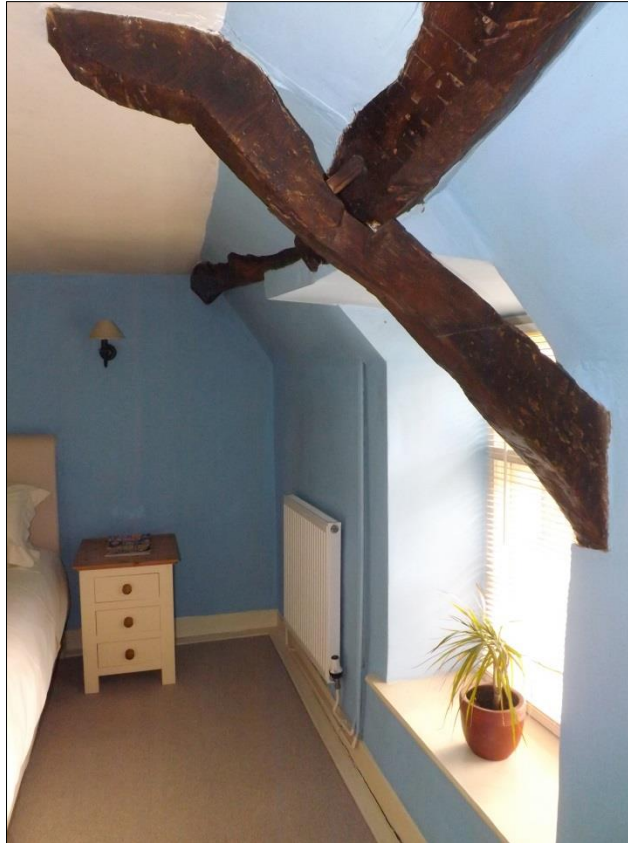
Fig 22: Bedroom F2, typical of the modernised finished interiors upstairs, but note the absence of a tie-beam. The wall-fast shoes of the truss ends have been strengthened in stone, visible on the outside.

Previous commentators (the listing team) comment that on the outside of the building, facing east are two jambs to a window which relate to a former early window. On close inspection, this now seems unlikely, as the jambs of all three windows on this side and one on the opposite, have been altered, either by re-building and strengthening them (where they already existed) or by giving them deliberately strong jambs (where they may not have existed before). This was to counteract the outward thrust of the roof trusses once they were bereft of their tie beams in the creation of the bedroom spaces.

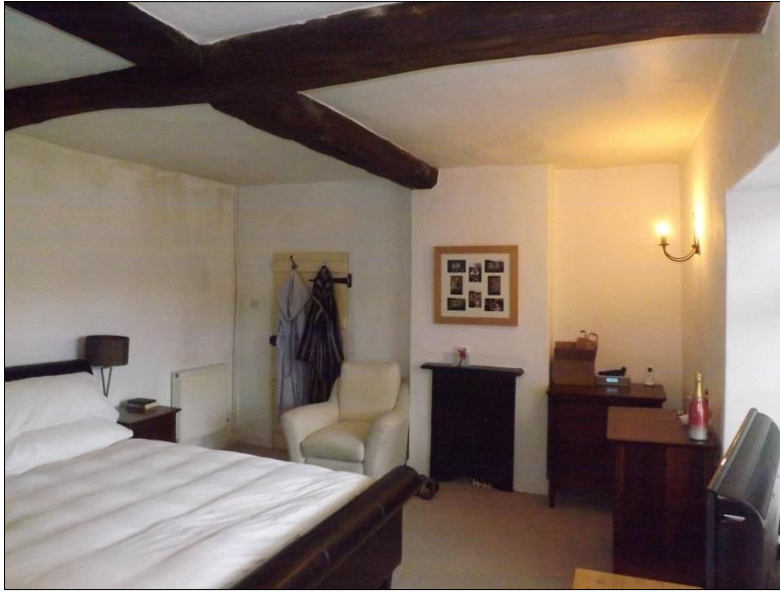
F6 A modern bedroom space which has been carved from two smaller spaces which formerly formed separate rooms, probably either side of a central partition. Out of the westerly of the two has been created a modern dressing room and a separate bathroom (F6a and F6b, respectively). The former of these has awkwardly split the function of the north-facing window down the middle using its partition. The original former stair behind the inglenook rises in the dressing room. A fireplace in F6 is probably a 19th century insertion.

A completely different construction method to the exterior stonework in the north-west wall of this floor, (Rooms F6 and F6b) suggests that this structure has been rebuilt or at least altered in a major fashion. This may be related to the re-roofing and the creation of the extravagant roof-overhang apparent on this side, which is depicted in Ordnance Survey maps as early as 1900.

Fig 23: Bedroom F6, the fireplace is a Victorian introduction

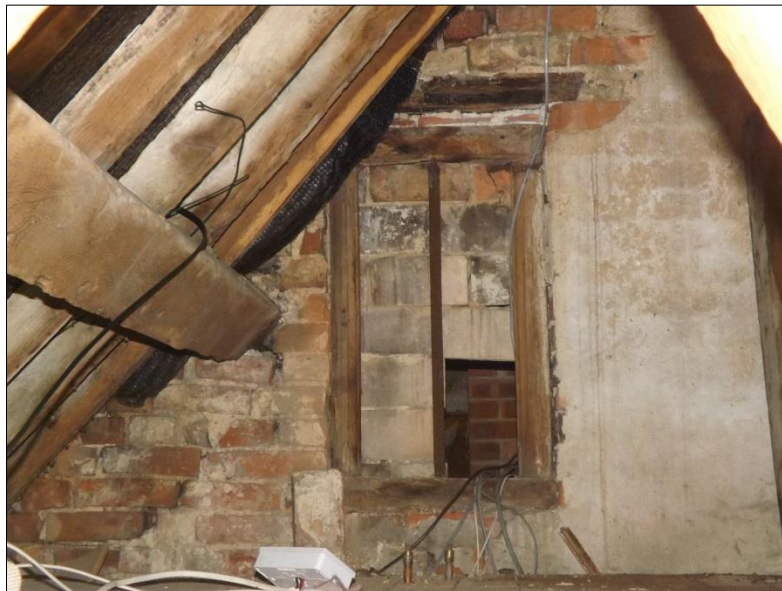
The two windows in the roof space are probably original to the 18th century. However, that in the east gable has been blocked in brick. This probably relates to two steps:

range. However, with the alteration of the roof-line and a conversion to a solid, rigid covering left that adjacent run-off impossible. A lead-lined roof valley was a possible solution, but the owners at the time chose simply to include the window and the space between the ranges within a new cross-gable.

Fig 26: 18th century range, roof, looking east. Blocked window in brick-lined gable. When thatched, this window looked out over the adjacent roof-slope and the main chimney stack. Slate or tile could not so easily run water away in a curve and the angle (and view) were lost beneath a covering roof junction.

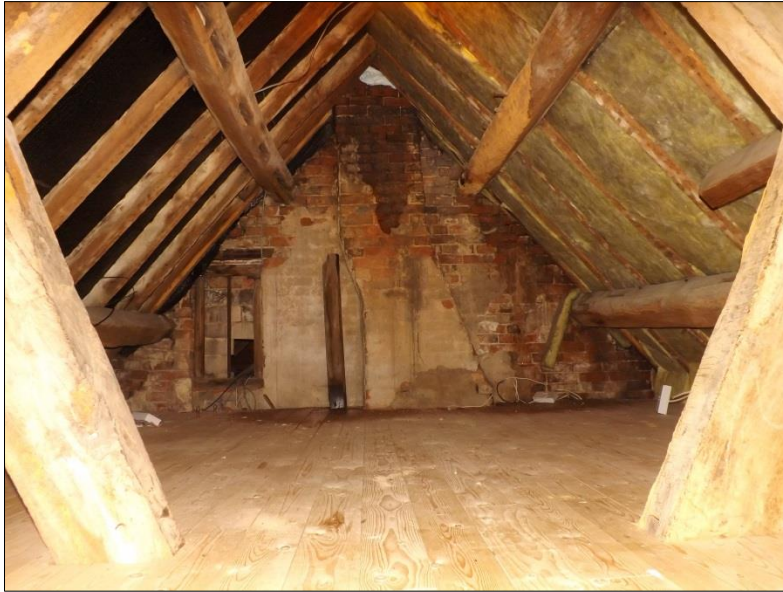
The roof of the 18th-century two-storey wing also contains evidence of earlier arrangements. There is a notable proportion of re-used timber in the roof (see figs below), and sufficient redundancy in the truss details to show that only the trusses are where intended in the 18th century. Probably everything else, most notably the purlins, have been re-used from elsewhere.

Fig 27: 18th century range, roof, looking east. Note the re-used timber of the purlin, top left

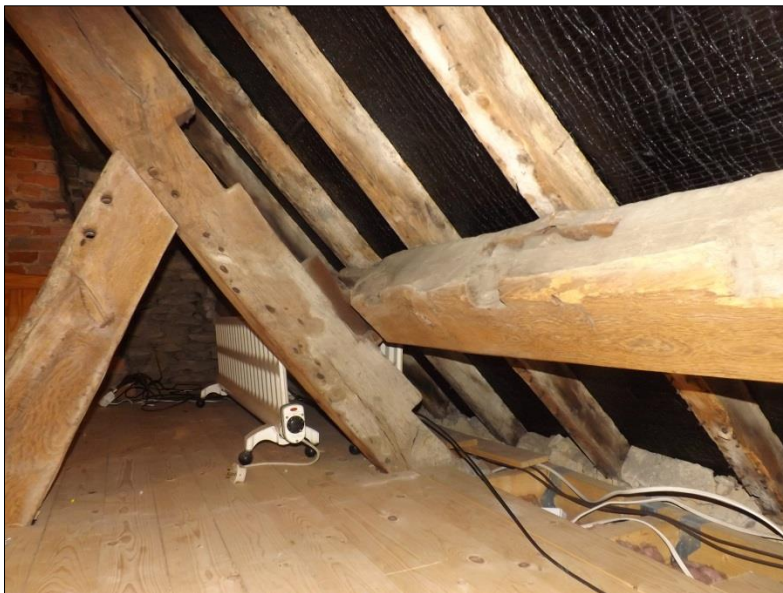
Fig 28: 18th century range, roof, looking west. Note the original roof arrangement indicated by the two empty purlin trenches in the truss. The replacement purlin is also re-used from elsewhere, being a former wall-plate or purlin turned around, with cut rafter shoes.
