# Iain Soden Heritage Services Ltd

**February 2014**

## Archaeological building recording, investigation and recording on a barn at 71a Church Street, Burton Latimer, 2014

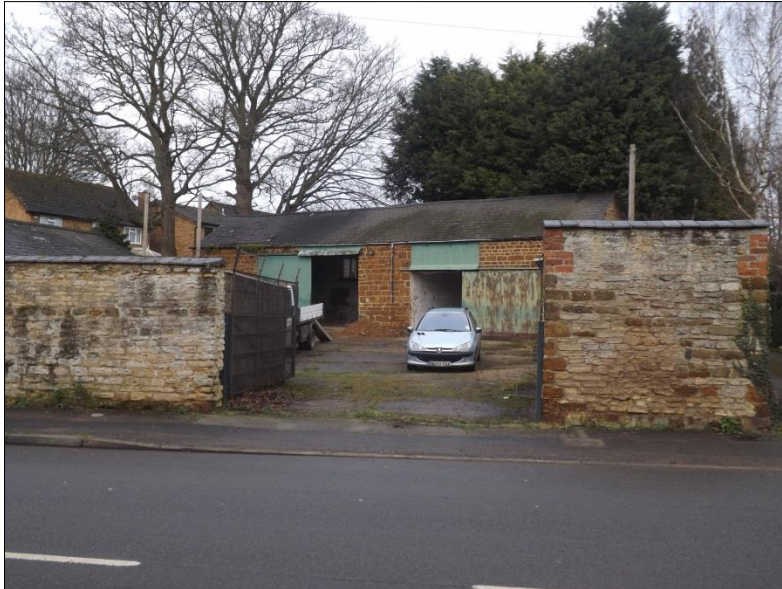
Fig 2: The barn and the courtyard in front, looking north, viewed across Church Street. Old photos show that the entrance was once flanked by substantial stone and brick gate-piers.

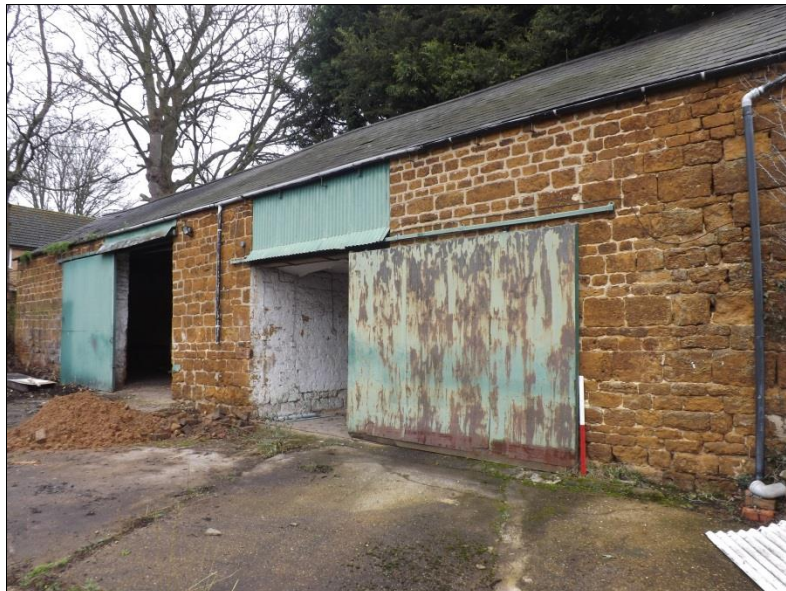
Fig 3: The barn's front (south) side; scale 1m

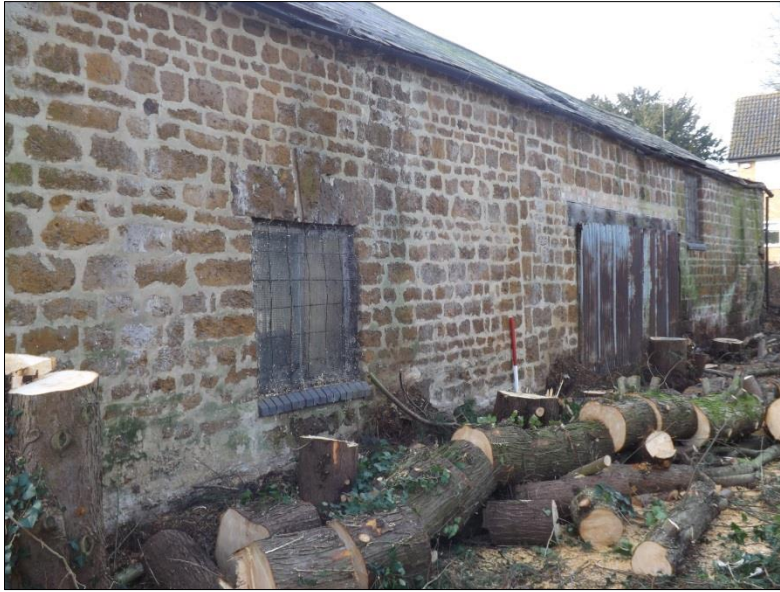
Fig 4: The barn's rear (north) side. Note the prominent butt joint of the two phases; scale 1m

The second phase comprised an added eastern portion to the structure, measuring 7.2m x 4.6m and of two bays internally, of which the butt-joint in the stonework on the north side was very prominent (Fig 4). Again a window looked north. This window had been shortened and the shortening effected in brick, possibly when the garage conversion took place. It is the barn of these final combined two-phase proportions which was mapped in 1886. Therefore the addition took place before this date. The stonework of the extension was provided with high, chamfered carriage-corners on the east end, suggesting that the turning of wains and other wheeled vehicles could be very tight around both corners. The chamfer helped prevent waggon axles damaging the stone and the corners catching on recently-gathered and messily stacked crops as they were brought in for processing or empty carts sent back out for more.

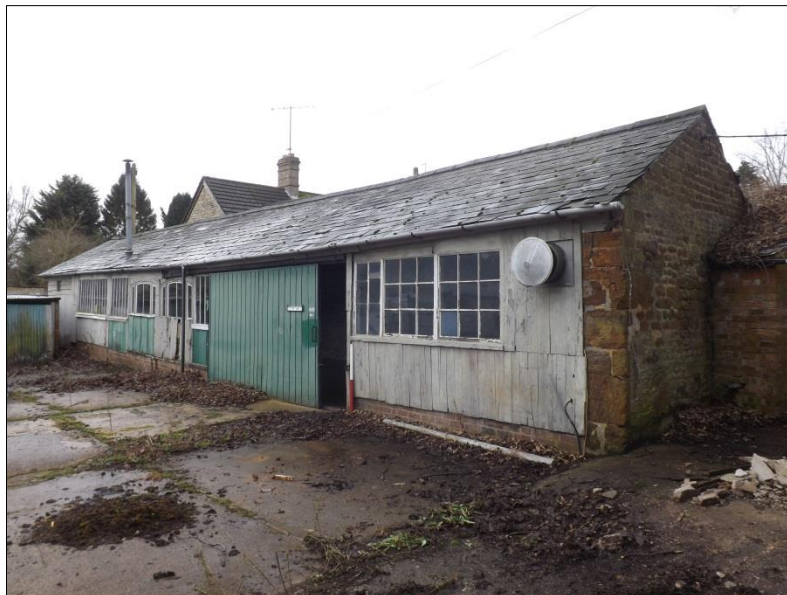
Fig 5: The adjacent former cart-shed, later garage office and workshop; scale 1m

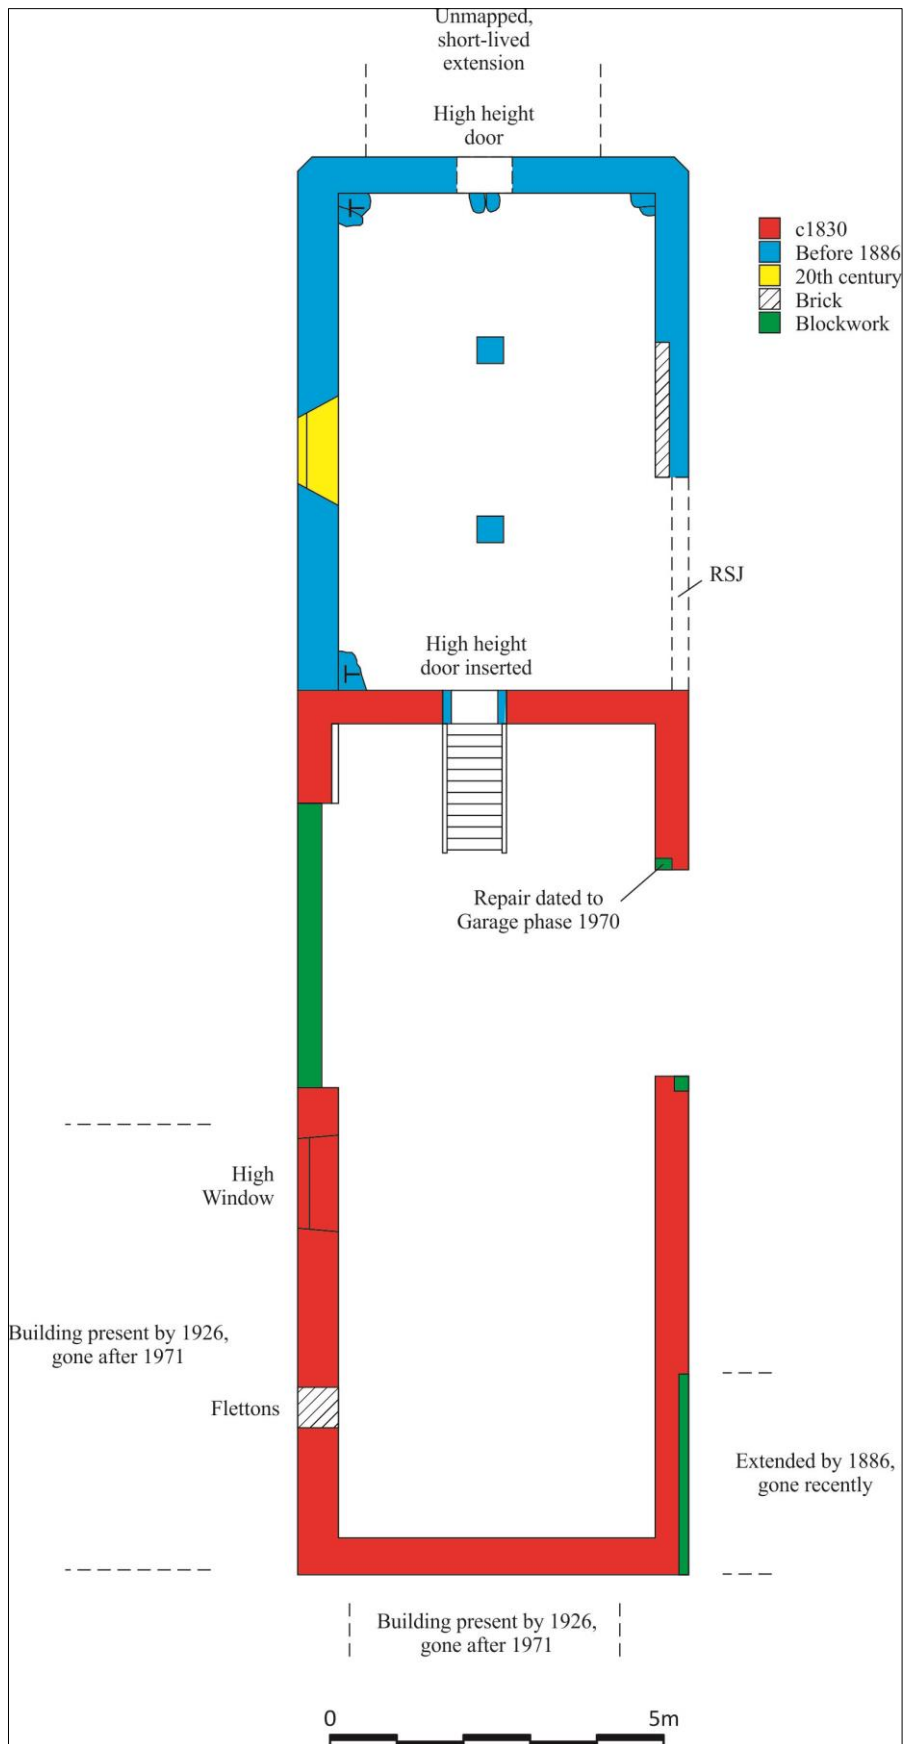
Fig 6: The barn ground plan, phased (north to left)

Scars in the stonework, brick-patches and remnants of cement or mortar flaunching showed small unrelated temporary structures had at some point been built against all four faces of the barn, but no indication existed as to what functions these may have served at any point. There was no indication either of the modes of their construction. Not all had survived long enough to even appear on a single Ordnance Survey map. The sizes in plan and relative lengths of their existence are noted in Fig 6, above.

The barn contained no farm-related fixtures or fittings, although marks covered by the lime-wash in the eastward extension indicated that animal troughs formerly stood at the northern corners there (each marked with a T in Fig 6). This was the first indication that the eastern half was built specifically for livestock, rather than being a second barn. In addition the extension had been supplied with a first floor hay-loft (at a height of 2.73m from the ground floor inside), with direct access from both a hatch in the outer gable and a connecting doorway (and stair) put into the original barn interior. While a stair was taken out in the current conversion (shown above), this must date to the modern garage phase only, since it stood on the concrete floor and spanned awkwardly across what would have been the route between the main through-doorways of the original barn.

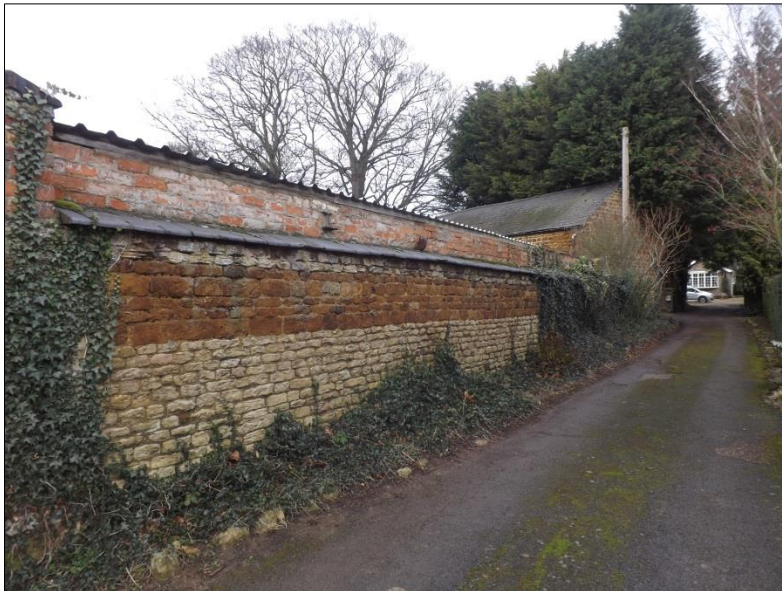
The surrounding farmyard wall was made from limestone, with occasional ironstone touches. It had been raised in brick on the east side, probably when the garage was set up, to screen it from the former farmhouse further east.

Fig 7: The farmyard eastern wall, distinctively of both limestone and ironstone, later raised in brick for the garage. The east end of the barn is glimpsed beyond. The row of overgrown Leylandii and two mature Sycamores behind had to be felled before the north side of the barn was photographed.

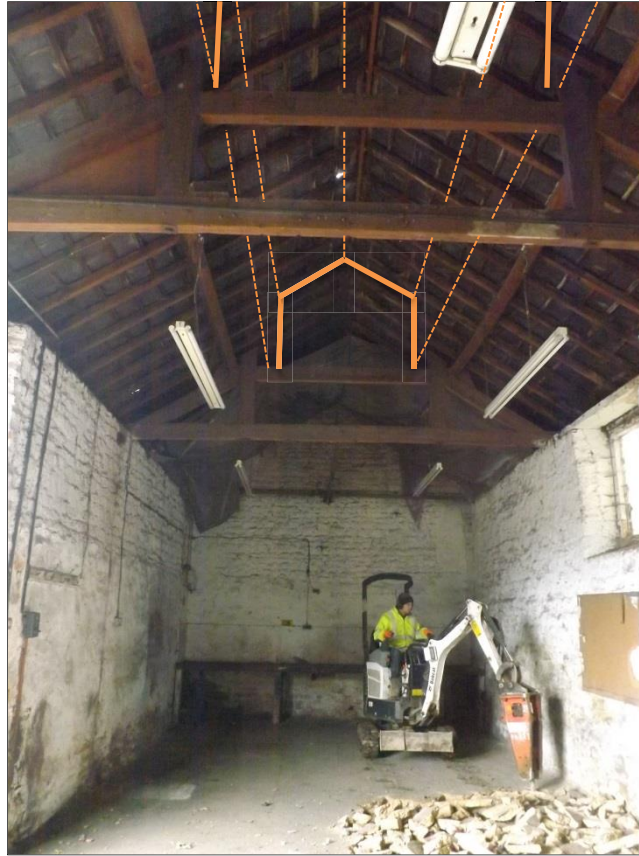
The roof structure of the barn was identical to that used over the nearby former cart shed, but was also identical to both barn-phases. They were formed by the use of a series of industrial trusses (three in the barn, five identical in the cart shed) with truncated uprights of a type to accept a further, narrower, timber lift to incorporate a ventilation louvre along the ridge (clearly not designed for a barn, or a cart-shed for that matter). No such louvre would ever have been needed on a barn or a cart shed; it is more at home on a railway loco-shed for allowing the escape of smoke and noxious gases. It is possible that this roof is only as old as the garage-phase of the site, although the dilapidated state of the Welsh Slate covering suggests it is older. Old photographs which show part of the former cart shed suggest that the roof and its underlying trusses may be of c1900 (Rotary Club 1991). The fact that the Wallis farming family also owned a mill and a factory suggests they would have had easy access to industrial architectural elements to re-use or makers to employ. Suffice to say, its ubiquity on this site shows that the roof is not original to the barn.

Fig 8: The barn interior and roof. The trusses are actually industrial and were designed to support a higher, central louvre (its position shown reconstructed here).

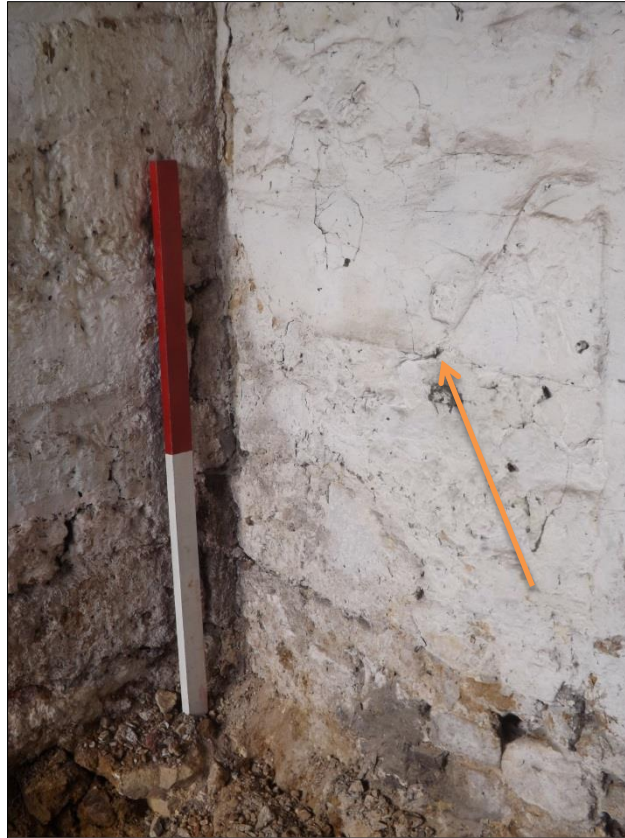
Fig 9: The scar (arrowed) of an animal trough in the eastern half of the barn; scale 1m

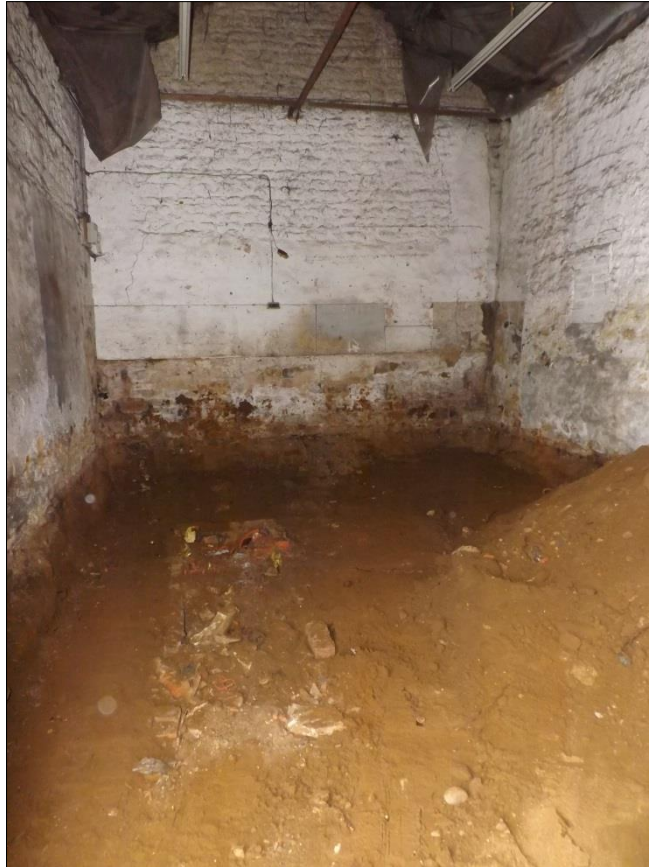
In the original, western half of the barn, 150-200mm thick concrete was broken up and taken away. Beneath this lay a ubiquitous sandy loam of old, compacted topsoil, presumably belonging to the plot on which the barn was constructed. The barn's foundations extended down through this, entirely filling any possible original construction trench, which was thus not visible. There were no indications of a purpose-laid barn floor predating the concrete and it is therefore assumed that it was earthen-floored. Cut through the soils and built at the same time as the concrete had been laid, was a brick lined vehicle inspection pit, which had evidently served the garage. At its demise it was filled with stone rubble, fragments of red ceramic pan-tile and numerous car and engine parts, including an entire wheel. On this evidence alone it appears that the barn had been the vehicle workshop. There were no finds of any sort which derived from the original barn soils. The ground inside was reduced a total of 450mm.

Fig 10: Western half of the barn; the vehicle inspection pit to left of centre, ground levels reduced.

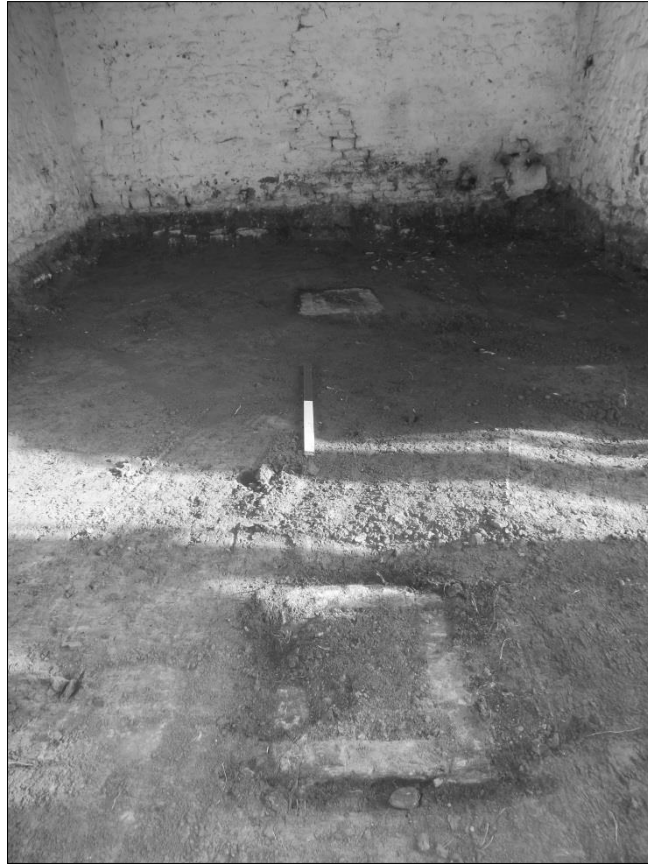
The same process was applied to the eastern half of the barn, with the breaking of a thinner floor, of perhaps an average 100-150mm of concrete. Again a total of 450mm was removed using a machine with a toothless ditching bucket. Here the soils had been imported and were not a former topsoil but comprised patches of clay and sand, with occasional water-worn pebbles in groups, perhaps suggestive of a former pebble-floor. Reduction exposed two brick-lined square drains along the mid-line of the barn, backfilled with soil. These were typical drains placed towards the back of a stall to drain waste from a stable. No drain grilles or certain floor surfaces survived and so these must have been removed to put down the concrete for the garage. Again there were no finds which predated the garage, and no finds had been imported with the material of which the stable sub-floor was composed. No features were present which pre-date the creation of the barn and its extension.

Fig 11: The two brick drains in the former stable half of the barn; scale 1m. In this depiction black and white is preferred as the yellow-brown soils and low, strong sunshine produced a (ghastly) yellow colour-cast over the view.
