**A Heritage Asset Survey at Chartlands,
The Farmhouse, 1 Cherry Tree Lane,
Great Houghton, Northamptonshire**

4 August 2014

A Heritage Asset Survey at Chartlands, The Farmhouse, 1 Cherry Tree Lane, Great Houghton, Northamptonshire

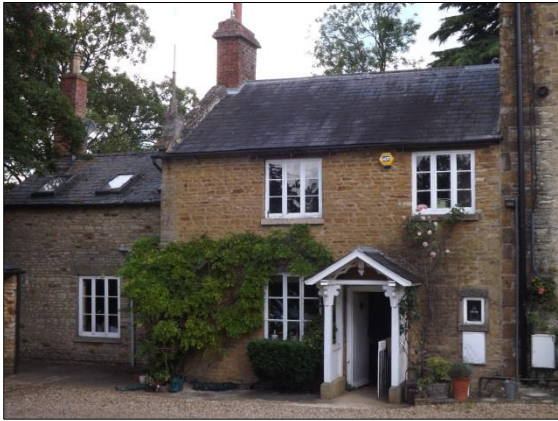
Fig 6: Kitchen range and service range set back to left (front, south, elevation)

Secondary to the main house is a two-storey kitchen block of the same depth as the main house (Fig 6). It is of ironstone with a brick chimney stack. It has been built to serve the main house but at some point has probably been fully separated off and lived-in as an individual dwelling.

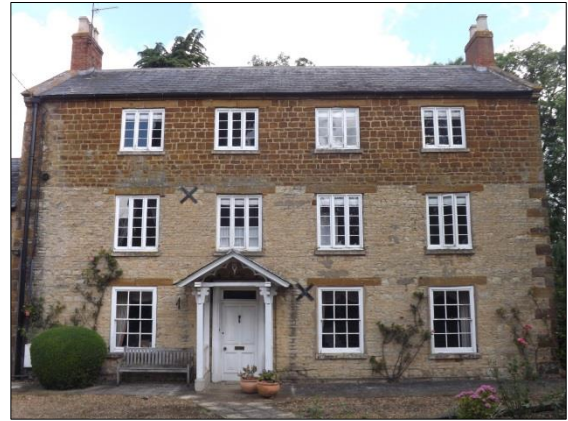
Fig 7: Main house, front, south, elevation; note the added second floor

The surviving building is principally a simple two-bay cottage with central cross-passage and stair. Built of Limestone with quoins of Northampton Sand with Ironstone it has end-stacks which more likely indicate a date in the 18th century rather than earlier (Fig 7 and 8). A second storey, entirely of the latter stone at the front (but a mixture at the rear), has been added, with the current (but obviously not the original) roof being of Welsh slate. The end chimney stacks, which relate to the building in its heightened state, are of brick.

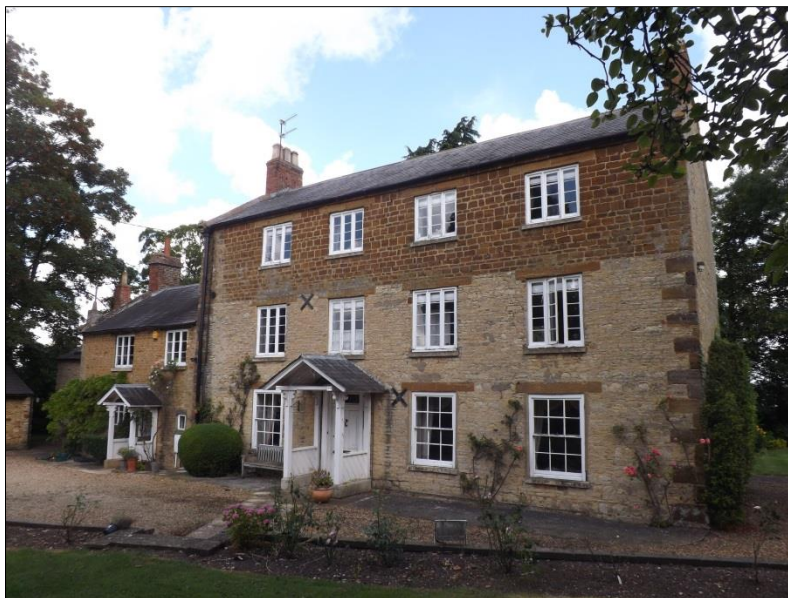
Fig 8: The front of The Farmhouse, with the whole surviving range visible; viewed from the south-east

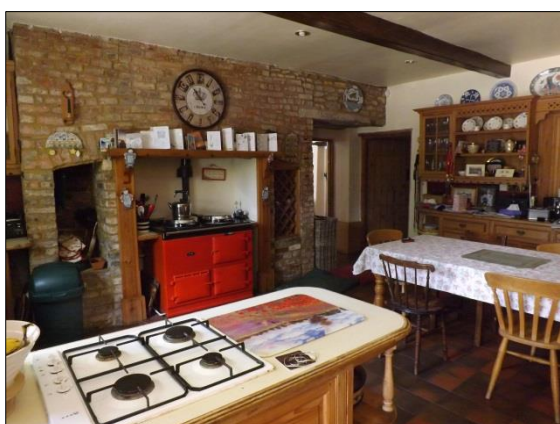
The ground floor of this block is today given over almost entirely to a farmhouse-kitchen function, with a simple inserted stair alongside. The kitchen itself, measuring 5.72m front to back x 5.25m side to side, is entirely modern, of stripped pine made to look old but fitted to accompany modern appliances. Only the window shutters and surround and the brick fireplace (probably once housing a cast-iron range) are older, but the last of these has been emptied, stripped of its plaster and incorporated as a feature; it now holds an Aga-stove and two flanking niches, themselves being subsequently added, have been partly blocked (Fig 9). A much-denuded bell-board is affixed high on the east wall, the only other old feature from when the room was fully developed as a 'service' kitchen (Fig 10). The doors in and out of the kitchen are a mish-mash of different dates and styles, suggesting that most if not all of them have been moved around or imported at the same time as the kitchen reached its final layout. The floor is of modern tiles, laid on concrete and probably a modern visqueen membrane; the floor has been dug out previously to lay these.

Fig 9: The kitchen, viewed from the front door

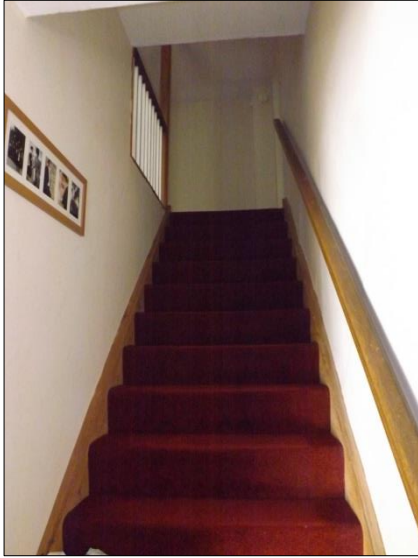
The stair to the side of the kitchen is an insert, which has left the main dining-room accessed awkwardly from the kitchen across their foot (Fig 11). This mix of service and private space would have been studiously avoided when the kitchen was first added. The original entrance directly from kitchen to dining room was at the opposite end of the same wall, where the old doorway is blocked and now used as a shoe cupboard. It lies in a dead space under the current stairs, adjacent to the old back door to the service range and shut off from the kitchen (Fig 12).

Fig 11: The inserted kitchen stair, from the foot; Kitchen door to left and Dining Room door to right (out of picture)

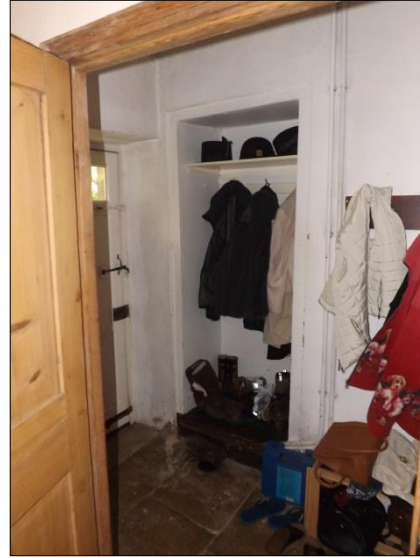
Fig 12: The blocked Dining Room doorway, from the Kitchen; also visible is the back door.

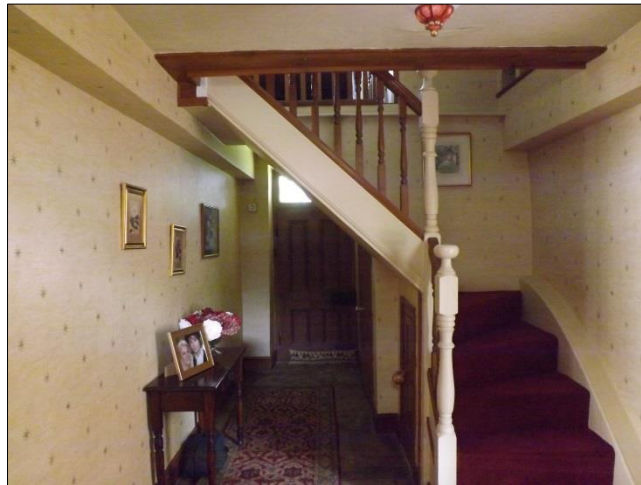
The main stairs of the house rise from the central hall, which is a modern approximation of the original entrance space, the stairs turned through 90-degrees where they would originally have ascended from the front door (possibly with a lost cellar-access beneath). Today, the modern partitions serve only to separate the lounge and dining room from the awkward stair, where their predecessors separated reception- from private-space (Fig 13).

Fig 13: The awkward centre hallway, its route blocked by a stair and flanked by modern RSJ-topped partitions

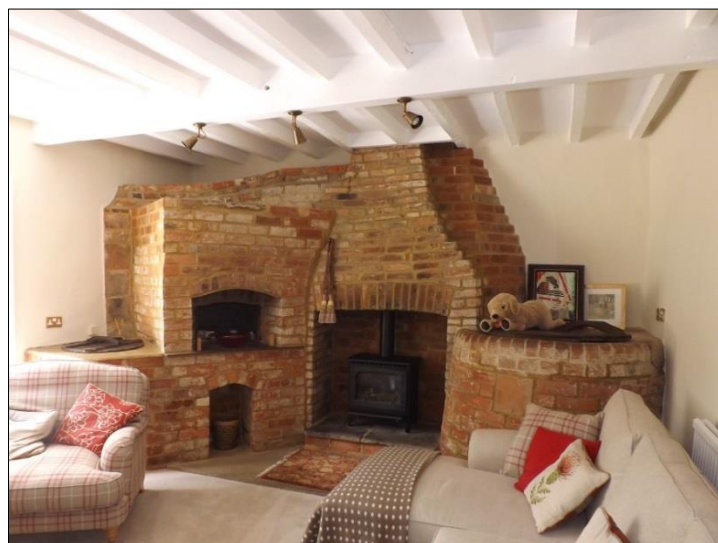
are the *raison d'être* for the room/block and are its pre-eminent heritage asset. While the bricks of the central fireplace are of late 18th-century or early 19th-century sizes, those used to build the added oven and coppers are of larger size, probably post-dating the final repeal of the 1770s brick tax (1851), while a row of bull-nosed bricks surmount one copper, a type not generally widespread until the High Victorian period 1850-75. This cooking/brewing/laundry array was built up therefore in increments, and not all fitted out straightaway. This service range did not have had a first floor originally. Indeed the inserted ceiling of the ground floor has fully exposed joists, but is entirely modern, painted white. The front-facing window is a replacement, probably of c1900-1920, based upon its chunkily proportioned timber mullions.

Fig 14: The beautifully-conserved service range with its end fireplace and added oven (L) and coppers (L & R)

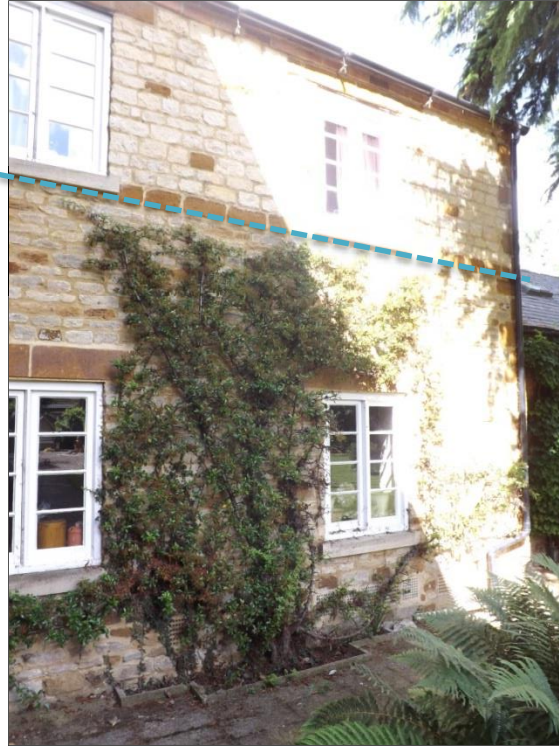
To the rear has been added a store-building, secondary to the service range, which makes a butt joint with both this and the kitchen adjacent to one of the back doors. Its eastern half has in recent years been given an added first floor, built in similar stonework which is discernible in its different coursing. On the ground floor it is divided into a study on the west and on the east a modern pantry and utility room; these lie to either side of an original corridor to a back door, beyond which today is a brick-built family room with modern stair, measuring 8.89m x 6.58m internally. As the only brick building on the site, the family room is a departure from the vernacular tradition hereabouts.

Fig 15: Added rear store wing, from the east. The first floor is entirely modern, the break visible.

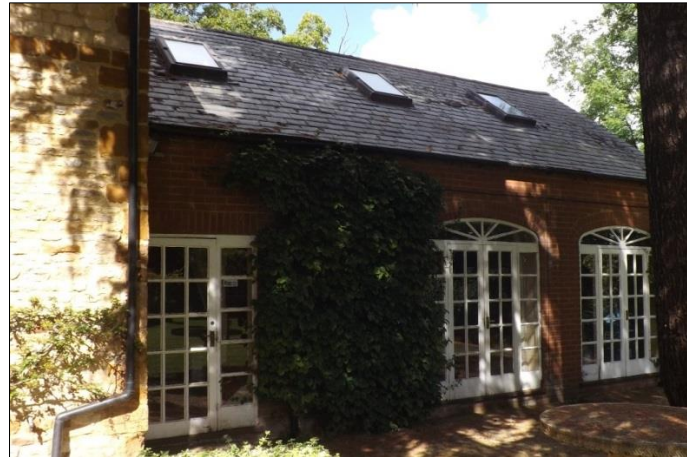
Fig 16: The modern, brick-built family room to the rear, viewed from the east

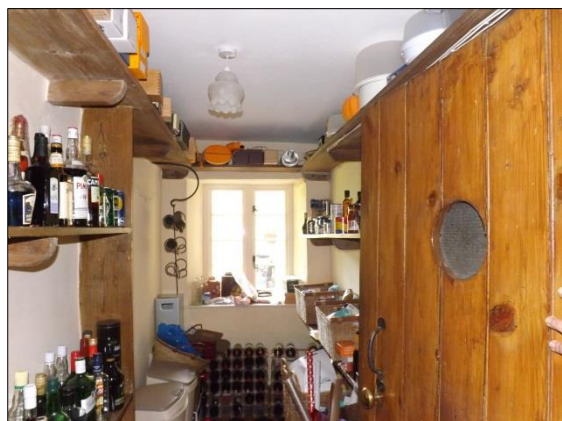
Fig 17: The pantry, created from part of the rear wing

The pantry and utility room back onto the kitchen but have themselves been created out of a single space (Figs 17 and 18). They share the same modern floor-type, of a chequerboard of faux-Victorian/Edwardian quarry tiles laid on concrete; again with the kitchen any older floor has been dug out for this replacement.

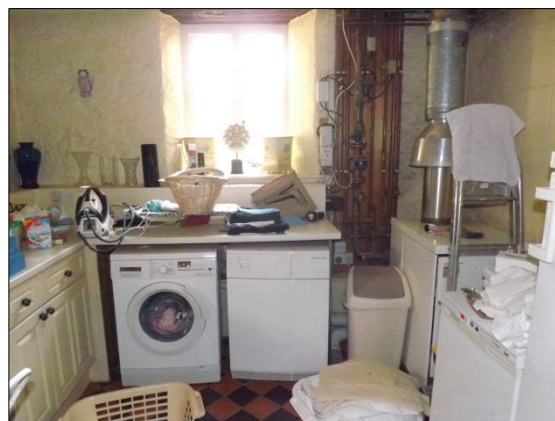
Fig 18: Utility room, also created from part of the rear wing

The outer (east) wall of the utility room carries the modern white goods with their drainage and ventilation, together with the boiler piping (Fig 18). This has resulted in the wall below the window having been chopped out over some distance, leaving almost no original unaltered stonework (Fig 19).

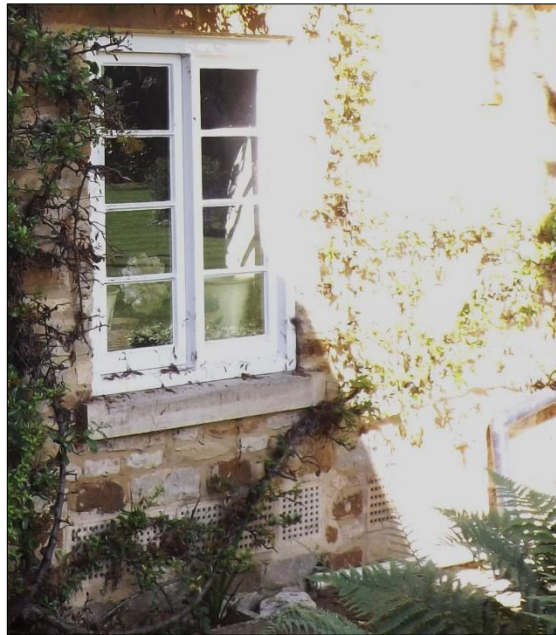
Fig 19: The utility room window, with its majority re-ordered stonework, due partly to six ventilators below

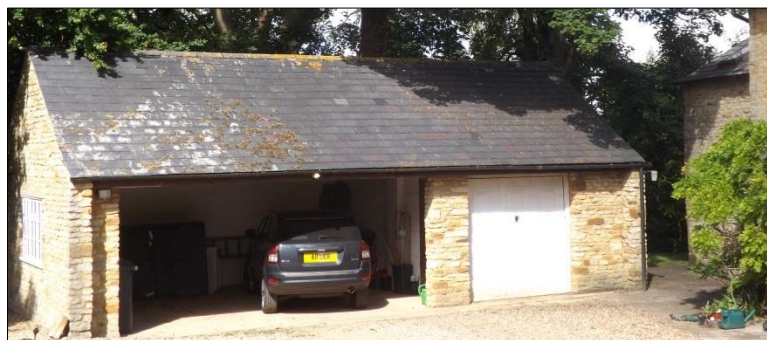
A separate garage building outside the front western end of the farmhouse is modern, but has replaced one of two earlier buildings of similar size and in a similar location (Fig 20; cf Figs 4 and 5).

Fig 20: modern garage

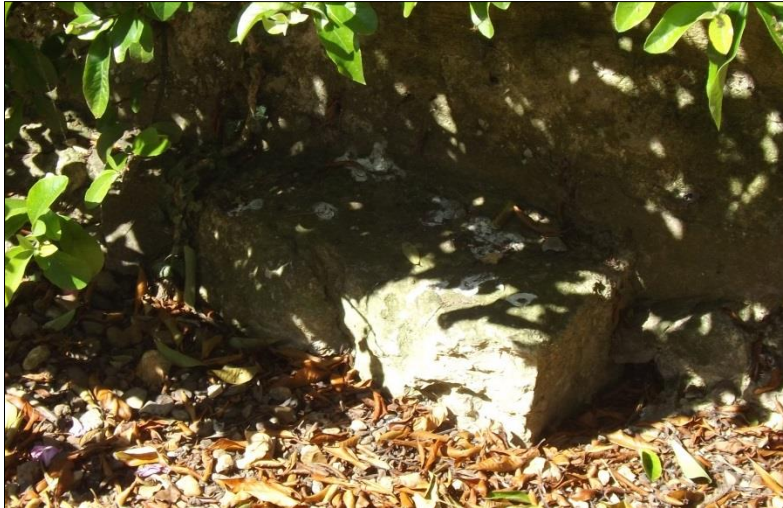
There remains a tiny piece of evidence on the ground for the former eastern arm of the farmhouse inferred from historic maps, where a redundant, reduced stone foundation protrudes at the foot of the eastern gable at its southern end (Fig 21). There is no evidence for the use of the former building but based upon the symmetry of the plan of 1839, one might expect buildings to balance both the kitchen and the set-back service range. Modern pointing on the east gable of the farmhouse has unfortunately masked any scar which may have accompanied the lost gable, and a clipped *cotoneaster-type* shrub prevents scrutiny of the wall face lower down.

Fig 21: Evidence for a lost, eastern range (see Fig 22 for exact location)

9	Construct new garage to east	Change in setting	The garage may replace the lost wing to some extent. The house has no prospect in this direction, nor does it present a desirable or favourable aspect, either from the road or close-up.	An archaeological watching brief may be appropriate on foundation-digging to plot the demolished wing, if remains are present.

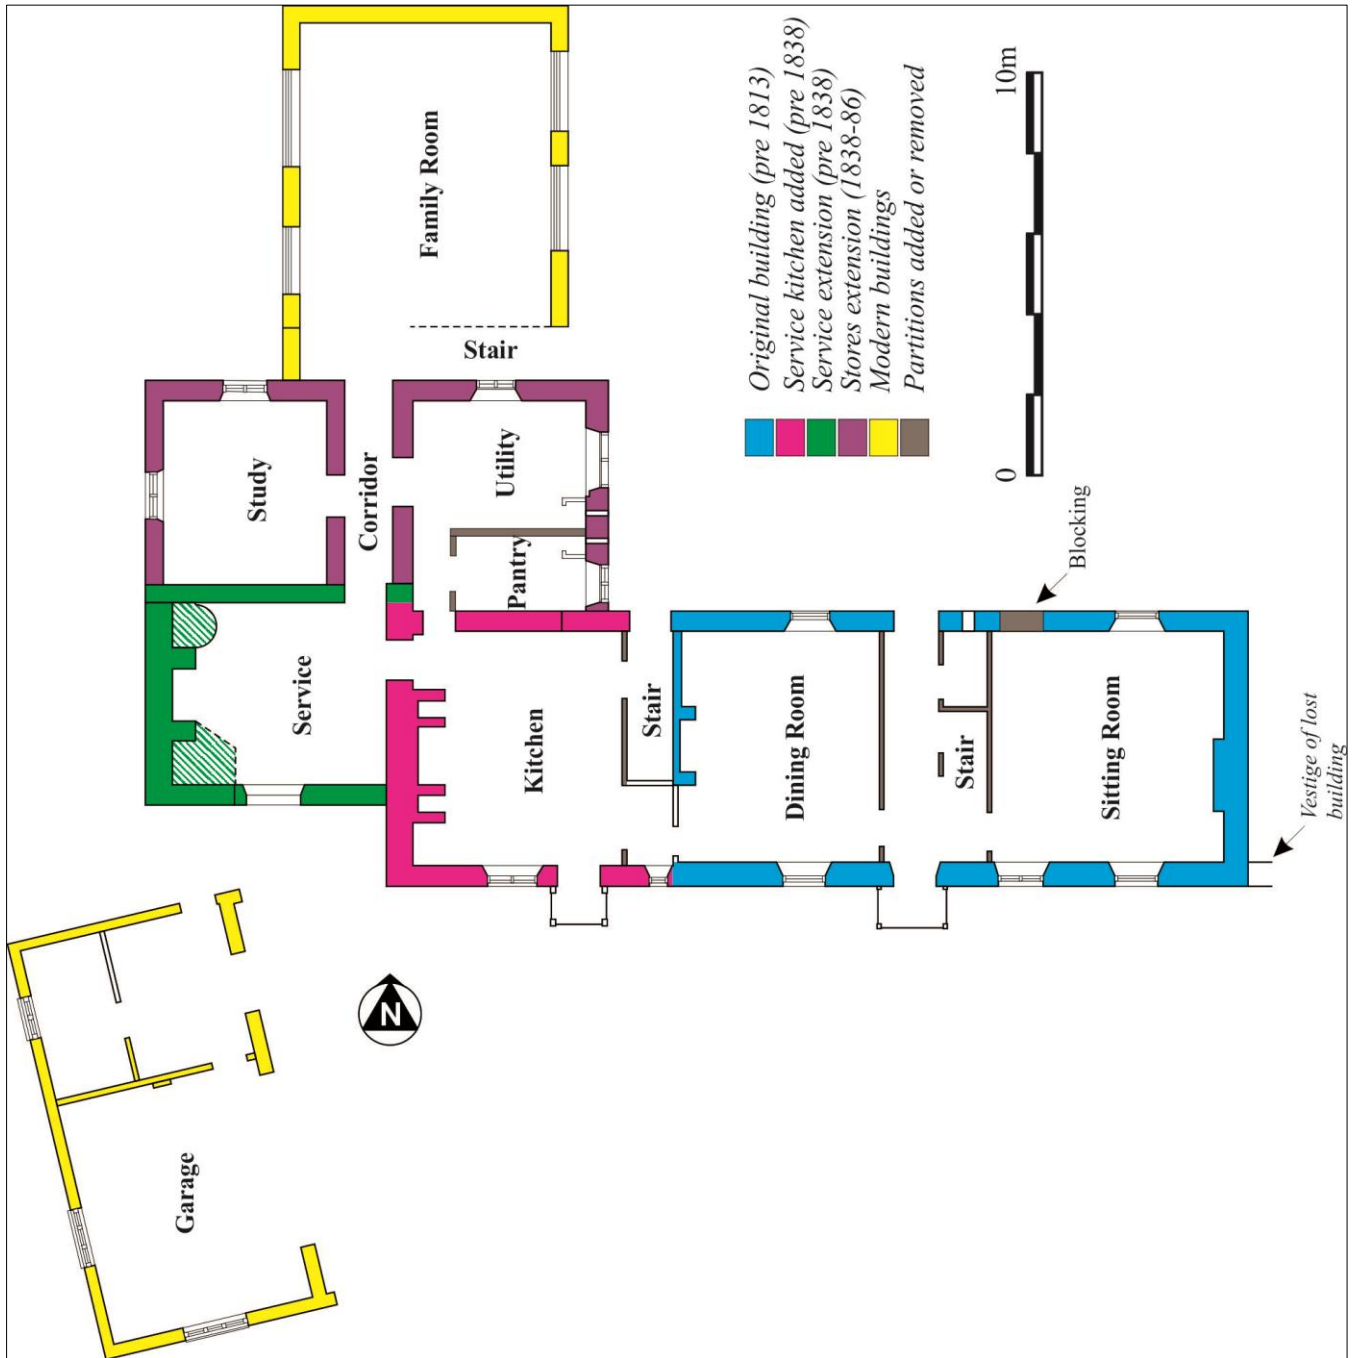
All the main blocks of the buildings as they survive can thus be read in some detail, being architecturally separable. They have been phased below and also dated in accordance with their appearance on historic maps (Fig 22).

Fig 22: The farmhouse, phased and (where possible) dated; based, with thanks, upon a plan by Tad Dobraszcyk RIBA.
