### A Level 2 building record of former stables at the Old Bakehouse

### Maidwell, Northamptonshire

### Summary

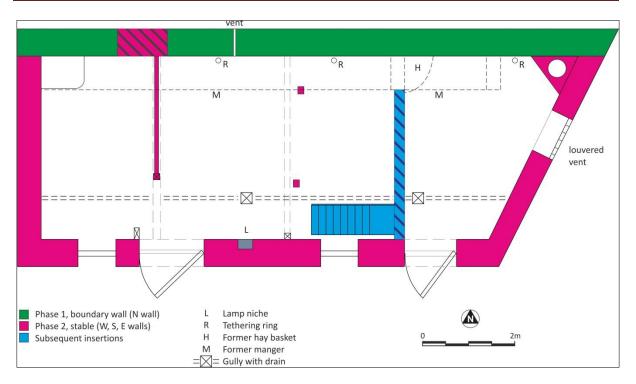
The east end appears to have been built in an oddly-skewed manner due to the former presence of another building immediately to the east, present in one map-version of the 1880s but demolished by 1900, as depicted in the reliable Ordnance Survey  $2^{nd}$  edition. It is likely that the demolished building must have been in existence when the current stable range was built and the angled east end built as it was to respect the existing structure (Fig 2, 3 & 5).

Fig 5: Phased plan, Ground Floor; the First Floor is single phase and without division or detail

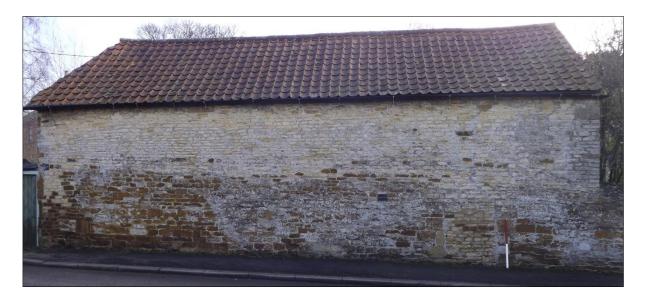
The north wall which forms the boundary with Draughton Road is constructed of both Northamptonshire Sand with Ironstone and limestone bonded alike in lime mortar (Fig 6). The wall is clearly built in two stages and it seems most likely that the lower portion, built mostly of ironstone, was originally simply a boundary/garden wall with, towards the western end, a pedestrian gate or doorway since infilled. This part of the north wall is poorly built with irregularly sized and dressed pieces of stone laid in irregularly defined courses indicating that it was not a structure deemed to be of any great importance. When the present stables were built this boundary wall was retained and simply heightened, this time mostly in limestone to form the stable's north wall. It was probably at this time that the former pedestrian doorway was blocked since it performed no purpose in the new building.

Fig 6: View south across Draughton Road. This shows clearly the two-phase north wall built off a former boundary wall with blocked pedestrian doorway; scale 1m

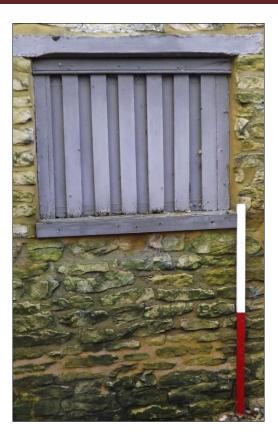
Fig 7: Ventilator, only feature in the east wall; scale 1m

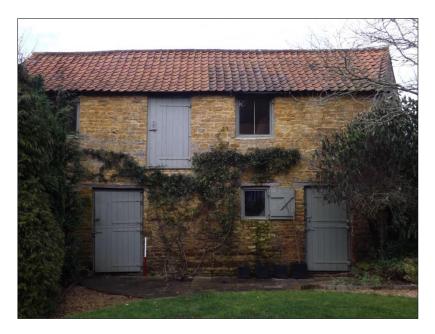
The south elevation faces the former Bakehouse and incorporates two doors and two windows at ground floor and one door (hayloft) and two windows at first floor (Fig 8). The two ground floor windows retain their timber frames, painted but probably oak, fitted with modern painted pine frames containing fixed double-glazed panes. Each window also retains external shutters which appear to be modern replacements and which are constructed of vertical softwood planks, ledged and braced with strap hinges hung on iron pintles driven into the oak frames. At first floor level the hayloft door is centrally positioned, fitted with a vertically planked painted pine door hung on strap hinges set within a painted oak frame. It has a simple iron drop latch and a modern galvanised iron draw bolt. The two windows retain their painted oak frames and each has two-light fixed glazing. Iron pintles set in the frames indicate that previously these windows were also fitted with external shutters.

Fig 8: The south wall; scale 1m

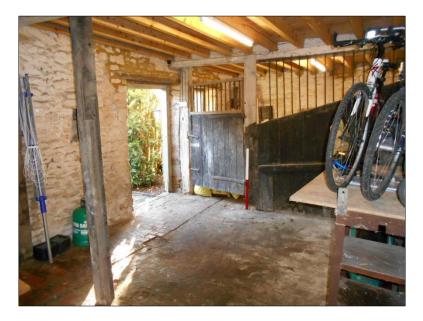
Fig 9: The interior, western part, looking south-west, showing the common-brick floor, with travis and door in background; scale 1m

This western part retains a single stall division comprising a simple square-section heel post into which are fitted rails between this and the north wall onto which are nailed vertical planks to form the travis or stall division which forms a loose box (Fig 9). The top of this travis slopes downward from north to south above which the partition is further enhanced by the addition of vertical, round section, iron bars to prevent the horses from biting each other over the timber division. At the southern end of the travis a door constructed in the same fashion, and of the same materials, is hinged onto the heel post. Within this loose box there were no manger or hayrack remains although there are faint indications that the rack was a simple sloping affair set against the north wall. It is likely to have comprised a top and bottom rail, the top rail set approximately twenty inches away from the wall with the bottom rail set against the north wall. Between the two rails timber slats would have been fitted thus creating a triangular space into which hay could be deposited from above allowing the horses to pull the hay through the gaps between the slats. The manger would have been situated below the rack and it is unclear how it was constructed here since no clear evidence remains but seems most likely to have been a timber trough since there is no scarring on the floor or wall to suggest that it was brick or stone built. There appears to have been no permanent provision for a water trough within the stall and most likely a bucket was provided. There is a single iron tethering ring set into the north wall. The overall arrangement as it may have looked can be seen at a comparative site with surviving features recorded by IS Heritage in Warwickshire in 2012 (Fig 11).

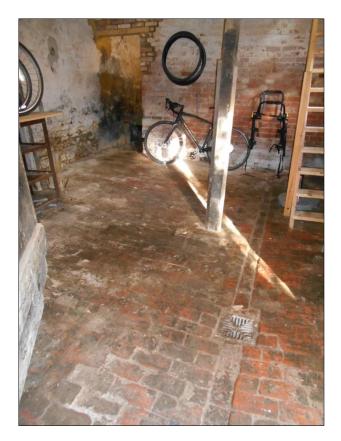
The whole of the floor is paved with common red brick laid on bed (size c220mm x 110mm x 60mm) and which slopes gently from the north wall towards the south with a slightly recessed single brick width drainage channel lying parallel to the south wall (Figs 5, 9 and 10). This relatively standard Victorian brick size almost always dates after the full 1850s repeal of the Brick Tax. The drainage gully falls towards two drains, each retaining a simple cast-iron pierced cover. This form of drainage would allow excess liquid to percolate away through the bedding keeping the feet of the horses reasonably dry. The use of common bricks for the flooring suggests that this was not a building on which a great deal of money or effort was expended. The use of ordinary bricks was common on farms and low status buildings and had little to recommend them apart from cheapness as they

Fig 10: Interior, western part, looking north-east. Note the floor of common bricks laid on-bed, with simple integral drainage gully

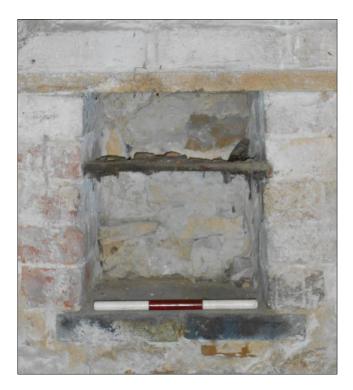
The walls are limewashed throughout and the only aperture in the north wall is a small iron grille to provide a degree of ventilation, noted above. Internally it can be seen that the reveals to the windows and doors are faced in the same red brick used to build the dividing wall and floor the building. To the east of the western doorway is a lamp niche built into the thickness of the wall. As its name suggests this small recess was situated in such a position to allow a lamp or enclosed candle to be set and provide a low level of light when feeding or checking on animals during darkness. As is most usual, it is placed just inside an access doorway, as far from combustible hay and bedding straw as possible (Fig 12).

Fig 12: Lamp niche in the south wall; scale 30cm

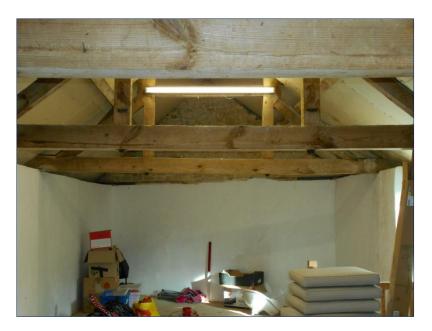
The first floor is accessed via a steep, fixed pine hayloft ladder; it is a modern structure though might be a copy of a former feature. The whole of the upper storey flooring is modern apart from the principal beams; all of the joists and floorboards are modern replacements. At the top of the ladder a simple rail prevents the likelihood of falling through the access hole. There are no historic features at this level apart from the three roof trusses which are of queen post construction (Fig 15). The underside of the roof is covered by insulation board but is unlikely to cover any historic features since it is known that the roof has been re-covered.

Fig 15: The upper storey; fully plastered out.
