A Heritage Asset Survey of Holly Bank

31 High Street, Bugbrooke.

A Heritage Asset Survey of Holly Bank, 31 High Street, Bugbrooke

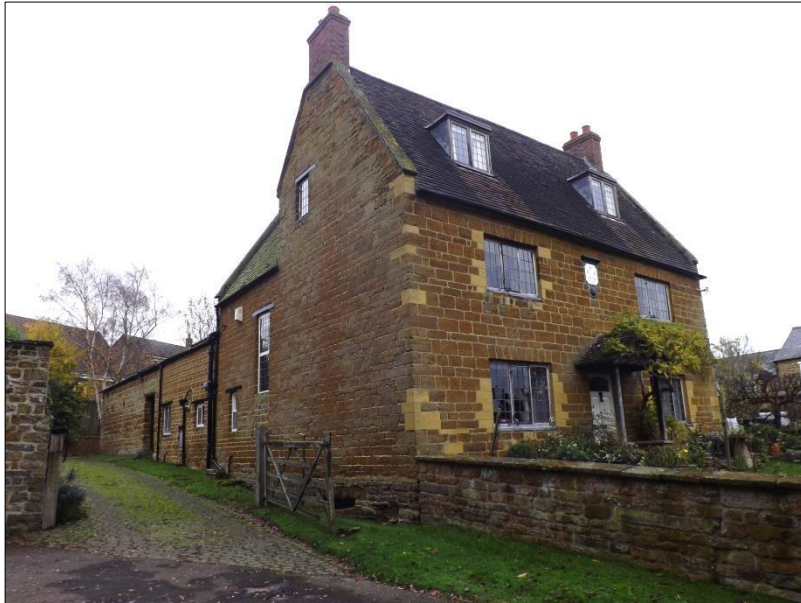
Fig 2: The front (west-facing) aspect of the house with its principal added range behind.

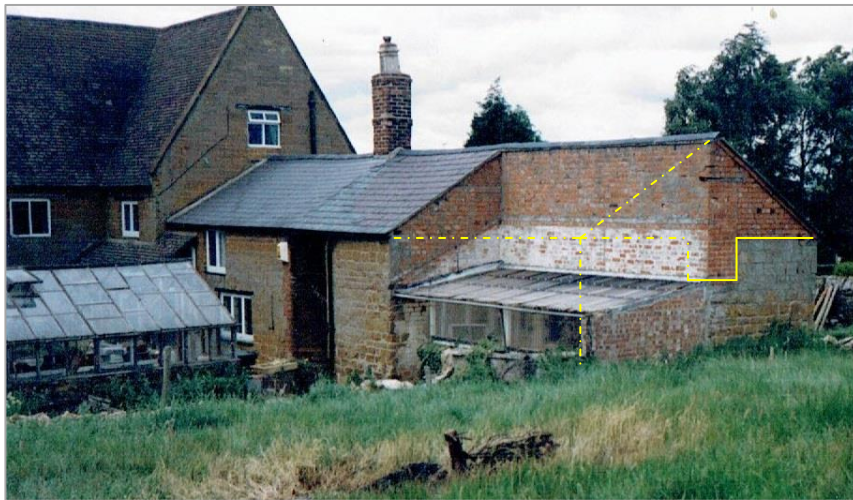
In the 1990s the outbuilding to the rear, which appears to already have been substantially altered from stone partly to brick (indicated below in Fig 7), was converted into a double garage. The conversion involved the demolition of a single storey brick lean-to potting shed/greenhouse at the eastern end of the outbuilding, although the northern, stone elevation remained unchanged to eaves height.

Fig 7: The form (in yellow) of the phase 3 stone outbuildings prior to a) partial brick rebuild with two phases of lean-to greenhouse and b) remodelling to form the current garage

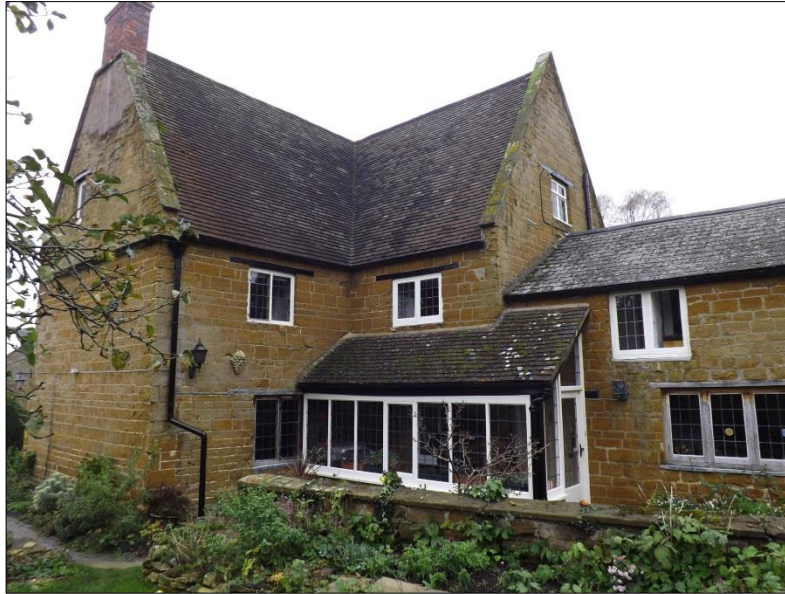
The east elevation of the same fine ashlar has a three light window to the ground floor divided into equal parts and glazed with leaded panes (Fig 10). It is set here beneath a timber, most probably oak, lintel and is now partly obscured by a low-level modern glazed porch (see Fig 9, Phase Four). At first floor level there is a smaller two light leaded casement window.

Fig 10: View of the property showing the south and east elevations

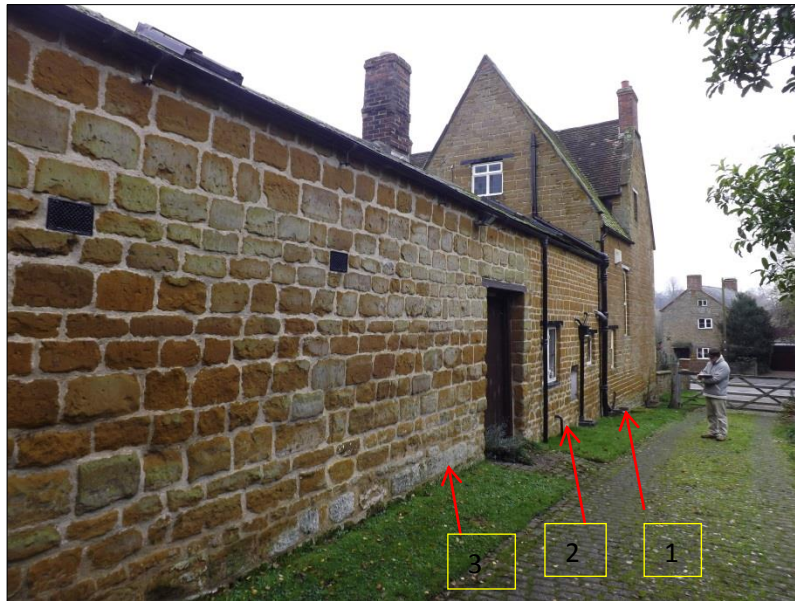
The north elevation comprises the gable end of the front part and the side portion of the rear wing, all constructed of the same, fine ashlar above a plinth (Figs 9 and 11).

Fig 11: The north elevation of phases one, two and three from the north-east

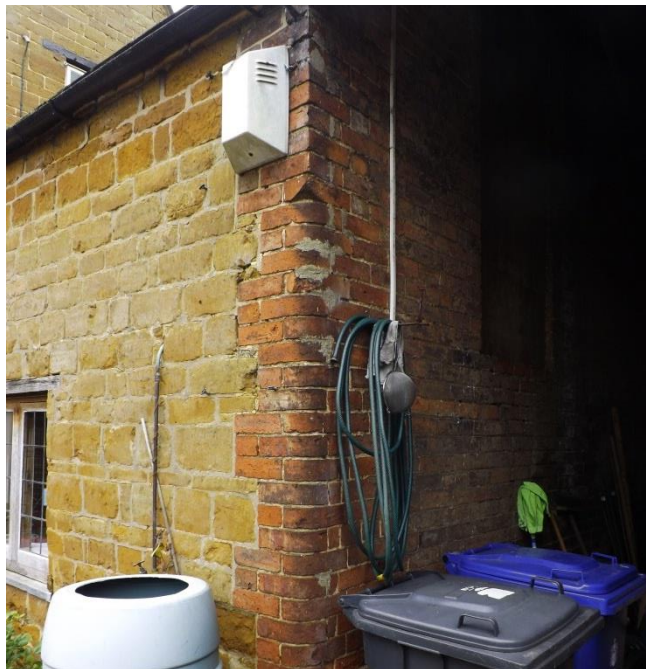
The east wall, which now forms one side of a cross passage, is built of red brick, laid methodically in three courses of stretchers then one of headers for the full height of the wall (English Garden wall Bond). The bricks are 230-235mm x 70mm x 110-115mm in size and rise 320mm in four courses. At the south-east the corner is formed of bull-nose bricks whilst the north-east corner is of standard bricks and the junction of this brick wall and the north and south stone walls are bonded with the bricks set neatly in a quoin fashion. Bull-nose bricks were not available before c1850 and were increasingly common during the years from 1860 onwards. A little below eaves height the bull-nosed bricks terminate neatly, so they form the rounded corner so often used to protect the wall-corner from damaging carriage-axes or protect livestock from a sharp arris. These suggest that the turn from the passageway into the garden may once have been considered sharp or abrupt for goods brought in or out, up to a height of some eight feet.

Fig 12 South-east corner of Phase Two showing bull-nose bricks and neat quoin joint

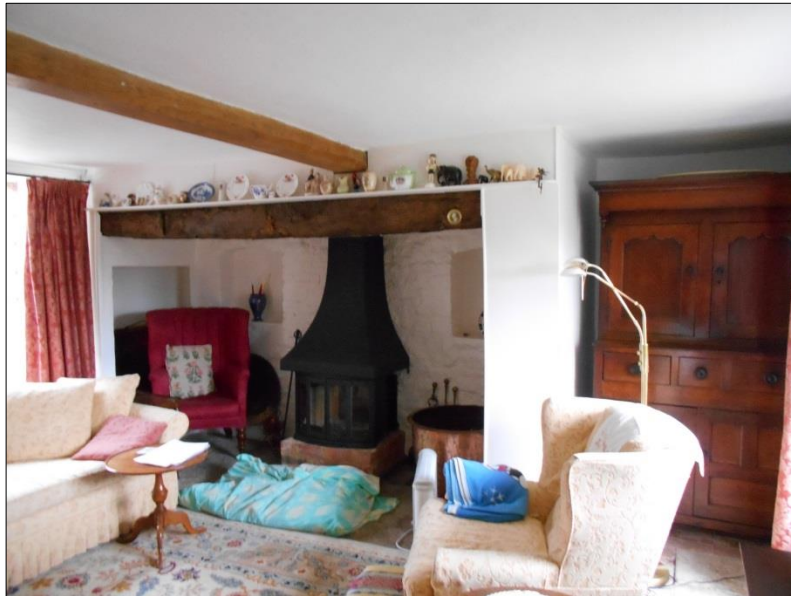
G1. Currently used as a sitting room, it has a limestone slab floor which extends into the inglenook situated against the south wall (Figs 9 and 13). The scar of a former cross passage which extended from the front door to an interior door in the east wall can be seen faintly in the limestone surface. The existing front door appears to be a replacement and is painted on the interior surface. The windows are simply as previously described from the exterior, the splayed reveals of the window openings retain simple panelled shutters. The inglenook is spanned by a bressumer in what is probably elm, which is crudely finished and still retains a wayney edge in places. Carpenter's scribe marks and other incongruous working of the timber suggest that the bressumer may have been reclaimed from an older building. The interior of the inglenook appears to have been much altered

and contains a modern wood-burning stove. In the south wall are two shallow niches which may be modern decorative features since they appear to be too shallow to serve any practical use. In the east side is a built-in seat set within the thickness of the east wall. Within the room the only feature which appears to be contemporary is the principal axial beam of chamfered oak with run-out stops; it is aligned north-south.

Fig 13 Room G1, the sitting room, looking south showing the inglenook

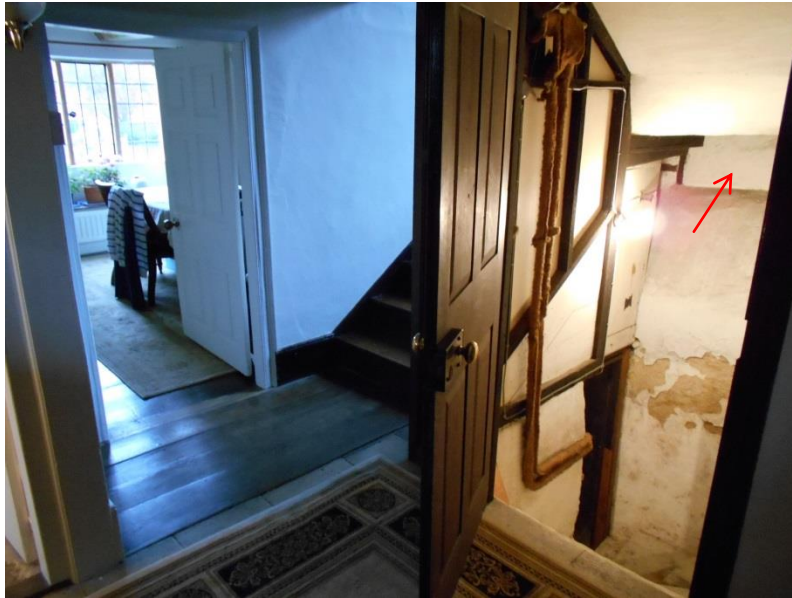
Fig 14: Door to cellar in north wall of G3, the rear hall, looking north-west; the blocked cellar window reveal is arrowed

Apart from the stone floor and underside of the timber floor of G2 above, the only feature is the window which is lit via the external light-well located against the north gable wall. On the staircase the blocked lower section of the tall staircase window, previously described, can be seen. The inner surface has been plastered and lime-washed, and it seems likely that although this blocking has removed any natural light from the cellar stairs, the window would have been blocked for security reasons. The only other feature within the cellar stair area is a small cupboard situated beneath the timberwork of the stairs above, the door of which is hung on simple butterfly hinges.

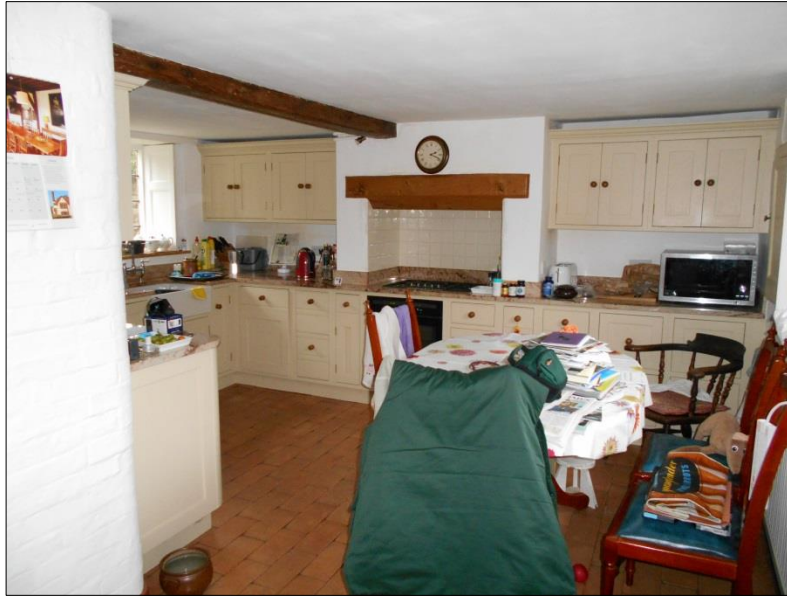
G6. An inserted doorway leads through the east wall of G3 to the present kitchen, G6, situated in the Phase Two addition (Figs 9 and 15). The door is a vertically planked door, ledged but not braced and fitted with a drop latch; it is hung on strap hinges. Within the kitchen there are almost no historic features apart from two small cupboards, probably originally for spice/salt, one each set within the north and south walls. Against the east wall are the brick cheeks of a fireplace with chimney flue above. None of the original fireplace opening survives, the arch having been raised to accommodate the present cooker. Around the north, east and west walls are modern kitchen units. The floor is of yellow brick which appears to be modern.

Fig 15: Room G6, the kitchen, looking east; note the larder (G7) corner at far left

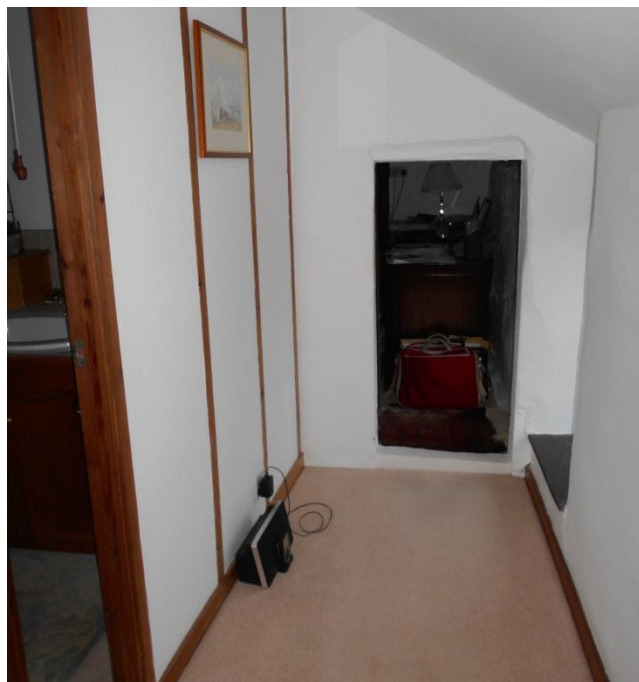
Fig 16: Room F6, passage with F7, bathroom, to the left and F8, study, through low inserted doorway

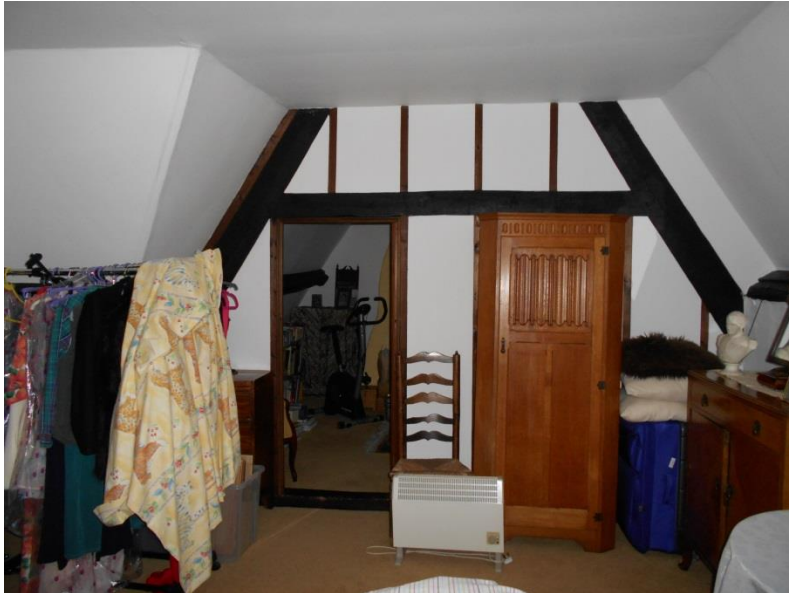
Fig 16: The partition between the north attic bedroom and the dividing wall on the line of the principal truss, looking south into the other bedroom
