**Follow-up recording at Bailey's Cottage,
4 School Lane, Eydon, Northamptonshire, 2015**

Iain Soden BA MCI*f*A

Bailey's Cottage, Eydon: Follow-up recording

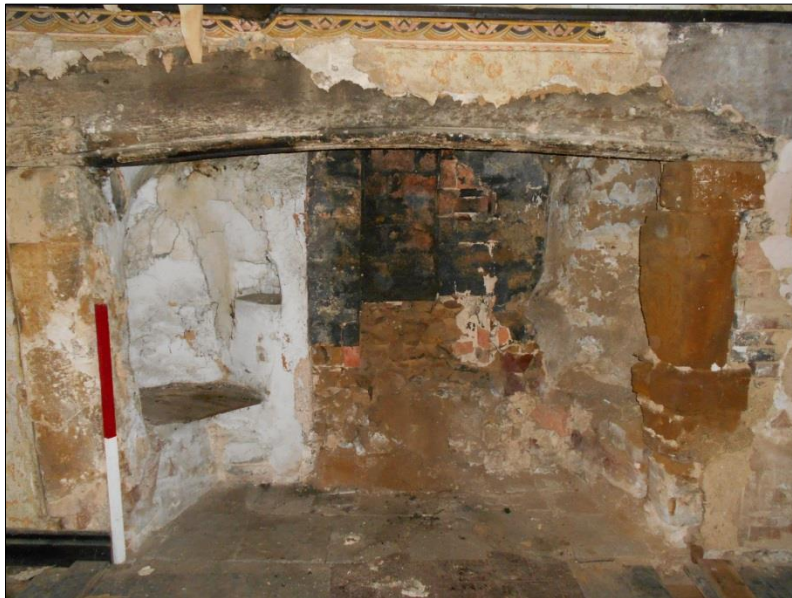
Fig 1: The western room inglenook, fully cleared; scale 1m. Note the seat-niches and tankard-rest

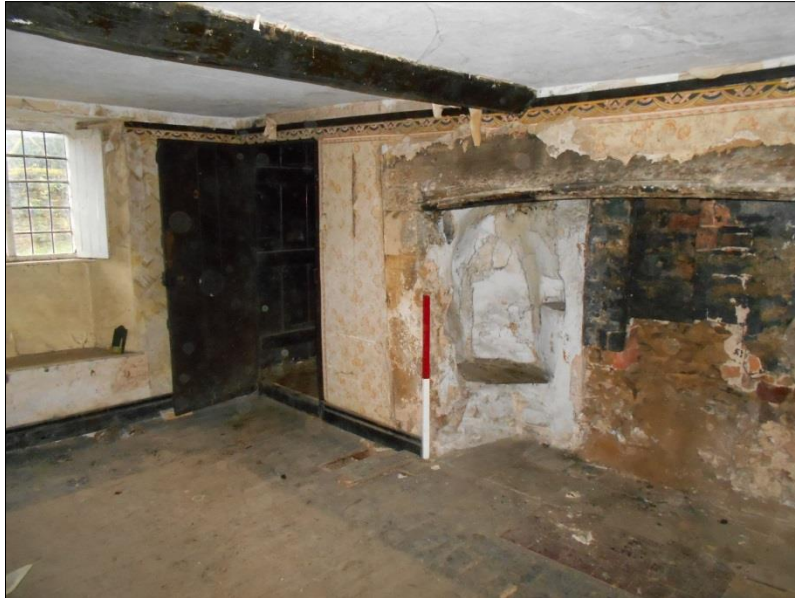
The timber floor and joists on which it lay were taken out. Surprisingly, the floor was not very old and the void beneath was clear of any debris. At its base was a skim of modern concrete put down directly upon the (truncated) natural ironstone. Any earlier floor which may once have existed, had been dug out, probably in the 1960s.

Fig 2: The western room (hall), fully cleared, looking south-west towards the front door; scale 1m. Under the timber floor was a void of some 300mm, and beneath that, a skim of concrete over the natural ironstone.

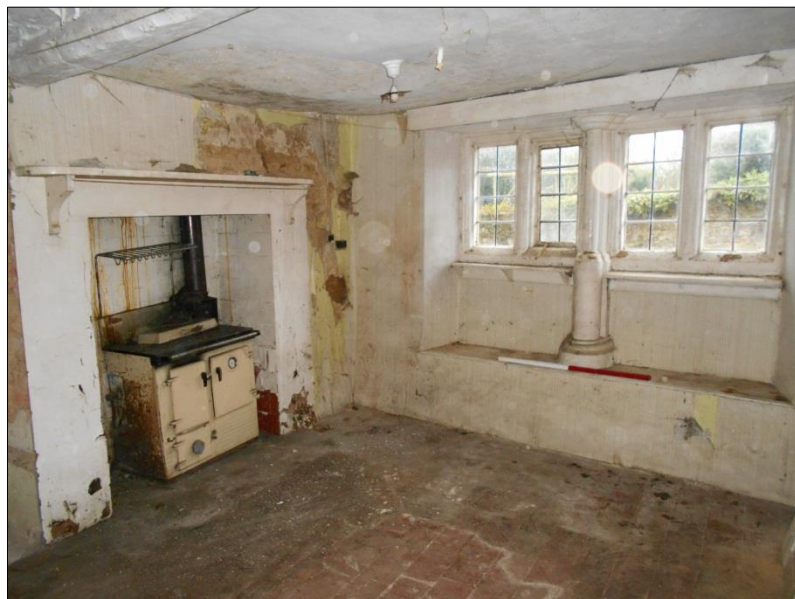
Fig 3: The eastern room (kitchen), fully cleared; scale 1m

The same process was repeated for the eastern room, the kitchen. Here the brick-blocking of the former doorway between the two rooms was fully revealed, as was the relatively recent brick sides to the former kitchen fireplace. There were no other features revealed in the walls which were stripped of their plaster. The Victorian quarry-tiled floor was taken up, and revealed to have been lain directly onto the natural ironstone, with no evidence of any earlier floor.

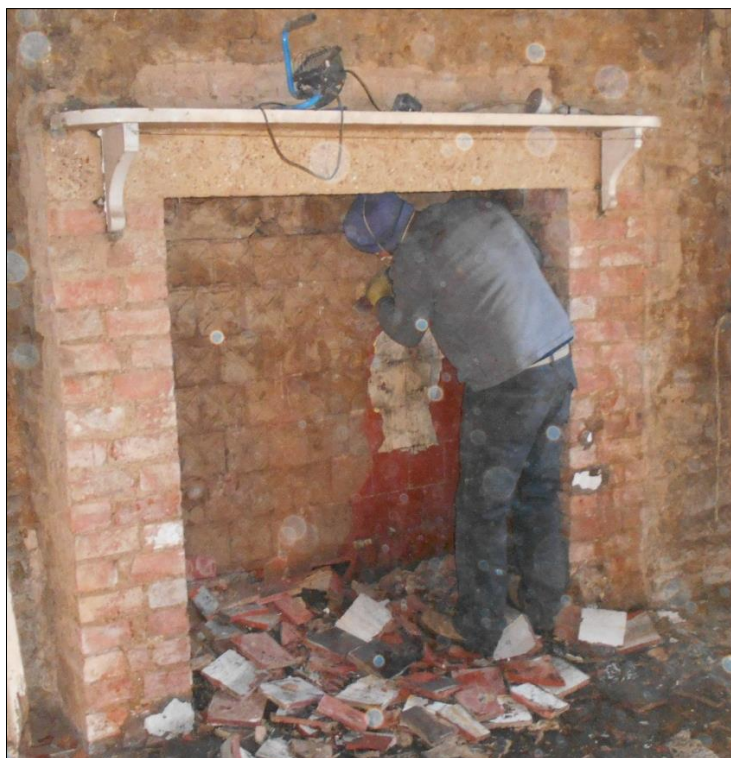
Fig 4: Paring back to the stone and brick on the east wall of the eastern room (kitchen)

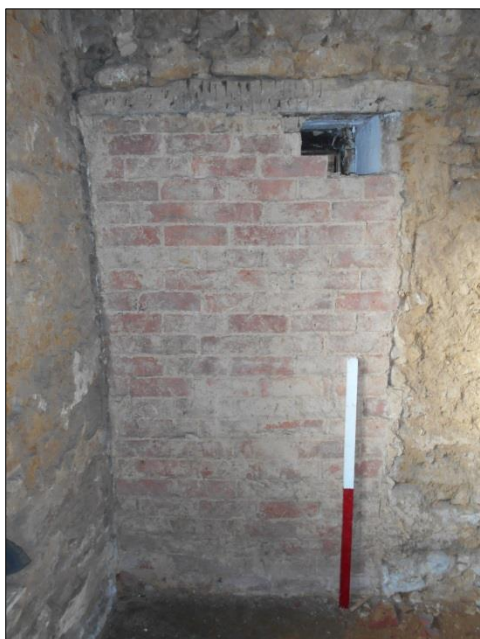
Fig 5: Blocked doorway from kitchen to hall;
scale 1m

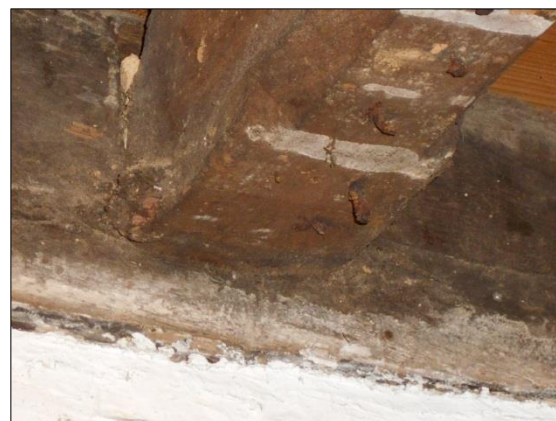
Removal of the laths of the existing ceiling indicated that the ceiling joists formerly had neatly-stopped chamfers to their lower arrises. This indicates that this room was formerly the parlour, the higher in status of the two rooms lying downstairs.

Fig 6: Stopped chamfers on the ceiling joists of
the kitchen (former parlour).

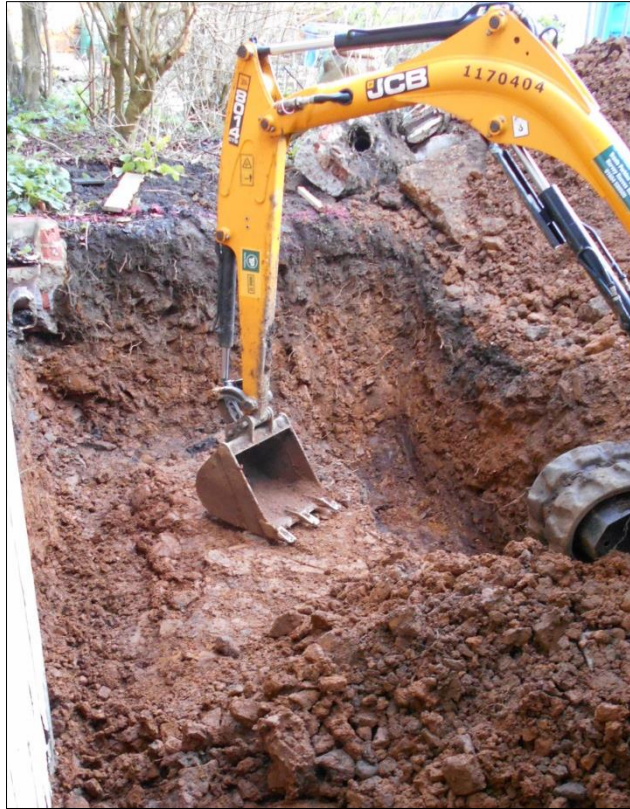
At the rear of the property the ground was reduced with a small mechanical excavator for a new rear extension. This process was watched archaeologically. It showed that there were no surviving archaeological levels or features. The ironstone natural lay directly beneath the topsoil of the garden. There were no remains present of the previous rear extension.

Fig 7: The new extension footprint to the property's rear

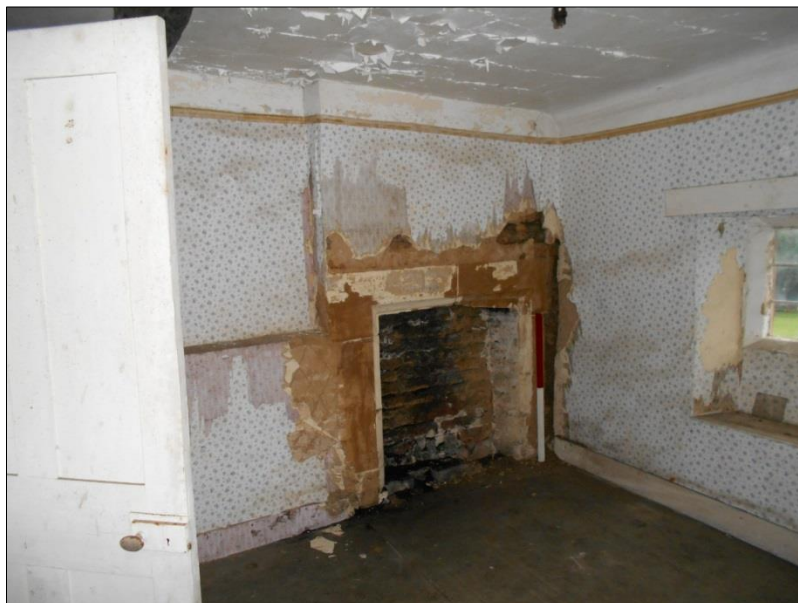
The same clearance process was applied upstairs, where the stripping-out followed on directly. This showed that there were no hidden features in the eastern bedroom which had not been previously detected.

Fig 8: the eastern bedroom, fully cleared, looking south-east; scale 1m

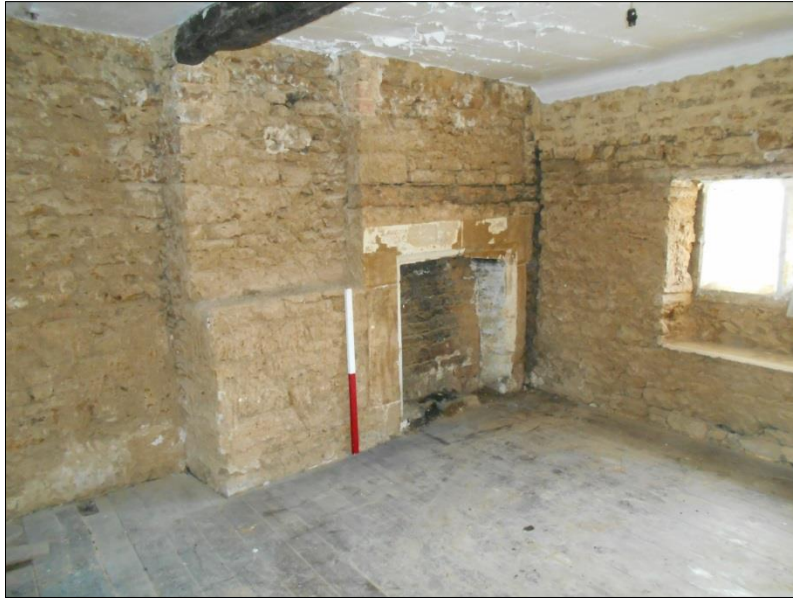
Fig 9: the eastern bedroom, looking south-east, pared back to the stonework; scale 1m

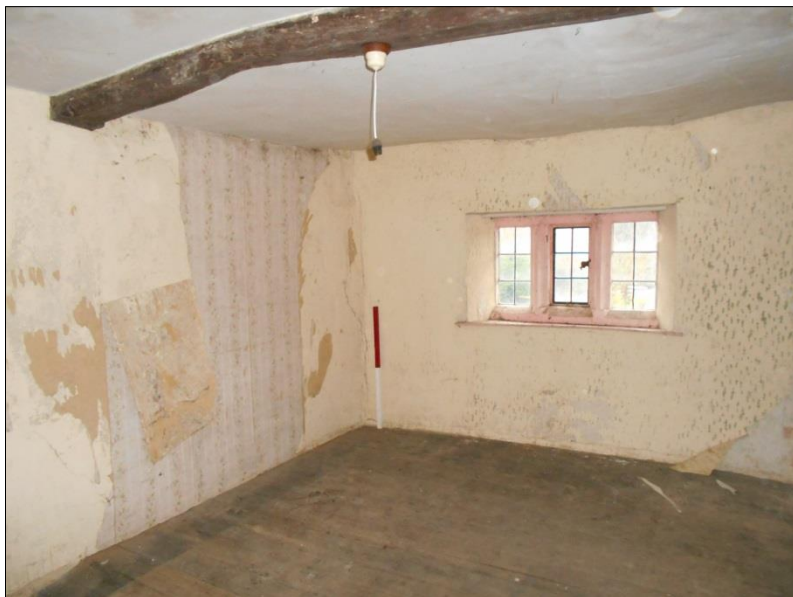
The western bedroom was similarly cleared and pared back to the stonework. It too revealed nothing which had not already been noted previously. Of note once more however, was the brick-blocked doorway through to the adjacent property, part of a corridor which allowed access along the whole range and still open when the current owner Mrs Turbett bought the property with her late husband. It was also clear that the doorway between the two bedrooms has been widened or rebuilt, being made good in brick.

Fig 10: The western bedroom, cleared, looking south-east; scale 1m

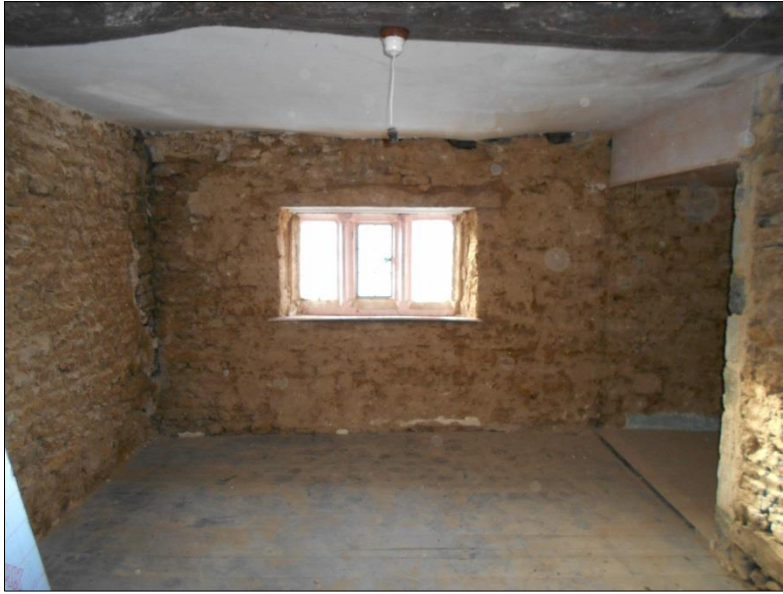
Fig 11: The western bedroom, pared back to the stonework, looking south.

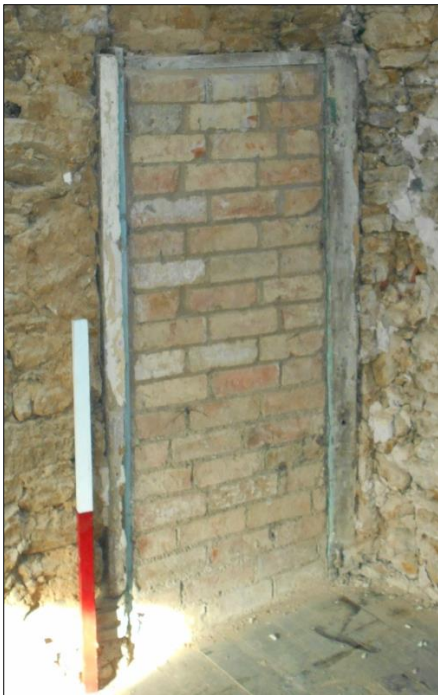
Fig 12: Blocked diminutive access doorway in NW corner of western bedroom (to no 6, next-door); scale 1m

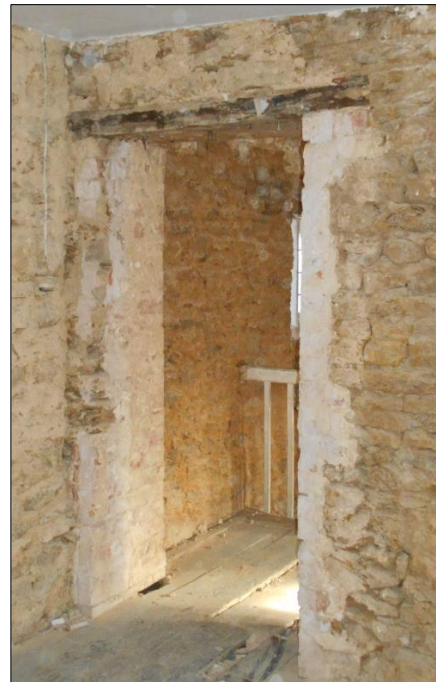
Fig 13: brick doorway alteration between bedrooms

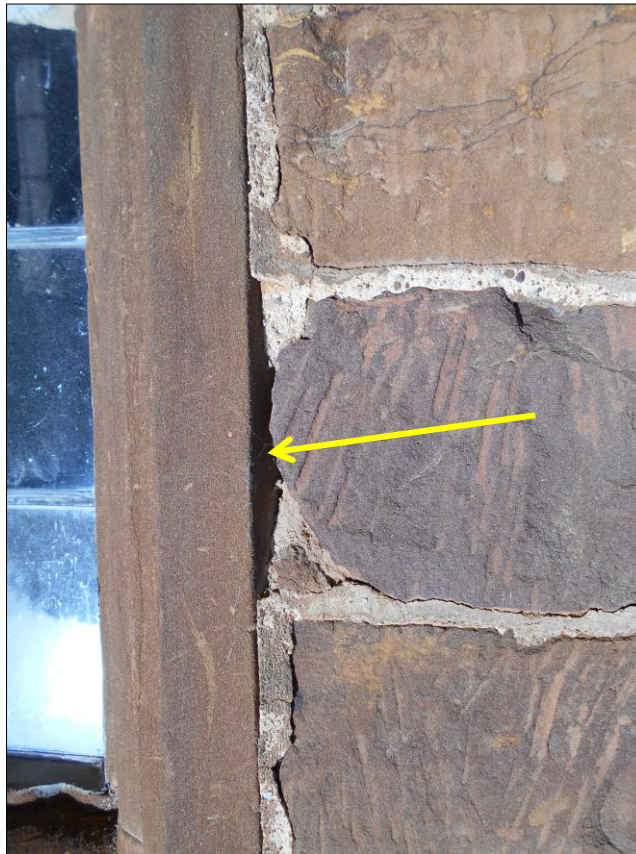
On the building's exterior only one new aspect was noted. The ground floor window to the kitchen, already known to be a reuse of mullions from elsewhere, as most of the windows in the building are, was seen to have come from an even wider window, since the jamb can be seen to have been itself a re-used mullion, with a moulding hidden within the wall fabric; it was noticed only when mortar was weathered out of an existing joint..

Fig 15: A built-in face to a former mullion, reused as a jamb (south-wall, east room exterior)
