Building Recording at 42-54 Broad Street, Earls Barton, Northamptonshire

Joe Prentice and Charlotte Walker

Summary

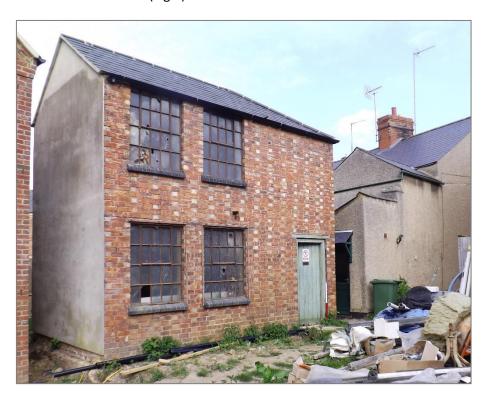
Fig 5: East elevation, looking north

The entrance doorway is situated towards the north end of the East elevation close to the cottages and the alleyway from Broad Street, presumably for easy access to workers and materials-in as well as completed items-out. The doorway appears to retain the original slightly-chamfered doorframe beneath the structural lintel. The door is of narrow vertical planks with chamfered edges and is ledged, but not braced, internally. The door retains parts of a simple iron drop latch superseded by a modern Yale lock.

The only other fixture is a letterbox. The door is hung on simple strap hinges. To the south of the doorway at ground floor level are two windows of equal size set beneath painted pine lintels. Each comprises twenty panes, five wide and four high, the upper centrally positioned six (three wide, two high) opening inwards with a hinge at the bottom, the remainder being fixed. Most, but not all, of the lower ten panes have a shallowly ribbed surface giving a slightly opaque view whilst most, but not all, of the upper half have standard clear glass. All the windows in the building are of the same size and all are glazed in the same way apart from some obvious repairs and so it seems that this form of glazing was a deliberate and most likely original feature; such use of opaque glass was common in factories as it was considered an easy way to stop the staff being distracted by events outside if they did not have a clear view. Its use here may also be a consideration of its proximity to the adjoining properties, particularly if the the original owners lived immediately to the north in the cottages there.

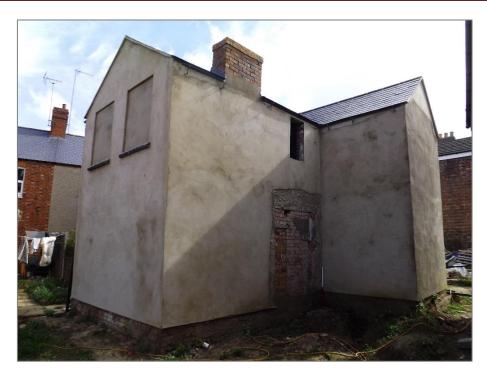
Fig 7: North and west elevations

Currently covered by a cement render the whole of these elevations reveal no evidence of previous fenestration or other openings. However, examination of the interior reveals that the west wall originally had two doorways at ground level and two windows at first floor (Fig 7). The northernmost doorway provided easy access to the houses, while the southernmost doorway led to a later toilet block, which had been demolished by 2002 (recorded as part of the English Heritage Boot and Shoe survey). The render therefore postdates 2002.

Although now blocked, the window openings are of the same size as the others and it must be assumed that they were similarly glazed. Nothing can be said of the doorways since neither frames nor doors survive. The southern elevations (there are two given the L-shape) contained a single wide opening at ground floor on the western arm and nothing on the southern. There was a single west-facing window at first floor level of the southern arm of the building (see below, First floor, interior). The only other feature visible from the south and west sides is the top of the chimney stack located on the south side of the western arm of the building; it has not been rendered and is constructed of the same brick used throughout. No chimney pots remain but there would have been two originally as there was a single fireplace to each floor, each requiring a separate flue.

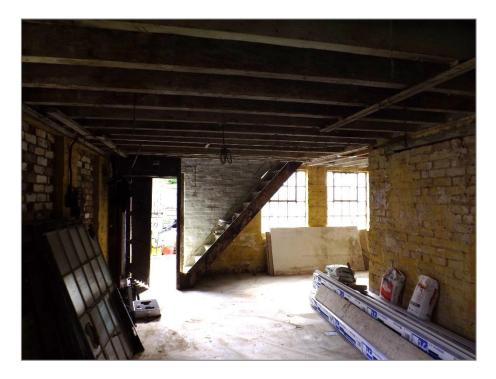
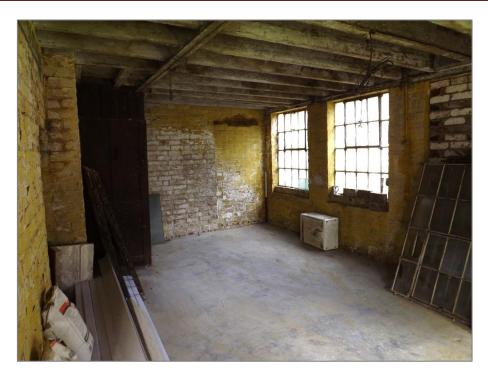
Fig 8: Ground floor, looking east

Fig 9: Ground floor, looking north-west

This is a single space and was apparently always so, since there are no signs that it has previously been subdivided (Figs 8 and 9). Entered via the doorway located at the northern end of the east wall, there is a small, and probably original, lobby which gives access to the stairs situated immediately on the left (south) side and straight ahead into the main lower floor area. There was a second door, now missing, although the doorframe and fragments of the vertical planking which would have boxed in this space survive to indicate that the lobby would have been a very cramped space and merely acted as a way of separating the main room from the outside and staircase. Lit by the two east-facing and four north-facing windows (previously described), the room is surprisingly light, but the lack of windows in the south- and west-facing walls was clearly a deliberate design. This was most likely to prevent too harsh sunlight and also overheating during the summer months, north light being preferred for its more uniform level. The floor is of concrete throughout and does not appear to be original.

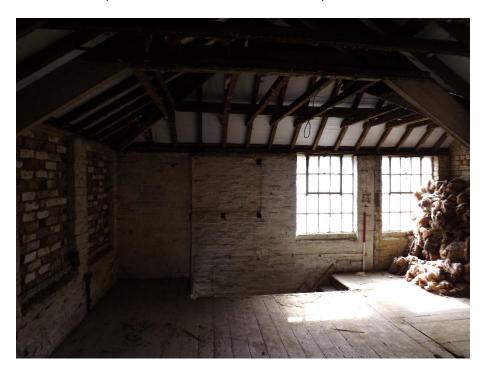
The first floor is reached via the staircase, previously described. The west side of the stair was originally boarded, most likely by vertical tongue and grove planking, scars of which can faintly be seen on the side of the string. It appears that the upper floor was originally a single open space since no indications can be seen of any dividing partitions although at an unknown date a small office was created at the top of the stairs in the southern arm by the addition of a stud wall (Fig 10).

Fig 10: First floor, looking south (scar of timber partition wall to right of 1m scale)

Scars of this timber partition wall along with pencil setting-out lines can be seen on the east and west walls and small square holes cut in the floor boards indicate the position of a central doorway. A small window appears to have been created in the west wall, perhaps at the same time; it has subsequently been infilled with Fletton brick.

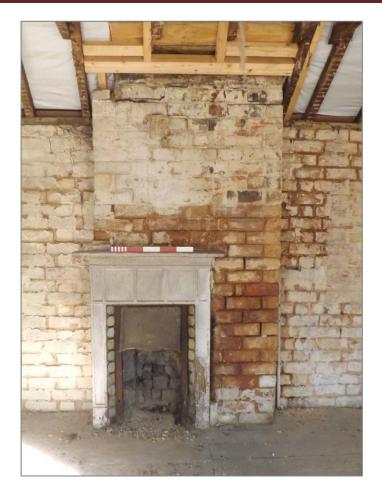
The remainder of the first floor is a single open space lit by the two windows in the east wall and five in the north; they are all identical to that previously described both in the framing and glazing. The floor is of 6 ½ inch pine boards and the walls are painted white. The chimneybreast on the south wall retains a simple cast iron bedroom (i.e. small) fireplace surround with integral mantle shelf and cream and green glazed slip-tiles down either side (Fig 11). The hearth slab is of cast concrete.

Fig 11: First floor fireplace, looking south; scale 50cm
