A building recording survey of former stables at The Plough, Everdon, Northamptonshire

A building recording survey of former stables at The Plough, Everdon, Northamptonshire.

The Plough, Everdon

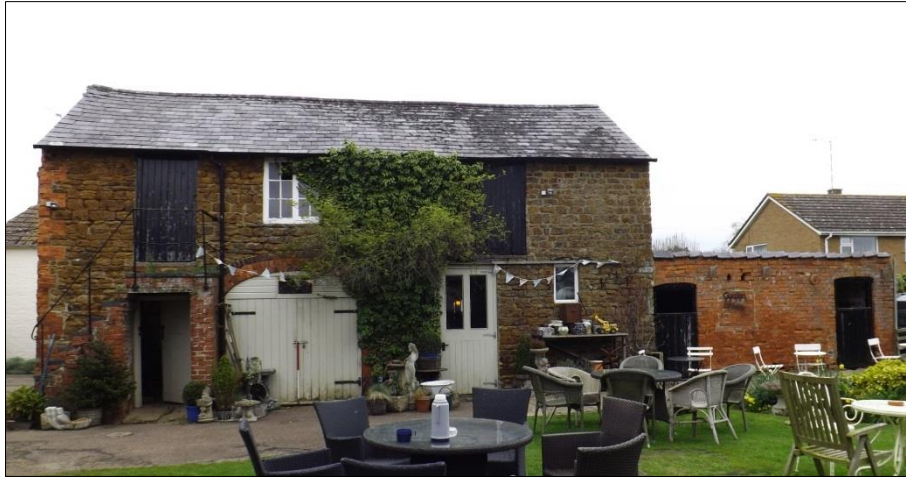
The building is constructed primarily of squared, coursed rubble using Northampton Sand with Ironstone, bonded in a soft, creamy white lime mortar on the north, east and south sides. The west gable end has been rebuilt in red brick including bullnose bricks at the south-west corner. At ground floor level there are three doorways in the south elevation. The central opening comprises a double-width doorway beneath a shallow brick arch which suggests that the central part was used as a coach- or cart-house (Figs 2 and 3). Two single pedestrian doors are located to either side and there is a small window towards the east end of the south elevation lighting the room at that end. At first floor level the south elevation contains two doorways and one window.

Fig 3: The south elevation of the former stables and later brick sheds, looking north.

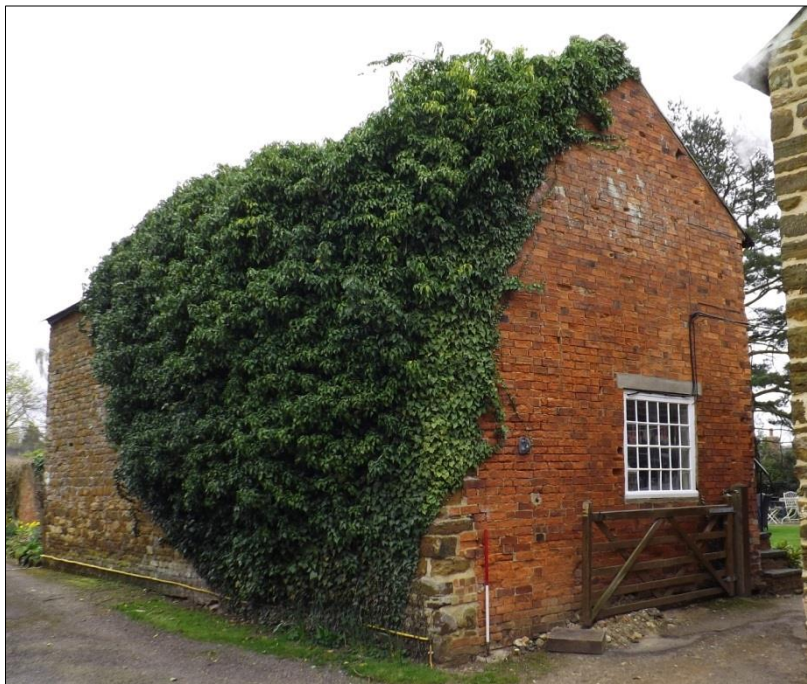
The west gable end contains a single window at ground floor level and is plain at first floor level. The window opening is fitted with a 24 pane fixed metal frame window beneath a concrete lintel. The rebuilt brick section is bonded into the ironstone wall with deliberate quoins for strength (Fig 4).

Fig 4: The west gable end and the north elevation looking south-east; 1m scale.

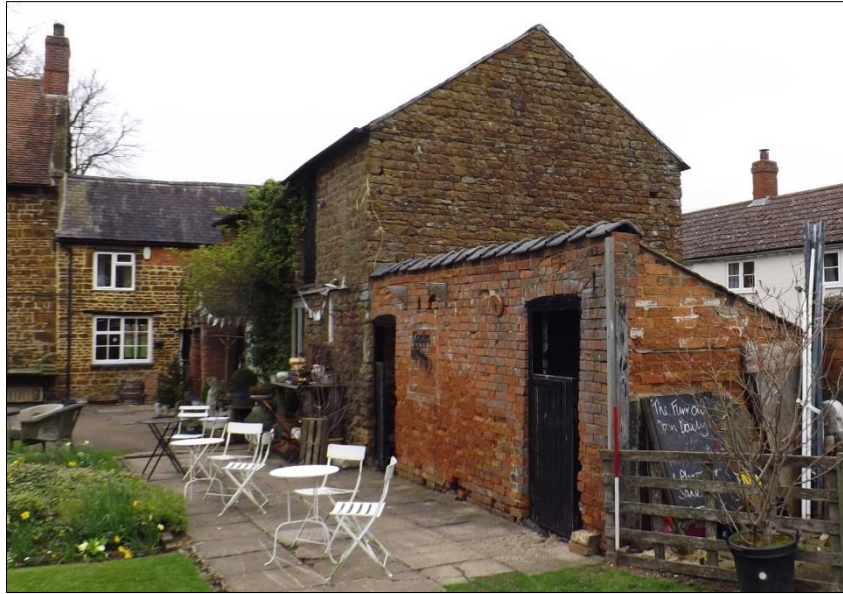
The stone east gable end is entirely plain and has no windows or doorways nor is there any indication that there were ever any present. The single storey brick sheds are butted against, but not bonded with, this east elevation (Fig 5).

Fig 5: The east gable of the former stables with the later brick-built sheds looking north-west. The rear of the public house is visible to the left; 1m scale.

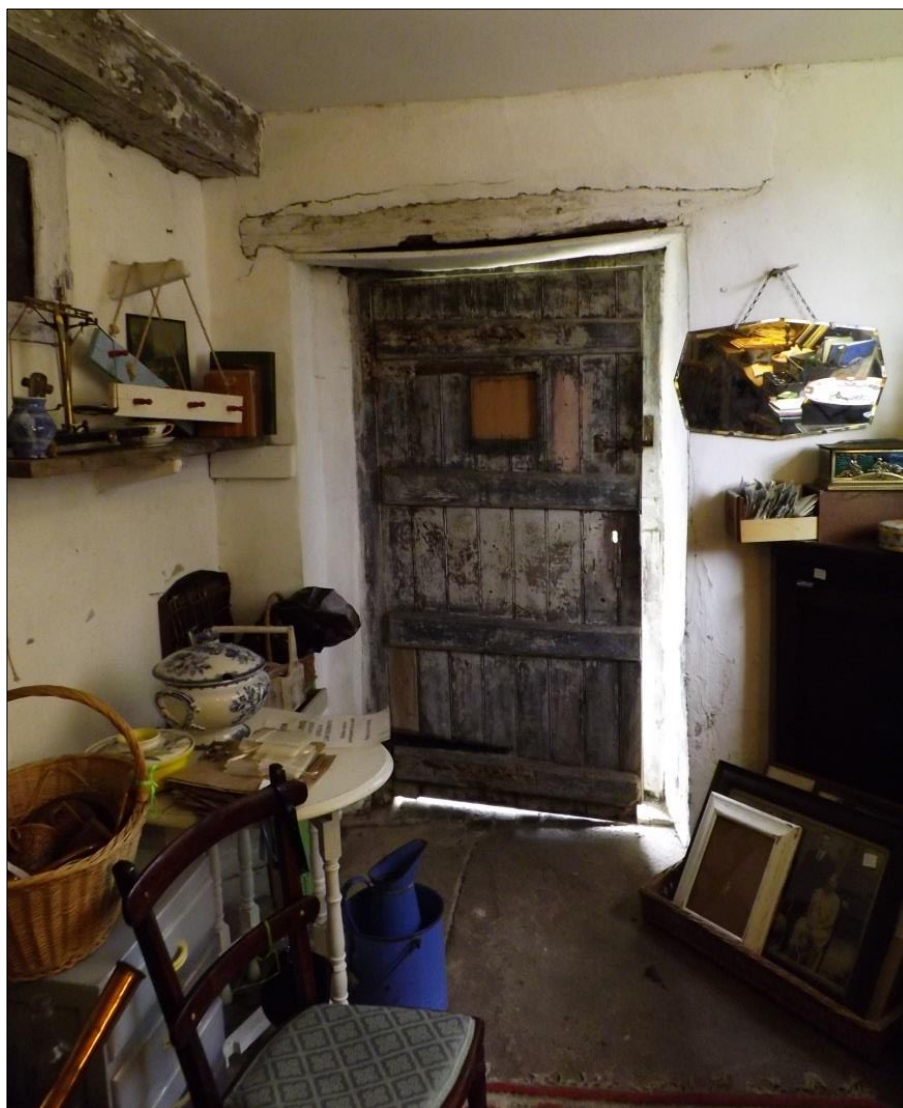
Situated at the western end of the main block this comprises a simple rectangular space accessed by the pedestrian doorway in the south elevation (Figs 2 and 3). The door is a simple vertical plank door, ledged but not braced internally. There was formerly a small glazed panel in the upper part of the door, now infilled with timber sheet (Fig 6). There is a simple iron drop latch internally and iron strap hinges. The internal surface retains what may be late nineteenth-century paintwork but the exterior has been repainted.

Fig 6: The storeroom

There is a timber lintel above the doorway and all of the walls have been plastered and painted. The ceiling is of modern plasterboard sheet, the floor is of cement. The metal framed 24 pane window in the west gable wall has previously been described (see Fig 4). A small internal window was present between this room and the central coach house in the dividing brick wall (see Fig 6 upper left). It is fitted with zinc mesh suggesting its presence was for ventilation. To the immediate south of this is a simple wooden peg set in the east wall was most likely used for hanging bridles or harness on. There were no other original fixtures or fittings.

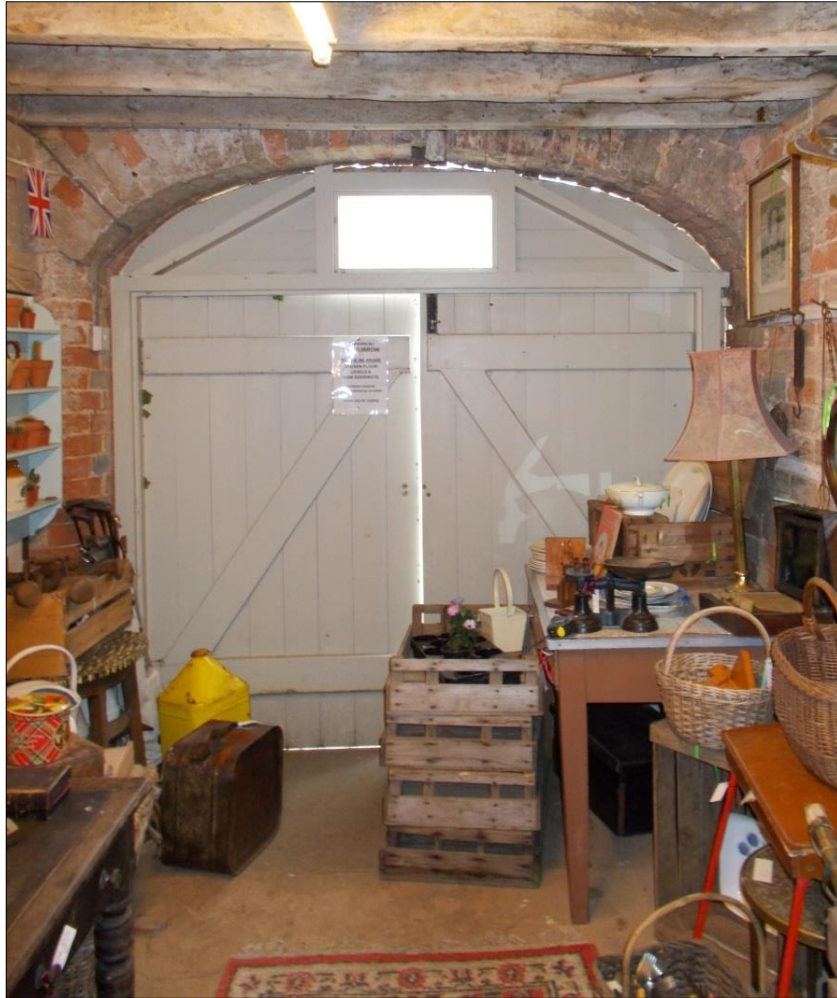
This room comprises the central of the three ground floor rooms (Figs 2 and 3). It is entered through a double-width opening which extends the full width of the room beneath a shallow brick arch (Fig 7). The present doors and doorframe are modern and there is no scar on the brickwork of the jambs or arch to indicate the presence of an earlier doorframe. It is therefore possible that this coach house was formerly without doors.

Fig 7: The coach house interior, looking south.

The north wall is constructed of ironstone, the two internal side walls are of red brick. All have been lime-washed. The internal jambs of the coach arch comprise bull-nose brick which suggests a date of c1850 or later for this structure. Since a building is indicated on the c1815 map it seems likely that the brick portions of the building are mid-century adaptations.

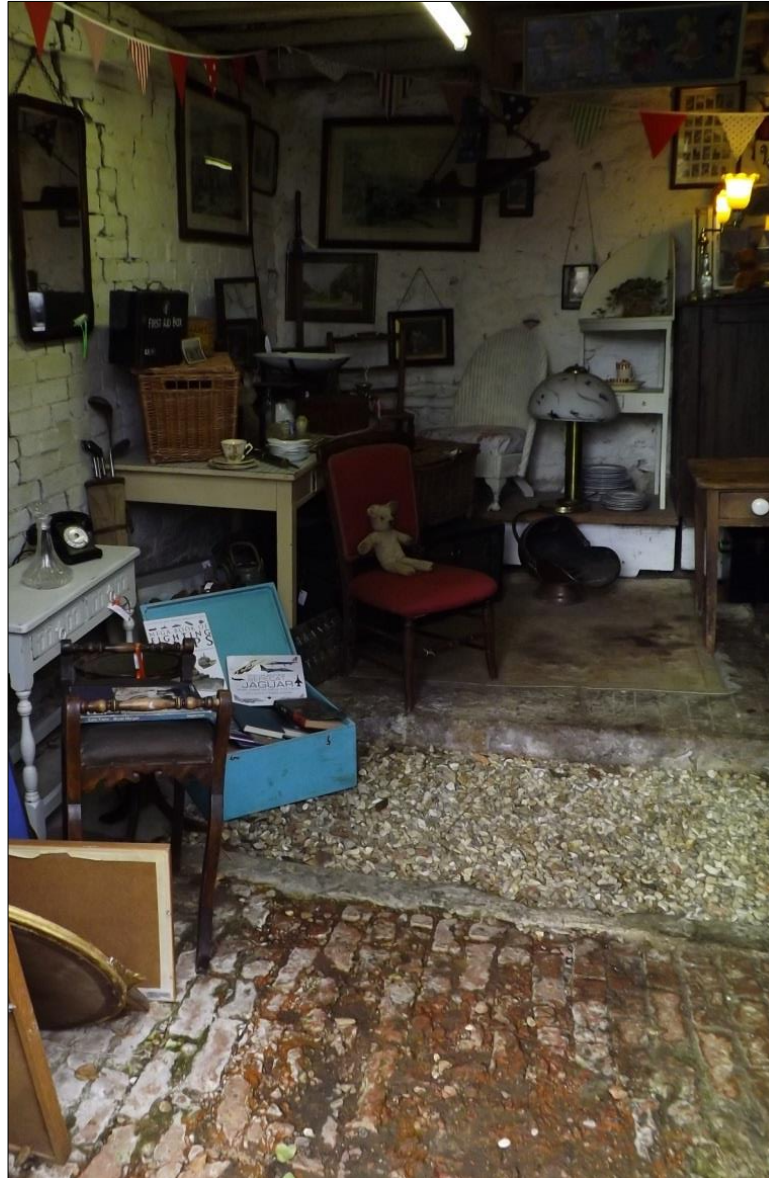
items. It is not clear if there was originally a gully or channel through the wall at that point though this seems most likely as there is no sign of sign an exit in the internal dividing wall, nor would none be expected. On the north side of the room a slightly raised portion is laid to concrete; this was the location of two former stalls (Figs 2 and 8).

Fig 8: The stable interior showing brick flooring, gravel-filled drainage channel and raised stall area. Looking north.

The north, east and south walls are of ironstone the west internal, wall is of brick. All are lime-washed. There is a single, letterbox shaped, air vent in the north wall which serves the east stall; there is no vent serving the west stall.

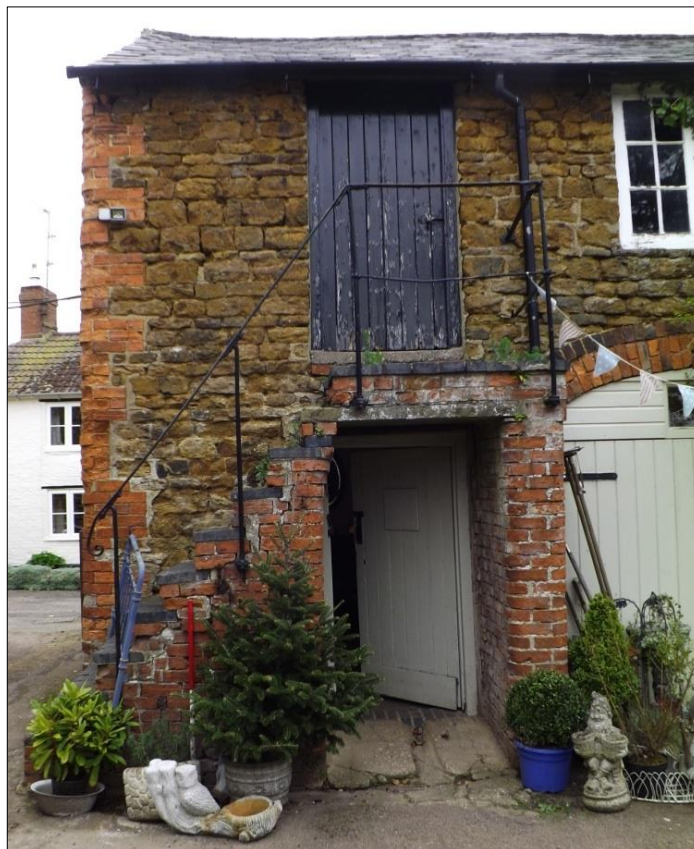
Fig 9: The external stairs, looking north; 1m scale.

The stairs are built of red brick bonded in lime mortar. They have bullnose bricks at the southern corners where the jambs of the addition form a porch to the west storeroom. The lintel above that porch is formed of a single slab of stone, perhaps York stone. Each tread is surfaced with embossed moulded blue engineering brick paviments to provide additional grip. The whole staircase is butted against, but not bonded with - the south elevation; its lowest step projects slightly beyond the west gable wall (Figs 2 and 9). A simple wrought-iron railing provides a handrail.

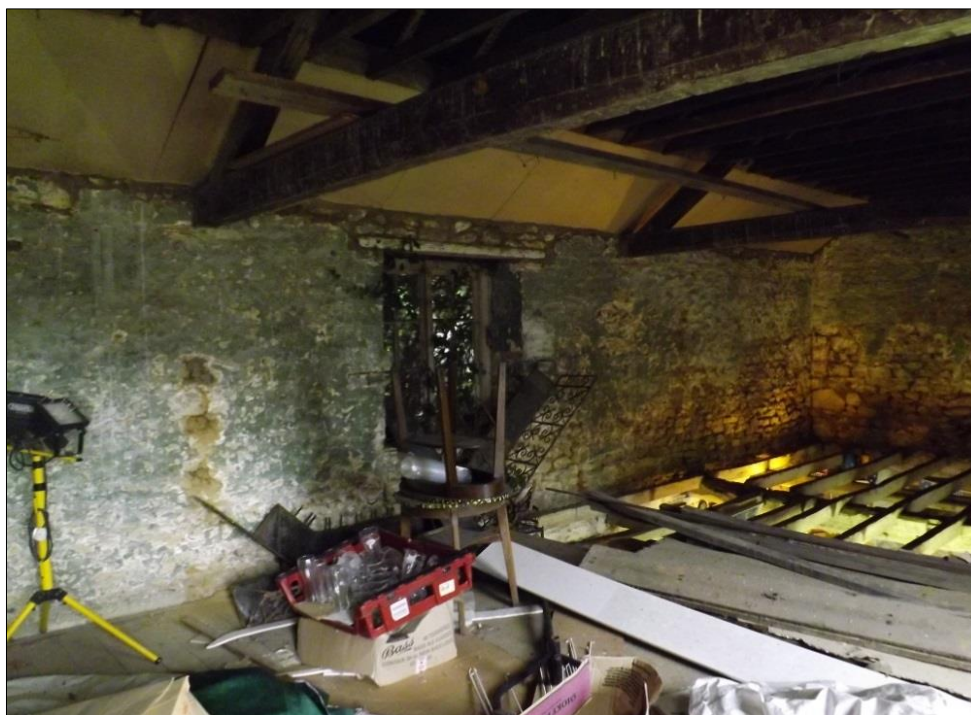
The western half of the upper floor retains some floorboards but these were mostly covered by stored items. The eastern half of this level retains the principal tie beams and joists but no floorboards (Fig 10).

Fig 10: The first floor level looking north-east. Note lack of floorboards at the eastern end and ivy-covered window in the centre of the north wall.

The windows in the north and south walls are both of the same configuration. Each is a timber casement with one fixed and one opening light, each containing six panes. Both are situated beneath timber lintels. The doorway at the eastern end of this level was not accessible at this level due to the unsafe nature of the flooring.

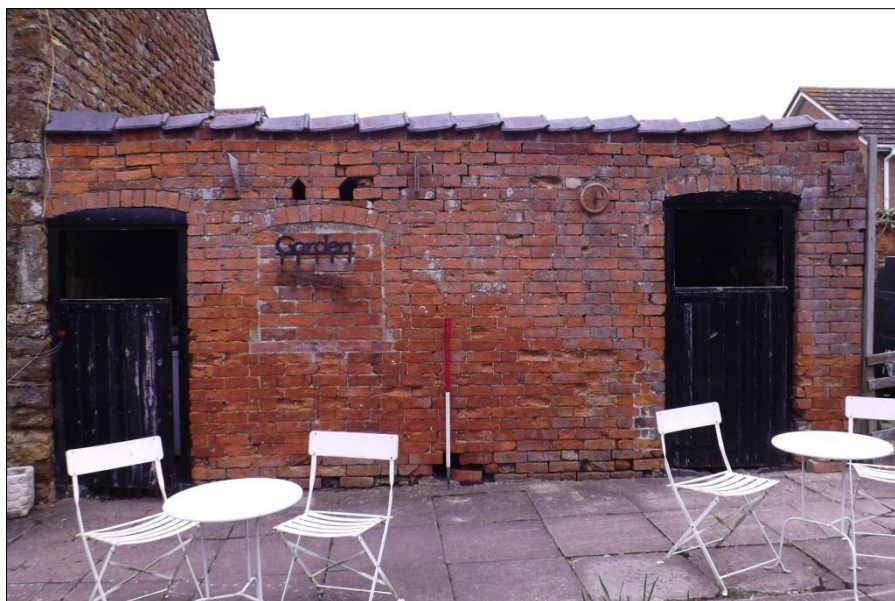
A single storey two-roomed shed has been added against the east gable wall of the former stables (Figs 2 and 3). Built entirely of red brick it comprises two small rooms, but it is thought that they may have extended further to the east since a stub of brick protrudes from the south-east corner suggesting a further length of walling. Each room is accessed via doorways formed beneath shallow segmental arches in the south elevation and each is fitted with timber frames and two-thirds height doors (Fig 11). These doors and frames are modern replacements.

Fig 11: The brick sheds looking north; 1m scale.

There is a blocked window to the western of the two rooms; it comprises a roughly square opening beneath a segmental arch. Above are two small air vents. The eastern room had no window. The size of the rooms and the heights of the doorways suggests that they may have been simple stores or perhaps pigsties, since they are too small to have been stables. It is also possible that at least one, or even both, may have been a privy.
