**A building recording survey at Highfields Farm,
Newnham, Northamptonshire**

A building recording survey at Highfields Farm, Newnham, Northamptonshire

Summary

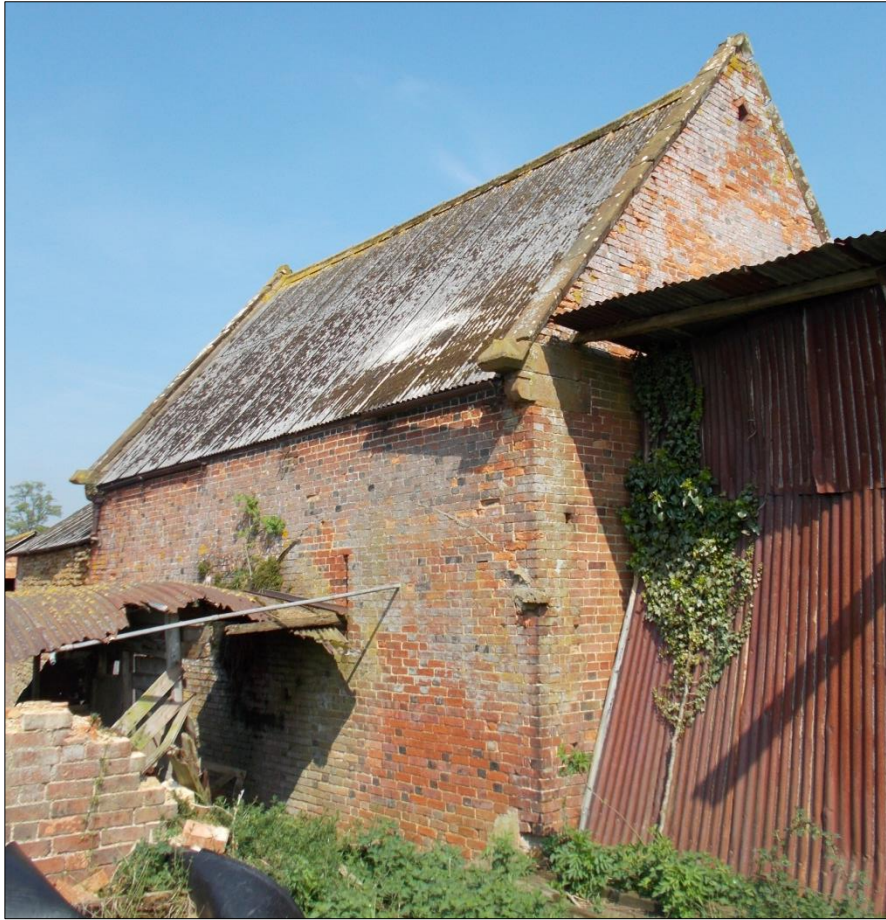
Fig 4: The field barn, looking north-west.

The bricks are laid fairly regularly in courses which are composed usually, but not exclusively, of two stretchers and a header but this varies around the building. Such bonding most closely equates to Mixed Garden Bond, a variation of Flemish Stretcher Bond in which headers do not lie above each other in any regular pattern (Brunskill 1990). In many, but not all, cases the headers are flared although they do not appear to have been used in any part of the building to form a deliberate pattern. On the east gable end there is a single pitching- or hayloft door, the base of which is slightly lower than the eaves. This small door was almost entirely hidden from the exterior by the corrugated metal roof of a modern shed built against that end but could be clearly observed from the interior (see below). Close to the ridge an owl-hole is present created from placing two bricks at an angle to form a triangular arch above a square opening.

The gables are surmounted with ironstone copings resting on ironstone kneelers, surprisingly well carved and decorated for an isolated field barn. At some stage, the coping stones have been inverted and currently their chamfered upper edges face downwards with the former drip grooves of the undersides of the stones facing upwards. It is assumed that the stones were turned over when the existing, corrugated asbestos roof was installed, although the reason is unclear. Previously the barn may have been tiled or thatched.

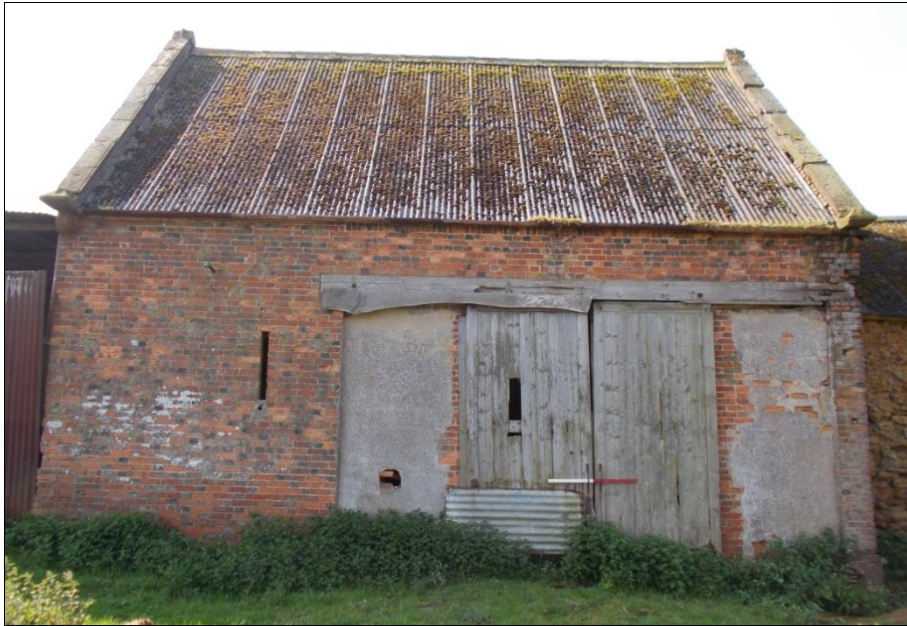
Fig 5: The north elevation of the field barn, looking south; 1m scale.

The sliding double-doors are not an original feature but most likely date to the late nineteenth- or early twentieth-century. The top and bottom of each door panel respectively hangs and sits on iron rails. These rails are located in rebated panels to allow the doors to be drawn back so that their outer faces are flush with the external elevation of the barn. The faced-off brickwork of the two recessed panels has been covered with a cement render. It is assumed that such effort has been taken so that the doors and their supporting rails are protected by the overhang of the eaves. It is also assumed that these doors replace an earlier, smaller pair of double doors although there is now almost no evidence for these. However, just to the left of the top edge of the boarding that covers the top rail of the sliding door rail on the east side a section of brickwork perhaps indicates the former position of a lintel. If this is the case it seems that the original double doors were placed centrally within this long axis. Just below the eaves a line of edge-laid bricks lies above a section of re-laid brickwork which spans the full width of the sliding door opening and recessed panels; here the bricks are laid in English Bond.

To the east of the sliding doors is a vertical ventilation slit which appears to be part of the original design of the building. There may have been a corresponding slit to the west of the original doors but if so it was lost when the sliding doors were inserted.

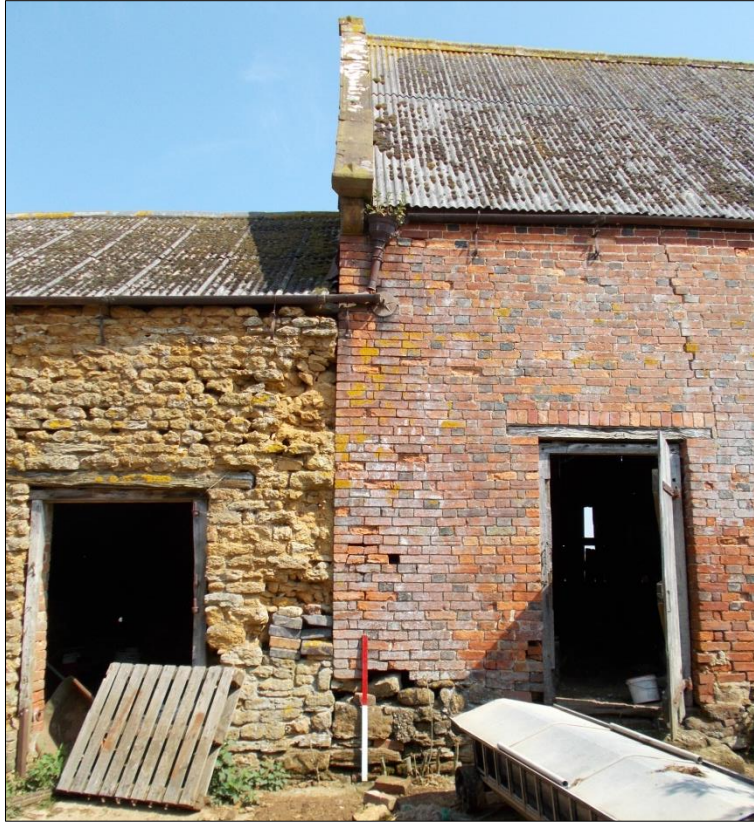
Fig 6: The south elevation of the field barn showing doorway into the barn (and later animal shelter to the left) looking north; 1m scale.

Built in the same materials as the rest of the structure this elevation reveals most clearly on the external elevation that the lower section of the barn is built of ironstone up to, and in places slightly above, the level of the internal floor. This construction extends around the entire building but is most visible in this location due to the downward slope of the ground from east to west (see Fig 11). It appears to be a contemporary feature.

The doorway into the barn from this side has been heightened but not widened; this is apparent from the presence of closers down both sides of the door opening and the faint scar of a setting for a lower lintel. The present doorframe is of pegged oak set beneath a shallow oak lintel; neither are painted. The present door is a simple plank door ledged and braced internally. It is hung on two plain strap hinges and closed with a hook and staple; there is no lock.

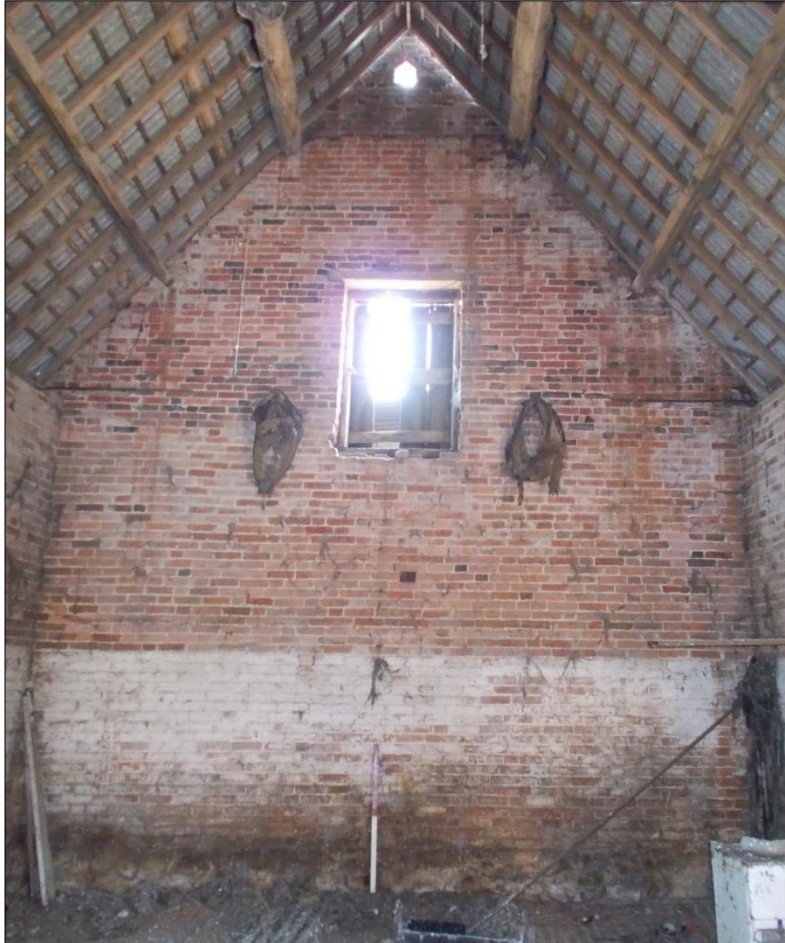
Fig 7: The field barn interior, east gable wall looking east; 1m scale.

The walls have been lime-washed to roughly head height, partly for cleanliness and also perhaps to reflect daylight into an otherwise fairly dark space. The hayloft door is fitted with a simple plank door, ledged but not braced. Due to its height in the wall it was not possible to determine whether or not it is original, but it seems more likely to be a replacement given its exposed position. The evidence for a hayloft floor is equivocal; there are a few blocked sockets, but these are only the sizes of individual headers and as such appear to be too small for joists. Also there is no evidence for any former socket of a principal cross-beam which would also be expected in either of the north or south walls.

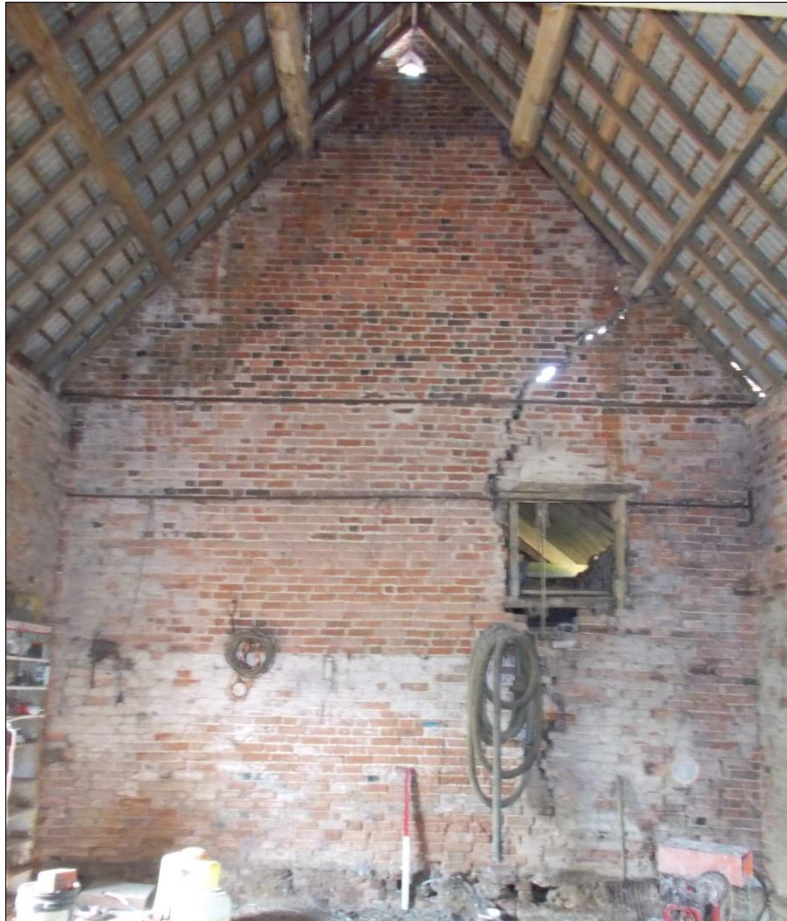
Fig 8: The west internal elevation of the field barn, looking west; 1m scale.

The loft door is a simple planked door set in an oak frame. The brickwork on all sides shows signs of being crudely chopped out to accommodate this new opening. There is a large structural crack rising from the floor and extending all the way to the level of the lower purlin. At some point an iron tie bar has been fitted in an attempt to alleviate this problem. The south end of the tie bar is fitted to a circular plate on the exterior of the south wall (see Fig 6), the north end of the bar has no plate and is simply bolted onto the outer surface of the beam above the sliding door rail.

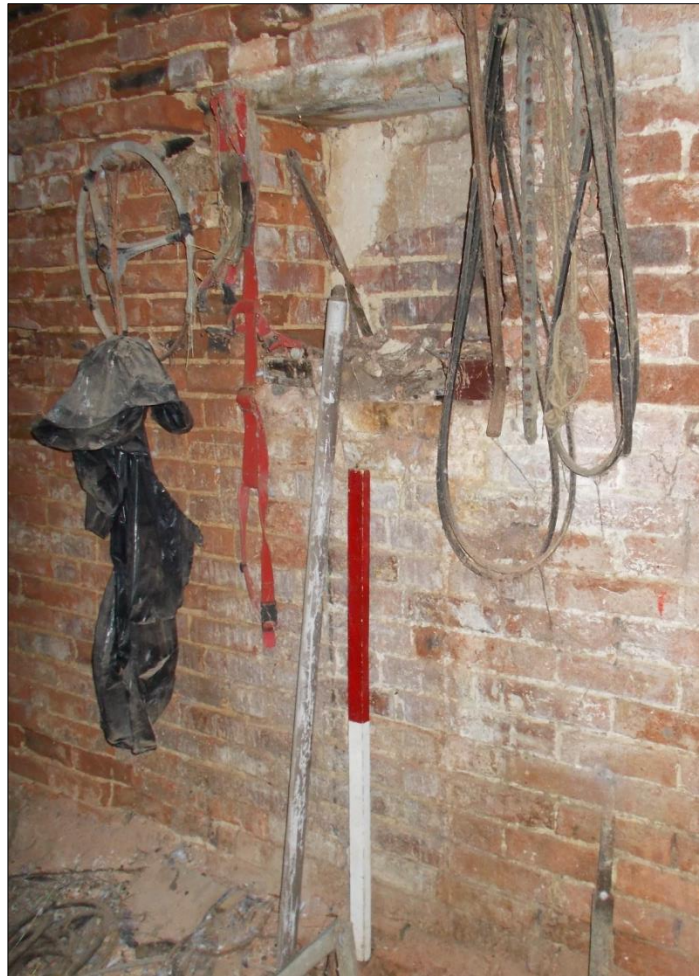
Fig 9: Lamp niche in the south wall, looking south-east; 1m scale.

The niche, built into the wall to hold a lamp or candle, is a standard feature of such barns built at a period prior to the installation of electric lighting. In a building where the risk of fire was high such a recess was an important feature, providing a relatively safe location for a naked flame. The internal surface retains sections of plaster lime-washed white to reflect the light outwards. It has an oak lintel.

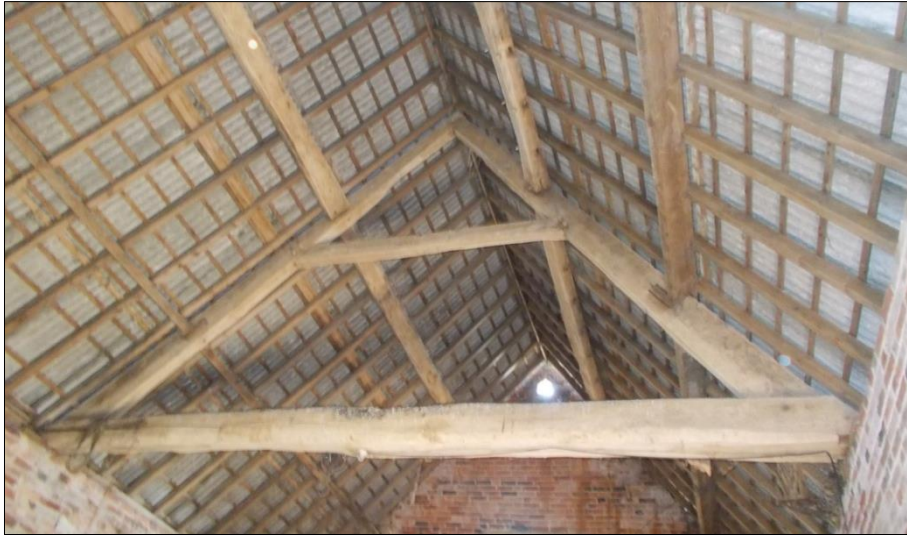
Fig 10: The roof of the field barn, looking east.

The truss comprises a principal tie beam, principal rafters and a single collar. On both the east and west sides at the upper level the original purlins remain, the lower purlins have been replaced although the filled sockets for the originals can be seen. All of the secondary rafters, laths and roof covering are modern.

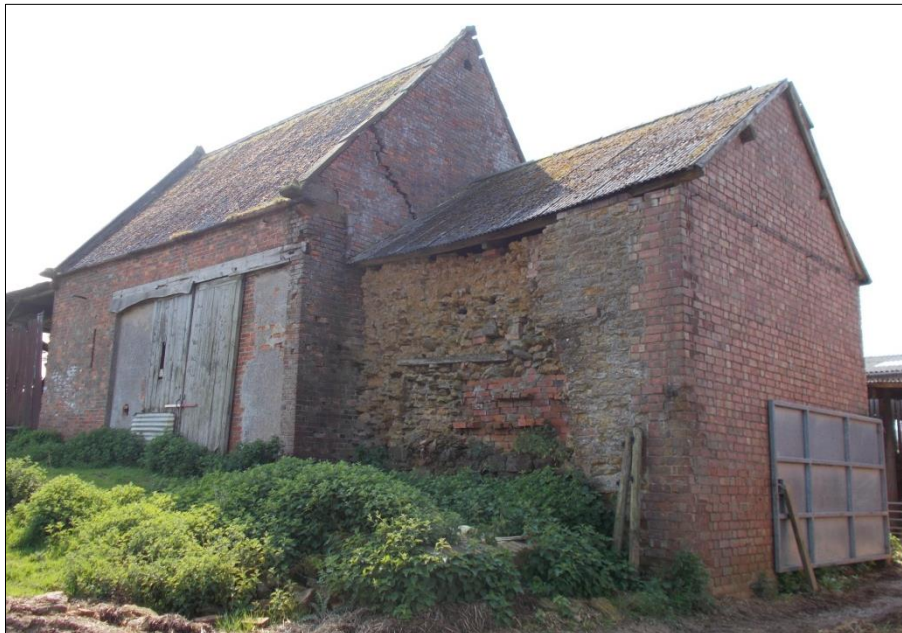
Fig 11: The animal shelter, looking south-east, with field barn beyond.

The north wall has partially collapsed along its outer face and only the inner skin remains. This reveals that the wall was originally built in ironstone rubble. There is an oak lintel within the inner section of stone walling which indicates the location of a former doorway (see Fig 3). The west end of the wall has been rebuilt in both stone and brick in at least two phases.

The whole of the west wall has been rebuilt in Fletton brick; no original fabric remains.

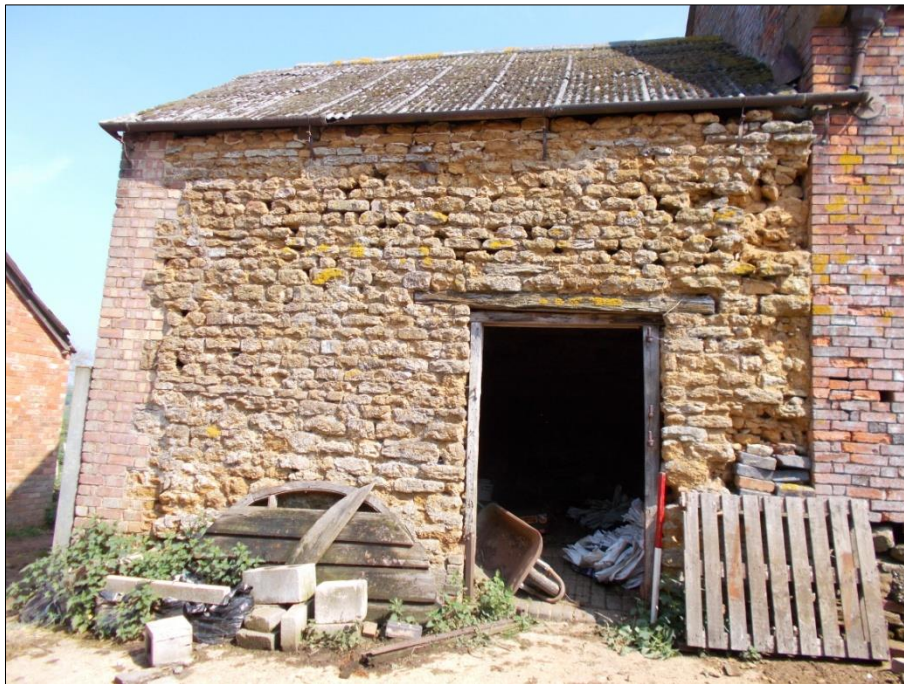
Fig 12: The south elevation of the animal shelter, looking north; 1m scale.

There is a single doorway fitted with a narrow oak lintel and beneath, an oak door frame. The doors are now missing but four iron hinge pins indicate that the doorway was fitted with two-part stable doors.

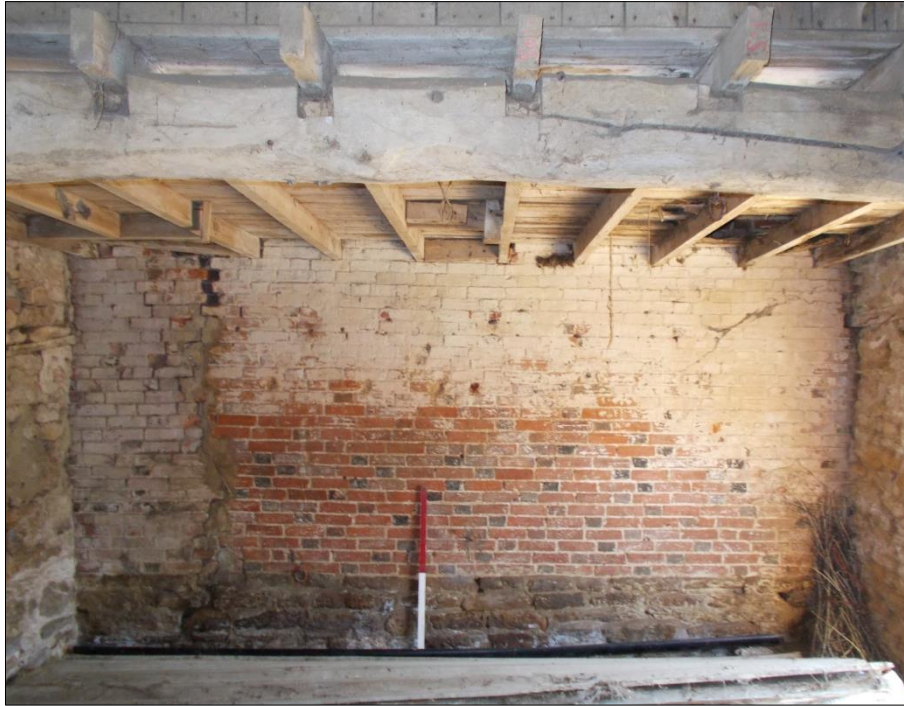
Fig 13: The animal shelter looking east with hayloft floor above; 1m scale.

The hayloft occupies the eastern half of the space and is supported on a single north-south principal tie beam. The west ends of the joists rest upon this and the east ends are set into the former external gable wall of the field barn. There is a small, square hatch in the north-east corner of the floor fitted with a trap door. The west end of the loft has a low, vertically boarded rail (Fig 14).

The floor of the shelter comprises a mixture of cobbles, plain blue brick and at least two patterns of moulded blue brick paviments indicating extensive repair after c1850.

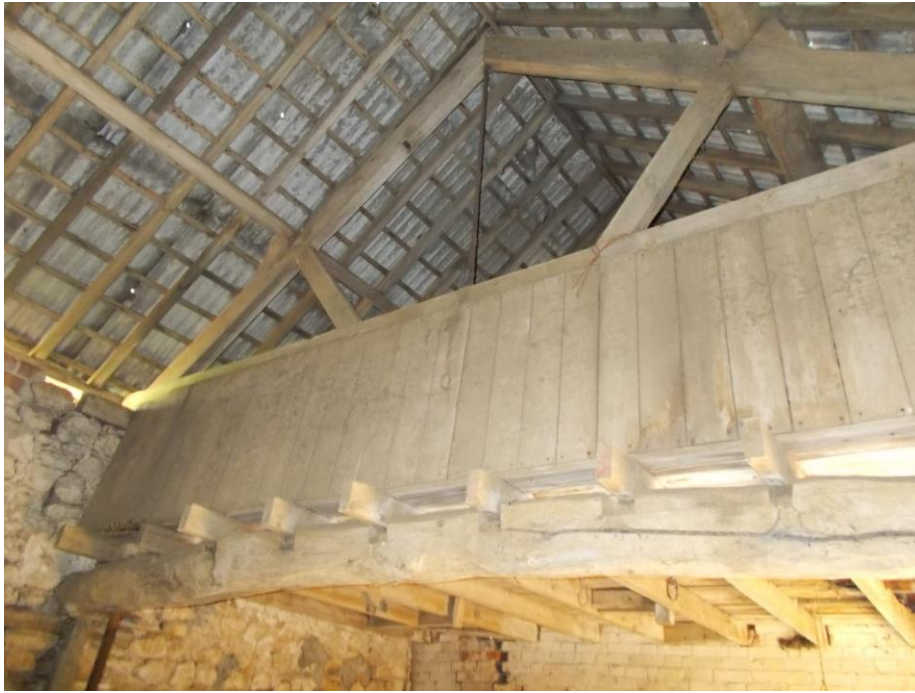
Fig 14: The roof truss and hay loft rail, looking north-east.

The truss appears to be of machine sawn pine and comprises a tie beam, principal rafters and a vertical iron rod from ridge to tie beam. Raking struts support the principal rafters at the point at which they support the purlins. The secondary rafters, laths and roof coverings are modern; the covering is corrugated asbestos sheeting.

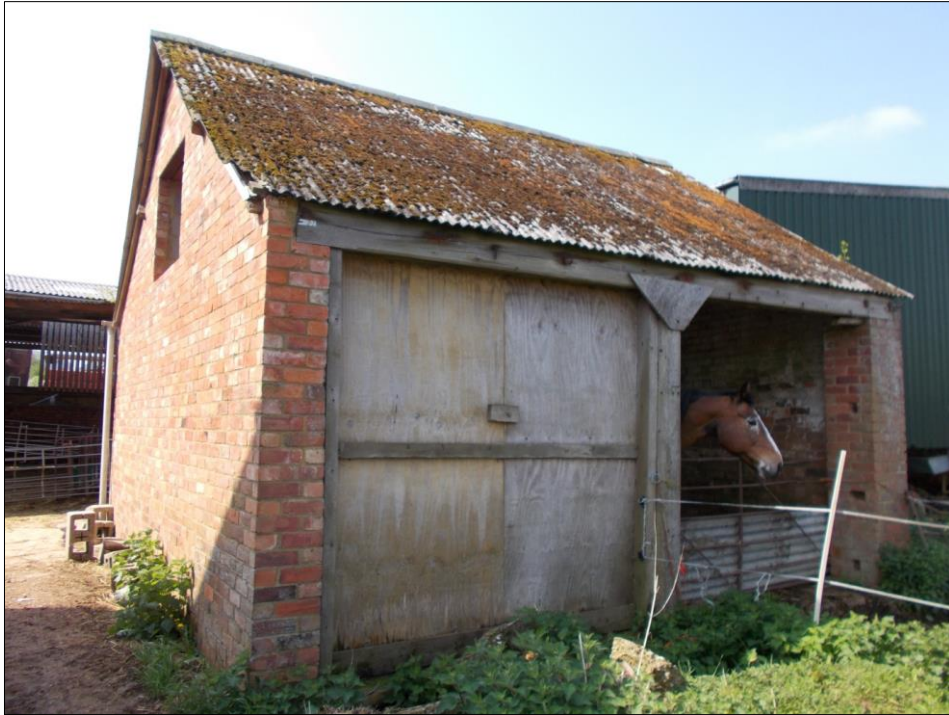
This building lies at the north end of a row of single storey shelters which form the western side of the group (Fig 3). The stable has been largely re-built with perhaps only part of the south wall being original. The whole of the east gable has recently been rebuilt (pers comm. current landowner) and the west side comprises Flettons indicating a likely post-Second World War date. The north side was entirely open with a central post but is now half closed by laminated timber sheets (Fig 15).

Fig 15: The stable, looking south-west.

The east wall is of blockwork internally with a brick external skin. There is a small window in the gable, without frame or glazing.

The south side contains a stable door of standard two leaves; it is modern as is the majority of the surrounding wall.

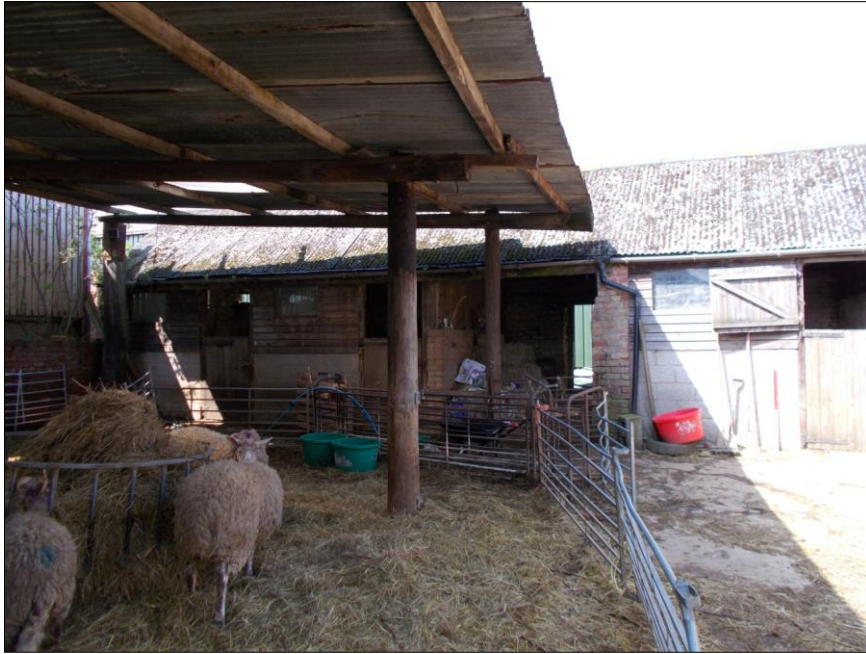
The remainder of the west range appears to have comprised open sided animal hovels or shelters but now the east (formerly open) side has been mostly infilled. The southern part of the west elevation is of ironstone as is the south gable end (Fig 3). The north wall of the current passage which allows access through to the west side is also of ironstone; these walls may delineate the size of the original building. The east wall is of modern horizontal timber planking and appears to be a simple infill of the open hovel facing the central stockyard (Fig 16).

Fig 16: The west range of former animal hovels, looking west.

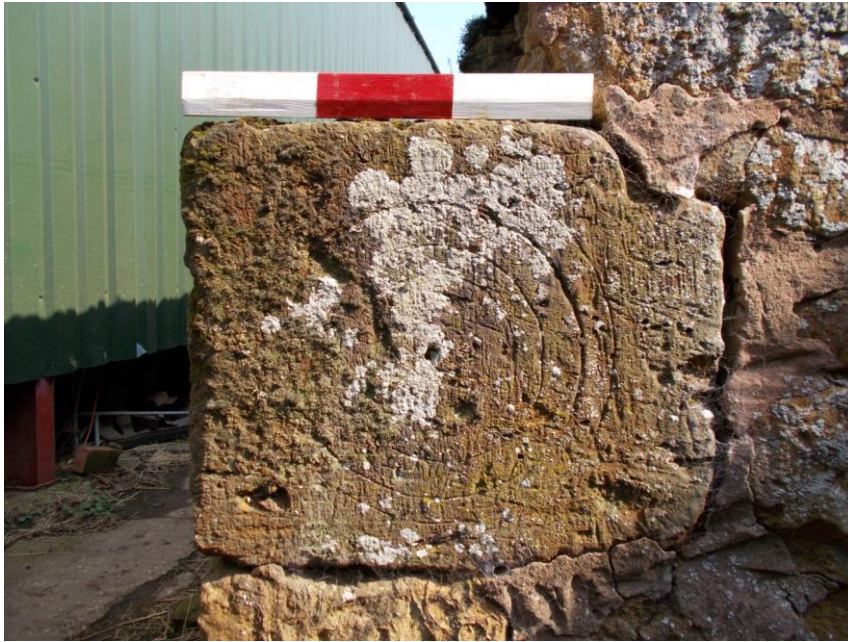
Fig 17: Decorated stone at south-west corner of the west range, looking north; scale 30cm.

The decoration has the appearance of folk art. These are probable apotropaic or ‘witch-’ marks. Such decoration was regarded as being helpful in warding off evil or unwelcome spirits and was usually placed close to doorways or other openings. Its position here suggests that the stone has been re-used since its location on an external corner away from any access routes is incongruous. There are other obviously re-used stones around the farm complex and so it might not even originate from the complex.
