A Level 2 Building Record of an outbuilding or annex at Blisworth House, Church Lane,
Blisworth, Northamptonshire

Iain Soden BA MCIfA

30 June 2016

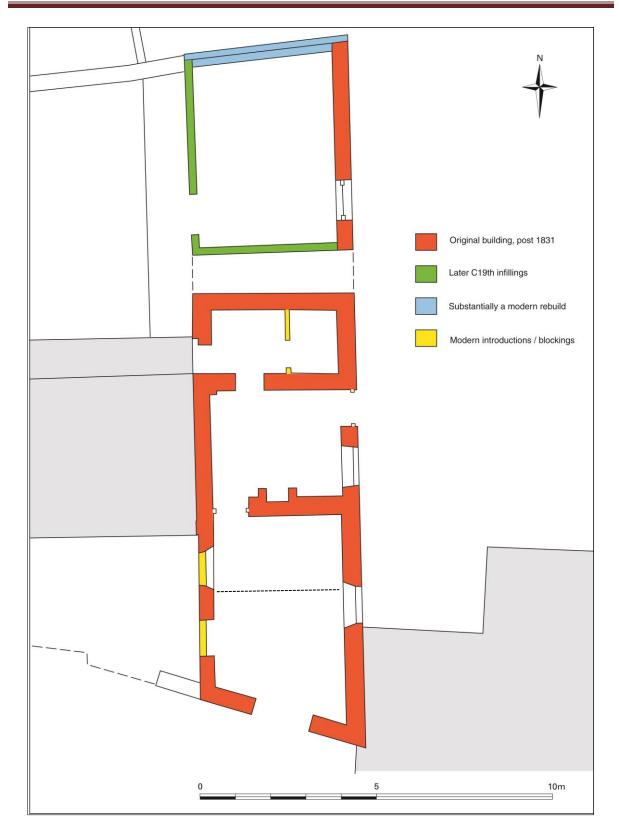
Fig 3: The outbuilding, phased (Andy Isham, with grateful acknowledgment to Alex Dalton)

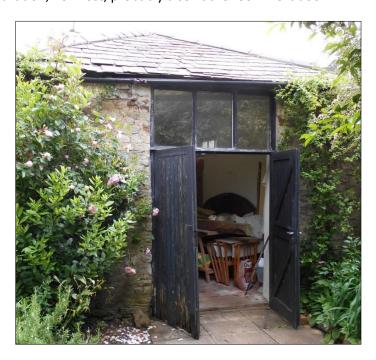
Fig 4: The double doors in the angled south end

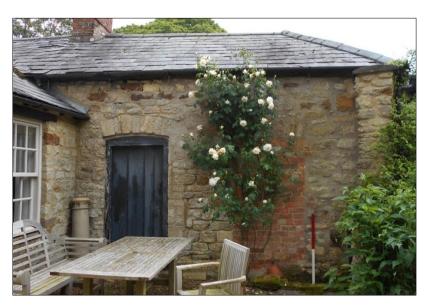
through a long working day. A pedestrian door in its west side has been blocked up. Here the floor, of 220mm-square unglazed quarry tiles, has been fully re-laid in modern times. Other than by opening the double doors, the room was lit by a window high up in the east wall, which, but for a probable internal partition, now lost, probably also lit the room next door.

Fig 5: The two doors to the former implement shed (right, blocked in brick), and the produce store (left, blocked on the inside); scale 1m

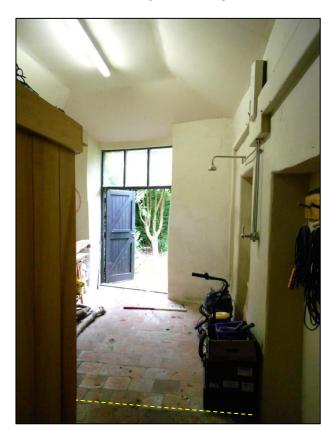
That room 'next door' no longer exists in its own right but is now part of the southern third, and today contains a sauna cubicle. Although the floor here is also of 220mm-square unglazed quarry tiles, here they have not been re-laid and show a pattern of wear through the doorway in the north wall to the middle third of the building. Another former doorway in the west wall, from the service yard adjacent to the house, gave independent access from that yard. Unlike the doorway surround

Fig 6: View from the possible 'apple store' through the implement shed; the dashed line indicates the location of the former partition

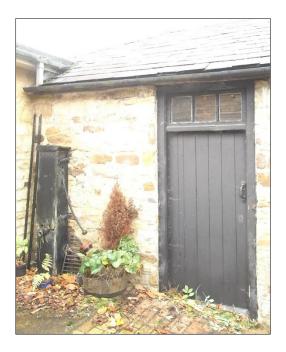
Late 19th-century maps indicate that a well and pump stood just outside the range to the east, in what is now an adjacent property, but what was formerly the stable yard. Pump and well still survive. Therefore both the gardener's room and an adjacent passage from the service yard, had direct access through to the water supply.

Fig 9: The stable yard pump still survives on the adjacent property (Photo: Alex Dalton)

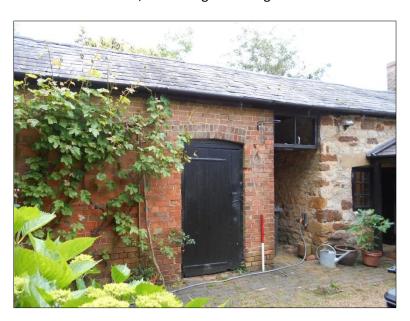
The northern gable end has been substantially rebuilt in brick and blockwork, so retains no historic interest. The front and inner side wall, which made a passageway out of the approach to a door into the stable-yard, is of Victorian red brick, measuring on average 225mm x 110mm x 70mm.

Fig 10: The northern, brick-infilled third, with passageway to the stable-yard; scale 1m

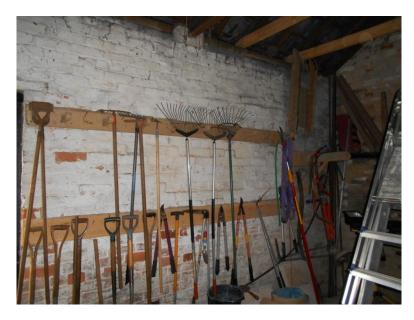
Fig 11: garden implements hung on a row of wooden bridle-hooks, battened to the west wall

The only clue to a second former use is a set of saddle- and bridle-hooks fixed to the walls, so the interior has been used as a tack room at some point. However, in the absence of any match-boarding or similar lining or a hearth, both usual pre-requisites for a proper tack-room, this function seems to have been secondary and perhaps half-hearted.
