Iain Soden Heritage Services Ltd

Building recording on agricultural barns at The Grange, Adstone, Northamptonshire

Joe Prentice

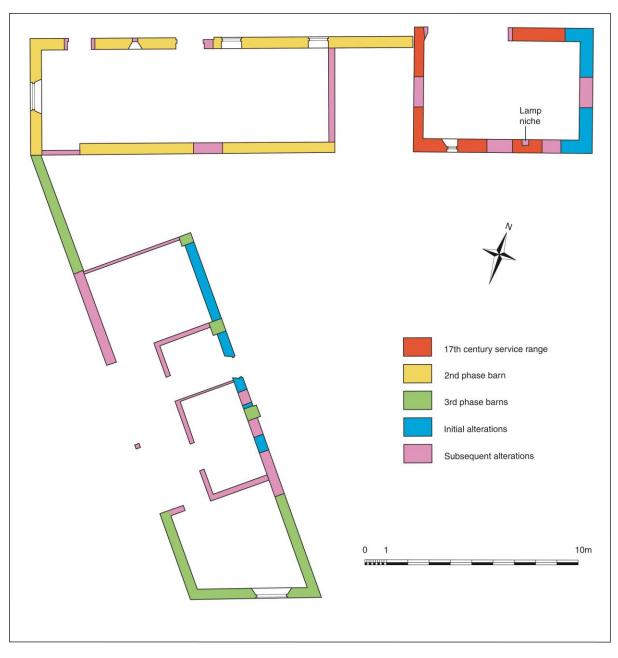
The easternmost portion of the north (barn) range appears to have been originally joined to the rear (west side) of the Grange which is dated to 1656 (Fig 4). It seems to have been a domestic arrangement and has all the small embellishments which accompany part of the house, and not a barn.

Fig 4: The barn group showing phases and alterations (Andy Isham after Roger Coy Partnership)

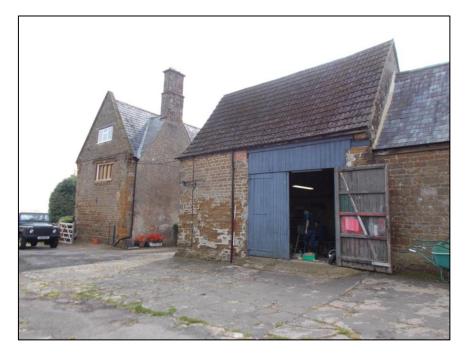
The barn range is constructed throughout in Northampton Sand Ironstone bonded in a pale creamy white lime mortar. The individual stones have been squared with dressed faces and laid in courses of varying thickness. Much altered, there are at present no door openings which relate to its original phase and the only access now is through a large full-height double door in the north side (Figs 4 and 5).

Fig 5: The north elevation of the 17th century service range, looking south-east; 2m scale. The original farmhouse lies to the left; note the rendered west wall beneath the chimney stack.

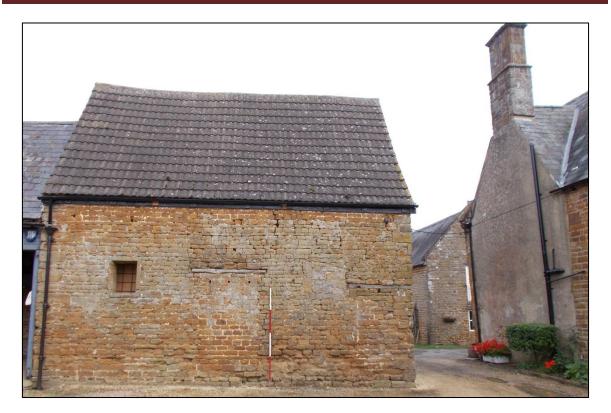
Fig 6: The south elevation of the 17th century service range, looking north; 2m scale. Note the vertical edge of the rendering on the chimney stack gable of the farmhouse to the right.

In order to make that entranceway, presumably for access when the west barn range was added (see below) sections of the north and south walls were removed and a new east gable wall built, severing this service range from the house. That new gable does not have the same quality of stonework seen on the original sections of the north and south walls neither do to courses of the new gable match those of the original elements (Fig 7). Also missing are the large 'long and short' quoins visible both on the original corners of the farmhouse and the south-west corner of the service building (see Fig 6, left side).

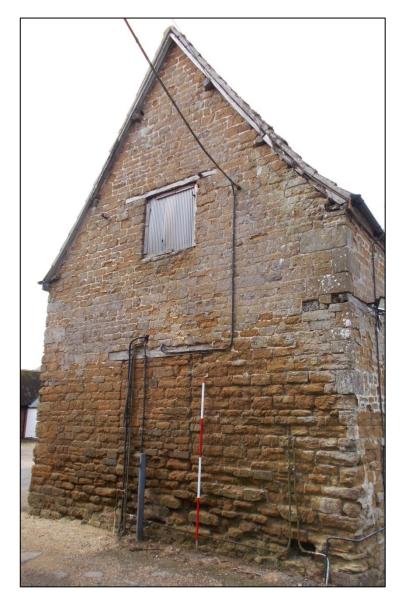
Fig 7: The east gable inserted when the service range was separated from the farmhouse, looking south-west; 2m scale. Secondary infilled door and hayloft door.

There is a now infilled doorway in the re-built east gable wall which would have given access at ground level (Fig 7). Directly above it is a window which appears was intended as a hayloft door fitted with what appears to be sheet plastic. Both are set beneath oak lintels.

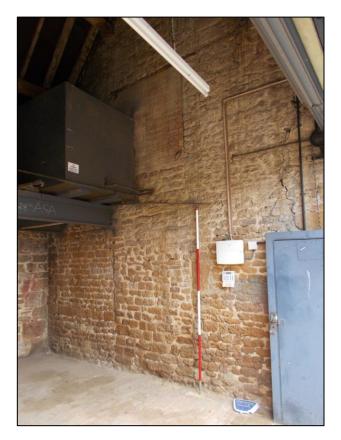
Within the west gable are two openings which may relate to the original configuration, one each at ground and first floor level (Figs 4 and 8).

Fig 8: The west gable of the 17th century service range, looking north-east; 2m scale.

The lower opening, formerly a doorway, retains only the outline only in the change of stonework and a few quoins, situated only on the south side; the lintel does not remain. The first floor opening is infilled with red brick and is of the same width. It does retain its lintel which is of wood, presumably oak, although neither the bricks nor the lintel could be closely examined due to their height above the ground surface.

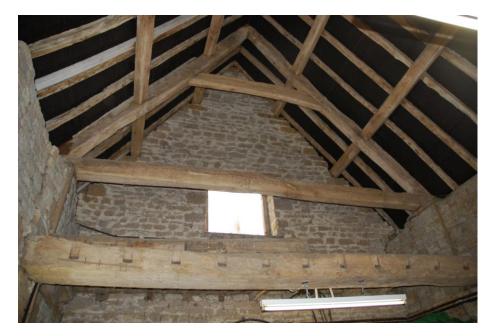
The roof is a finely constructed oak structure with details and elements which indicate its original status as a building joined to the farmhouse and is embellished with a much higher level of craftsmanship than is usually seen in barns (Fig 9).

Fig 9: The 17th century service range roof, looking east towards the later east gable wall.

There are two principal trusses at present, their disposition further indicating that the range extended to the east since the eastern of the two is unnecessarily close to the re-built east gable wall (Figs 4 and 9). However, it is the quality of the finish on all of the timbers that is unusual. Both of the principal truss tie beams are chamfered on their lower edges and all chamfers ends in step and run-out stops (Alcock and Hall 1994, 36.g). This type of stop is usually only seen in domestic interiors and the example quoted above dates from 1577, though being one of the most simple designs it has a long lifespan and its use here is not unusual for the mid-seventeenth century. In addition to this, the undersides of all the visible purlins (two rows to each side), principal *and* secondary rafters as well as the collars have chamfered lower edges. This high degree of finish is unusual in a domestic roof unless they could be seen close up but is even more rare in a barn. It is worth noting that the Listing description notes the 'chamfered beams' and 'collar truss roof' when describing the farmhouse. That the same form of construction is present here confirms the fact that the present barn and the farmhouse were built at the same time and using the same methods. The roof has been relatively recently re-covered since the present tiles are twentieth-century concrete tiles laid over an impermeable membrane.

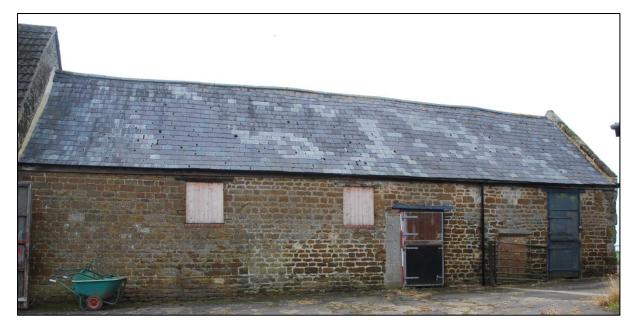
The barn is constructed of the same Northampton ironstone used in the remainder of the complex (Fig 10).

Fig 10: The north elevation of the 2nd phase barn, looking south; 2m scale.

The north elevation retains two window openings which appear to be original in size but reconfigured; they both have bullnose brick sills which suggest remodelling during the latter half of the nineteenth-century. They both have timber, probably oak, lintels. Each is currently boarded over and no indications remains as to the earlier fittings. The only other opening in this elevation is a narrow ventilation slit located towards the west gable, now infilled only on the outer surface so that the deeply splayed internal jambs remain visible (Fig 4). A second slit partially remains on the east edge of the doorway inserted slightly further west, but in this case only part of the east side of the splay survives.

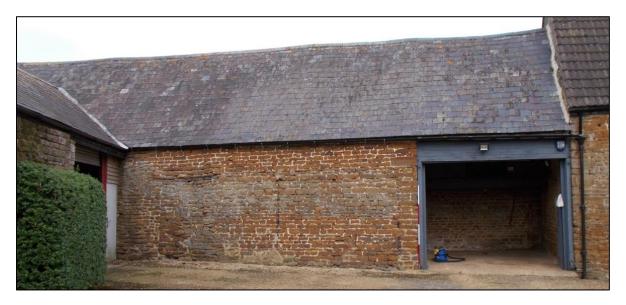
Fig 11: The south elevation of the 2nd phase barn, looking north; 2m scale.

The south elevation is only partially visible in its entirety since the west (hovel) range was built against its west end (Figs 4 and 11). The eastern bay of the barn comprises a full-width and full height door opening (Figs 4 and 12). The opening appears to be part of the original layout and was at that stage simply a cart opening either for storage or for loading and unloading. At a later date, most likely during the early years of the nineteenth century, this bay was separated from the remainder of the barn by the insertion of an interior brick wall.

To the west of this opening a pedestrian doorway has been infilled though its outline can be discerned (Figs 4 and 11). The oak lintel survives.

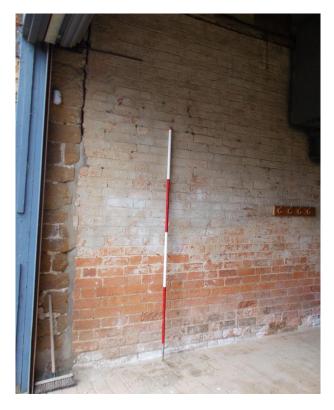
Fig 12: The 2nd phase barn with inserted brick wall at the east end, looking north-west; 2m scale.

The brick wall when inserted was not keyed into either the north or south stone walls but simply butted against both. The wall is of standard 9-inch construction using Flemish garden-wall bond, where three stretchers are used between each header in each course (Brunskill 1990). The wall rises only to the height of the eaves above which one of the roof trusses is located. The truss is of simple tie beam construction with raking queen struts (Cordingley 1961). Presumably when the brick wall was inserted the truss was also infilled with further timber struts, covered with split laths and plastered. At the same time a brick floor was laid to provide a smooth and easily cleaned surface (Fig 12). This separation and laying of the new floor suggests a change of use from cart storage or loading to a separate, enclosed, coach house. It is probable that the double doors were added at this time. A timber frame was inserted (probably pine) and double doors hung, only one of which now survives.

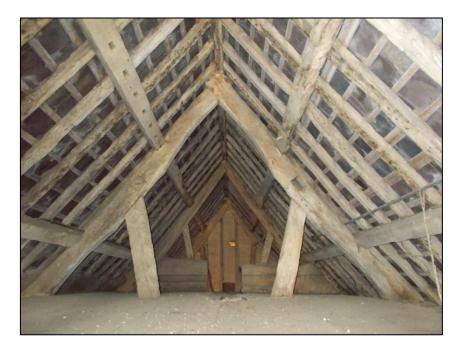
The roof comprises three tie-beam trusses of the same configuration as previously described (Fig 13).

Fig 13: The roof of the 2nd phase barn, looking east. Note the lath and plaster infill within the far truss above the brick wall which forms the west side of the coach-house.

Many of the roof timbers, both rafters and purlins, have been re-used and retain empty sockets, peg holes and nails. They are all of oak. The present loft floor appears to be of pine but was not closely investigated since its structural integrity was not certain.

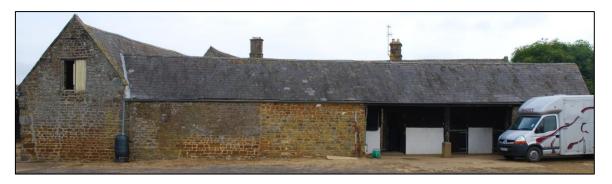
This single storey range closes the west side of the courtyard which lies to the west of the farmhouse (Fig 4). It is set an acute angle to the western of the two barns which make up the north range though the reason for this angle is unclear. The only section of walling which abuts the north range barn is built with a simple butt joint with no attempt at keying. From the west the elevation presents a long, low facade of plain wall although only the two ends relate to the first phase of building (Figs 4 and 14).

Fig 14: The west range, looking east; 2m scale.

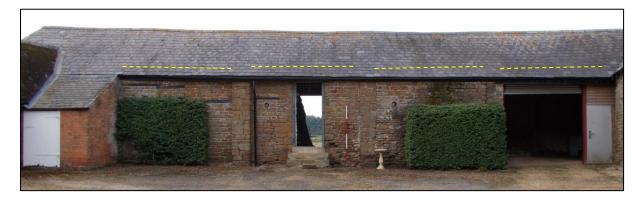
Fig 15: The east elevation of the west range, looking west, infilled bays marked; 2m scale.

Each of the piers is square in section and constructed of well-dressed blocks of ironstone bonded in lime mortar. Currently only the northern bay remains open although this has a modern garage door and subsidiary pedestrian door fitted into it (Fig 15, right side). The remaining three bays have been subsequently infilled with ironstone laid neatly in courses of varying thickness. The central bay currently has a doorway leading into the range with, to the south, a small blocked window. In the southern infilled bay there is evidence of two further blocked openings partially visible behind the current panel of hedging (Fig 15, left side) where lintels are visible.

It is probable that when the east side was infilled at the same time the west side was opened up so that the central three bays were opened, facing the fields beyond. When this was done the internal floor must have been raised, since the ground level to the west is higher than that within the courtyard, on which side three steps give access to the current interior (Fig 15).

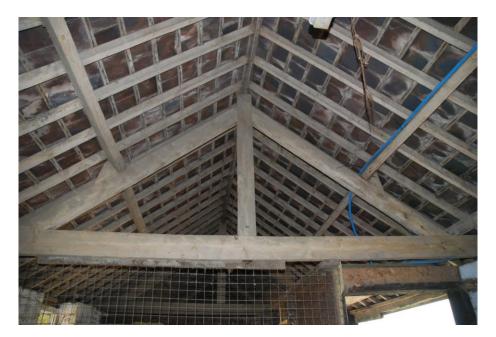
The current roof has a shallow pitch and is covered with blue slate; it is not the original roof as none of the trusses sit directly on top of each of the piers along the east side of the building (Fig 4). At best they lie close to the edge of the pier, but in the other cases sit on top of the later infill. The trusses are of typical mid nineteenth-century construction, all made of machine-sawn pine (Fig 16).

Fig 16: The roof trusses of the west range, looking south.

Each truss comprises a tie beam, king-post and integral principal rafter. There is a vertical iron bolt fixing the king-post to the tie beam in each. On each principal rafter are cleats which support a single purlin on either side; these in turn support the secondary rafters which support the laths onto which the slates are fixed. There is a thin ridge-plank. This simple type of roof truss is illustrated in pattern books for such buildings during the third quarter of the nineteenth-century (Newlands 1880).
