Level 2 archaeological buildings recording
at 15 Kings Lane, Little Harrowden, Northamptonshire

## Level 2 archaeological buildings recording

## at 15 Kings Lane, Little Harrowden, Northamptonshire

### Iain Soden BA MCIfA

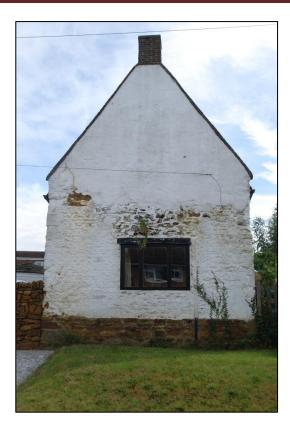
Fig 4: West-facing roadside gable-end.

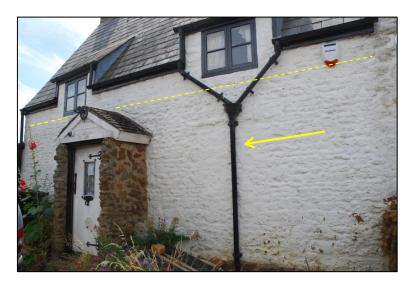
The Lincolnshire dormers are part of a move to insert a first floor where previously there was none. This can be seen in the numerous courses of different stonework added to the top of the long-axis walls.

Fig 5: The north-east facing long axis. Note the blocked window beneath a timber lintel. A dashed line shows where the roof has been raised to create the first floor.

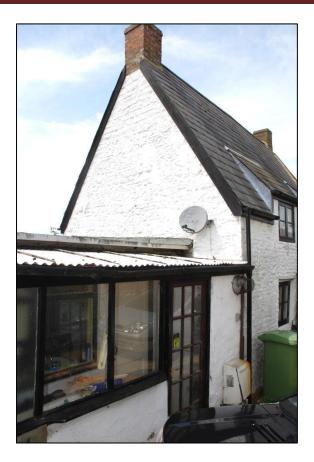
Fig 6: The southern gable and modern extension (G3 just visible) through outshut (G4)

To the south-eastern end has been added a sequence of modern extensions, all single-storey. The first was of Fletton-type brick, under a flat asphalt roof and appears to have been added during the second half of the 20<sup>th</sup> century, followed by an out-shut and a UPVC conservatory on a dwarf brick wall. Scars on the edge of the exposed gable above suggest that there may once have stood another building here, with a pitched roof of a height similar to the current core building. This is also suggested by the 1886 Ordnance Survey depiction (above).

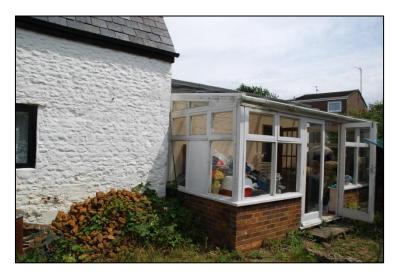
Fig 7: The south-western side and modern conservatory (G5)

G4 is a simple out-shut or lean-to, built of various materials but which looks a very temporary structure indeed. G5 is a brick-mounted UPVC conservatory of likely 1980s or 1990s vintage. None of G3, G4 or G5 have either historic value or architectural merit.

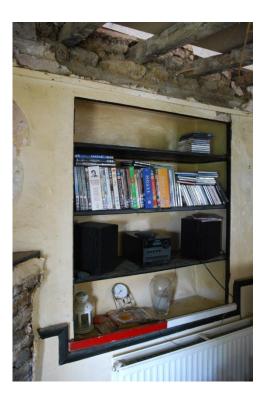
The ground floor interior is lit by windows in both long axes and one in the road-side gable, all timber casements, while a fourth window has been blocked up which faced the entranceway adjacent to the porch. On the interior this is now a recess containing shelves.

Fig 8: Blocked north-facing window in G2 – shelves on the inside; Scale 1m

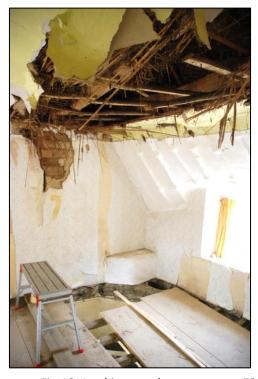
Above the bedrooms a ceiling had been inserted which was made of reed-plaster. It was subsequently under-drawn with modern plaster-board. The whole thing had sagged and massively collapsed in F2, exposing more of the former thatch-remnants and a glimpse of the common rafters which, as the bedroom-render suggests, are all waney-edged branches, almost straight off the tree.

Fig 12: Looking north-west across F2.
