Iain Soden Heritage Services Ltd

Archaeological survey and recording before and during conservation of basement rooms at Kelmarsh Hall, with observation and recording on outbuildings

Joe Prentice and Iain Soden

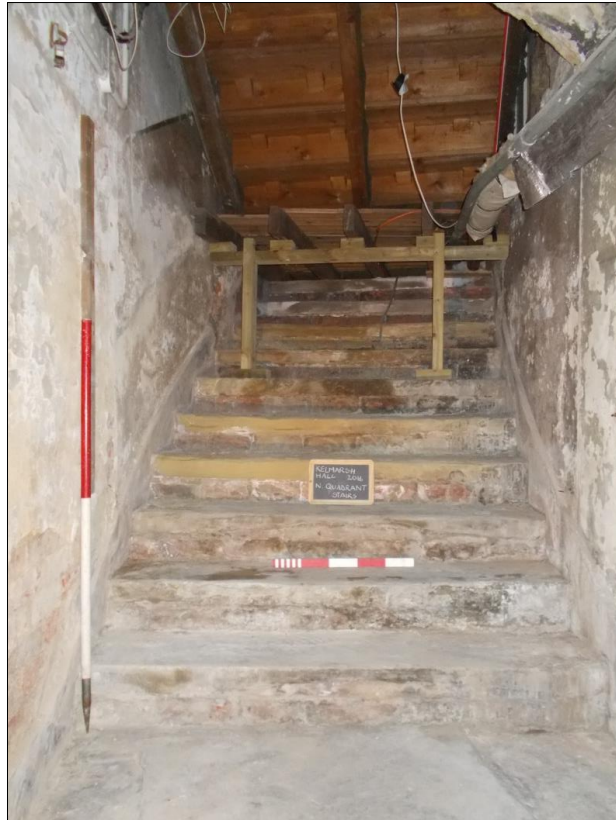
The flight of stone and brick steps which led up from the basement to the quadrant corridor comprised ten treads including that level with the corridor floor. Each tread was made from York stone and some were slightly wedge-shaped in plan to accommodate the curve of the quadrant into which it had been inserted. The floor at the base of the flight was also of York stone flags almost as far as the doorway through the north wall of the basement (Fig 5); west of that point it was of modern concrete.

Fig 6: The stone and timber steps in the north quadrant, looking north; 1m and 50cm scales.

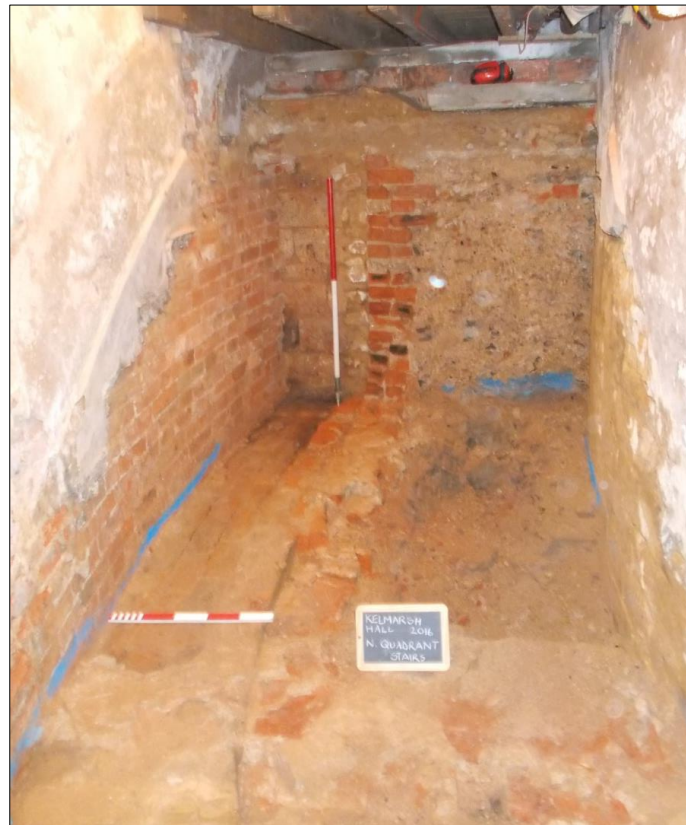
The earlier sequence of structures had been partially removed by the insertion of the existing flight of steps which appear to have been inserted during the nineteenth century. Beneath them an almost central curving spine wall remained in a truncated condition which shows that formerly the space had been at least partly accessible and on the north-west side of that spine wall a brick floor remained *in situ* (Figs 5, 6 and 7).

Fig 7: The former curving spine wall and brick floor, looking north. 1m and 50cm scales. NB: The bright blue colour is modern marker-paint

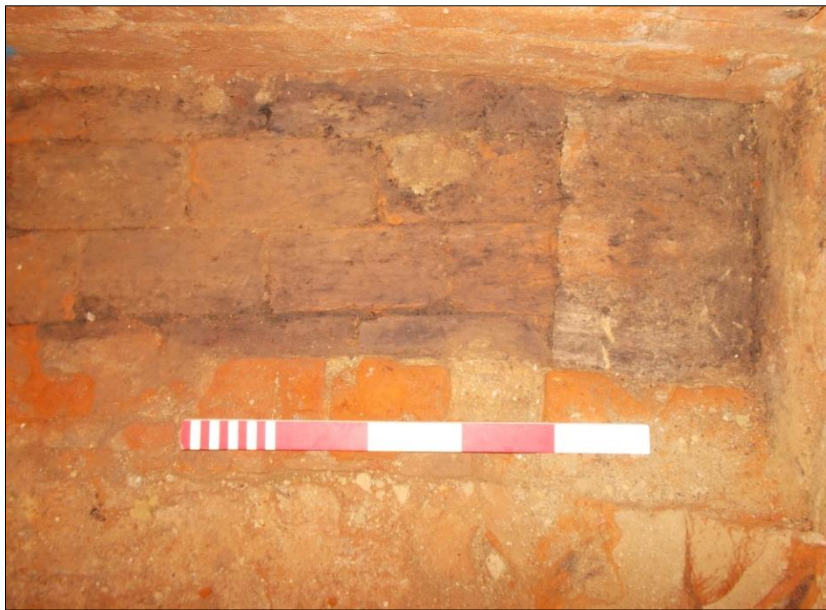
One possible use for this earlier configuration may have been a previous coal store or access point. The reason for this supposition is the presence of coal dust with the interstices between the bricks of the floor (Fig 8).

Fig 8: Coal dust between the joints and on the surface of the bricks laid in the floor of the earlier basement level corridor. North to the right, 50 cm scale.

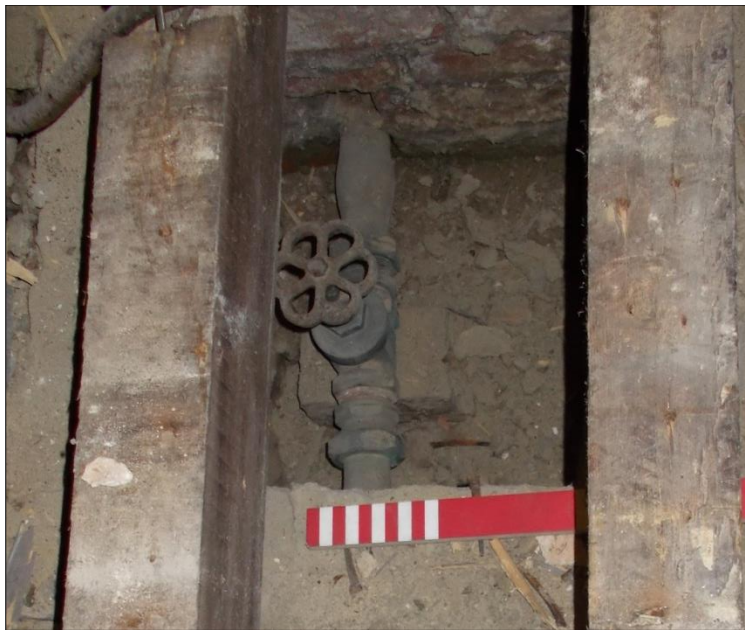
Fig 12: The water pipe and tap beneath the timber floor of Room B7. Scale with 1cm divisions.

Within the small inspection chamber a short section of the pipe was visible and fitted to it was a brass tap, presumably for regulating the supply. It seems most likely that the water supply came from the water tank known to be located beneath the lawn on the east entrance front of the house which stores rainwater from the roof. To the immediate west of this room, on the east side of B9, a water pump is known to have been located, though it is now missing. The most likely scenario is that the pipe supplied water to that pump.

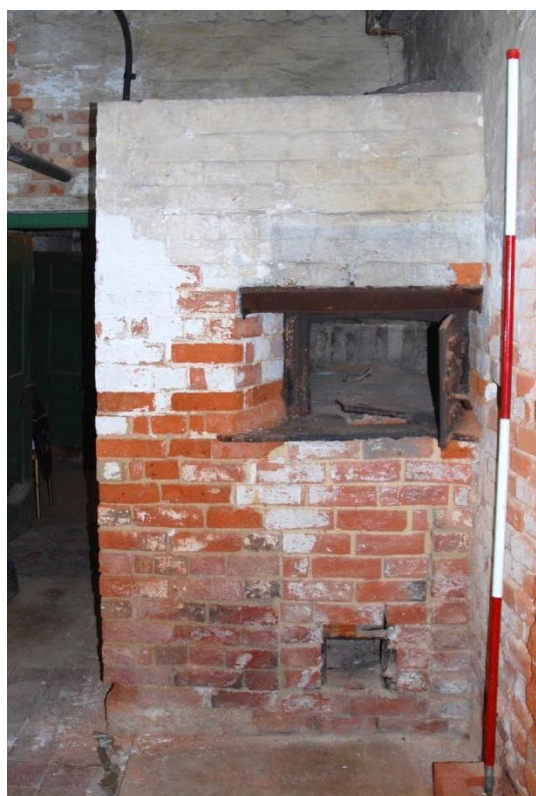
Fig 17: The secondary bread oven which dominates room B8 and which when first built, lay fully within a conjoined B7 and B8; Scale 2m. In 2016 the authors recorded the remains of an identically-sized square oven like this in Buckinghamshire dated c1842.

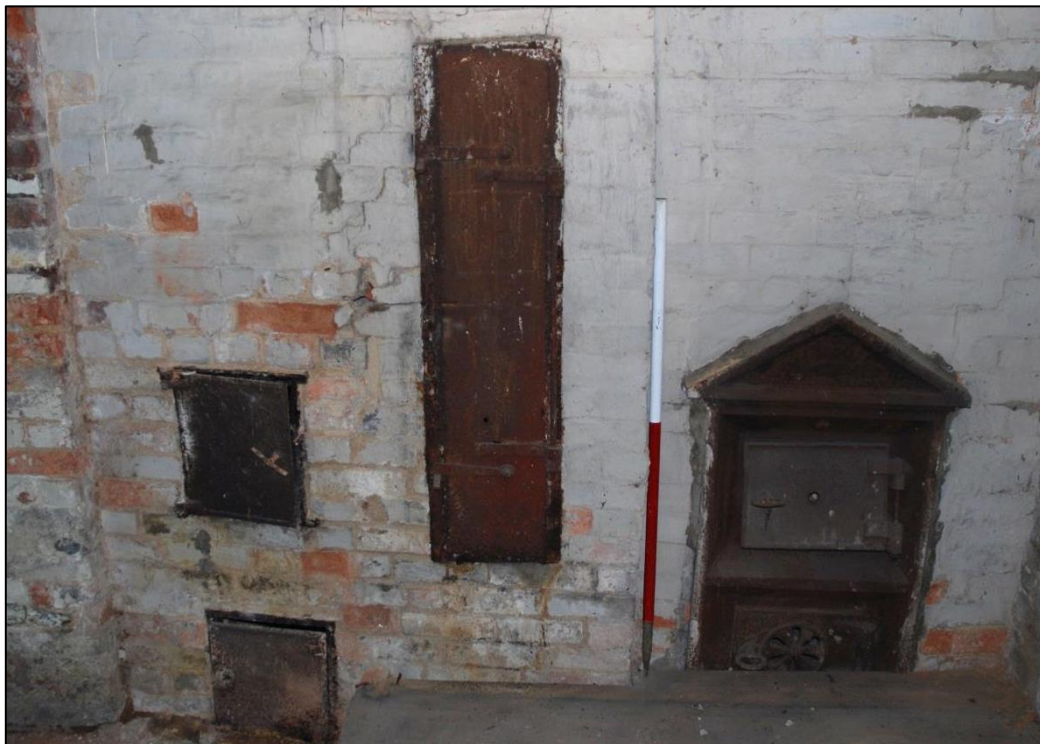
Removal of the boarding and the raised timber floor exposed a series of cast iron flue boxes and air regulation vents which relate to a previously unknown warm air heating mechanism. This system appears to have been heated by a boiler. More exists in the rear of this wall adjacent to the dumb waiter.

Fig 18: The hot-air firebox and flue boxes in the so-called 'Brush Room' (B17). The iron pediment on the firebox on the right is cast with the name in relief 'G & F Haden, Trowbridge', a 19th-century supplier of heating to country houses and large institutions. Scale 1m.

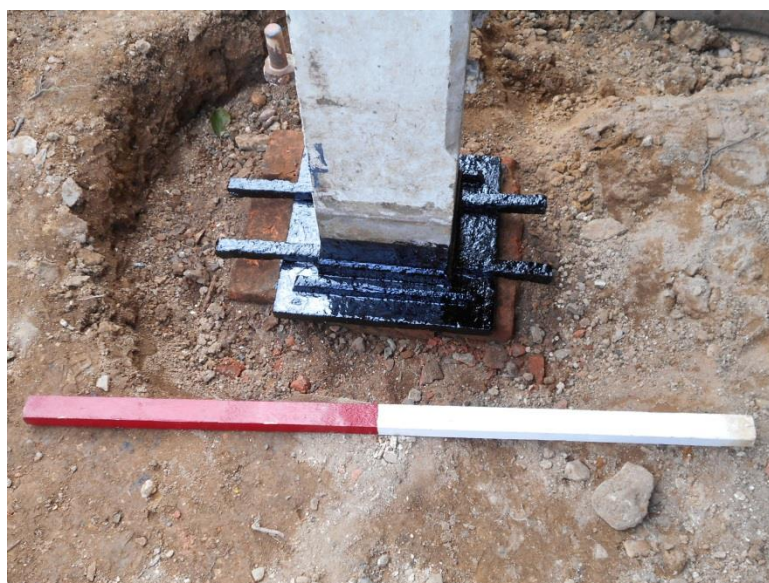
The majority of the long range had most recently been converted to a garage, and the front wall-plate was supported on a row of cast-iron columns of square section. These had been slotted in under the existing roof and fixed by means of opposed wedges (tipping the whole roof structure slightly backwards and out of true) and were seated on inserted brick piers under their base.

Fig 20: Cast iron pier/door-post on inserted brick base. Scale 1m

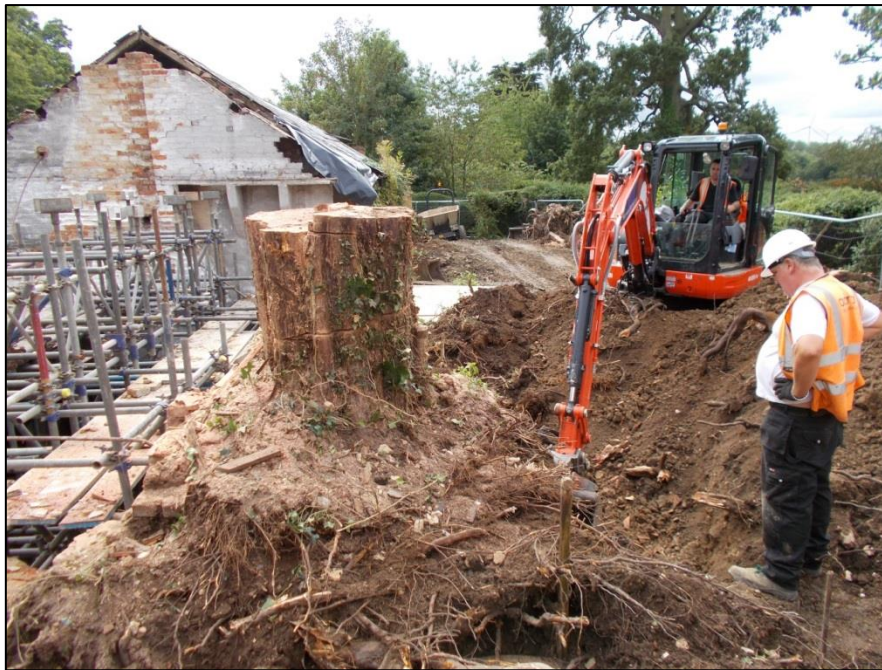
The weak joints between walls did however leave the structure unduly prone to the heave produced by two mature pine trees which were mechanically dug out as part of the dismantling of the ironing room and adjacent buildings. Both trees had compromised the brickwork of the building, not least because they were growing within what had become a thickened embankment of earth against the north and west sides of the building.

Fig 21: Digging out one of the pine tree stumps from against the still-scaffolded ironing room. Note the steam collector high on the gable behind.

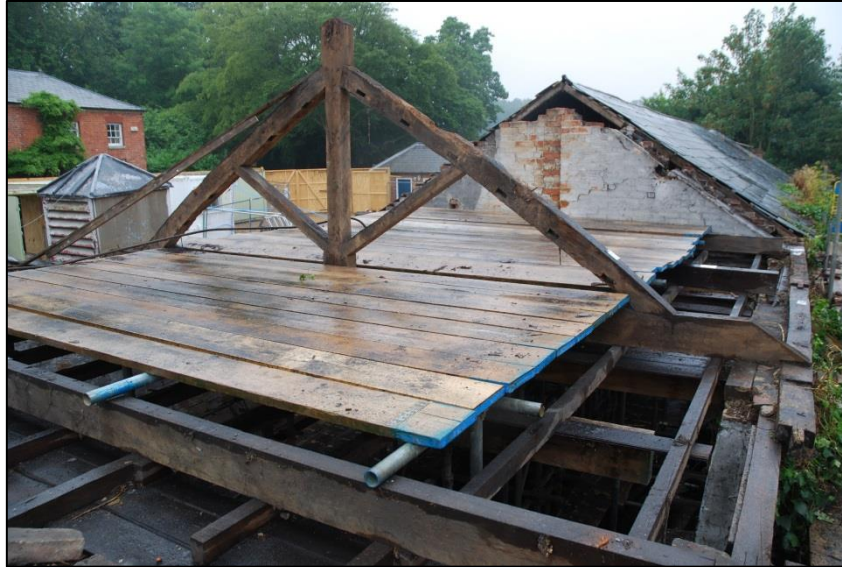
Fig 22: The roof of the ironing room, stripped down to its principal truss. Note at far right the sections of wall-plate falling away from the wall-line. Also the ceiling-frame inside the wall-lines.

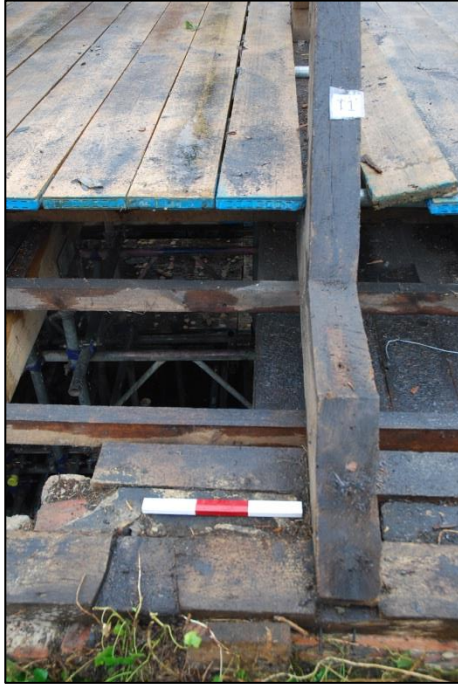
Fig 23: The two wall-plates. Outer one for the roof, inner one to fix the ceiling frame. Between them the brick of the wall top with the scale resting on it. This view shows a mistakenly-cut lap-dovetail adjacent to that actually used to grip the tie-beam of the truss. Scale 30cm

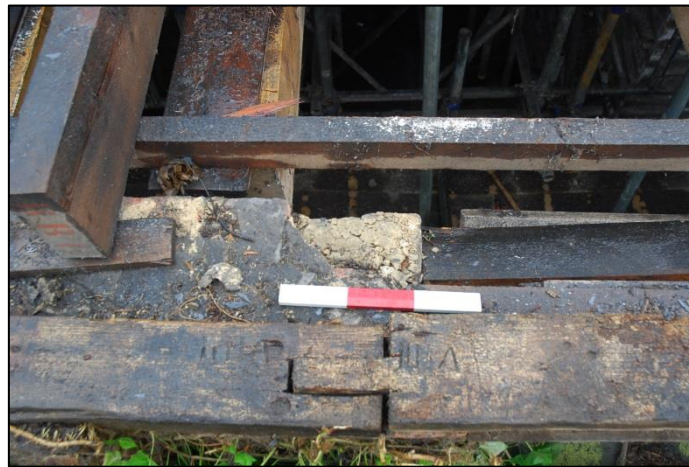
The truss and rafters rested on wall plates made of short lengths of oak joined in pre-cut sections by simple, if awkwardly-executed, scarf-joints, some (but not all) marked with simple chisel-cut carpenter's marks in Roman numerals.

Fig 24: Scarfed sections of wall-plate with carpenter's marks (VIII); scale 30cm

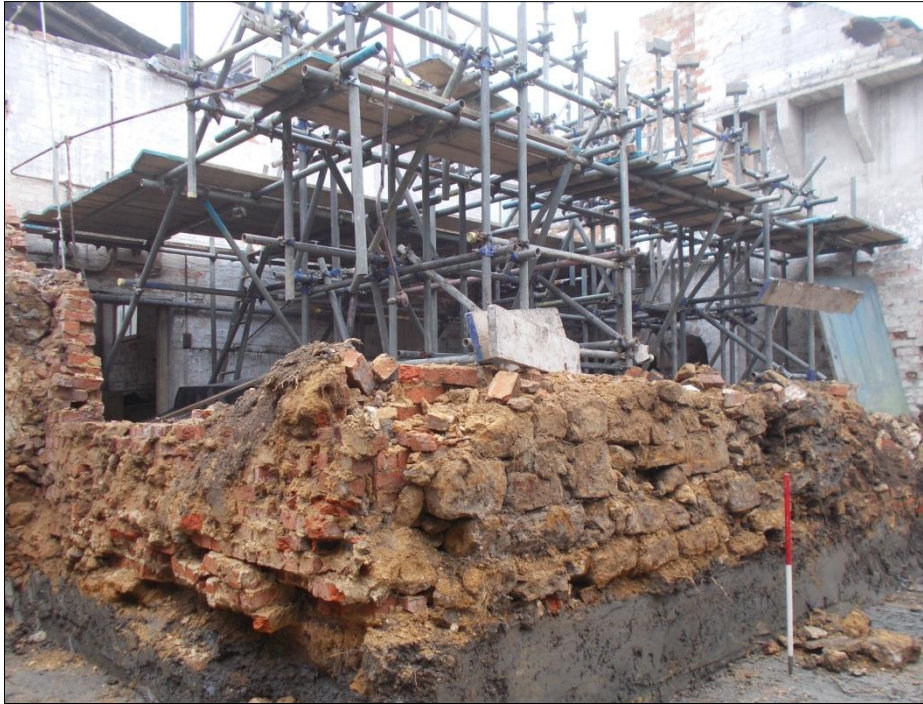
The walls of the ironing room comprised red brick bonded in lime mortar. Due to the largely basemented nature of the space, the walls as retainers were one half brick thicker than the standard 9-inch wall; however, the bonding between the stretchers and headers was erratic which might in part explain the failure of the two external elements. As with the plethora of butt-joints within the building, quite why such relatively poor brick laying was undertaken is not clear. Below ground level the internal wall surface of the room was of brick, the face against the surrounding soil was of rough ironstone blocks bonded only with clay.

Fig 26: The below-ground stone and brick north and west walls of the ironing room reduced, looking south-east. Note the high-level steam-collector (top right). 1m scale.

There were no 'foundations' as such and both the brick and stone retaining walls ceased level with the internal floor surface of the ironing room. The brick and stone walls were laid directly onto the natural blue lias clay and the whole appears to have been trench built, i.e. a large hole was dug slightly larger than the final dimension of the required room size and the walls then lined the sides of that hole from the inside. There was no evidence for the creation of construction trenches to finish off the outside faces.

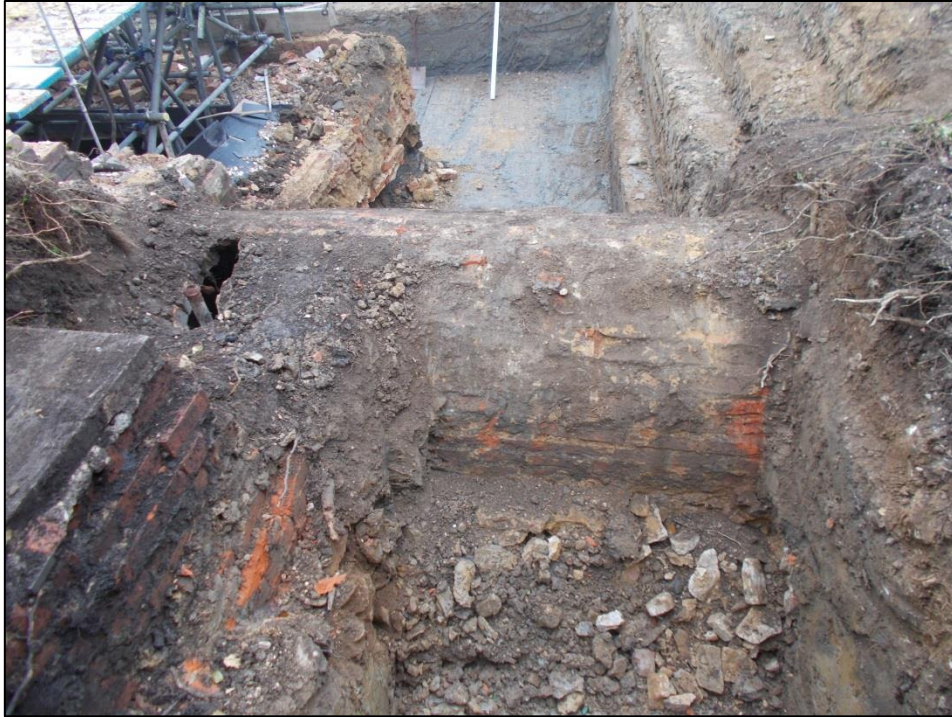
Where the tunnel connects with the north wall of the ironing room the integrity of the structure had been affected by the movement in the north wall of the room which had caused weakness within the tunnel itself. The side walls were built of dressed and undressed ironstone and limestone and the vault made of a simple semi-circular or barrel vault constructed from a single brick laid on edge and bonded in lime mortar. Though the tunnel is not deeply buried beneath the ground, the use of a single un-weatherproofed brick skin for the vault is perhaps flimsy but perhaps reflects the amount of money prepared to be spent on the staff.

Fig 30: The tunnel vault during uncovering. Note the left-hand end breached. To left front is a later drain with inspection chamber.

When the southern end of the tunnel was rebuilt where it connects with the north wall of the ironing room it was observed that it had been trench built with the construction trench being slightly wider than the finished brick and stonework.

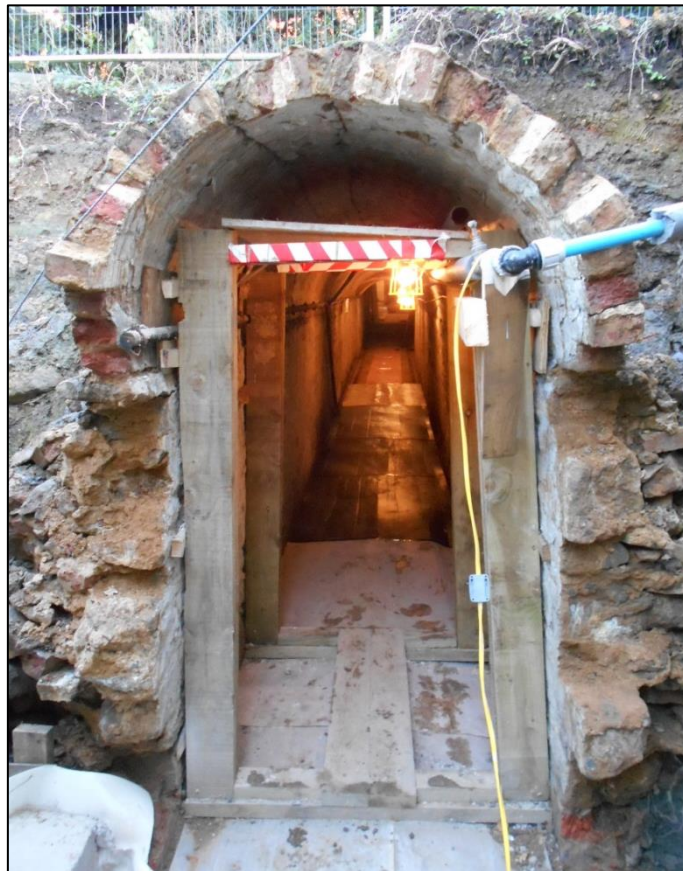
Fig 31: The tunnel, during conservation at its broken end. Note its shallow burial at its apex.

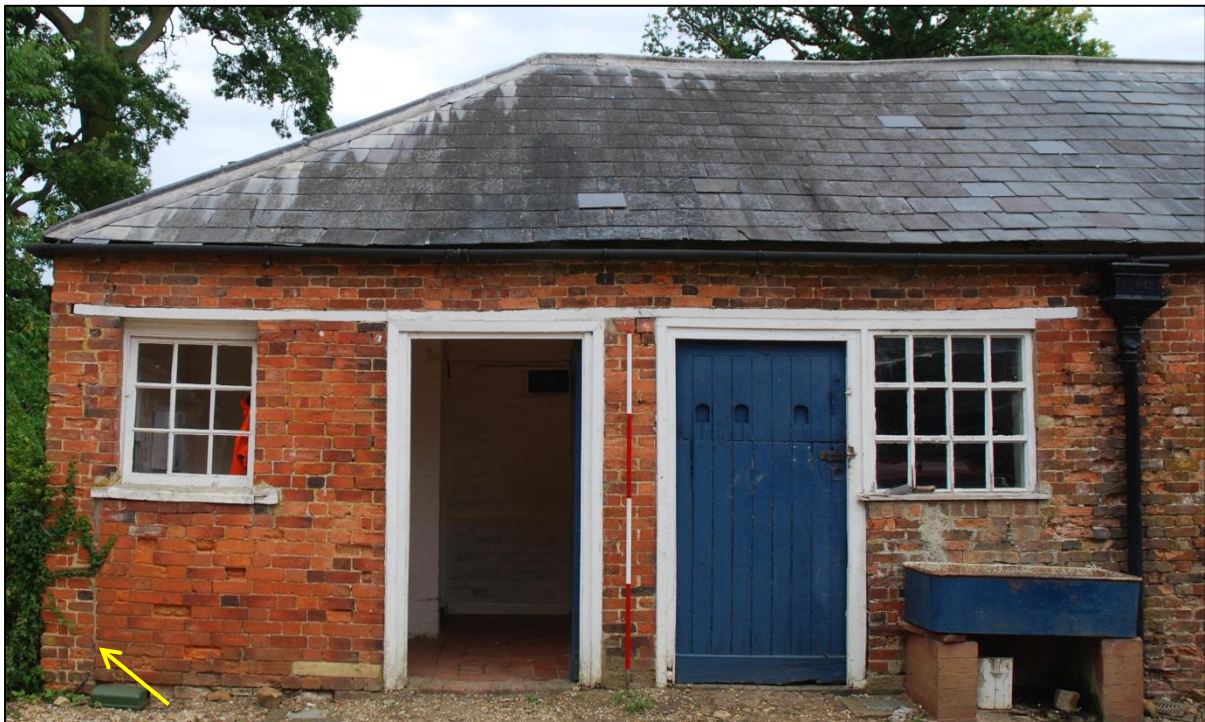
Fig 32: WC to left, stable to right. Note the continuous (flimsy) wall-plate and the butt joint (arrowed) showing how the front of the WC wall is an insert to block a previously open front; scale 2m

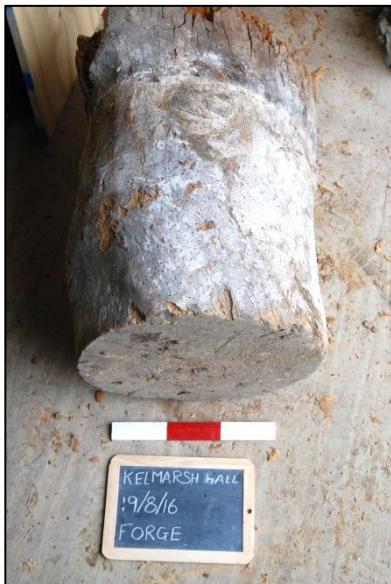
Firstly it must be noted that a forge was not the original, intended use of the room, since the base for the anvil, a huge waney-edged tree trunk log of (probably) elm, was set into a 300mm-deep pit dug through the existing blue-brick floor. Excessively rotted, it was not retained.

Fig 36: The anvil base removed; scale 30cm

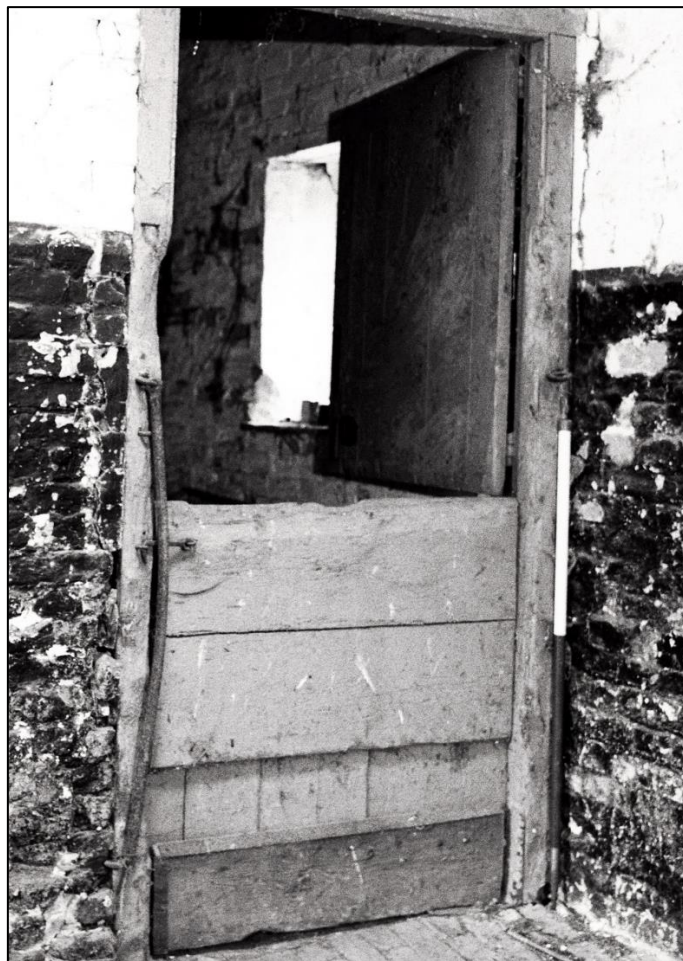
Between the stable and the forge it served was a proper two-piece stable door, kicked, chewed and battered by both horses and (not chewed perhaps) the Blacksmith. It was much repaired. A curved iron bar which could be stretched across the open top half would prevent a horse putting its nose through too far. As a measure against well-aimed kicks at the door-jambs, these uprights had been fixed to the brick floor with iron straps.

Fig 38: The stable door between stable and forge. Note the hinged iron bar to left, iron strap at lower right, and the excessively chewed exposed edges of the timber; scale 1m

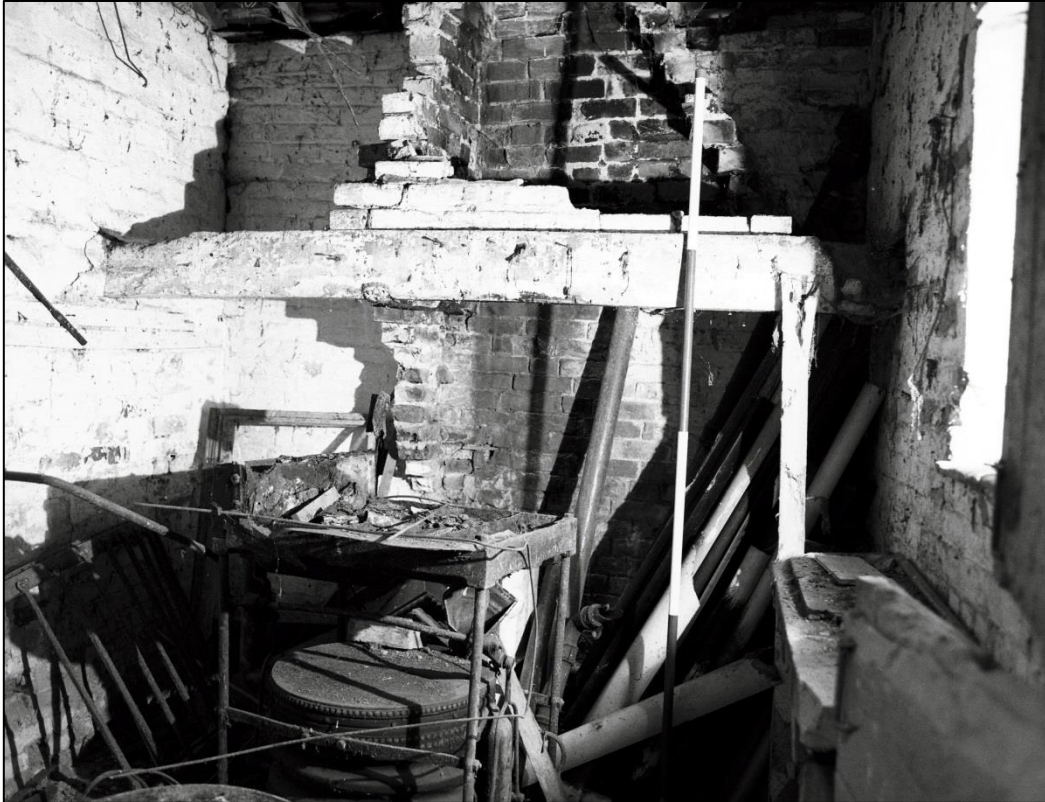
Fig 39: View through the stable door into the clutter of the abandoned forge. To the rear is the part-collapsed brick smoke-canopy and timber bressumer beam; scale 2m.

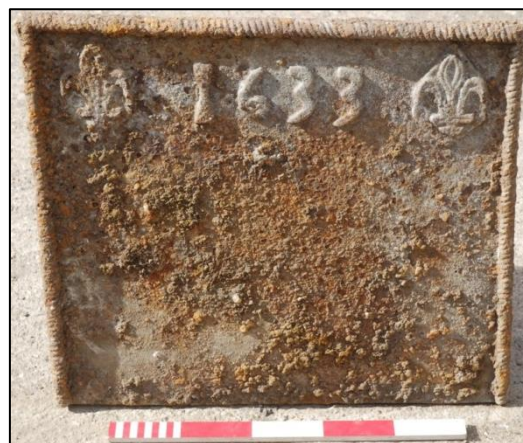
A cast-iron fireback was retrieved by the contractors when clearing scrub to the west of the coach house. It is badly corroded but cast in relief, it bears the date 1633 between two crudely moulded fleurs-de-lys (Fig 43). The sides and top are finished with a raised moulded rope-twist border and the remainder of the casting is blank. Such firebacks were widely used to protect the stone-, or more often, brick-work in the rear of fireplaces and do exist from the sixteenth century. However, they are and were much-copied. It may therefore be original or a later copy. If it is an original it might have come from the original hall although it could have been bought in at a later date; there is another, similar, example within the Chinese Room which bears the initials and Coat of Arms for Elizabeth I which if original, must be of an even earlier date. The provenance of that is also uncertain.

Fig 43: The cast iron fireback; scale 50cm
