**Archaeological building recording of former
farm buildings at Dovehouse Barns, formerly part of
Stanwick Hall Farm, Stanwick, Northamptonshire**

Joe Prentice

Stanwick Hall Farm Barns 2017

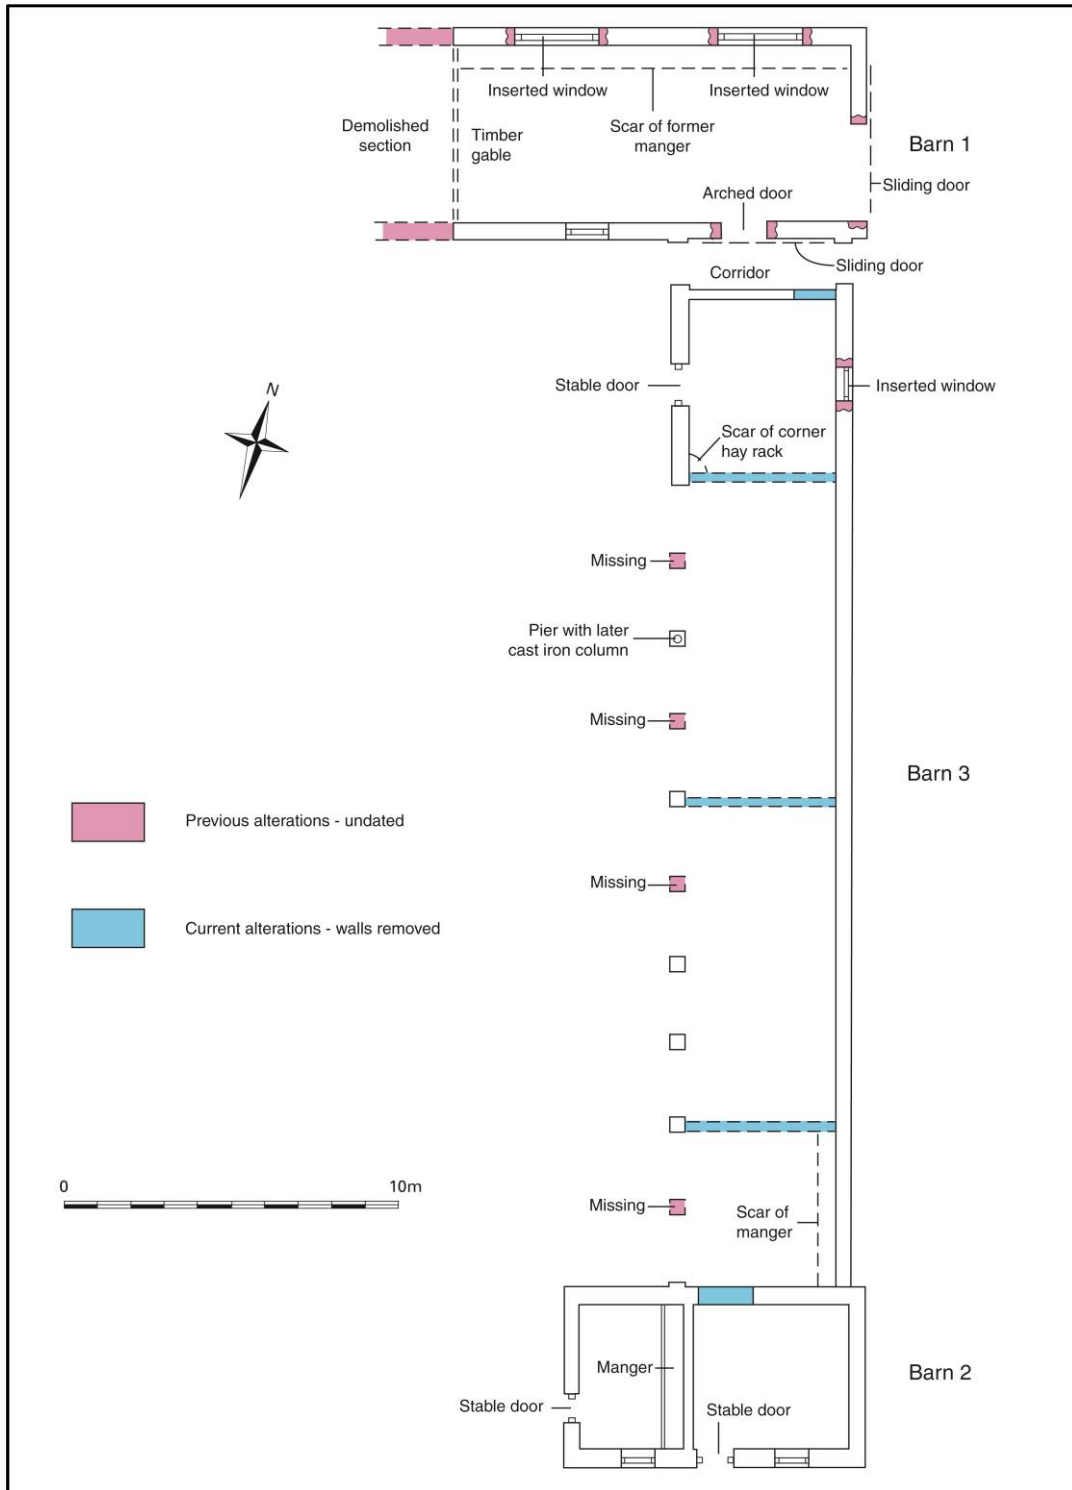
Fig 3: Plan of the (eastern arm) buildings under consideration (Andy Isham).

Towards the northern end of the range one brick pier had been replaced by a cast iron column although the brick plinth remained (Fig 3).

No internal features survived in any of the formerly separate sections but a faint scar against the east wall of the southern portion indicates that there had been a manger against the wall in that location (Fig 3).

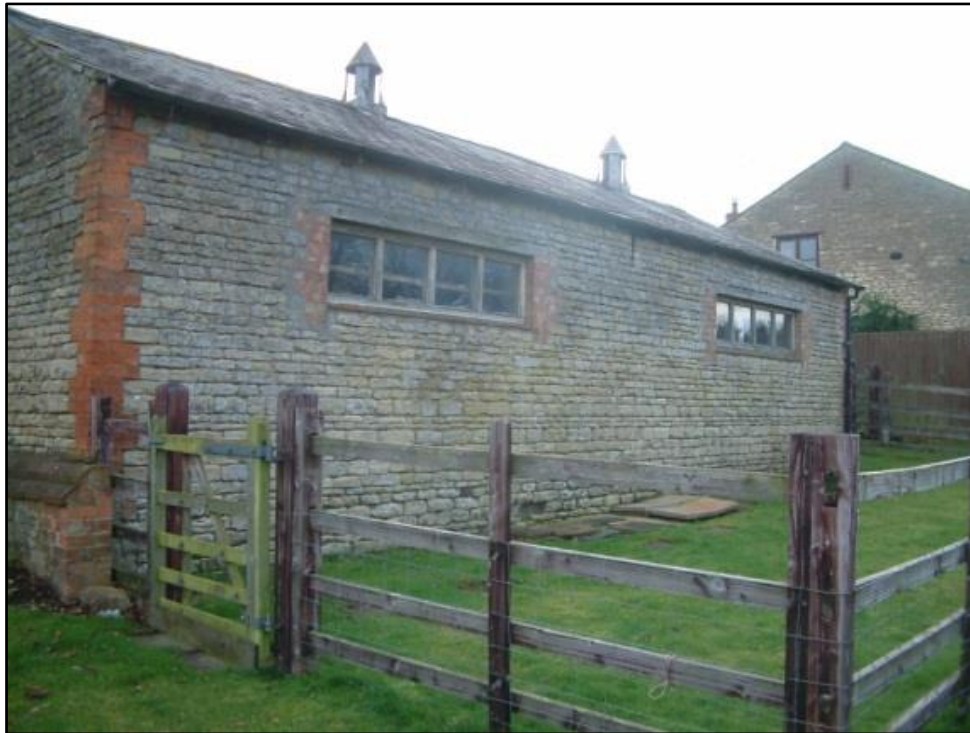
Located at the north-east corner of the complex this currently single space is a truncated surviving section of the original north range (Fig 3). The walls, both internally and externally, are constructed of coursed roughly dressed limestone with brick dressings around window and door openings and at the corners where they have been laid to give the appearance of quoins (Fig 4).

Fig 4: The north elevation of Barn 1 showing brick quoin dressings at corner and inserted window openings, looking south-west.

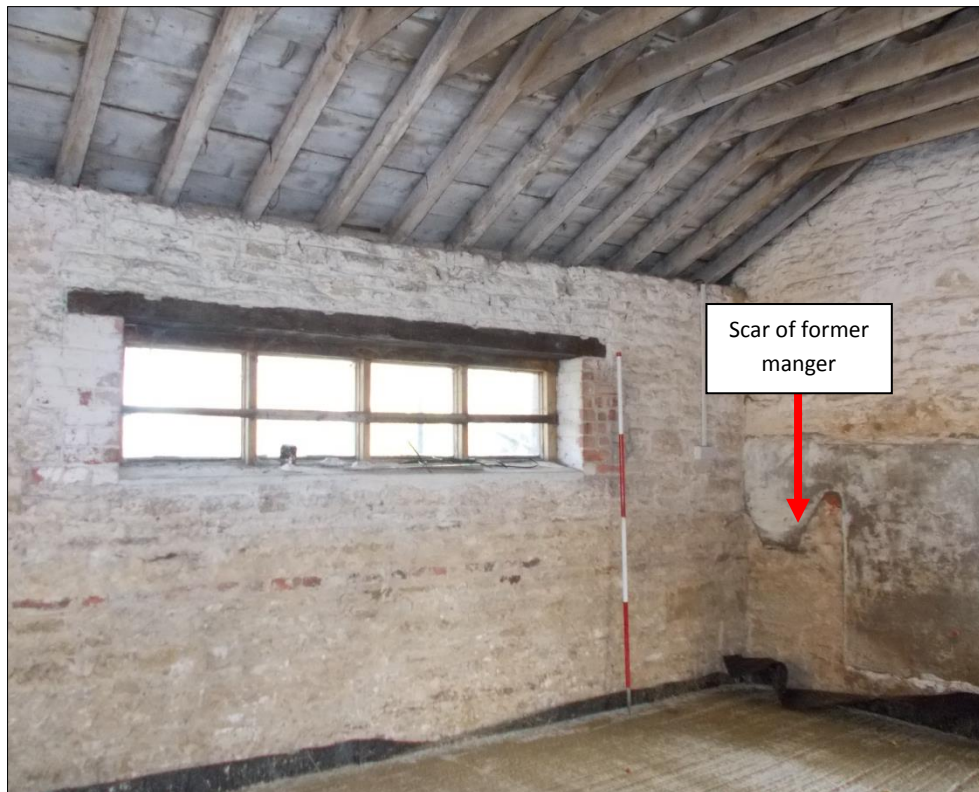
Fig 5: Barn 1, the inserted east window of the north wall, looking north-east. 2m scale.

The window openings are both of the same shape and size and each has dressings at either side of red brick, but of modern hard brick similar to Flettons rather than the soft deep orange brick used originally. Internally the whole interior wall surface was limewashed, apart from a lower level skirting formed from modern cement render (Fig 5). Externally each has a sloping sill made from red clay tiles and internally a cement sill. The frames to each are of pine painted white, divided into eight, each with fixed panes.

Beneath was formerly located a manger positioned against the north wall, only the scar of the profile of which can now be seen against the east wall (see Figs 3 and 5).

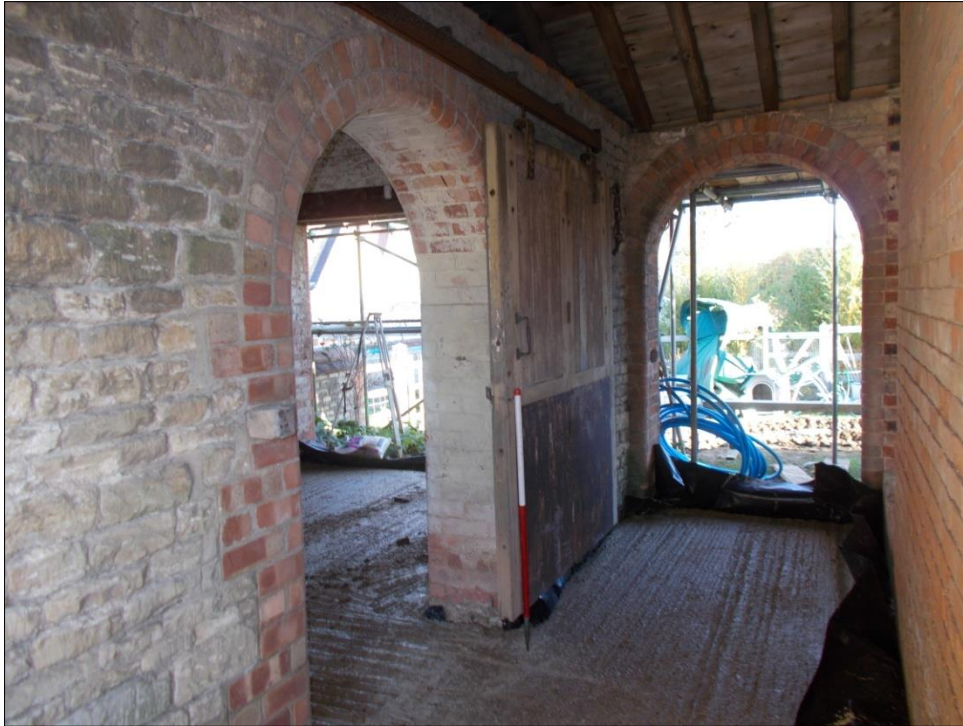
Fig 6: The sliding door closing the arched door from Barn 1 (left) into the corridor (right), looking north-east; 1m scale.

The archway, although constructed in a similar method to those which form the openings at either end of the corridor into which it leads, is constructed of different brick to that used in the original elements of the building. The original brick is of a rougher texture and a more consistent colour whereas the bricks used here contain pale pink bands, similar to Flettons (see Fig 6, left jamb). The sliding door on the south side within the adjacent corridor is hung from an iron rail but has been made from two smaller hinged doors fixed open to create one wider door. The lower half on the south side has had a metal plate fixed to it.

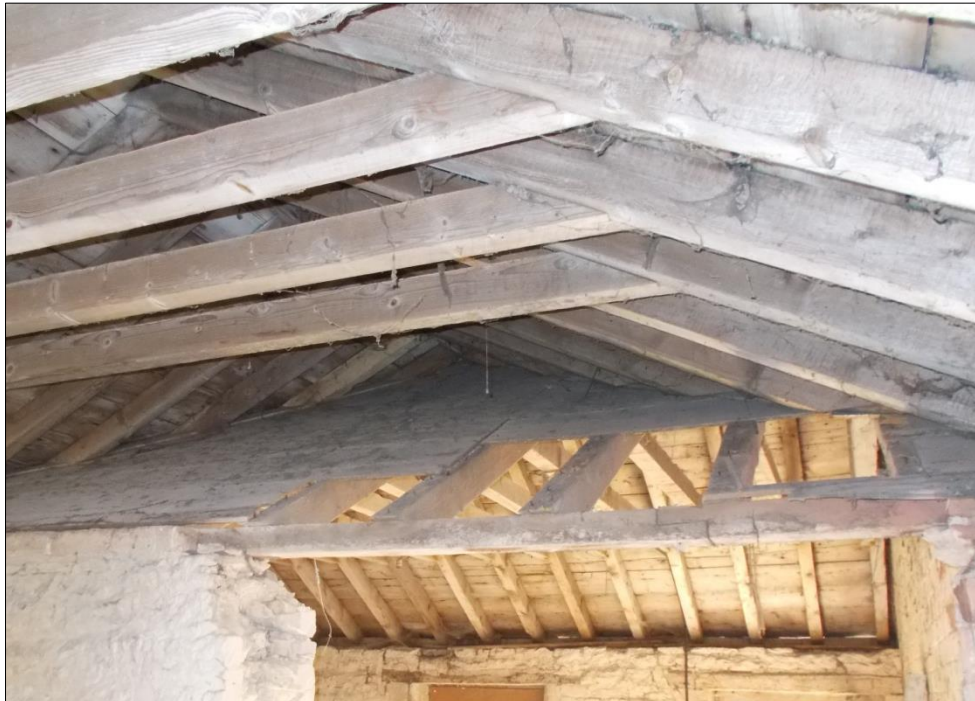
The southern barn group is also aligned east-west and terminates the barn group at the south-eastern corner of the complex (see Figs 2 and 3). Where this short east-west range is linked to the long north-south range the roof of Barn 2 underlies that of Barn 3. This is most evident in the surviving section of sarking boards which remain above the rafters on the north slope of the roof (Fig 7).

Fig 7: The north roof slope of Barn 2 covered with sarking boards, beneath the roof of Barn 3, looking south.

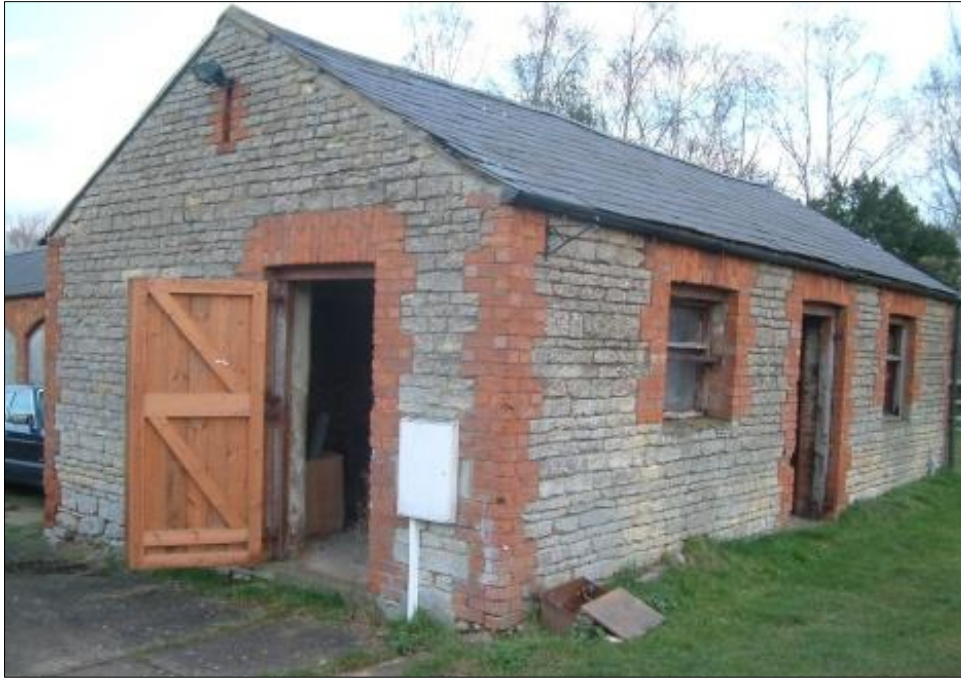
Fig 8: Barn 2, looking north-east.

The south elevation has a central doorway flanked by two windows, one to each side. All openings are set beneath almost-flat segmental arches, more akin to gauged brick lintels, made from red brick which is used to form the dressings to the door jambs and quoins. High in the east and west gable walls are simple vertical slot air vents, also dressed with brick (see Figs 8 and 10). The roof is of slate over sarking boards (see above) and the ridge is covered by blue clay tiles. On this barn there are no ridge-mounted ventilators.

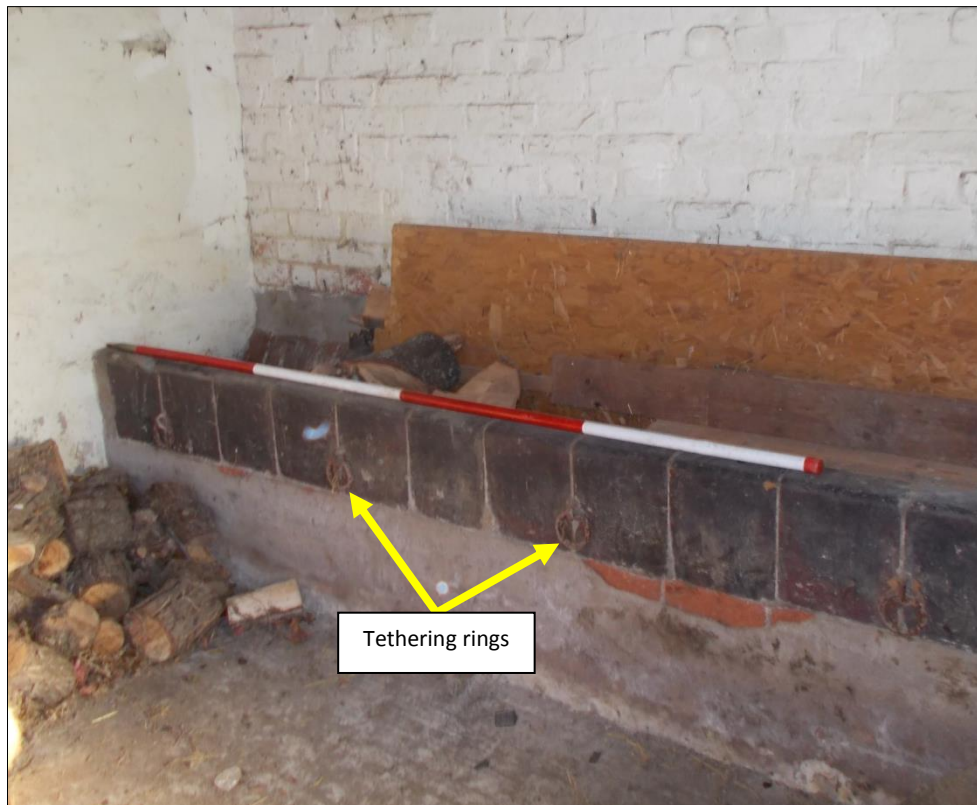
Fig 9: The manger in the west room of Barn 2, looking north-east. 2m scale.

The manger is constructed of red brick cement, rendered externally and internally for ease of cleaning. The outer rim is formed of large blue engineering brick blocks to provide a hard-wearing edge. Set along this rim are a series of iron tethering rings set into the joints between the blocks for tying livestock to. The height of the trough suggests that this room was designed to house calves since it appears to be rather low for cattle, much too low for horses, but at the same time too high for sheep or pigs. There is no indication that there was a hayrack above it on the same wall.

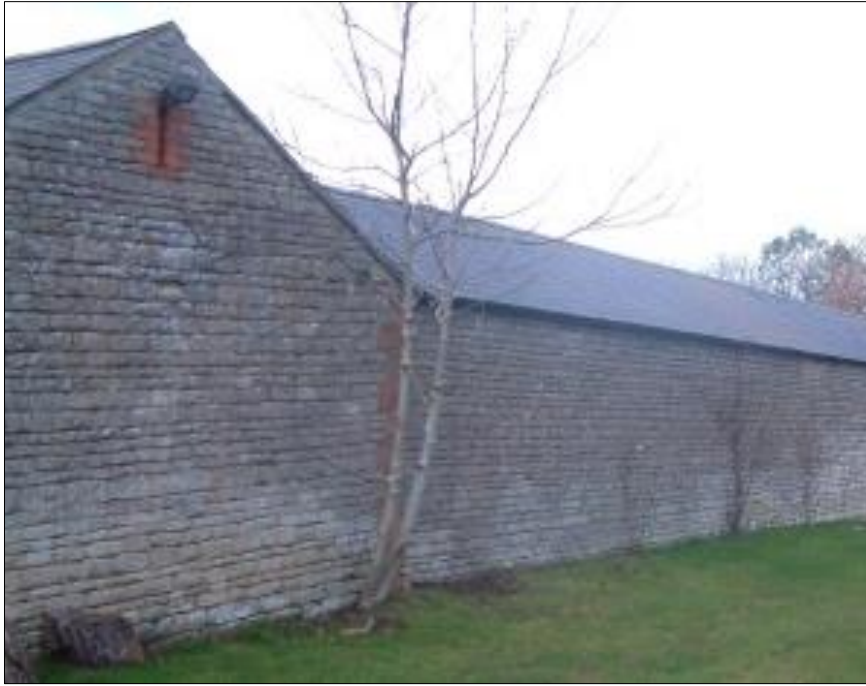
This long range spans between Barns 1 and 2 and forms the east side of the entire former complex (Fig 3). It is constructed of the same materials as the two other barn groups. Where the two ranges abut it can be observed that the coursing of the three separate groups is different; in Barns 1 and 2 the courses of stonework are distinctly horizontal as these buildings are located across the natural slope, whilst in Barn 3 the courses of the long east elevation fall with the natural slope of the ground (from south to north) on which the range is built (Fig 10).

Fig 10: The east gable of Barn 2 (left) and elevation of Barn 3 (right) showing disparate levels of stone courses, looking north-west.

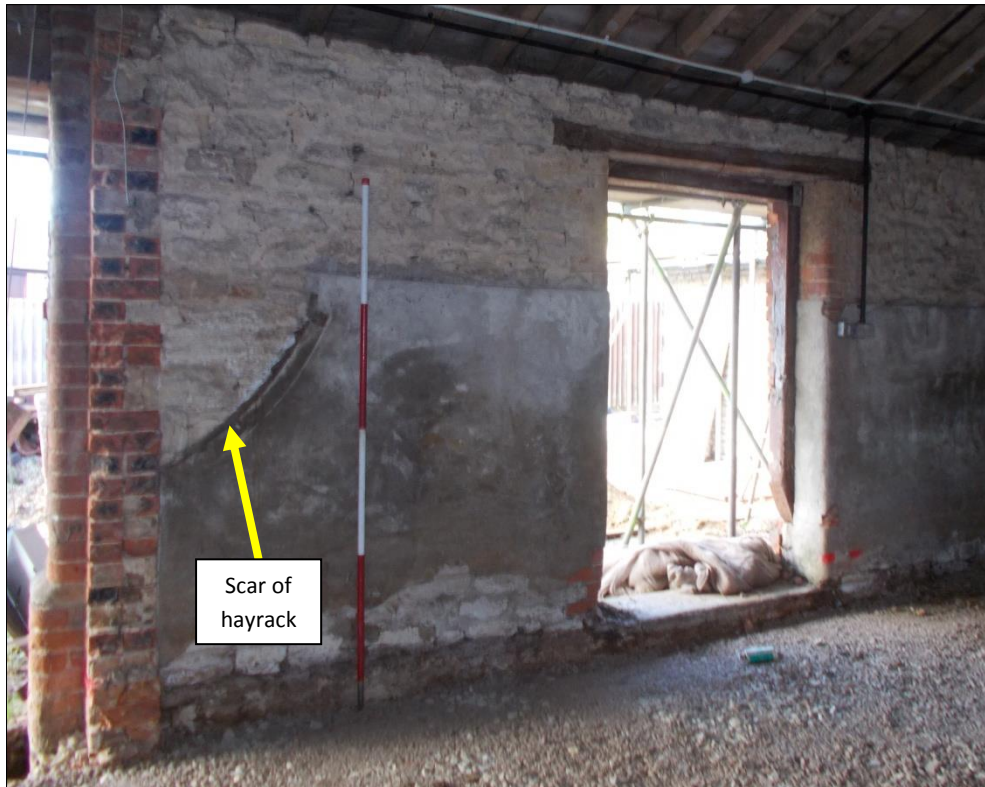
The original south wall has been removed as part of the present alterations but in the south-west angle of the room the scar of a corner hayrack survives in the cement render of the west wall which covers the lower portion of the interior wall surface (Fig 11).

Fig 11: The former room in Barn 3 with the scar of the corner hayrack, looking north-west.

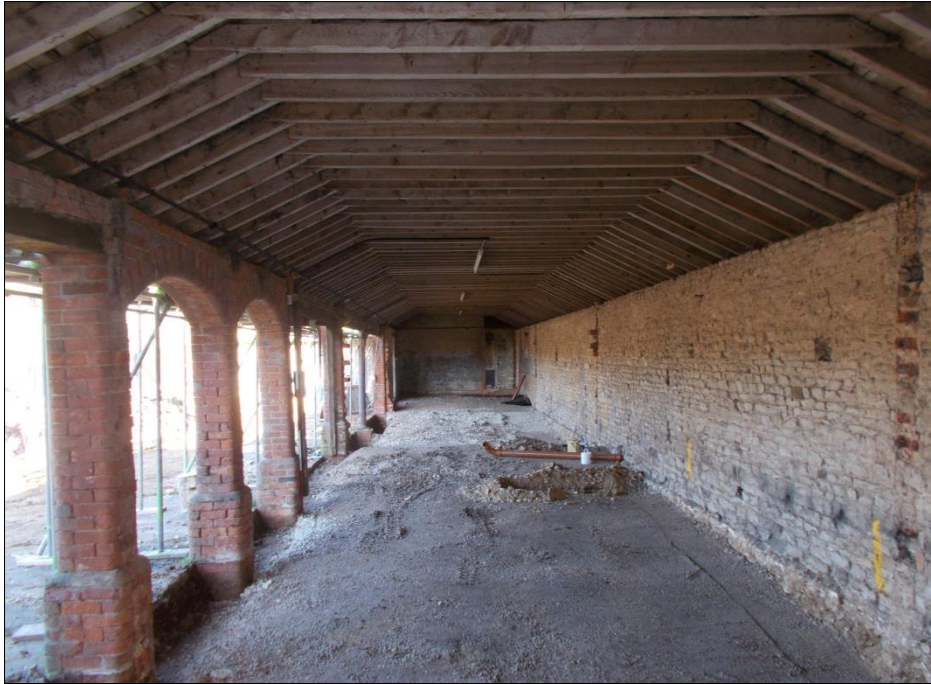
To the south of this room the remainder of the east range (Barn 3) was an open-sided hovel with nine free-standing brick piers and two engaged piers at the north and south ends which supported a series of ten shallow red brick arches (Fig 12). The bays were formerly divided into two four-bay sections and one two-bay section although the internal brick walls have been removed as part of the current alterations; the scars at the east and west ends reveal their former locations (Fig 3).

Four of the brick piers have been removed and which this has occurred the arches were removed also and replaced by timber lintels which spanned the wider openings. In all instances the lintels were re-used railway sleepers.

Fig 12: Barn 3, showing surviving brick piers and arches, looking north.

Each pier comprised a low square plinth topped by a stone block with chamfered upper edges on which the slightly narrower pier was built. All of the plinths and piers were constructed with bullnose bricks on all corners, as were the undersides of the shallow segmental soffits of the arches. At the time of the survey four of the plinths and piers were missing, having been previously removed although their locations could be observed in the ground.
