Iain Soden Heritage Services Ltd

Archaeological monitoring of a machine-dug trench to locate a culvert at Canons Ashby, Northamptonshire.

(Scheduled Monument 13643; National Heritage List for England 1015534)

27 February 2018

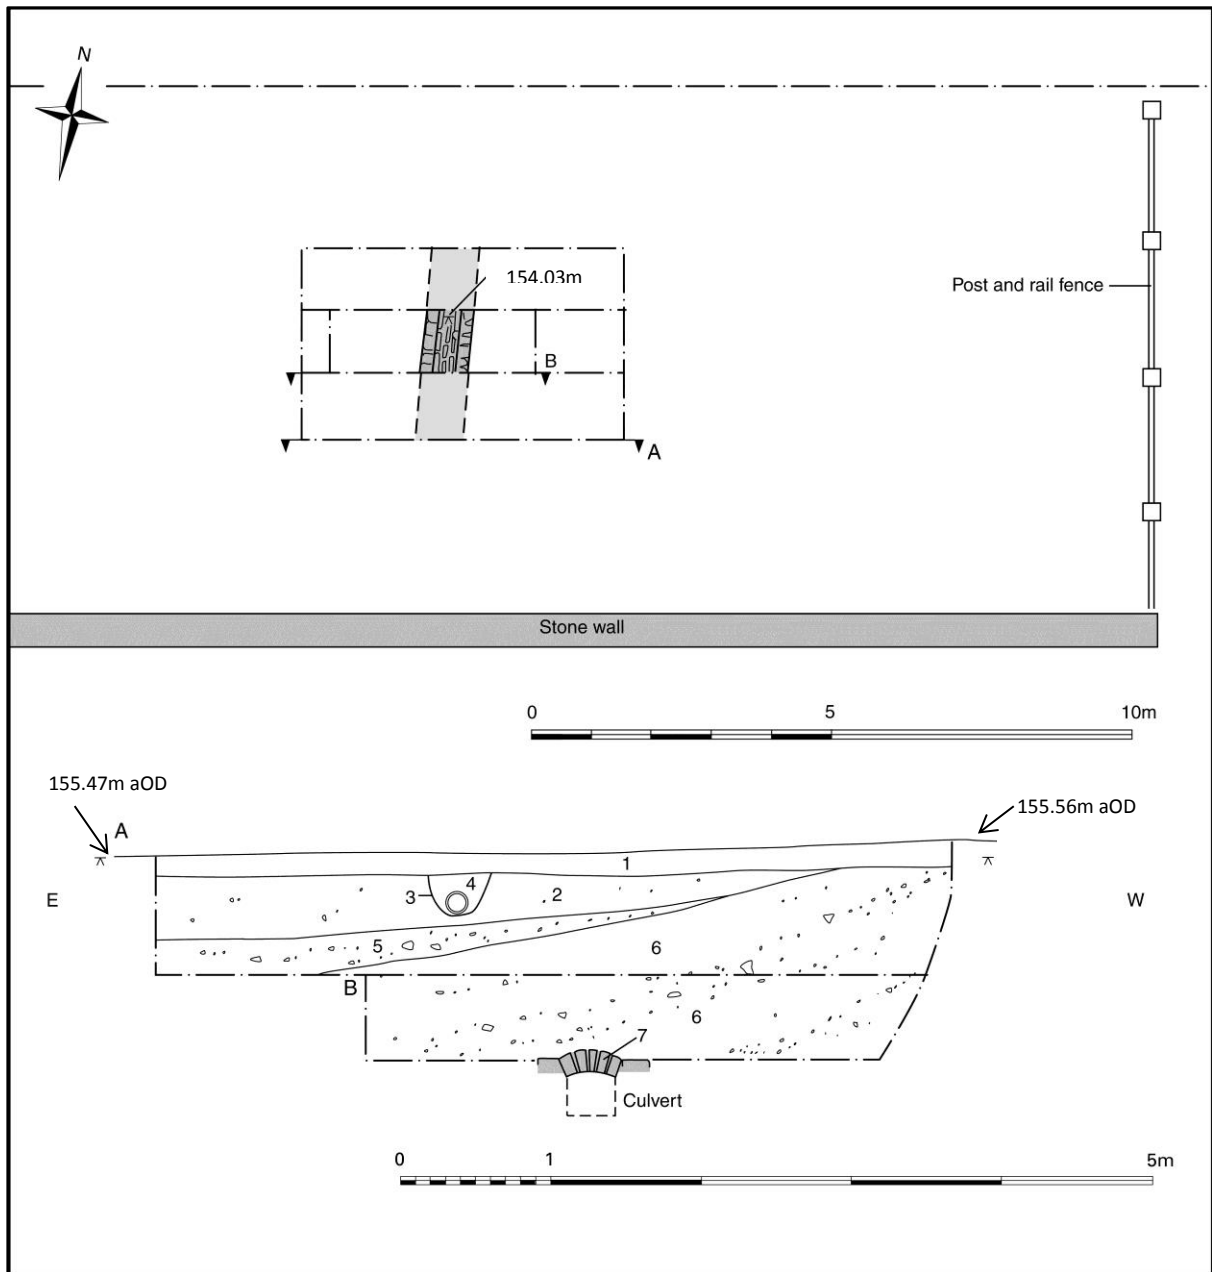
Fig 5: Plan and section of the trial trench. Note that the southern (north-facing) section was slightly more instructive for drawing. (Andy Isham)

Beneath this was a layer containing fragments of ironstone (Northampton Sand with Ironstone) and occasional smears of lime mortar within a mid-orange/brown slightly clay loam [2]. Cutting this was a shallow U-shaped feature [3], filled with what was most likely topsoil which surrounded a terracotta field drain aligned north-south [4]. This field drain appears to have formerly served a boiler-house which is thought to have heated a range of glasshouses which stood on the other (south) side of the nearby wall. The field drain was most probably used to channel the rainwater from the roof of that boiler-house into the ditch nearby to the north since it fell in that direction. The pipe sections had a 13cm (5 inch) external diameter and were of machine-made extruded variety indicating a late nineteenth- or early twentieth-century date.

Beneath layer [2] was a further layer which displayed a more distinctive tip-line characteristic of material deposited from higher ground to the west [5]. This tip comprised a lighter orange, slightly sandy clay loam with small fragments of ironstone and occasional mortar flecks indicative of degraded building debris.

Beneath was a thicker layer, which contained larger stone fragments (both ironstone and occasional, but fewer, limestone pieces), mortar smears and charcoal flecks, all within a mid-brown clay loam matrix [6]. It was almost certainly also deposited downslope from the west. It contained a variety of finds including fragments of clay roof tile, brick, floor tile, pottery and glass. Roof tile, unless glazed was not retained, nor were small fragments of brick or stone unless they retained worked or moulded surfaces. The retained finds from context [6] were as follows:

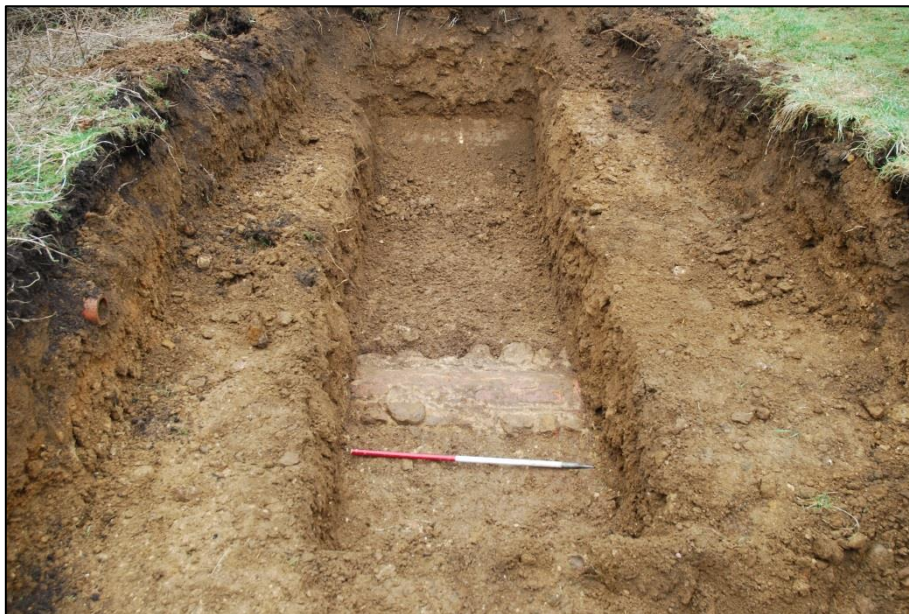
Set within layer [6], and showing no clear indications of a construction trench, was an ironstone and red brick culvert aligned north-south [7]. It lay c1.5m below the modern ground surface.

Fig 6: The brick and ironstone culvert, looking west; scale 1m.

The two sides of the culvert were constructed from irregular pieces of ironstone with flat surfaces being used to create the side walls. It did not appear that dressed stone was utilised. Only the upper surface was exposed but all of the stonework appeared to be mortared with a pale-yellow lime mortar. The top of the culvert was capped by a shallow segmental arch composed of five voussoir-bricks laid on edge, mortared together with the same yellow mortar used on the side walls. The brick size was 230mm x 110mm x 65mm indicating a probably early nineteenth-century date as was also apparent from the fabric, a hard, highly-fired iron-rich matrix with few inclusions and well oxidised throughout.

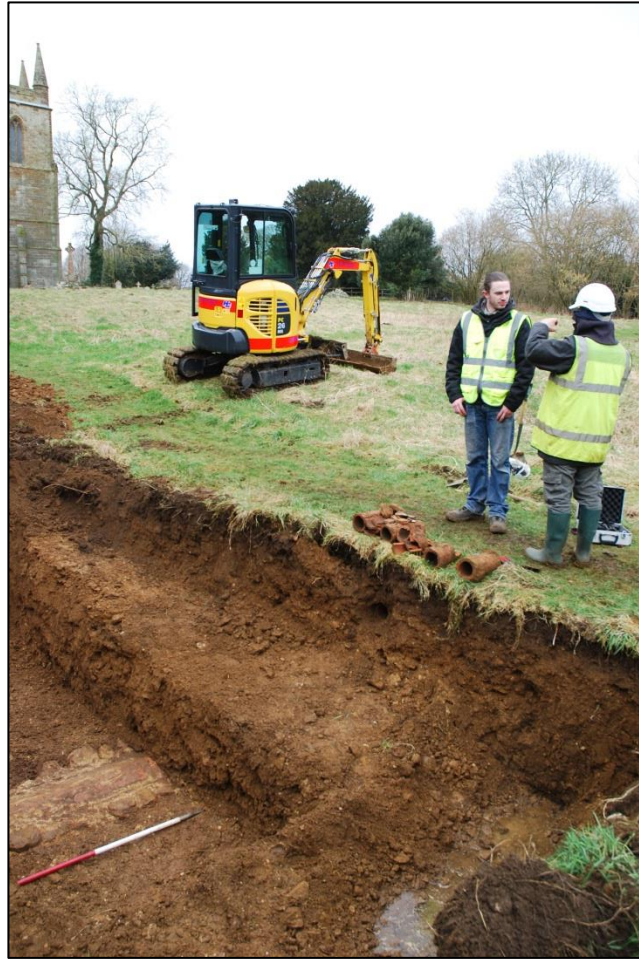
Fig 7: The brick and ironstone culvert, relative to the works, looking north-west; scale 1m

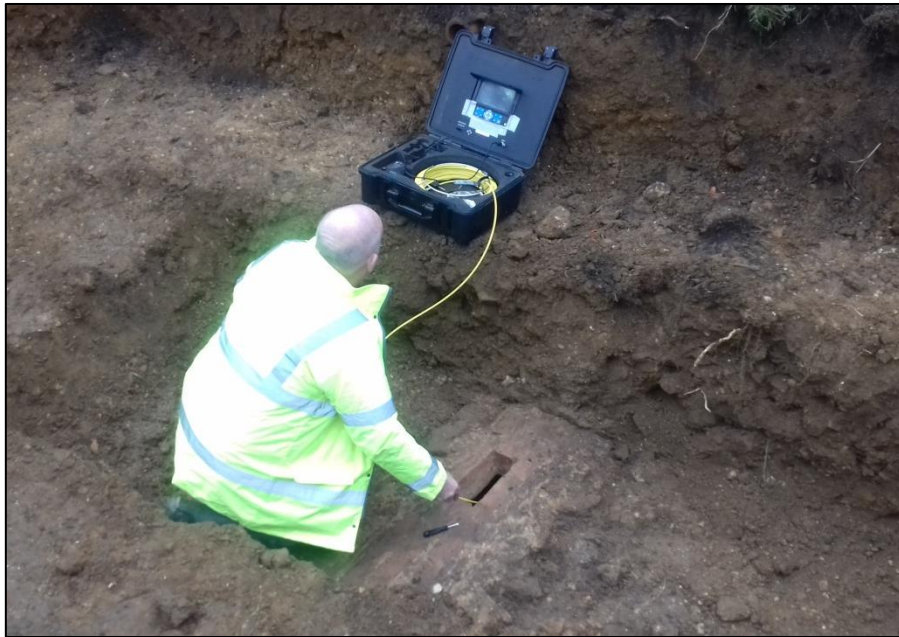
A single brick was removed from the apex of the arch to allow inspection with an endoscopic camera. It could be seen that there was a layer of silt with mortar and brick fragments accumulated on the base of the culvert. Though the removed brick allowed a space too small to allow removal of this material a probe indicated a probable depth of the culvert to be c260mm from the underside of the arch to the apparently solid base of the channel.

A consistent flow of water could be observed flowing from the north to the south within the base of the culvert.

Fig 8: camera-probing the culvert interior.

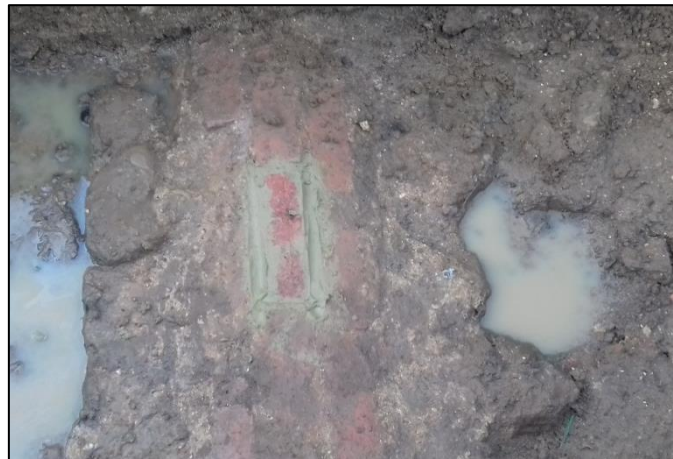
Fig 9: The inspection hole in the vault made-good

When sufficient data had been gained from the camera-work, the keyhole left by the brick removal was made good the next day with a new, purposely-cut brick, which was mortared into position. The orientation and centre-line of the culvert was marked with a yellow spray-marker dot on the adjacent wall, and a small wooden peg driven in, its top flush with the ground (so as not to snag mowers); this too was sprayed yellow on top. *Spray-marker is a construction-site paint and will dissolve with time, so the marks should be renewed occasionally.* Then the trench was backfilled with its own up-cast, lightly tamped down to restore the ground level.

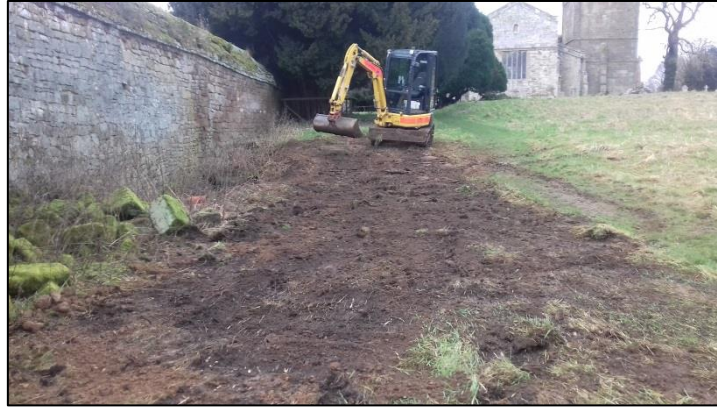
Fig 10: The trench backfilled, looking west
