**Buildings Recording at  
Park View Farm, Grange Cottage & Yew Tree Cottage,  
Astwith, Derbyshire; three properties belonging to  
The National Trust.**

Joe Prentice and Iain Soden

### Summary

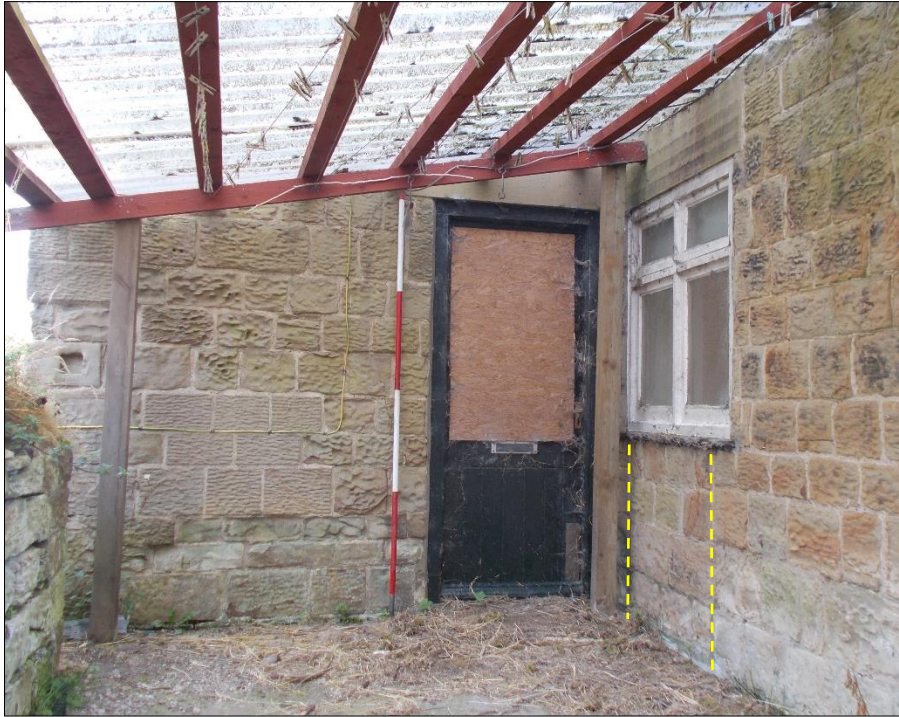
Fig 21: The inserted doorway on the west facing wall of the north bay, looking east. 2m scale. Former doorway indicated by yellow dashed lines

The north elevation of the south two-bay section of the building formerly contained a doorway at ground level, the lower jambs of which can be observed as vertical scars (see Fig 21, yellow dashed lines). This doorway has subsequently been infilled in the lower half and slightly widened in the upper half to form a window. Whilst this would have allowed light to enter the room from the north, it perhaps was more useful to allow sight of the approach to the building from that side. The window is a four-light timber mullion and transom arrangement, each containing a single pane of crinkled opaque glass. The two smaller upper lights are top-hinged casements. The sill is made from clay roof tiles, the lintel a large ashlar stone block.

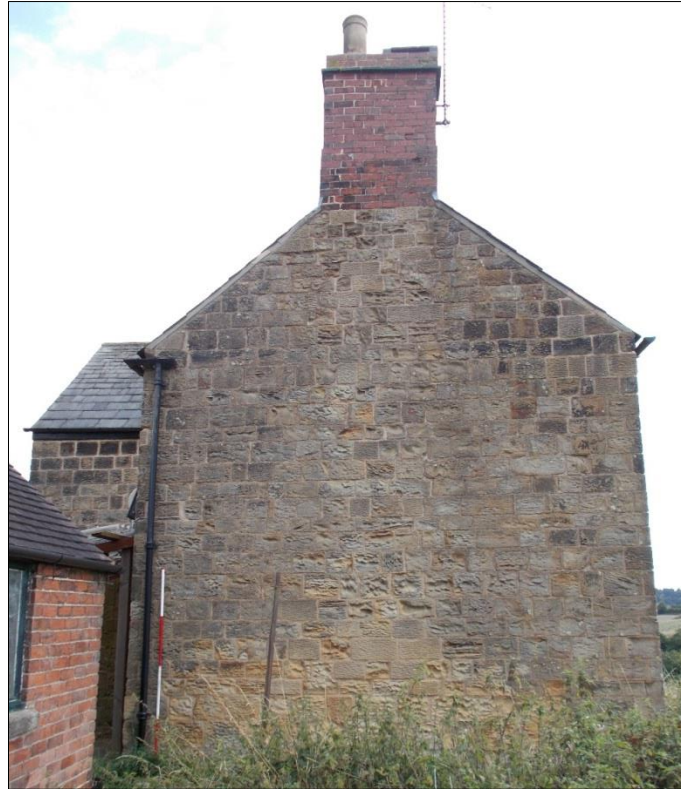
Fig 22: The west gable of the cottage, looking east. 2m scale.

Constructed from the same materials as all other elevations this gable has no openings and apart from a single cast-iron downpipe is unadorned. The only variation is to the weathering of the stonework and some evidence of stone replacement. A single red brick double chimney stack rises from the apex of the gable and retains a single chamfered string. The stack retains a single clay pot, the other presumably removed and the flue capped. On the south side is a modern bracket for a television aerial.

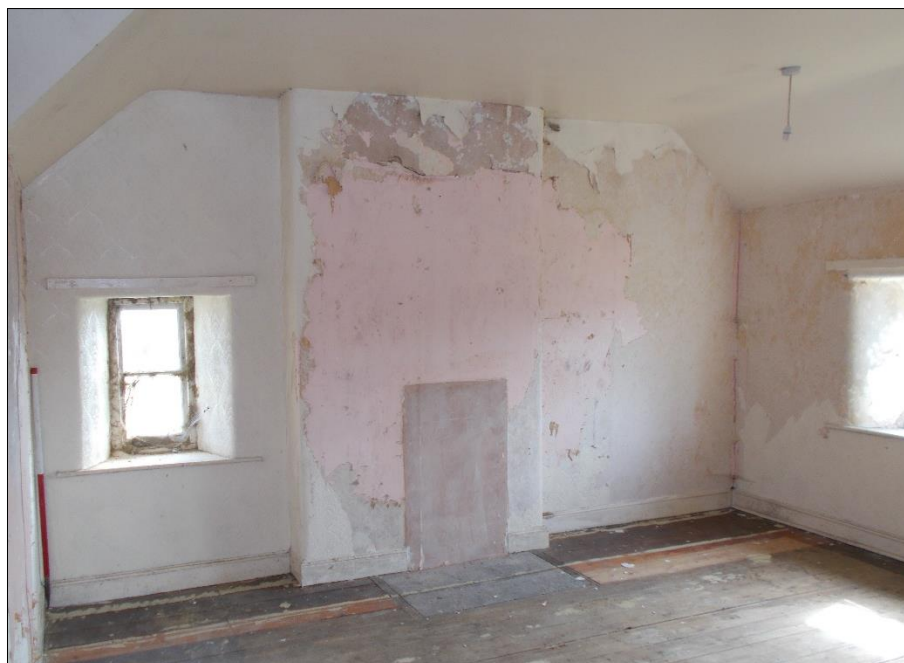
Fig 30: Room F1, looking south-east showing infilled fireplace and hearth-slab in floor; 1m scale.

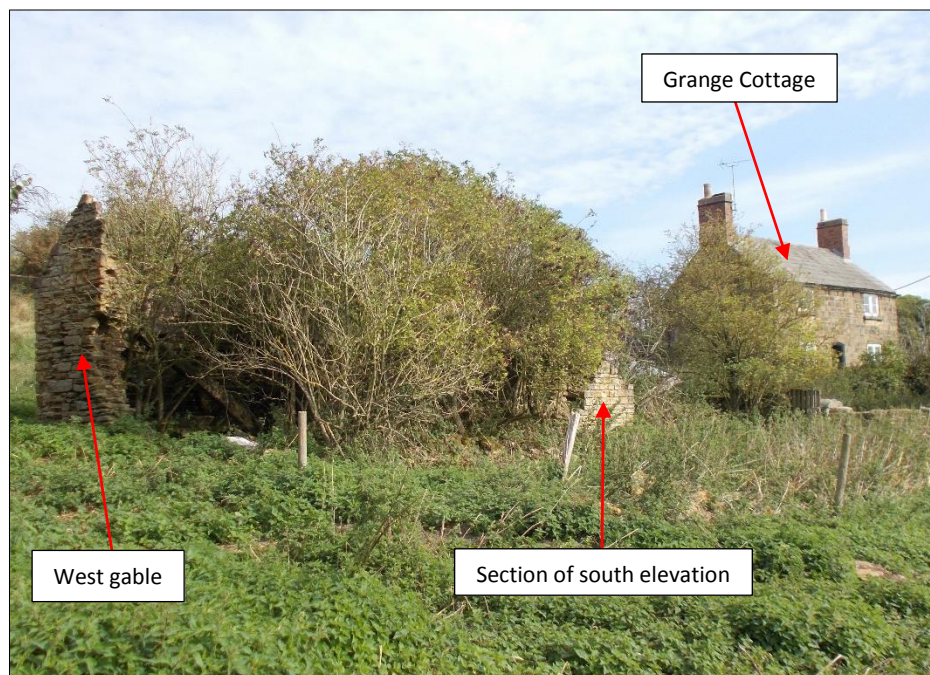
Fig 41: The derelict animal shelters, looking north-east towards Grange Cottage.

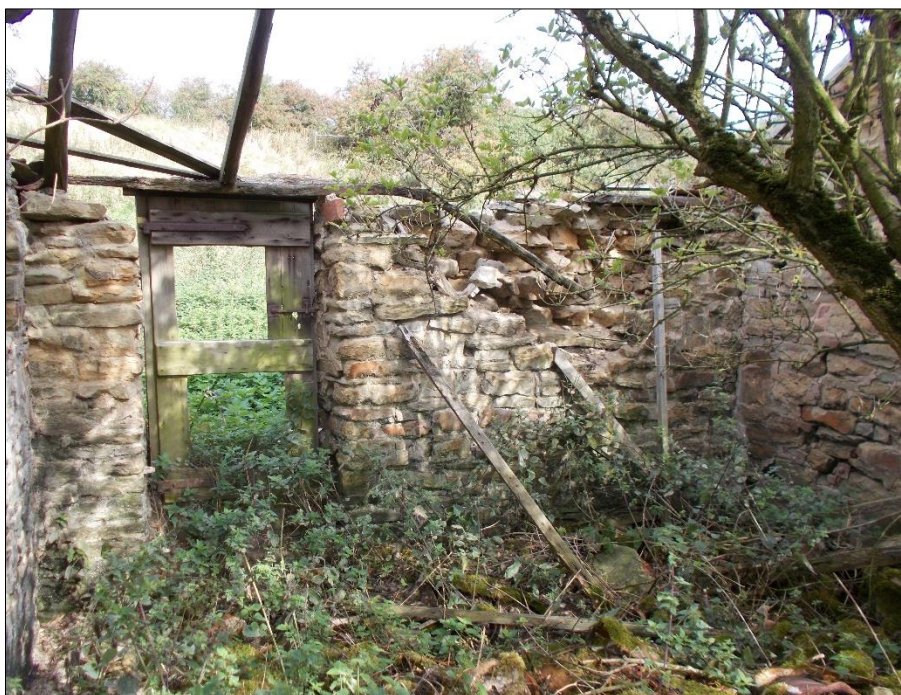
The central and eastern sections of the building are almost entirely ruinous.

Fig 42: The central section of the animal shelter, looking north.

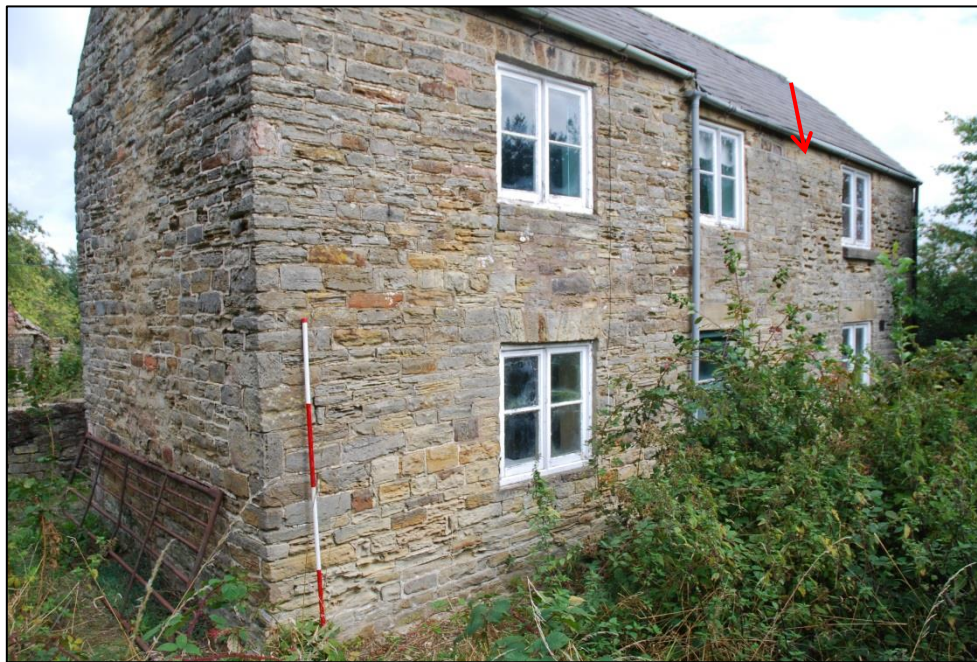
The principal front of the house faces south (its immediate garden) and here can be seen the exterior butt-joint which demarks that the building is of two phases (Fig 49). The western two-thirds portion is the earlier, with the addition of the eastern third and the kitchen block to the rear. Their coursing and the stonework actually employed vary sufficiently for the joint to be corroborated in the overall finish. The first phase is coursed rubble all round, while the later addition has quoin stones and many carefully squared blocks have been laid.

Fig 49: The principal (south) front. Vertical butt joint between phases is arrowed. Note the two window-configurations of Phase 1 and Phase 2; scale 2m

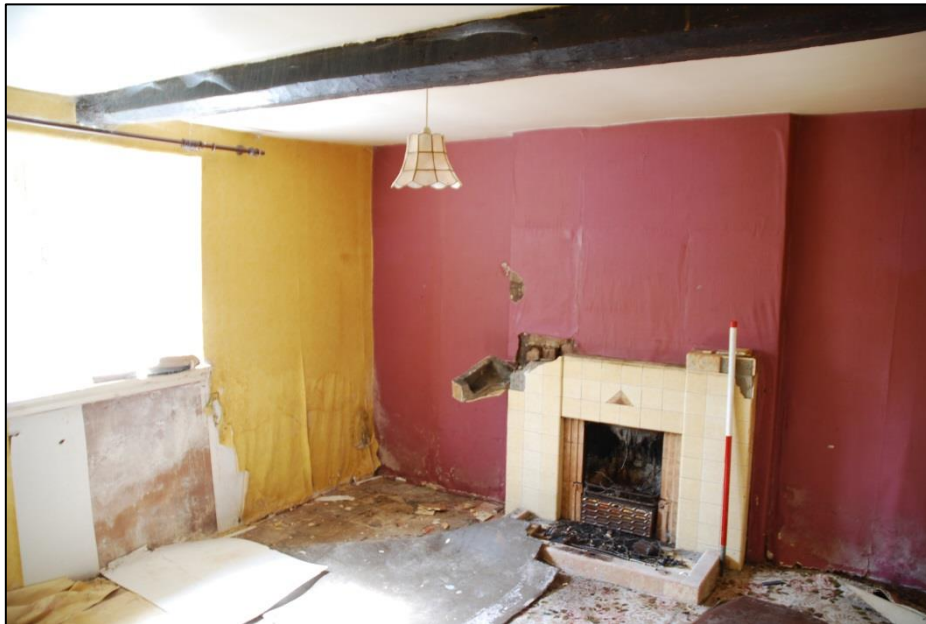
A doorway in the south wall leads through the south wall into Room G2, the downstairs room of the first-phase building. This room faces south and in its west wall is a fireplace with a beige tiled surround and grate which dates from the 1930s (see for instance Calloway 2012, 433). It is badly damaged but even now is probably conservable if appropriate (Fig 52).

Fig 52 room G2, showing the effects of damp and the damaged 1930s fireplace surround. Scale 1m

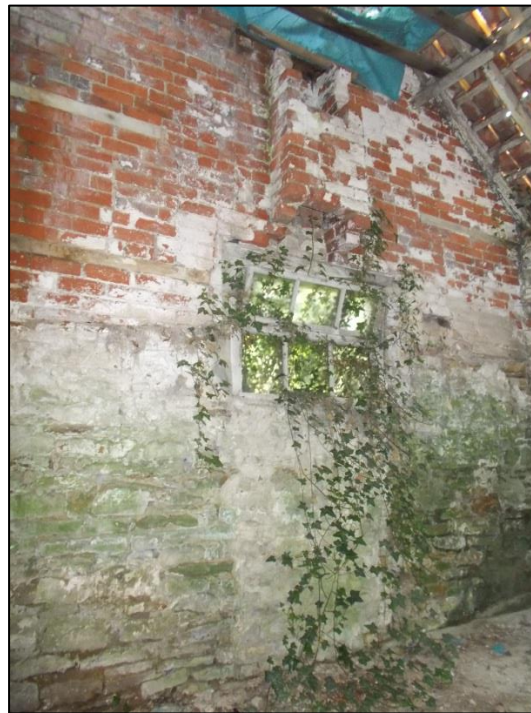
Fig 67: The rear portion of the large animal shelter (Fig 60, e). The window is an insertion, and has replaced a former projecting fireplace on the first floor, which has been entirely lost. Only the chimney survives.
