### An archaeological building record of the former Union Chapel, Grendon, Northamptonshire

Iain Soden

#### Summary

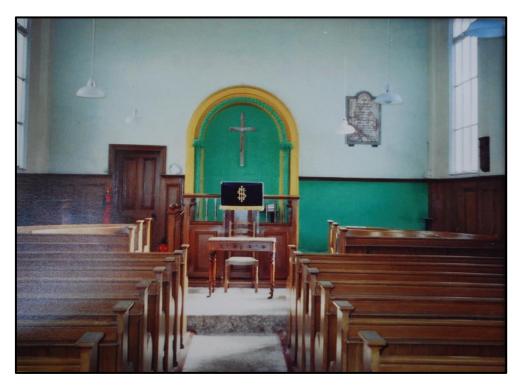
Fig 3: View of the chapel just before closure. This is essentially the re-ordered layout of 1925. The organ had stood far right against the end wall. Note the un-boxed high level ventilator above the panelling on right, and the memorial tablet on the east gable wall. Copy of a photograph in the owners' possession, with thanks.

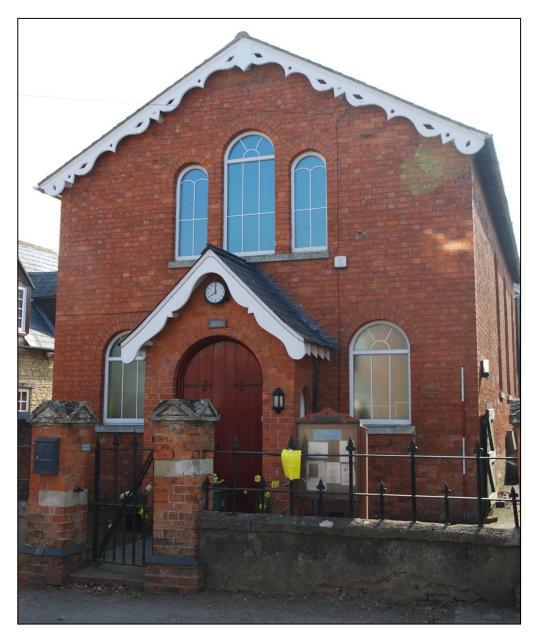
Fig 4: Street-facing west gable of the chapel, 1861 with the porch added in 1925; scale 2m

the west end lies the main entrance to the chapel, sheltered by a shallow brick porch with slate roof, known from records to date from 1925.

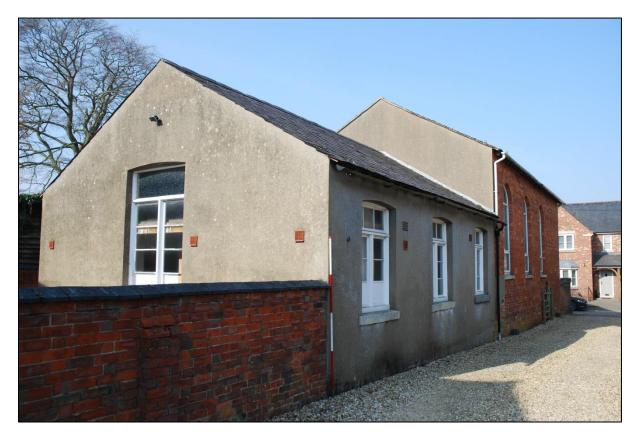
The schoolrooms contain no historic features, although a former fireplace is visible in the north wall, with a chimney above it. The room has in modern times been divided up to accept an array of WCs.

Fig 5: The fully-cement-rendered schoolrooms (foreground) added to the east gable of the chapel; scale 2m

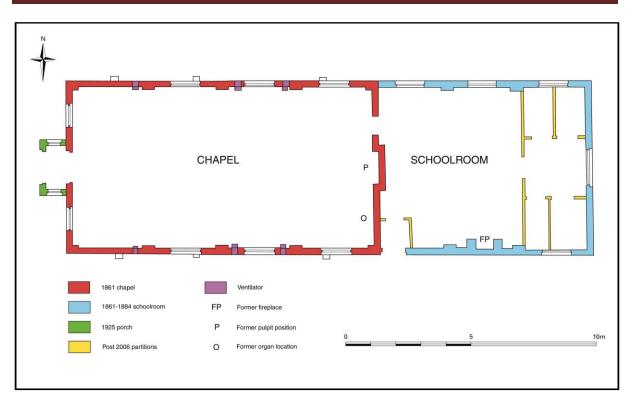
Fig 6: Plan of the chapel, schoolroom and porch, phased. Andy Isham, after Coles Architects, with thanks.

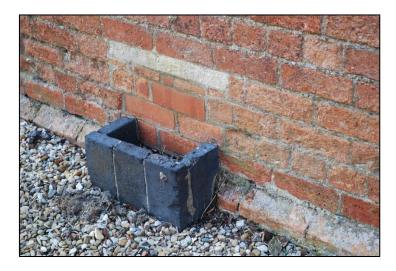
There is a row of partly infilled ventilation holes along the foot of the chapel side walls (projecting from walls on Fig 6, and see Fig 7). These appear to have been to create a passage of air under the floor. They have been largely bricked-up, possibly when the 1925 works introduced panelling over their interior wall surfaces.

Fig 7: Bricked-up ventilator at ground level (three to each long side), probably reduced in size and efficiency in 1925; Note chamfered brick plinth integral to the chapel

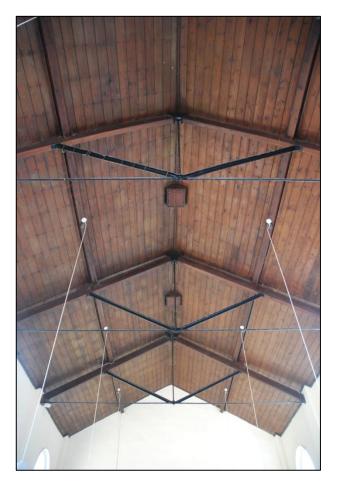
The roof of both principal elements, comprising trusses and purlins, with internal edge-to-edge cladding, is of pine, with collars and braces in slender steel angle-iron, braced in the centre with long vertical threaded bolts. The wooden portions have all been painted in a light-oak grained finish, known from documents to be the scheme of 1925. Steel elements are painted black.

Fig 9: the chapel roof looking east

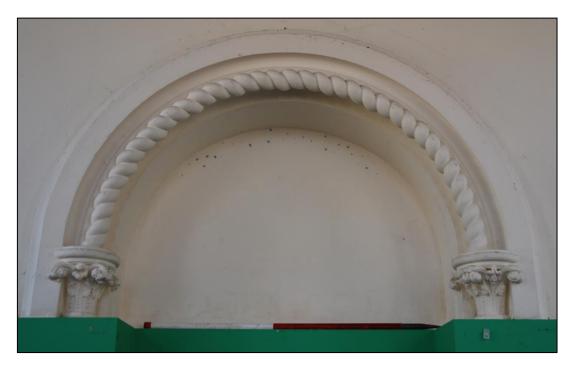
The ornate round arched alcove which once framed the pulpit still survives, flanked by a pair of columns with developed Romanesque capitals and a rolled cable moulding between.

Fig 10: Round-arched alcove in the east gable framing the former pulpit location; scale 1m
