Iain Soden Heritage Services Ltd

Historic Building Recording of Southwood Farm, Calke Abbey Estate, Derbyshire

By Joe Prentice, with a contribution by Iain Soden

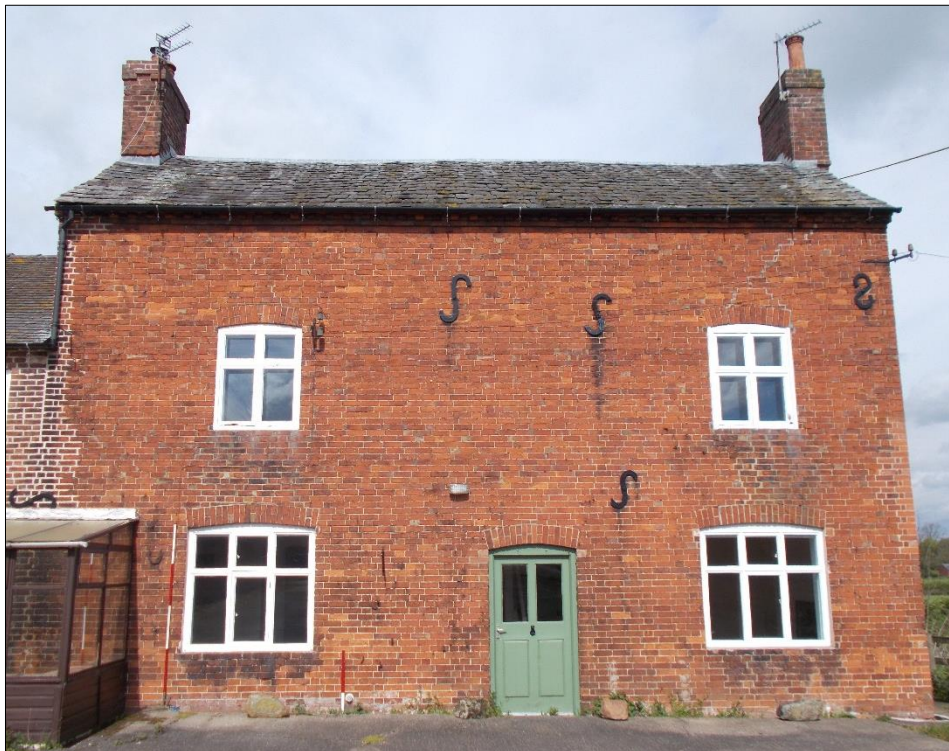
Fig 6: The two and a half storey phase one portion of the main farmhouse, looking north-west. 1m and 2m scale rods. The 1m rod rests in a 300mm-deep French drain cut through the surrounding concrete apron.

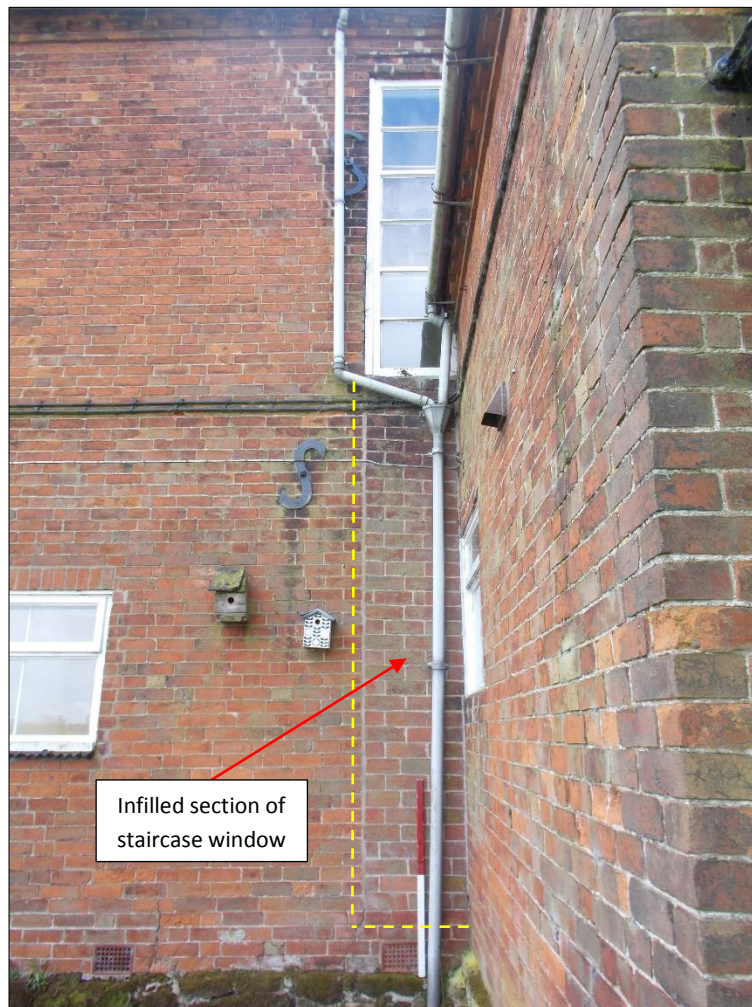
To the south-west the original ground-to-eaves level stair-light has been partially infilled, perhaps due to fears that it may have compromised the structural integrity of the building since such a tall, narrow slit means that effectively the rear wall was built in two, barely-connected portions (see Figs 8 and 9).

Fig 9: The partially infilled vertical stair-light, looking south-east. 1m scale rod. Note stone plinth.

Quite why such a window was contemplated is unknown; no similar configuration has been observed by either of the authors of this report either in rural or urban buildings, almost certainly for good reasons since, as stated above, it had the potential to compromise wall-stability. The upper section, still glazed, contains six fixed glass panes set within a timber frame, each pane separated by narrow glazing bars. The presence of this window explains the lack of a first-floor central window in the south-east elevation, the more common configuration and far better for illumination since it would admit direct sunlight.

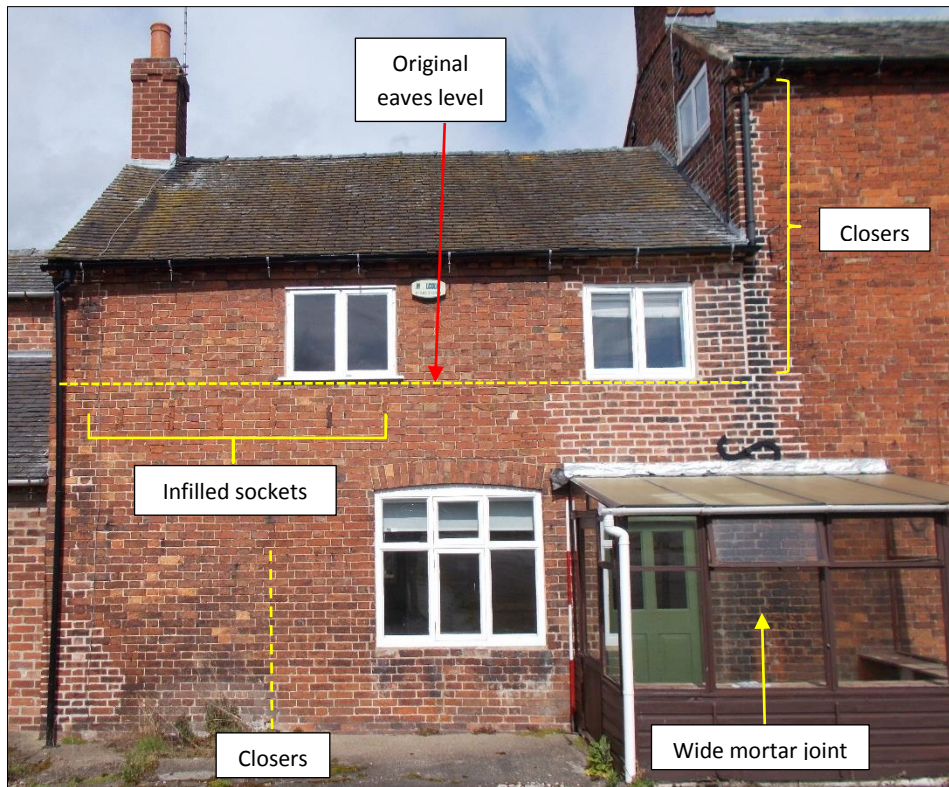
Fig 30: The phase two addition to the farmhouse, looking north-west. 2m scale rod.

However, a clear vertical break in the walling indicated by a wider mortar course directly beneath where the clear gable end of the building is visible, indicated by the closers, suggests that two-storey section was added (Fig 30). This wide joint could, however, simply be a filled structural crack and not indicate separate phases at all.

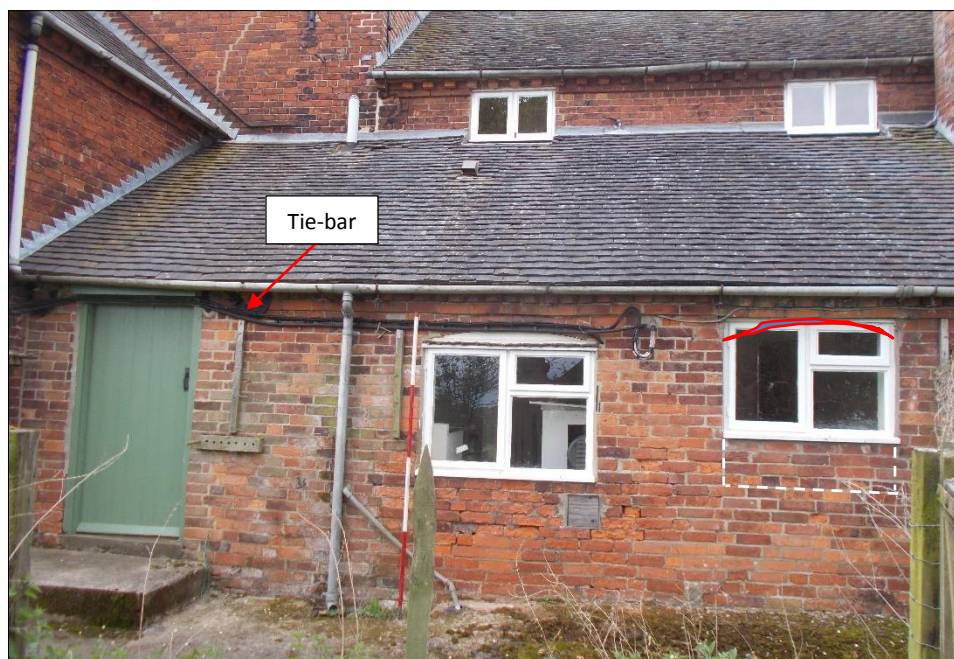
Fig 35: The phase three lean-to extension, looking east. The white dashed lines show reduced window to the right, red line former segmental arch above same opening. 2m scale rod.

There is certainly an area of re-built brickwork around the door which leads to the exterior, but it is uncertain whether this is repair or evidence of an entirely new opening, as previously stated. The more southerly of the two windows has been reduced; it originally was of the same depth as that to the immediate north. Almost certainly at the same time, the segmental arch was removed and a flat lintel introduced although the springing for the former can be observed. Each opening is fitted with modern timber casements, of three-lights. The long light of each is side-opening with the small light a top-hinged casement; the remaining light is fixed.

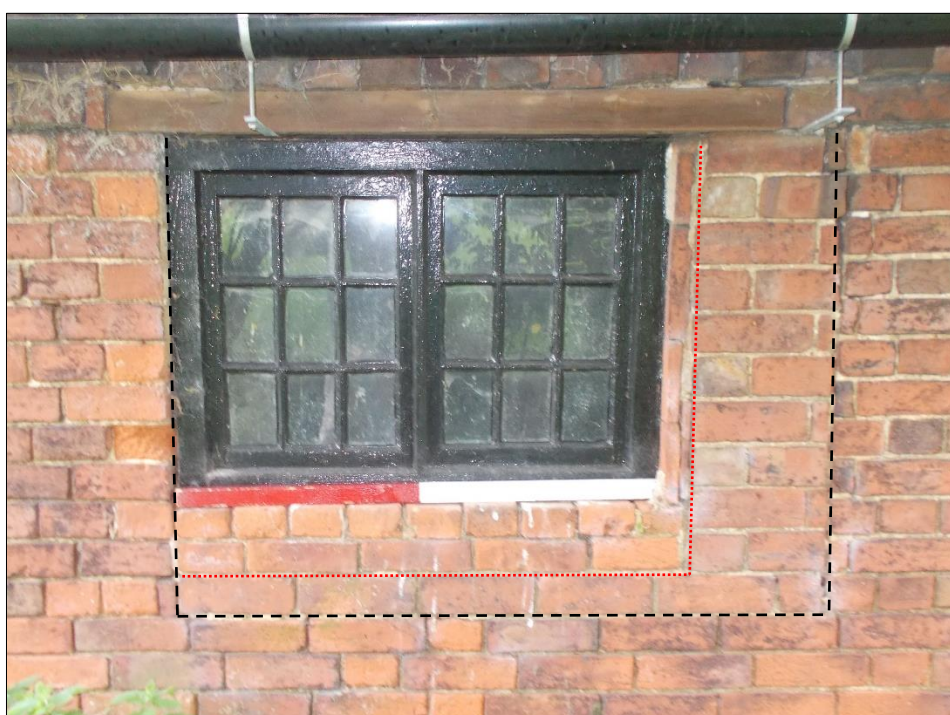
Fig 45: Room G12, the re-set window showing two previous settings; the first outlined in black dashed lines, the second in red dotted lines. Looking north-east. 1m scale rod.

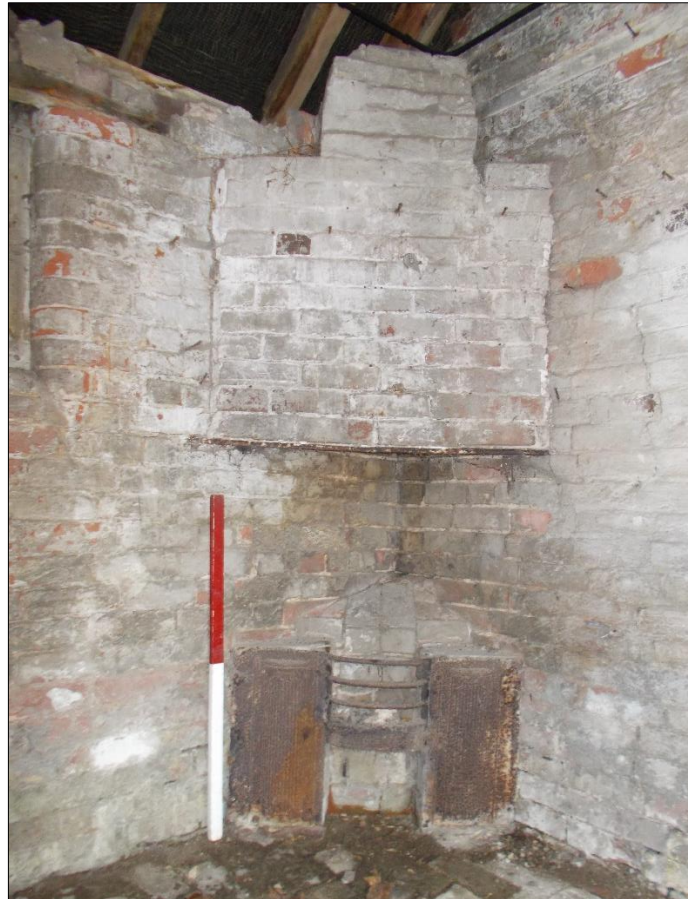
Fig 46: Room G12, the secondary corner fireplace, looking south-west. 1m scale rod.

The grate is of cast iron and of a type commonly found in domestic situations in the period c1810-1837 (Calloway 1998, 190). Its inclusion here, clearly secondary and crudely abutting the adjacent walls indicates that whatever the room was originally designed for, later it was deemed necessary to provide rudimentary heating and an old grate was available to insert. The flue above comprises a simple hood formed by building a brick wall at an angle across the corner, supported by a thin iron bar; the flue has been truncated beneath the level of the roof and the external stack no longer survives. Such a small fireplace is often found in a tack room where the leather harnesses, saddles and traces were stored. Such relatively expensive and vitally important items needed constant cleaning, oiling and waxing to keep them in good condition. In order to do this, some form of heat was needed so that they didn't remain wet after use and the oils and waxes would penetrate the leather. It seems unlikely that the fireplace would have been added if the room was only used as a coach house, though the space could have combined the two functions.

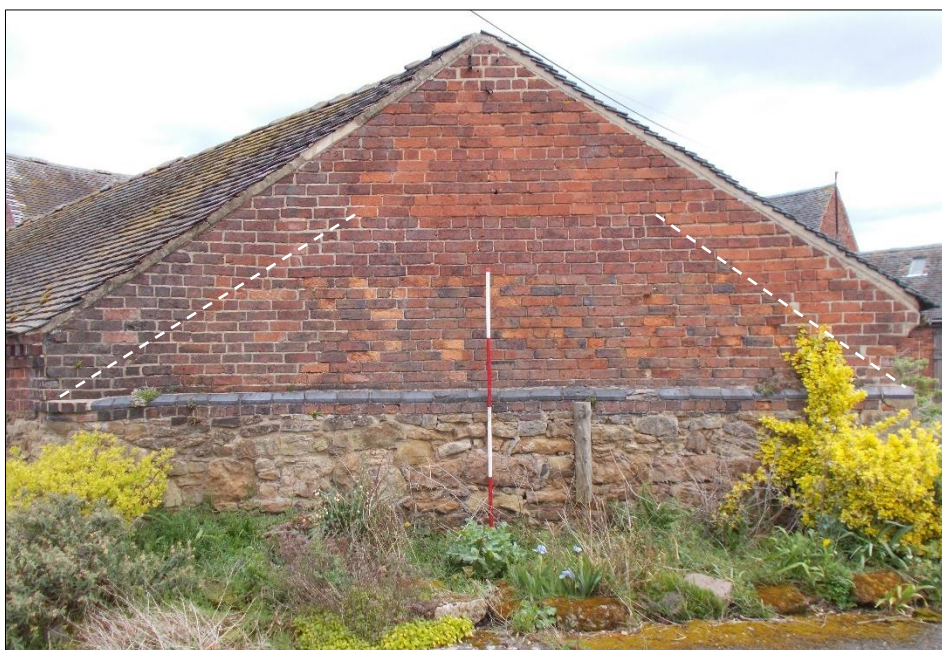
Fig 82: The south gable of the cattle stall range, looking north-east. The white dashed lines indicate the earlier roof profile. 2m scale rod.

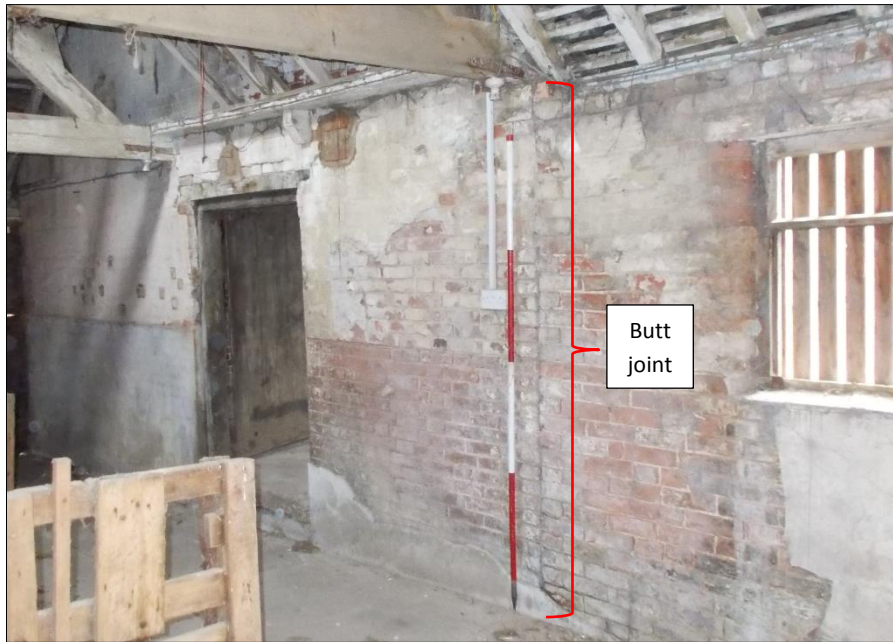
Fig 88: The butt-joint between the eastern elevation of the cattle stall range (right) and the north-west gable wall of the store or threshing barn (left). 2m scale rod.
