Iain Soden Heritage Services Ltd

**Level 2 building recording of barns at Wood Farm,
Banbury Road, Moreton Pinkney, Northamptonshire**

November 2019

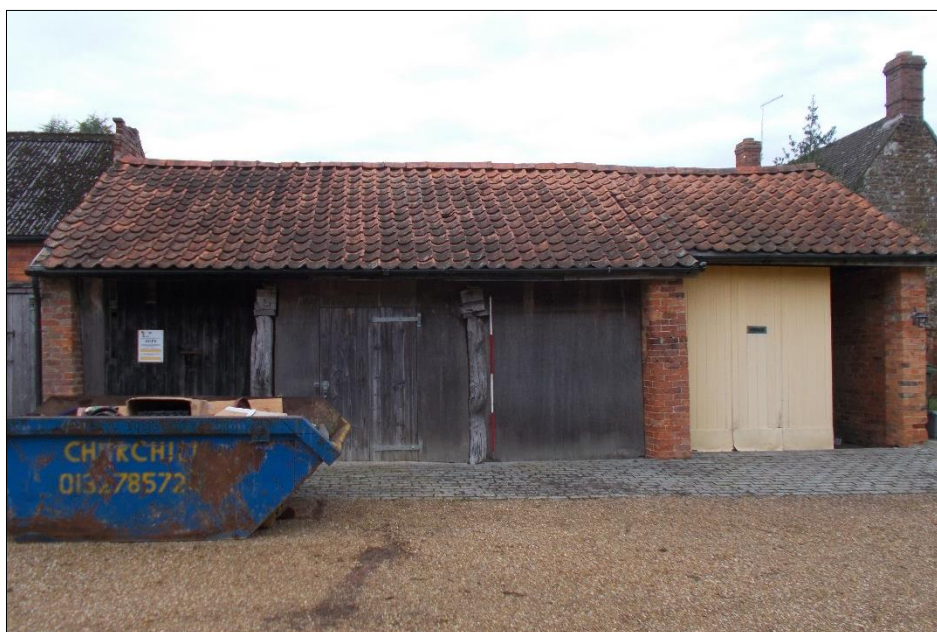
The formerly open three-bay hovel comprises a north wall which appears to have been originally a simple, largely stone-built, boundary wall. It is much patched with areas of brick repair and in addition, two brick piers have been added against the south elevation to support two oak trusses which support the roof (Fig 4). The west and east exterior gable walls are of brick, as is the dividing wall which separates the eastern room. The roof is covered with red clay pantiles (Fig 5).

Fig 5: The east range looking north. 2m scale rod.

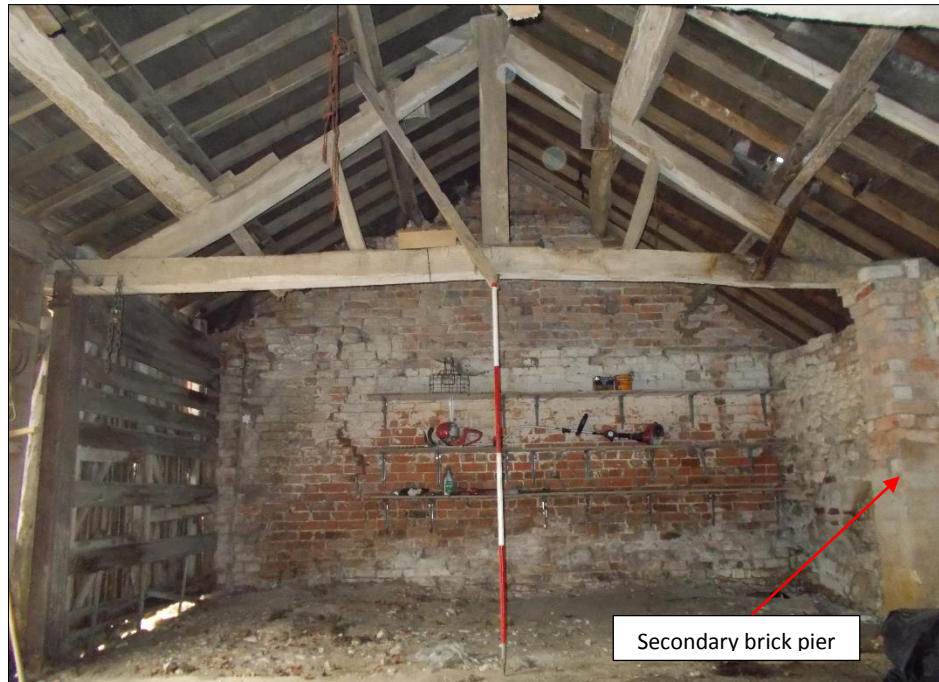
Fig 6: The east range three-bay hovel with western roof truss, looking west. 2m scale rod.

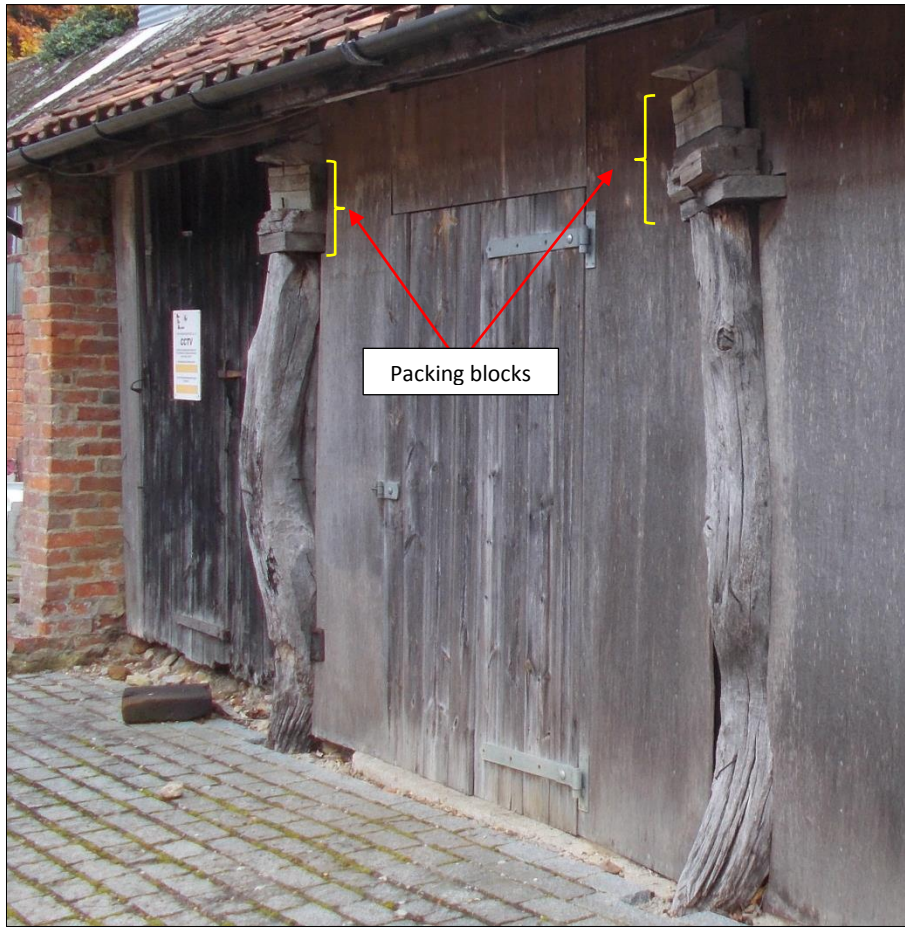
The southern ends of both of the roof trusses are supported on a much-amended series of posts. The originals are two roughly trimmed oak, little more than roughly straight tree-trunks (Fig 7). It seems that when the piers were added, the front extended to the south and the trusses re-positioned, these were re-set but, given that the trusses were heightened at the same time, they were subsequently too short and so a series of crudely cut timber packing pieces have been added to provide the necessary height (Fig 7).

Fig 7: The re-set oak posts with timber packing to support the roof trusses.

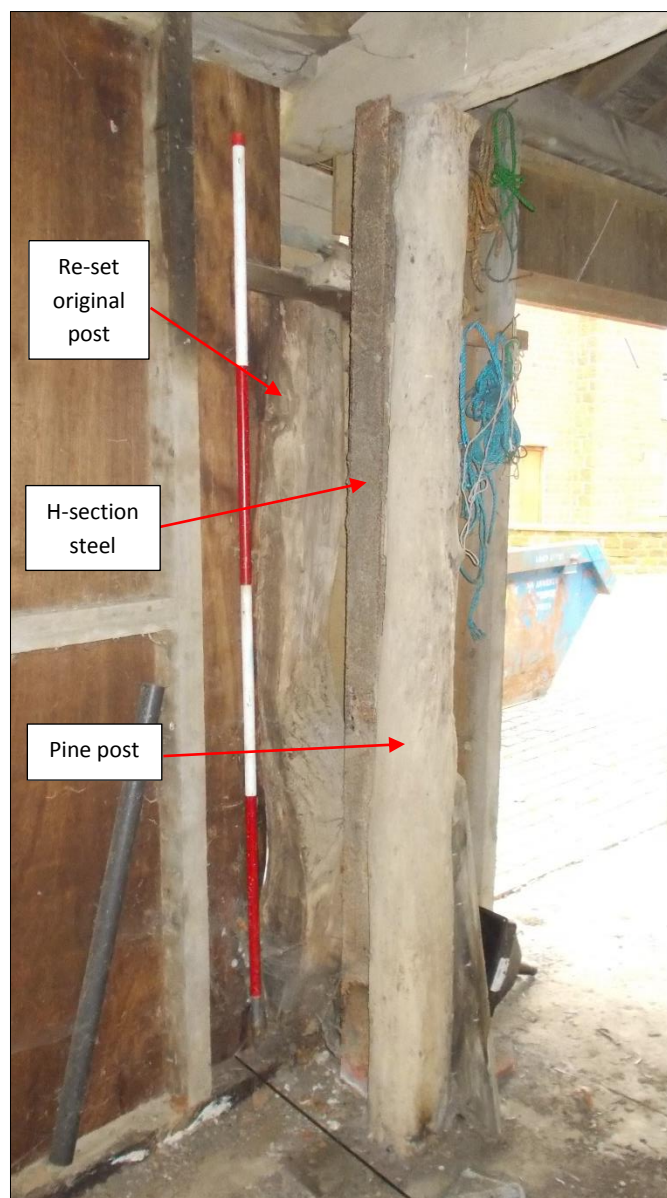
These oak posts are rotten at the base and have had to be strengthened by the addition of both iron H-section steels and, in the eastern example, a second timber post (see Fig 4 inset and Fig 8).

Fig 8: The southern truss supports showing original oak, and secondary H-section steel and pine posts, looking south-west. 2m scale rod.

The west truss has just a single secondary H-section steel but not the third timber post. The presence of these secondary and tertiary additions indicates that the oak posts continued to suffer from decay and there was a need to undertake ongoing repairs to support the roof.

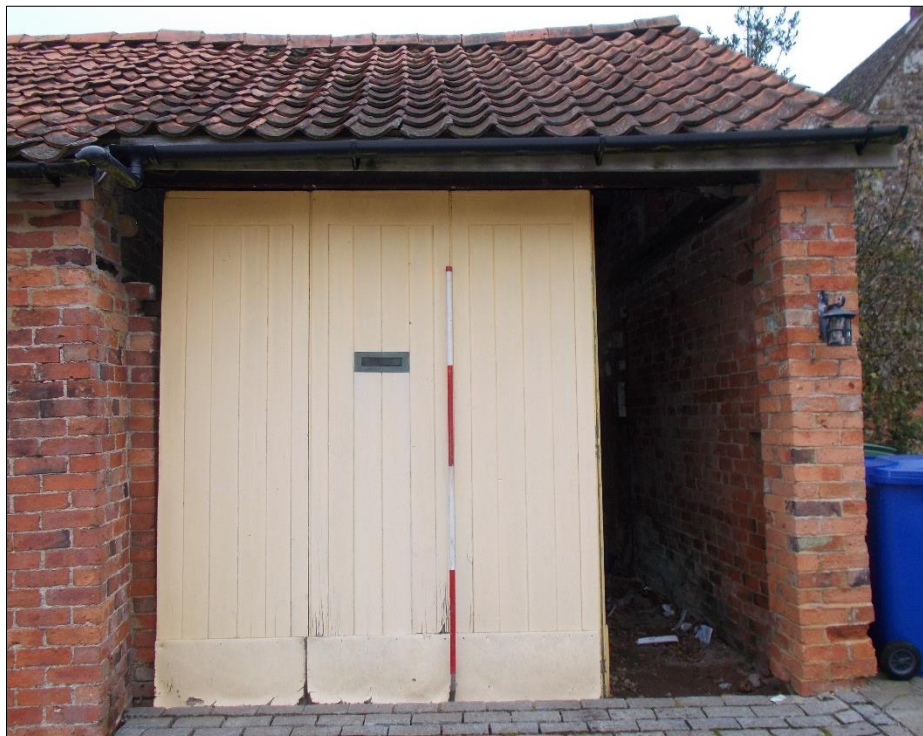
Fig 9: The eastern bay of the east range showing the sliding garage door, looking north. 2m scale rod.

each door have suffered from rot and have been covered externally with galvanised sheeting, also painted.

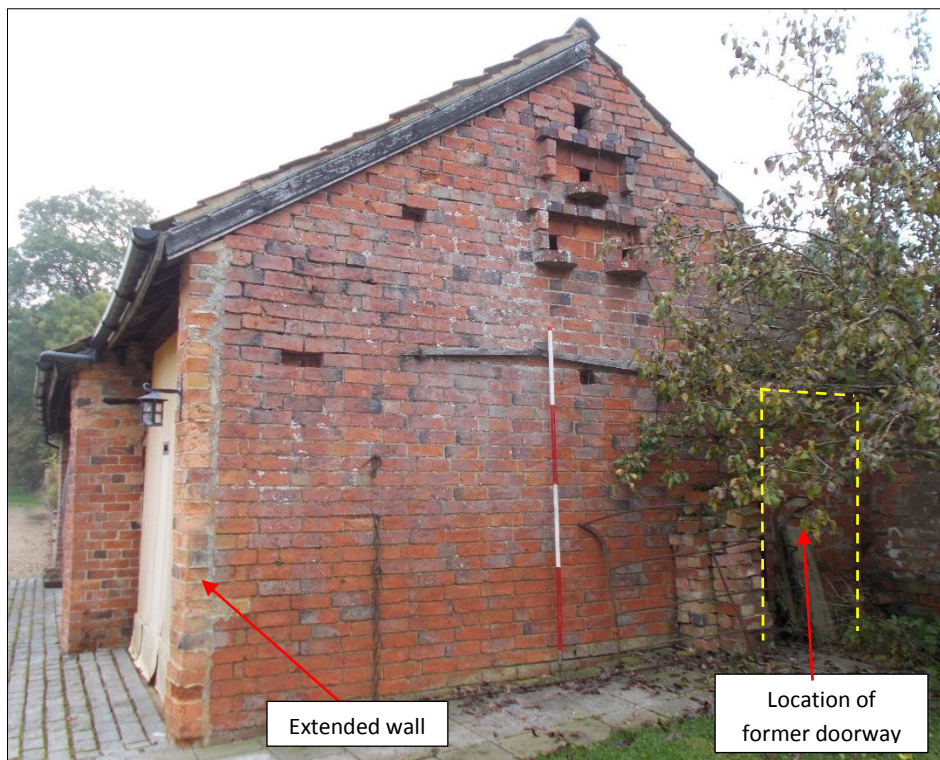
Fig 10: The east gable wall of the east range showing the former pigeon loft holes and flight ledges. Note also infilled door and extended south end. 2m scale rod.

A former doorway towards the north end of the gable has been infilled with a single thickness of brickwork and originally allowed access into that corner of the building (see Figs 4 and 10). It is most likely, but not now evident due to the total lack of surviving fittings, that this was a privy. Such facilities were common in outbuildings for use of both the family and farm workers in living memory.

The south end of the gable wall has been extended by a single brick thickness which wraps around the original southern end to form a pier; it appears that this was added when the current sliding garage doors were added (Figs 4 and 10).

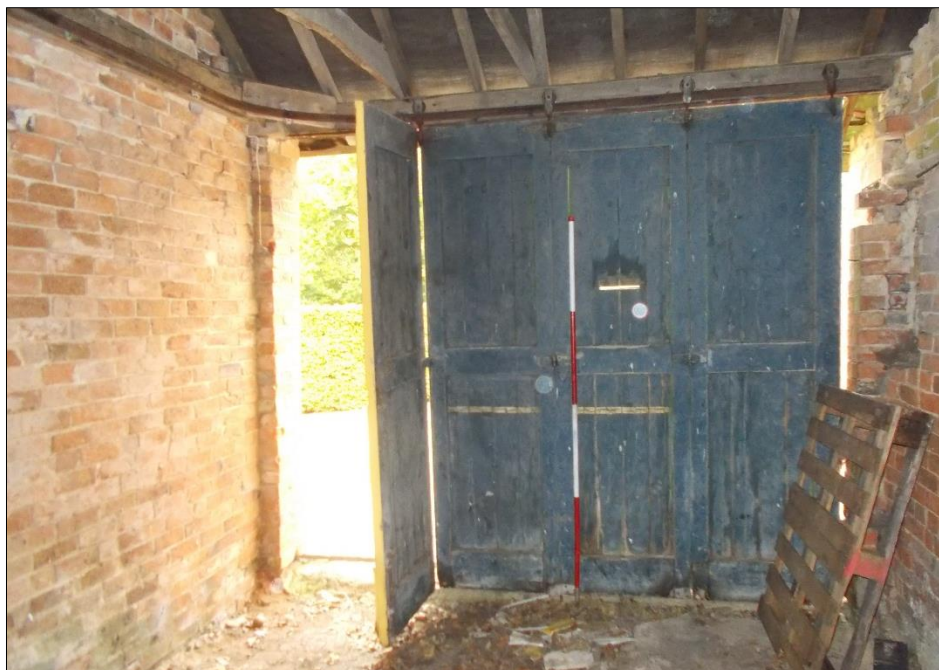
Fig 11: The eastern room of the east range, showing the inner face of the sliding door and hanging rail. 2m scale rod.

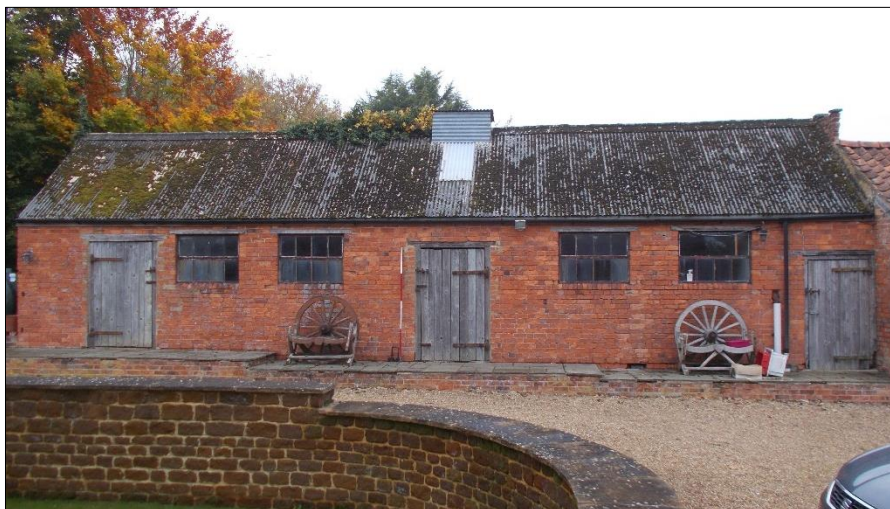
Fig 12: The west range, looking north. 2m scale rod.

This range does not appear in its current form on the OS map of 1884 and appears to be a later rebuild of a single phase. Stylistically it most likely dates from the 1930s.

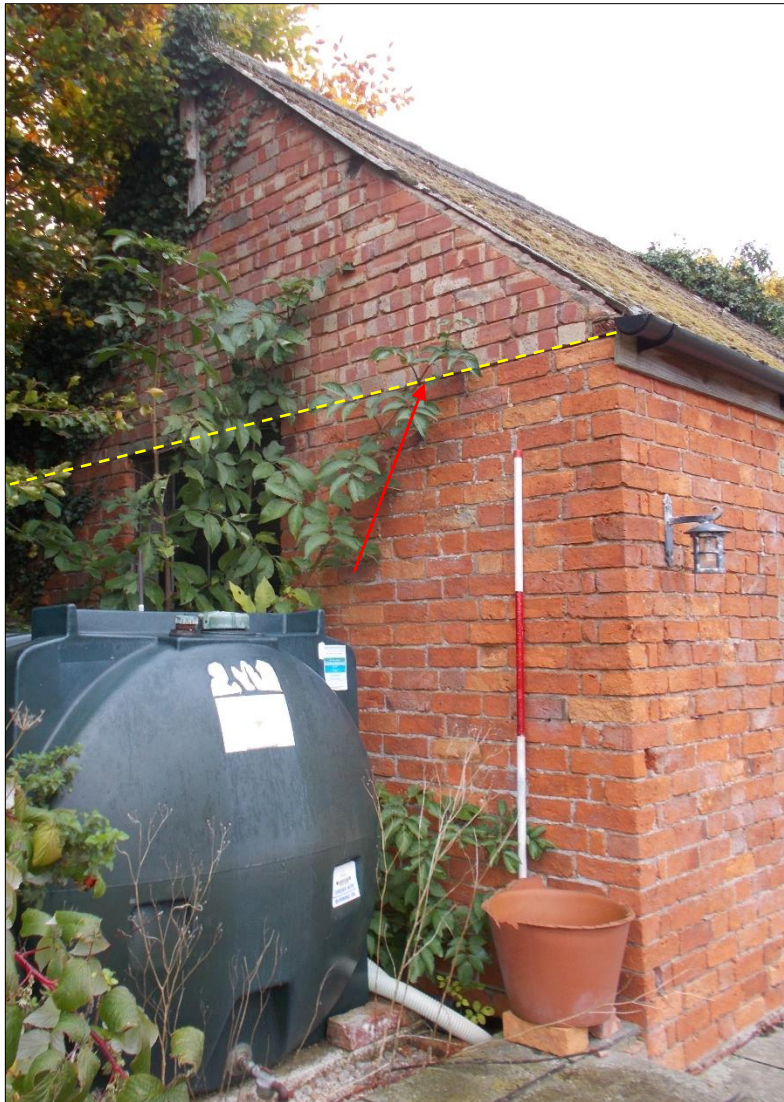
The roof covering, as mentioned above, is currently corrugated asbestos sheeting and is clearly a secondary replacement. Central to the ridge is a raised section, now entirely covered with corrugated metal sheeting but which originally may have comprised a louvered ventilation device. There is also evidence that much of the west gable wall has been rebuilt since the upper section is made from Fletton or common brick (Fig 13).

Fig 13: The west gable showing the upper re-built section (above yellow dashed line). 2m scale rod.

Similar evidence of rebuilding above eaves level can be seen within the internal dividing walling, suggesting that there was either a need through deterioration or some other unidentified desire to rebuild the upper part of the whole range. The current corrugated sheet covering is supported on flimsy pine trusses comprising a tie beam and two raking struts, each supporting a single principal rafter. The tops of the latter are fixed together with triangles of plywood which in turn support a ridge plank (Fig 14). On each side is a single purlin and there are no common rafters apart from where they are necessary to support the sides of the single roof light simply fitted with a sheet of clear corrugated plastic or polycarbonate (see Figs 12 and 14). The same roof structure and covering extends long the whole range.

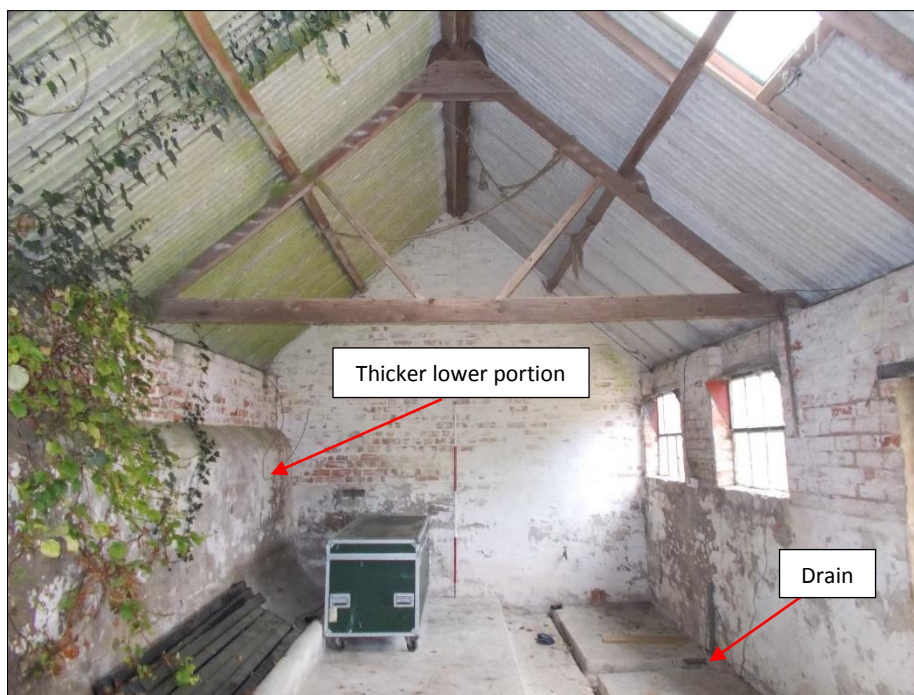
Fig 14: The interior of the central section of the east range, looking east. 2m scale rod.

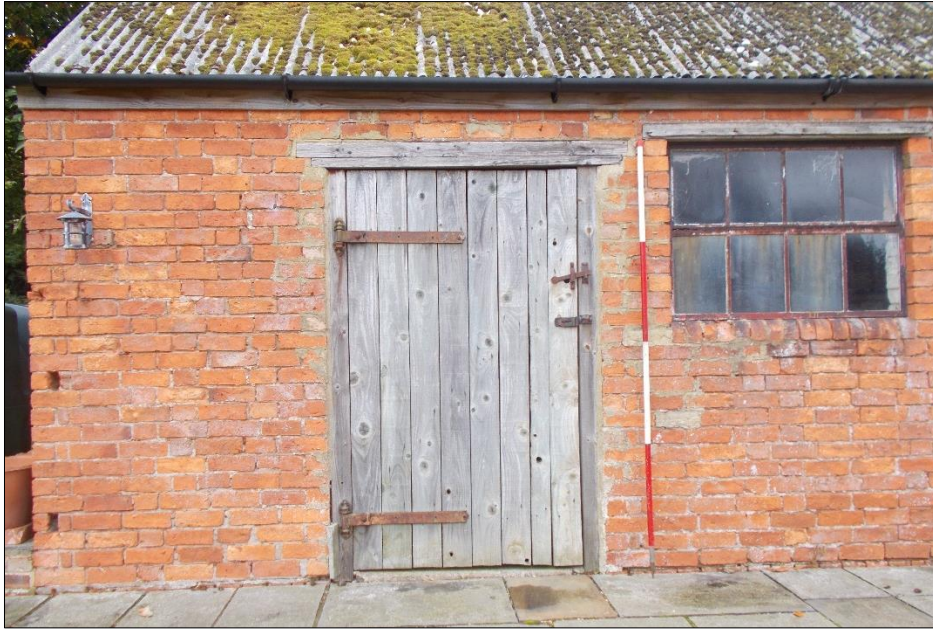
Fig 15: An example of the door and window furniture of the east range, looking north. 2m scale rod.

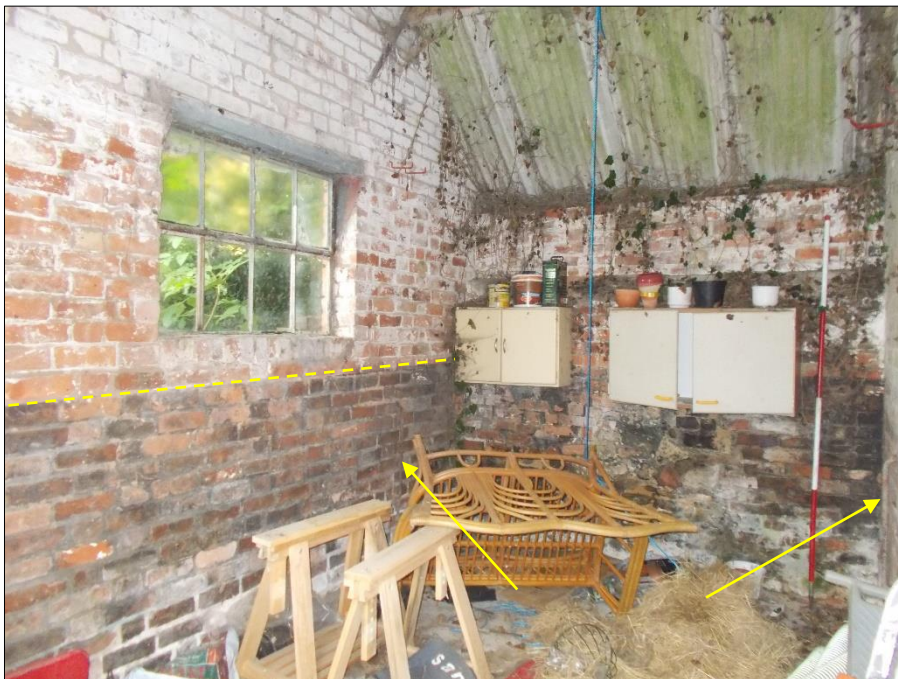
Fig 16: The west room of the west range, looking north-west. 2m scale rod. Tethering bars arrowed.

The partially rebuilt west gable wall is evident, although on this internal elevation the re-build commences from a lower level, two courses below the window sill (Fig 16, yellow dashed line). The lintel above the window is of concrete. The iron window frame is a single-unit construction which appears to have originally been galvanised, though is now extremely rusty. It contains two rows of

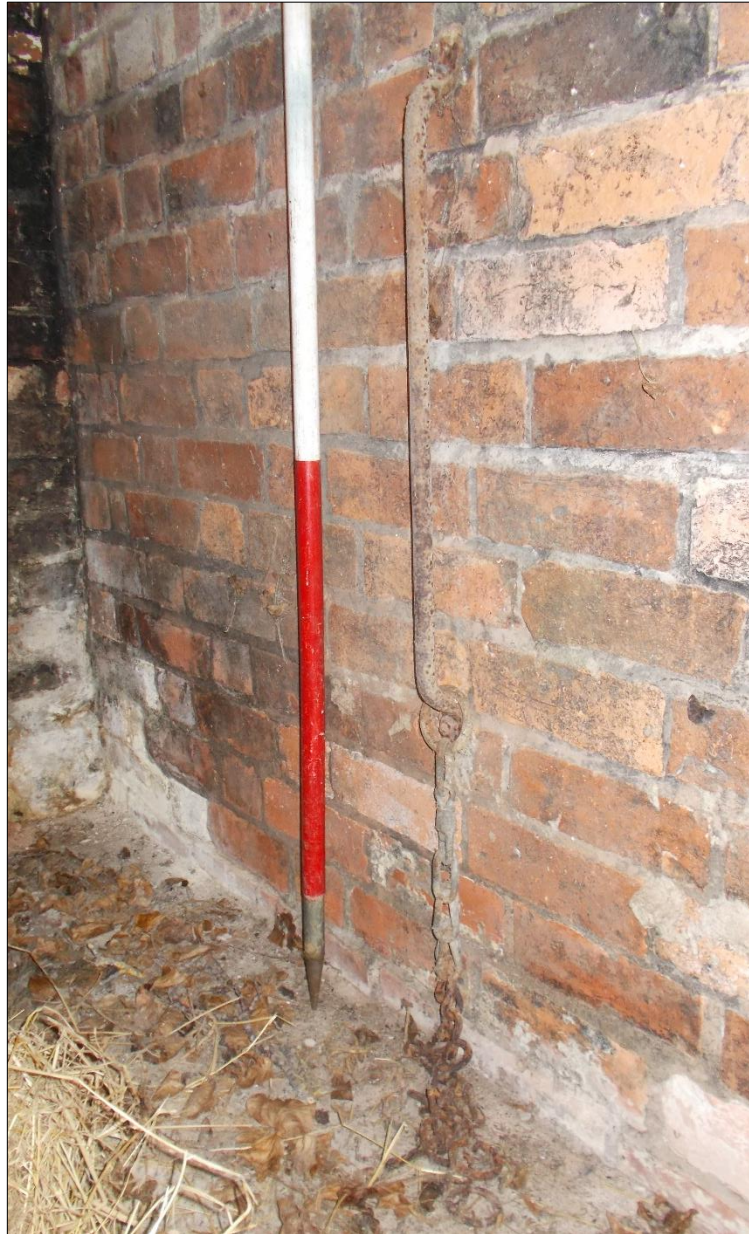
Low in the west and east walls are vertical tethering bars, both retaining their tethering chains (Figs 16 and 17). These indicate that the room could accommodate two beasts, though the low setting suggests they were most likely calves not full-grown cattle.

Fig 17: A tethering bar and chain in the west room of the west range. Scale in 50cm sections.

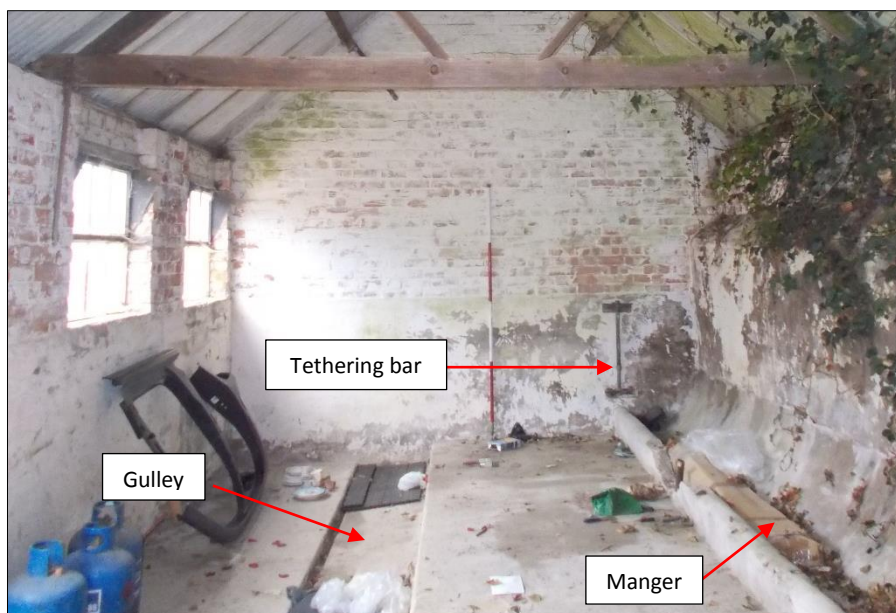
Fig 18: The interior of the central room in the west range, looking west. 2m scale rod.

That manger is unusually low for cattle and suggests, as do the tethering bars in the west room, that this space may more likely have been used to accommodate calves rather than full-grown cattle. Similarly, the location of the drainage gully at the foot of each former stall suggests a relatively short beast (the length is 2,10m, 7 feet). That gully falls gently towards a short spur on the south side of the room before passing through the south wall to the exterior (see Fig 14).

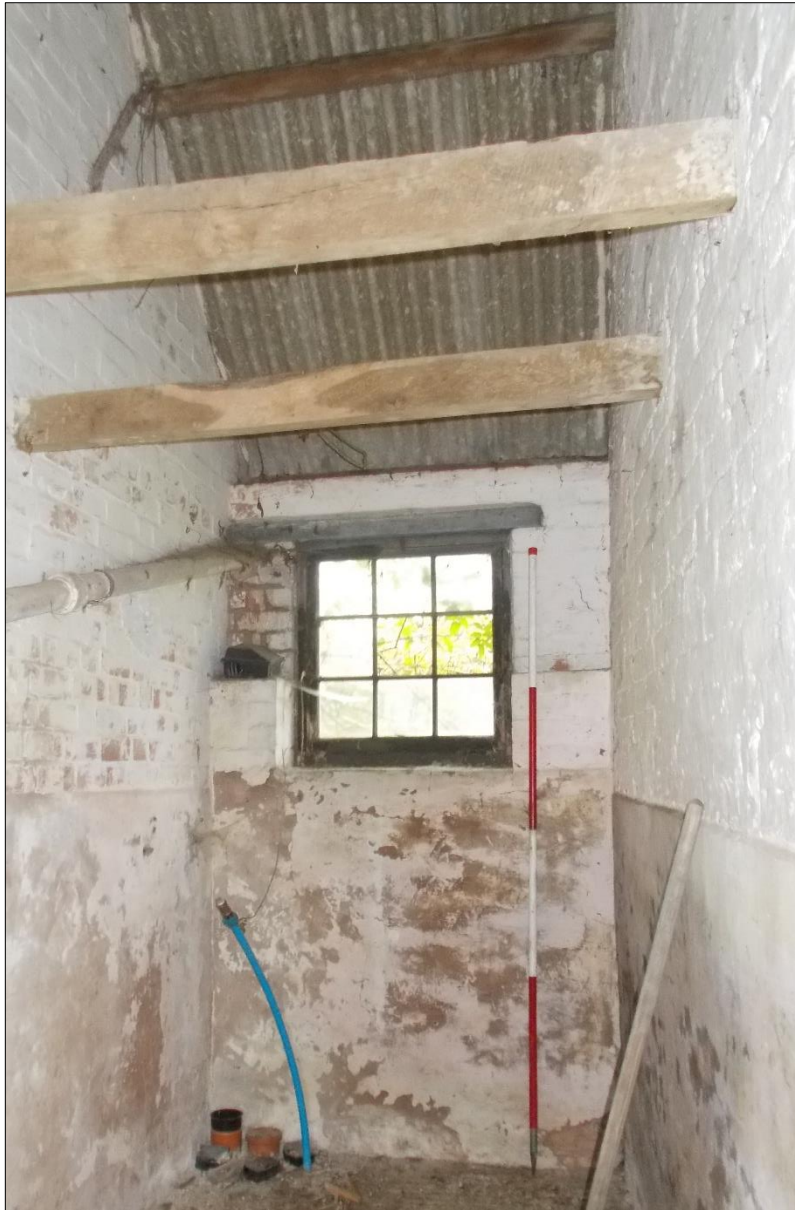
Fig 19: The eastern room of the west range, looking north. 2m scale rod.

There are two horizontal timbers set into the west and east gable walls of uncertain purpose (Fig 19). Apart from these and a cast-iron downpipe which must serve guttering along the north side and which falls towards the south, there are no fixture or fittings other than a modern water pipe and tap.
