**An archaeological building record of former barns at
Marstan House Farm, Hannington, Northamptonshire.**

Marstan House Farm barns, Hannington

A group of farm barns located just off the A43 Kettering Road in the eastern part of the parish of Hannington, Northamptonshire has been recorded to Historic England Level 2 by Iain Soden Heritage Services for new owners prior to their proposed conversion for residential use, the work taking place in response to condition 8 of planning consent DA/2018/0967 (NGR: SP 82477 70841; Fig 1).

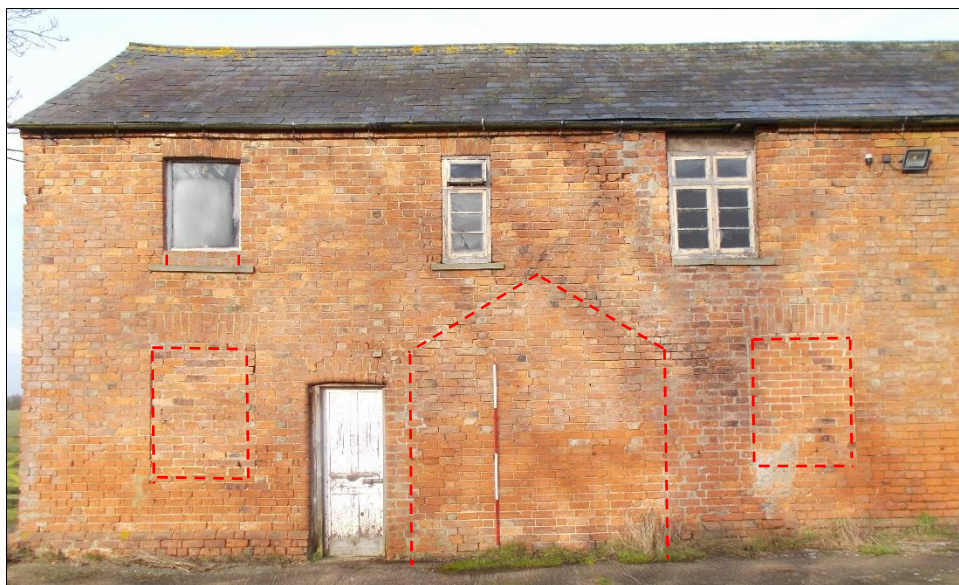
The former farmhouse was served by an off-centre door facing east to the south of the former building (possibly a wash-house or laundry) which was constructed against this elevation (see Figs 3 and 4) but has since been removed. However, the scar of the roofline and poor-quality patching with hard cementitious pointing suggests the locations of the north and south walls (Fig 7).

Fig 7: The farmhouse showing scar of former single-storey range, infilled ground-floor windows and reduced first-floor window (red dashed lines), looking west. Note stone sills to first-floor windows. 2m scale rod.

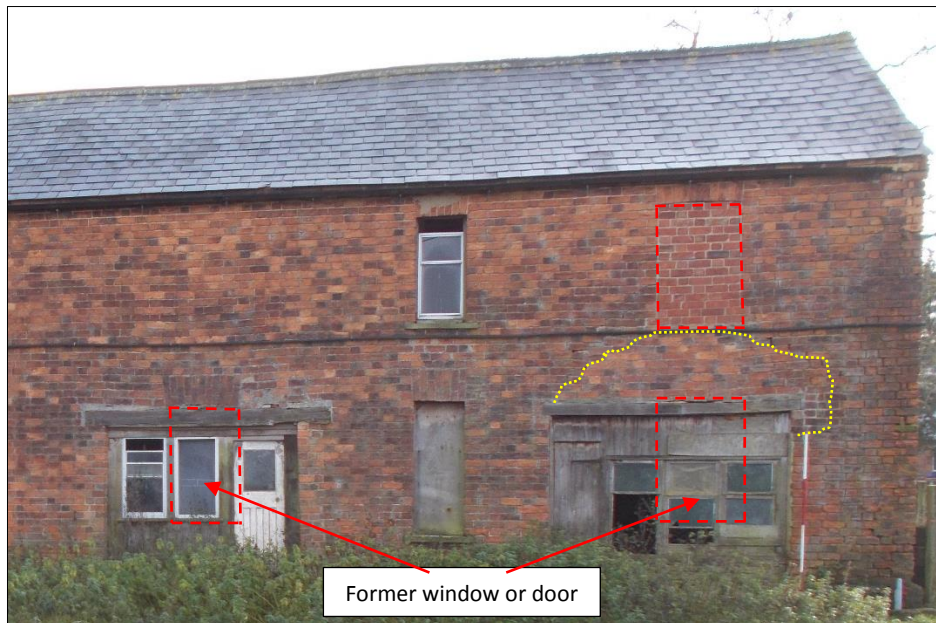
Fig 10: The former farmhouse, west elevation, looking east showing alterations. Red dashed lines indicate former openings, yellow dotted line indicates re-built walling. 2m scale rod.

To the north and south large openings have been created which have removed the majority of the ground-floor walling when the lower floor rooms were used to house chickens. Both openings have had crude and sagging timber lintels inserted which have removed all traces of the original

construction but the edge-laid bricks forming the lintel of a ground-floor window or doorway remains to the north (see Fig 10, left side). The fact that the surviving voussoir section is wider than the narrow window lighting the under-stairs cupboard, but narrower than the surviving window voussoir, might suggest it was for a doorway. The southern opening has caused even more damage to the original brickwork and there are no surviving indications of any former openings, though it seems likely that there was a similar window beneath that which survives at first-floor level (see Fig 10, right side).

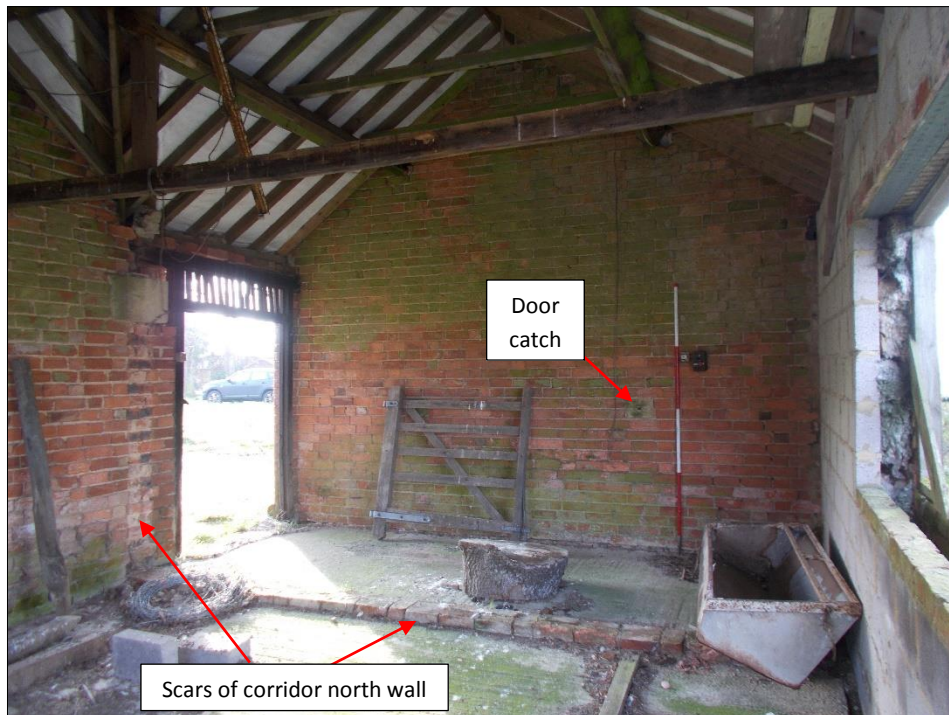
The corner room, shown on the early mapping, has been partly re-built but remains incomplete (see Fig 3). The original configuration of doors and windows is now unknown since both the north and west walls have been entirely re-built, but it must be assumed that at least one was present. The line of the former corridor can be seen in the wall line still present in the floor and the east wall (Fig 14).

Fig 14: The corner room, looking south-east. Note scars of former corridor wall and breeze block re-build to right. 2m scale rod.

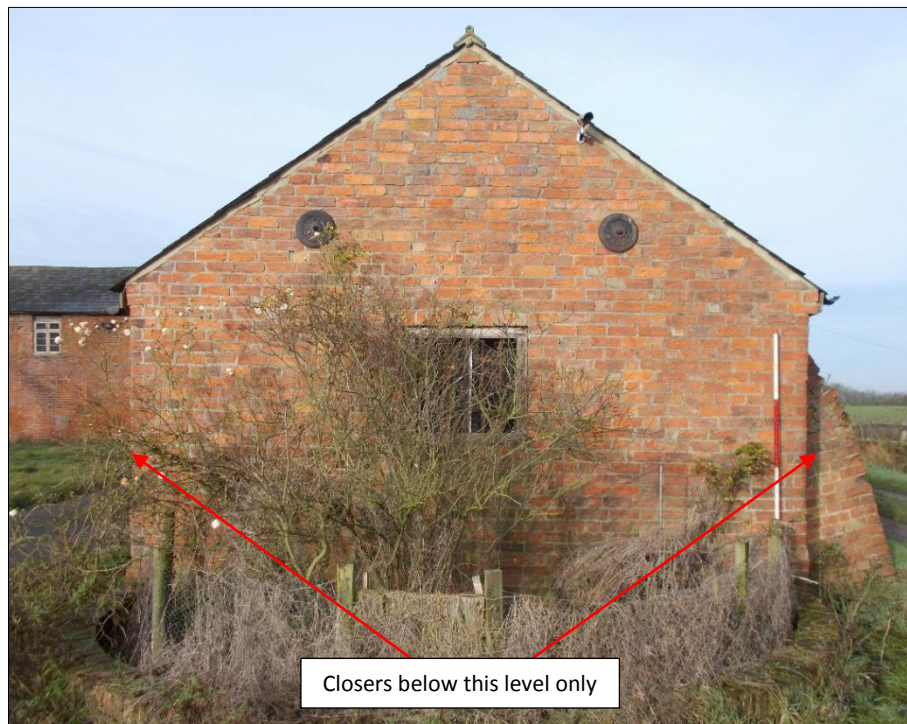
Fig 16: The eastern range, east gable wall, looking west. 2m scale rod.

It appears that the upper part has been re-built, although using the original bricks, since there are no closers above sill level (Fig 16). This also explains why the window has no real lintel, simply a row of edge-laid headers across the top of a replaced window frame. Above this two circular iron plates suggest there has been structural difficulty, as do buttresses along the north elevation (fig 17).

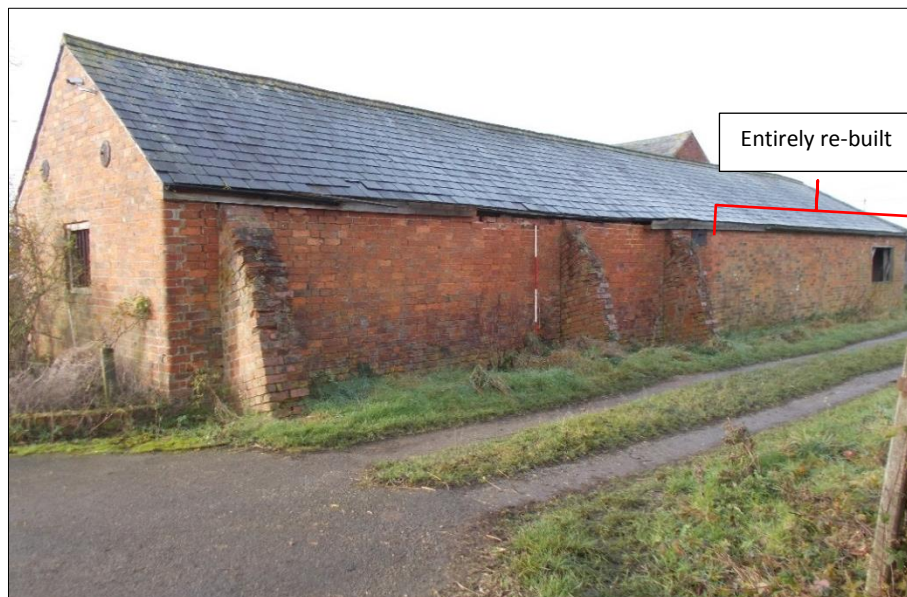
Fig 17: The north elevation of the eastern range, looking south-west. 2m scale rod.

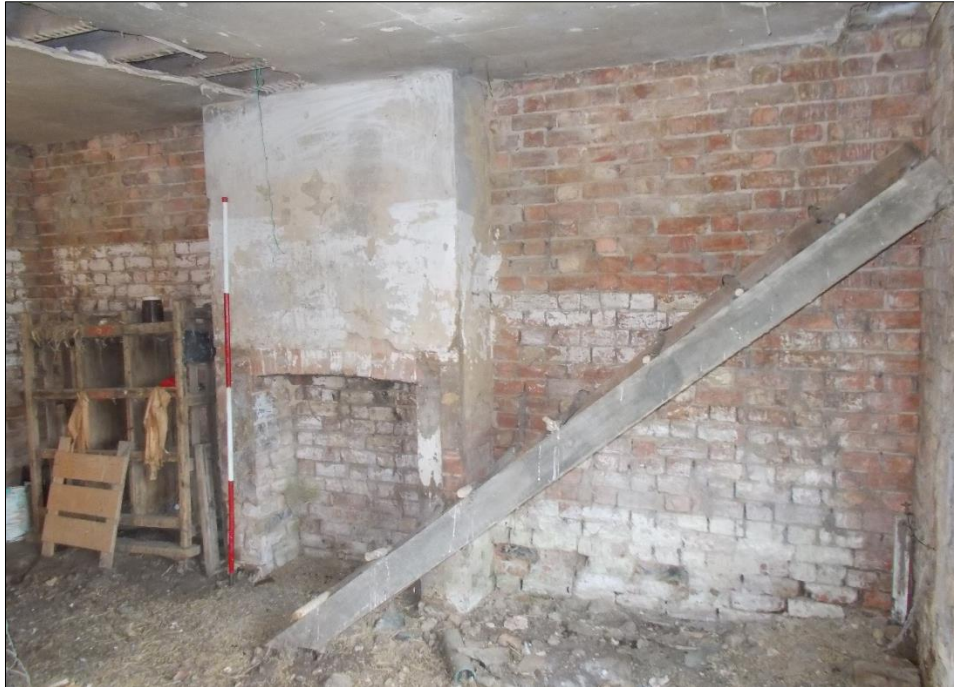
Fig 18: Room G1, the former farmhouse, looking south. 2m scale rod.

The room has either lost, or had removed, the majority of the plaster so that the brick structure is now exposed, apart from the chimney breast. This also contains scars of the fireplace jambs, perhaps like those present in room G3 (see below). The grate is no longer present.

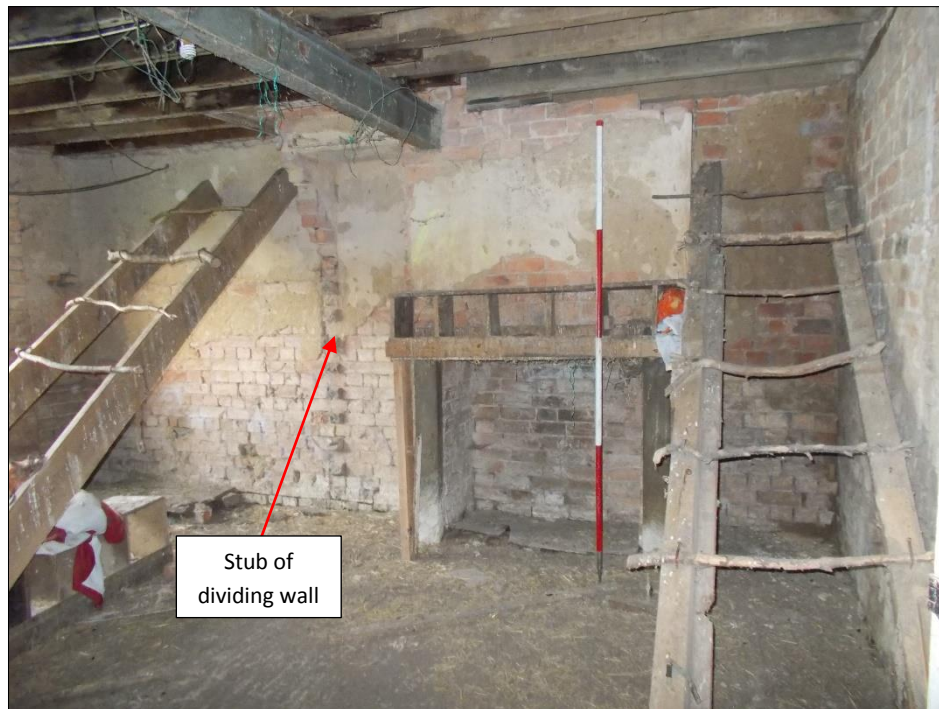
Fig 20: Room G3, looking north showing former fireplace and dividing wall. 2m scale rod.

An H-section RSJ (rolled steel joist) has been added to support the joists of the flooring above, perhaps following the removal of the dividing wall (see Fig 20). To the east of this steel joist the majority of the current joists are of modern Far-Eastern timber, many stamped with 'F D KERUING PRODUCT OF MALAYSIA' and a series of numbers, perhaps batch numbers. Keruing is a type of timber (*Dipterocarpus*), a medium hardwood much used in construction. Its use here most likely results from leakage before the roof was re-covered, although an exact date is unknown.

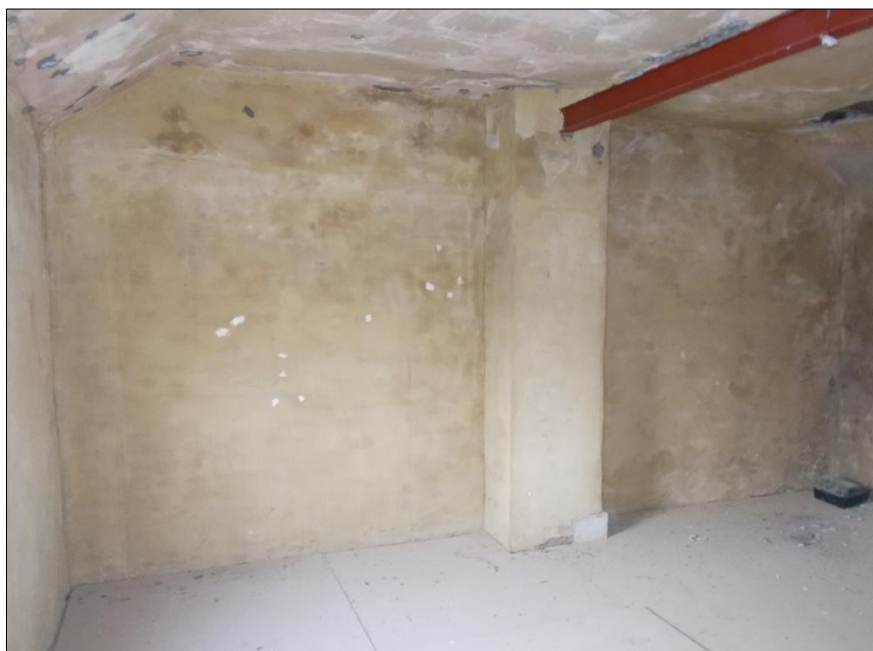
Fig 22: Room F2, looking south showing chimney stack from G1 below. Note modern RSJ.

Much of the wall plaster has been removed and replaced, though most of the ceiling-plaster remains. For reasons which are not obvious, a modern RSJ has been positioned across the ceiling, presumably due to failure of the joists there (see Fig 22).

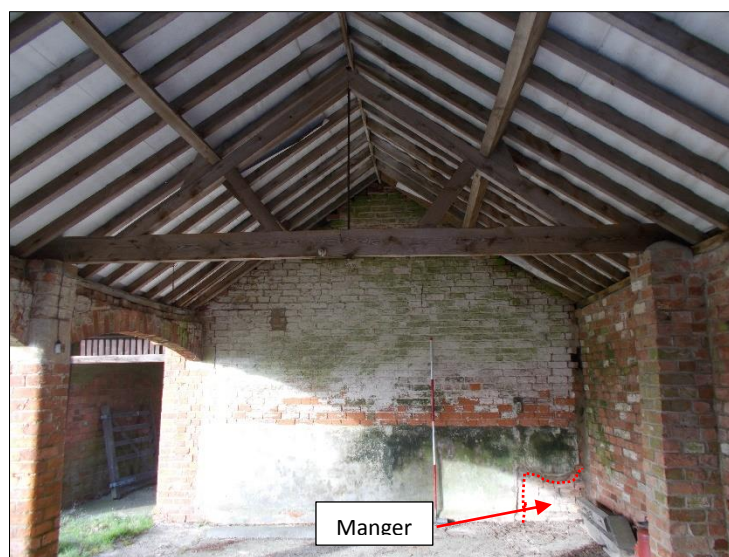
Fig 27: Room G6: The former livestock hovel, showing scar of former manger (red dotted line) and roof truss. Looking west. 2m scale rod.

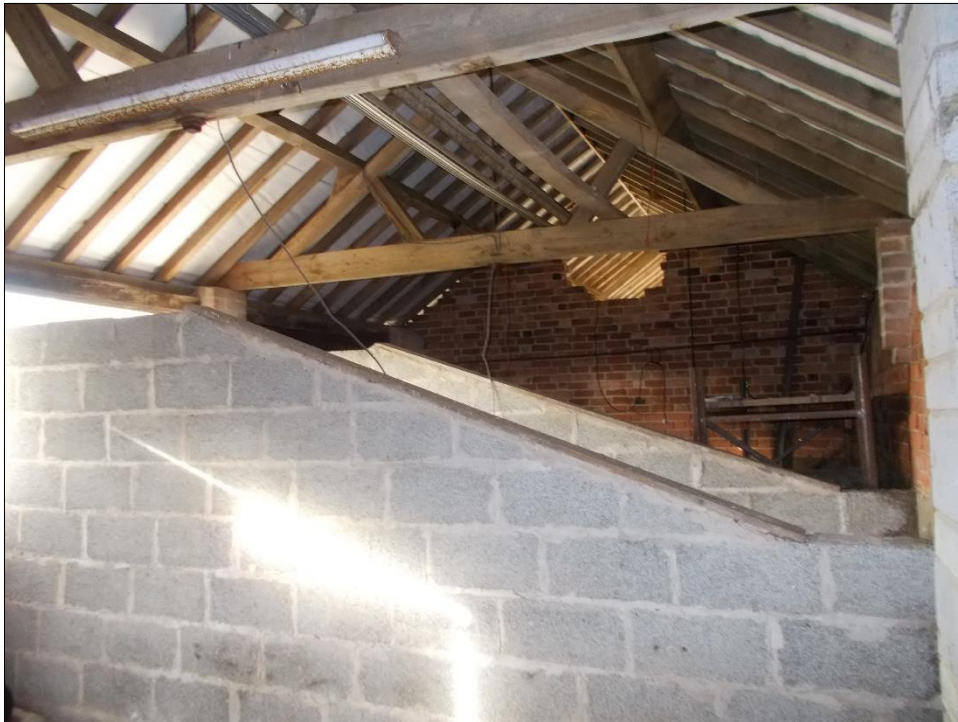
These three rooms are re-configured spaces and contain modern block-work dividing walls and modern brick piers along the south side, all fitted with contemporary timber doors or, in the case of G8, a partly open block-work wall (see Fig 15). None contains any historic detail apart from the roof structure which is the same as that visible and previously described above G6. This is partly supported on a breeze-block pier in G9 where the north wall has fallen outwards (see far right in Fig 28).

Fig 28: Rooms G9 (foreground), G8 (between breeze-block sloping walls) and G7 (beyond far sloping breeze-block wall). Looking west.
