# OLD PLACE, PULBOROUGH

By V. W. TYLER

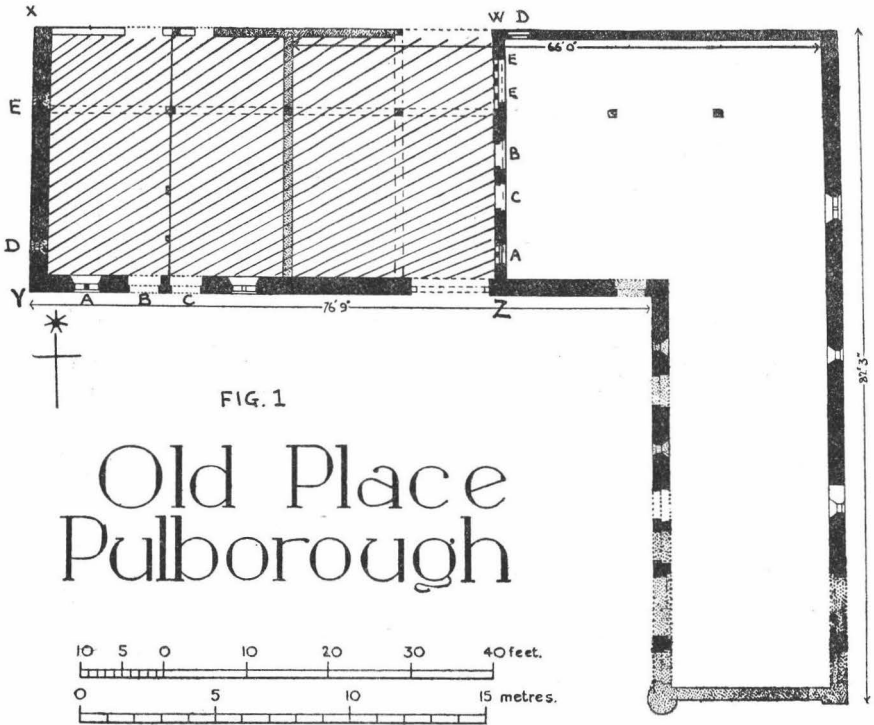
FIG. I.—Plan showing alterations. This should be compared with the plan in *S.A.C.*, vol. 70, p.122.

In the accompanying plan (Fig. 1), which is taken from that in Mr. Peckham's article (p. 122), the area, W, X, Y, Z, shaded with diagonal lines, represents the portion demolished. The windows and doorways A, B, C, D, E, in the demolished part are shown in their new positions in the new wall WZ, which was built entirely out of material from the portion removed. In this connection it should be explained that, in order to have a wide window here for the admission of light into the interior, only the stones of the sides of window E (shown in the new position as EE) were used, a horizontal stone lintel being built to join them. For a similar reason window D at the eastern end of the south wall was widened by the insertion of a stone at the apex of the arch.

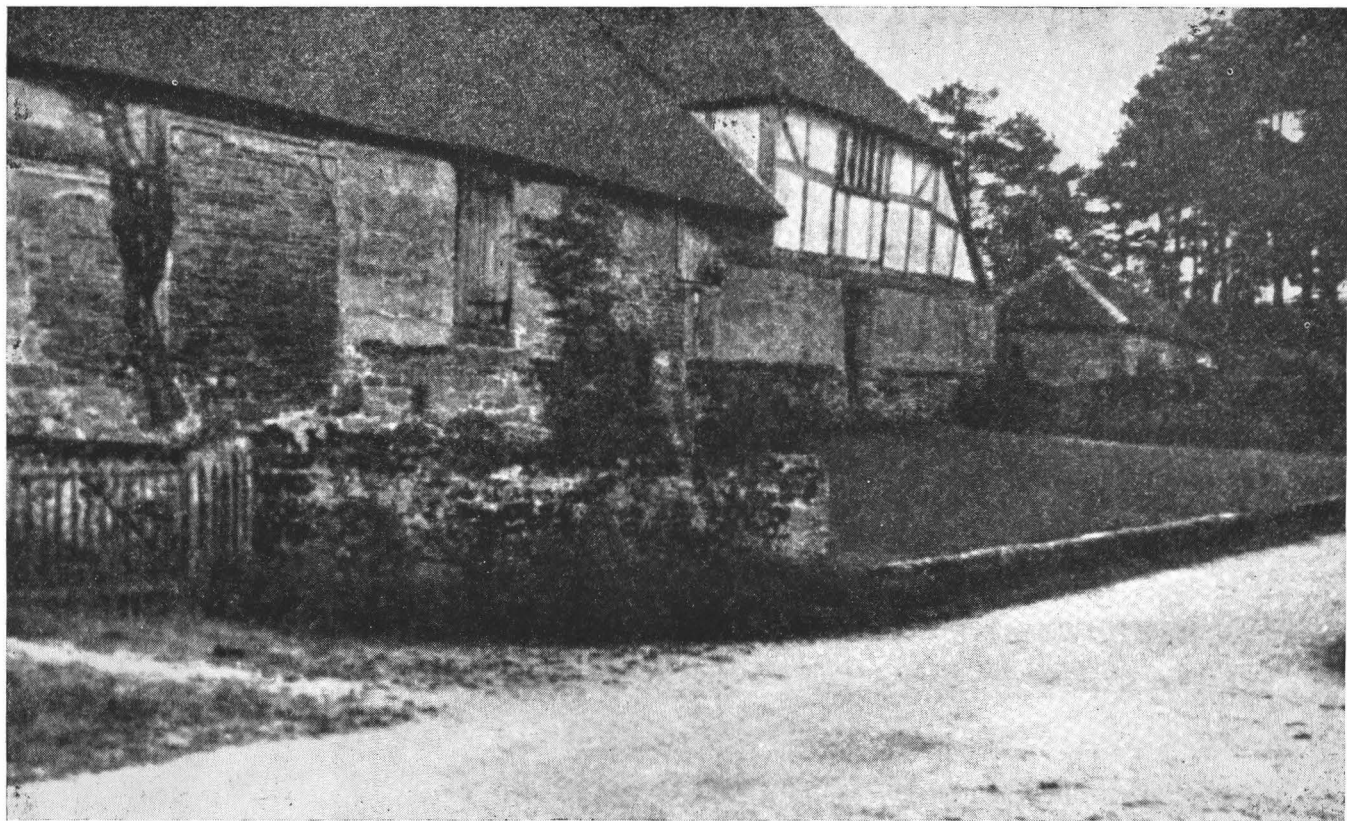
PLATE II. OLD PLACE. View from north-west before alteration

It will be observed from Plate II that the west wall before restoration contained no windows at ground floor level, the only openings being the doorway mentioned by Mr. Peckham on p. 123 and two holes broken through the wall for farming purposes. To provide the necessary light to the interior, the windows shown in Plate IVa and b were inserted. These were all made locally of oak to the same design and as nearly as practicable to the measurements of two mediaeval windows incorporated in "the House." A similar procedure was adopted for the windows D and EE in the reconstructed east and south walls, mentioned previously and shown in Plate V. From these photographs it will be seen that the string course and the best-preserved of the oak-mullioned windows, drawings of which appear on page 126 of Mr. Peckham's article, were again utilised. Other than in the cases mentioned, no alterations were made in the existing windows, which were merely filled with leaded glass.
