# TWO TIMBER-FRAMED HOUSES IN CHESTER

# by J. C. Grenville and R. C. Turner

# (i) 1 WHITEFRIARS, CHESTER by J. C. Grenville

# (ii) 23, CASTLE STREET by R. C. Turner

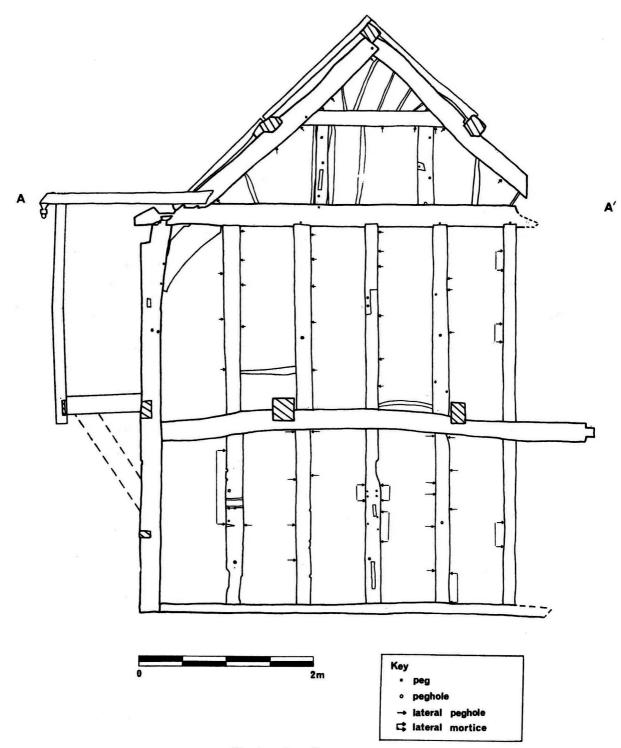
Fig. 1 — East Truss at A—A'

# The east cross-frame (Fig. 1)

The dimensions of the cross-frame are c. 5.4 m. (17'5'') in width and c. 6.9 m. (22'8'') in height. The height of the first floor is c. 2.12 m. (6'11'') from floor level. It is intact except for the loss of its southern post, which was still in situ in early 1987 but was performing no structural role having been severely disturbed by the insertion of the brick chimney in the south-east corner of the house, probably in the mid 17th century (see below for a discussion of the development of heating arrangements). It was therefore removed before restoration work began although its position may easily be projected.

The cross-frame stands on a sleeper wall of rubble with two upper courses of hammer-dressed local red sandstone which carry a scarfed groundsill, into which the northern post is morticed. Presumably the same arrangement obtained at its southern end. The bressumer at first floor level has a steep camber which is, perhaps surprisingly, not reflected in the tie beam above. At its north end the tie beam is secured to the post by means of an arch brace: we may postulate a similar arrangement at the southern end.

The beam, post and wall-plate were secured by the very commonly-used tiebeam lap-dovetail assembly, which in this case can be closely observed because of the removal of the wall plate at the time of the addition of the jetty and the subsequent rotting away of the timbers to reveal the internal mortices and tenons. The studs, of which there are five to each storey, are affixed by means of morticeand-tenon joints, although not all of these are pegged. Some, notably the first from the north on the ground floor, and the second from the north on the first floor, appear to be re-used, that to the ground floor having mortices and pegholes

The roof structure of this cross-frame differs from that of the other cross-frame and this may hold some significance for the early heating arrangements. One principal rafter is bridled into the other at the apex to form a cradle into which the ridge is laid diagonally. Roughly-cut purlins are trenched into the backs of the principals, that to the north additionally secured by means of a free tenon. Smaller common rafters overlie the purlins. The method of their fixing at the apex is not visible. There is a collar, surprisingly set slightly above the level of the purlins and therefore offering them no support, itself supported by queen struts both of which carry mortices which will be further discussed in the section on heating arrangements. Sawn stakes, some vertical, some inclined, to carry the infill panelling, complete the framing of the cross-frame. The positions of missing stakes can be inferred from the auger holes marked on fig. 1.

The jetty: the eastern cross-frame is the only one in which the relationship of the jetty to the main building can be traced. It is quite clear that it is an addition. In an integral jetty the bressumer would surely have extended to carry the side wall of the jetty. Here the side wall is carried on a short member morticed into the corner post, at a higher level than the main bressumer. This poor piece of construction is further weakened by the failure in the west bay to run joists through from the main beam carrying the floor of the earlier structure. The wall-plate of the jetty is crudely nailed with iron nails to the inner edge of the principal structural weakness of the jetty was visually manifest at the time of the survey. An unsuccessful attempt to prop it has been made with the insertion of braces, probably in the 19th century but certainly before 1848 (Fig. 11). Although jerry-built, the jetty is a structure of some pretention with a carved fascia board bearing the initials R and JM and pargetting to its panels and gable ends, surviving to the east end. There is no reason to doubt the date of 1658 on the east gable.

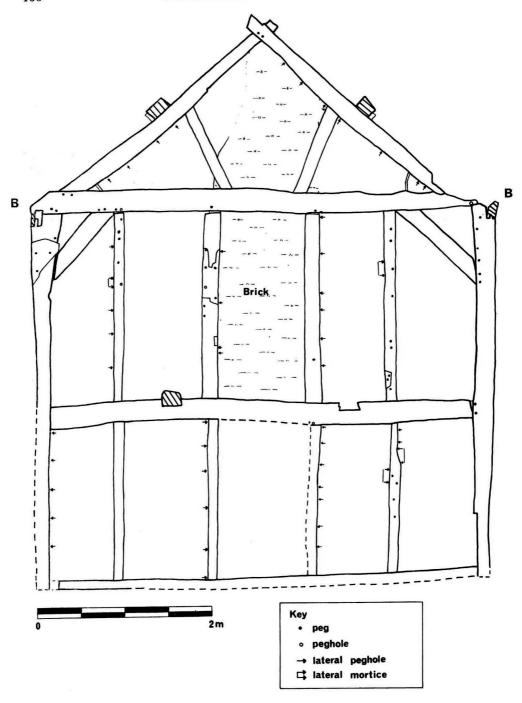
Fig. 2 — West Truss at B-B'

#### The west cross-frame (Fig. 2)

In essence this cross-frame is similar to that already discussed, being of post-and-truss construction with a principal rafter roof. It differs, however, in certain details. Although similar in width, it is slightly lower, at c. 6.6 m. (21'8"). This is almost certainly to take account of the slightly upward rise of the ground to the west. There are four studs, as opposed to five in the east cross-frame. The southernmost studs on both floors contain mortices which are not readily explicable

but may represent the position of doorways. The bressumer is not cambered. A particularly interesting joint may be observed in this bressumer, where the southern floor beam has been removed to allow the insertion of a later stairway. The empty slot revealed shows that the lap joint was double-dovetailed, on two levels and was also slightly wider at the bottom than the top. This is a complex joint and not one which would have been easy to frame once the bressumer was in place. It is the first piece of evidence to suggest that the first floor is integral with the building. This contention will be discussed in further detail below. The tie beam is supported by straight rather than arch braces. The tie-beam lap-dovetail assembly may once more be clearly observed to the north, but has rotted to the south.

The roof structure of this cross-frame is rather cruder than that of the east cross-frame. The principal rafters cross over and are halved and pegged, rather than bridled and pegged, forming a cradle into which the ridge, now removed to make way for an 18th-century chimney, was laid diagonally. The purlins, laid diagonally across the backs of the principals, are not trenched, but simply secured by means of free tenons. There is no collar. Two angle struts support the principals, again above the level of the purlins. Two small stakes survive; pegholes for others are visible.

There are several points to notice about this cross-frame. Firstly, it is less well finished than the gable end cross-frame to the east. Secondly, its northern purlin projects c. 0.5 m. to the west. Thirdly, to its west and at right angles to it, fragments of a further cross-frame remain, one whose principal rafter was originally jointed at the junction of the southern post and tie-beam (Figs. 3 & 7). This cross-frame is very fragmentary, but is of similar proportions and construction to the west cross-frame. All these factors taken together suggest that the building extended further west and that this was an integral cross-frame. I would suggest, on the basis of the fragment of cross-frame aligned east-west and the general proportions of the surviving bays, that the building continued westward for at least a further two narrow bays, with a contemporary gabled wing to the south.

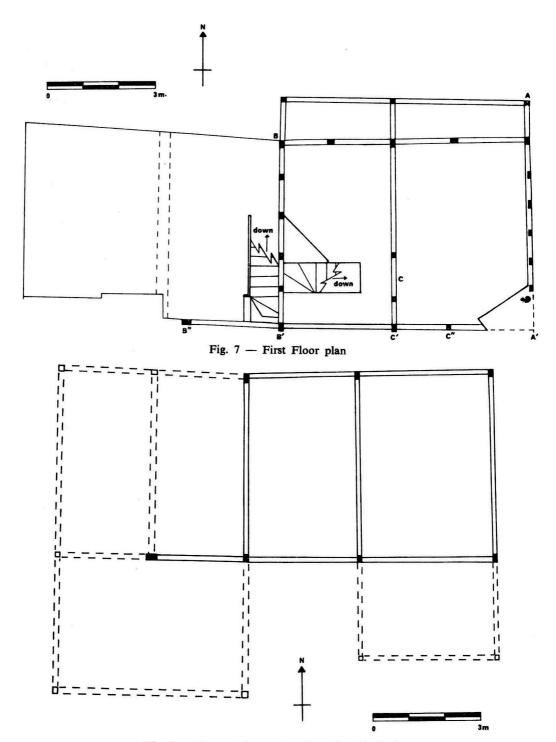
Fig. 8 — Suggested reconstruction of original plan

A study of the basic constructional details of the building suggests, therefore, a structure of at least four bays, parallel to the street with two rear cross wings. A suggested reconstruction of the original plan is shown in fig. 8.

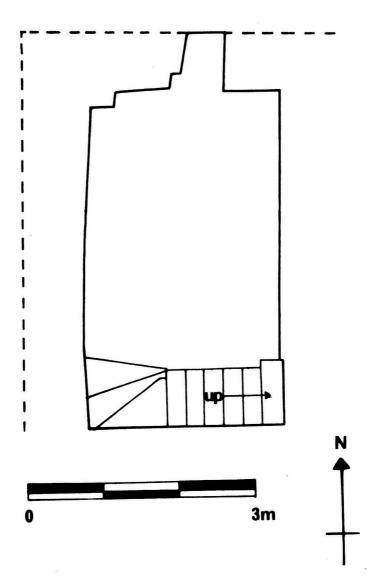
Fig. 9 — Cellar Plan

Some months after the original study of the building it was possible to examine the cellar in closer detail (Fig. 9). The posts and floor joists of the timber frame could clearly be seen to be structurally integral with the cellar walls. This can also be demonstrated in the front facade of the building. The partition at the head of the steps down to the cellar is of the same construction as that to the adjacent stairwell (i.e. 18th-century), suggesting that this access may be a later insertion. The present floor of the cellar, which seems to be bedrock for at least some if its extent, is 1.52 m. below street level. The walls are of roughly-dressed sandstone blocks of varying sizes, built up from floor level, implying that the cellar is not dug into bedrock. In the west wall five courses stand to a height of 1.17 m. while a 3 m. stretch of walling contains six blocks. Sizes of individual blocks vary from 0.22 x 0.22 m, to 0.75 x 0.20 m, and 0.64 x 0.14 m. There is a break in construction in the west wall approximately one metre from its southern end. Here the dressed blocks are replaced by random rubble and the wall shows a distinct bulge. This may represent a blocked doorway, implying original access from a cellar next door beneath No. 3, now itself inaccessible. In the north wall is an opening to the street with a deeply-splayed sill, flanked by well-cut (and possibly re-used) blocks, standing on their ends and measuring an average of 0.55 x 0.45 x 0.25 m. The east wall was unfortunately not available for inspection but is said to be of rougher construction than the west wall, and to contain some very large blocks.

A jetton or counting token was discovered in the loose fill of the north wall, bearing the stamp 'Hans Shultes in Nurnberg'. Dr. Lloyd Morgan of the Grosvenor Museum has dated it to the late 16th century. Bearing in mind the two caveats that although not satisfactorily stratified, its position within the wall rather than on the floor is suggestive, and although jettons, like coins, remained in circulation for a number of years, the piece provides us with a reasonably reliable terminus post quem for the cellar and hence for the building itself.

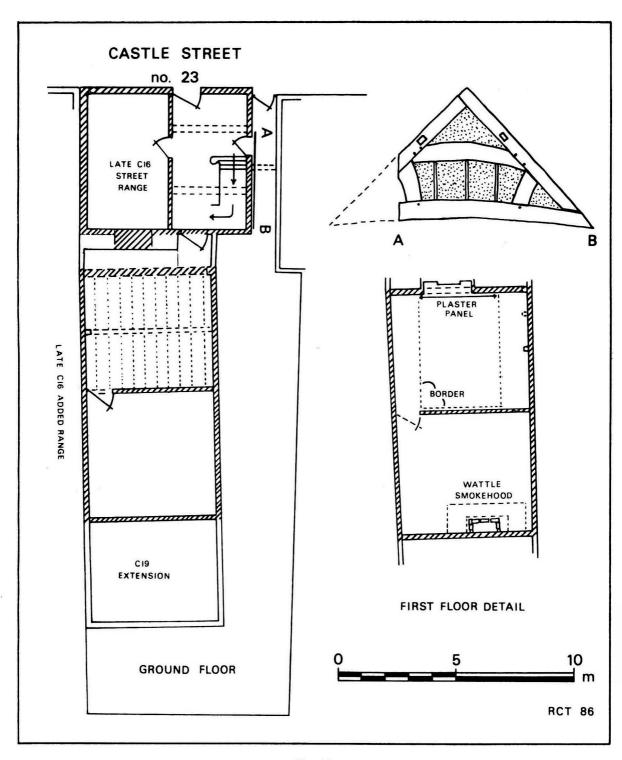
Fig. 11

In the room above can be seen the remains of a truss from the original building on the site. It formed part of the eastern gable and is of large, well-jointed timbers, with a canted tiebeam and collar, and two arched diagonal struts (Fig. 11). Despite its incompleteness, it shows that the early 18th-century facade was added to the front of the building, and the remainder of the timber framing must have been dismantled behind. The roof line has been carried up with brickwork to the

The main room on each floor is 5 m. long (Fig. 11). At ground level, it retains its ceiling consisting of a chamfered beam and chamfered joists, with fillet and tongue stops. One or two posts survive in the room above, as does the wall plate and roof trusses. The latter are simple, with a tiebeam, two diagonal struts and wind-braced purlins, and are filled with wattle and daub. The room retains an early plastered ceiling, with a moulded border at the level of the purlins, which is contemporary with a plaster overmantel at the north end. This overmantel is of three panels with the arms of Elizabeth I at the centre, a griffon carrying a helmet with Tudor roses and fleur-de-lys to the left, and a dog's head with similar additional details to the right (plate). Underneath is a restored or pastiche inglenook which contains a good but small sandstone fireplace, with a cyma-moulded square opening (jambs restored) and a cyma-moulded mantel shelf. The lintel has three raised and painted hatchments; all are halved with the wife's arms of the same family, separated by a line of roses. The fireplace is not in its original position and must have been introduced into the house with the mock timber framing of the 1950s. All this detailing was the work of Harry Brown, rebuilder of such historic properties as the Quaintways site (12-16 Northgate Street).
