## Completion Report

**Repair to Brickwork, Copings and  
Render to Garden and Hot House  
Walls**

**Pencarrow House  
Washaway  
Bodmin  
Cornwall  
PL30 3AG**

**March 2016**

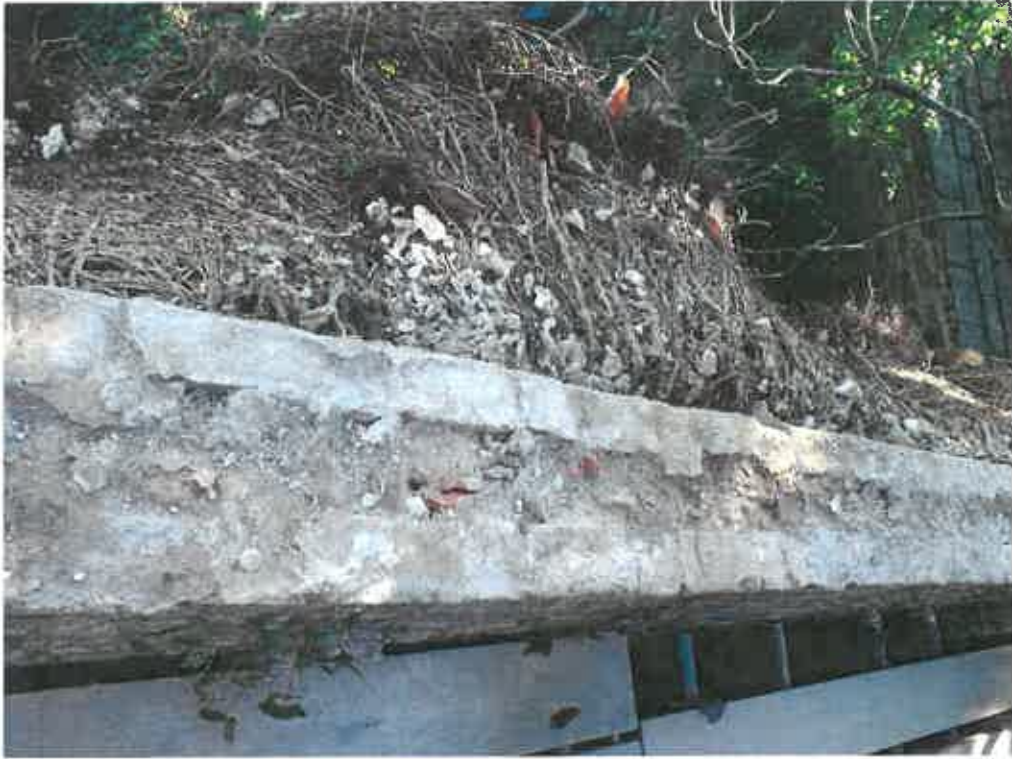
The brickwork walls running from Bay 9 to 16 were provided with scaffold on both sides and carefully had the vegetation removed from the head of the walls. It became apparent that on removal of the vegetation and plant growth that the wall was unstable and that large section of the pointing and mortar beds were coming away with the vegetation. It was therefore agreed that some additional buttress supports should be provided to the garden side of the wall to ensure the stability of the walls during the works. The long term stability of the wall was also a concern and it was agreed that initially the brickwork column between Bay 10 and 11 would be reduced down to the level of the stonework. It was hoped that by taking this down the column could be rebuilt incorporating stainless steel reinforcement to stiffen up the length of the wall. The column was supported and carefully taken down by hand, which then revealed a significant issue with the wall structure. The brickwork wall had

been built with predominantly snapped stretchers, which meant that effectively there were two separate leafs of brickwork with little tying the two together. In a normal garden wall the stretchers would be bonded across the two leaves of the wall providing a strong and uniform wall. In this situation the movement in the wall was exacerbated by the lack of full stretchers in the wall.

**Evidence of lack of stretchers to brick wall Bays 9 to 16**

The original scheme of works had come in under budget and therefore there was the ability to undertake and complete the repair works to leave the long term future of the secure. It was therefore agreed that the best way forward was to remove completely the brick walls from Bay 9 and 10 and then gradually step back up with the wall over the remaining bays. This allowed for the wall to be carefully taken down by hand and the bricks salvaged for reuse in the wall, with the wall then being rebuilt with the correct bond. The main issue in rebuilding the wall is that due to the high number of snapped stretchers there were not enough full bricks that could be salvaged to rebuild the wall. It was therefore agreed that the salvaged bricks could be used on the inside face of the wall and the new handmade bricks used on the outside face. The new brickwork has been rebuilt incorporating stainless steel bars tying in with the existing wall and new bed reinforcement thus ensuring a full and stable wall for the future.

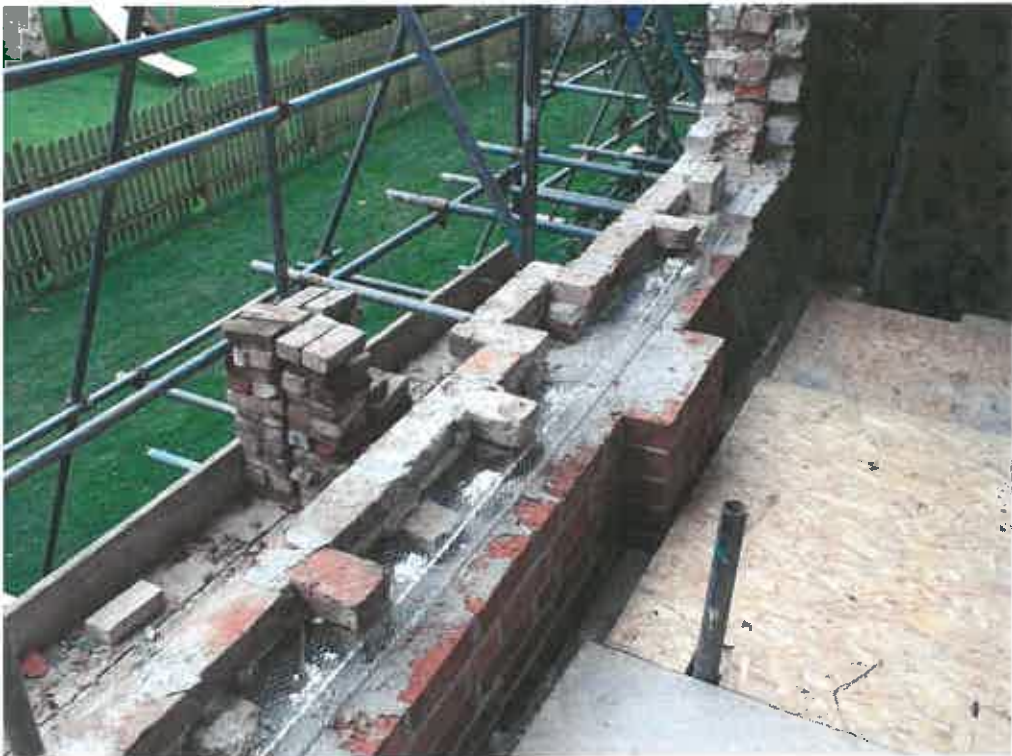
**Re-construction of the brick wall with stainless steel reinforcement**

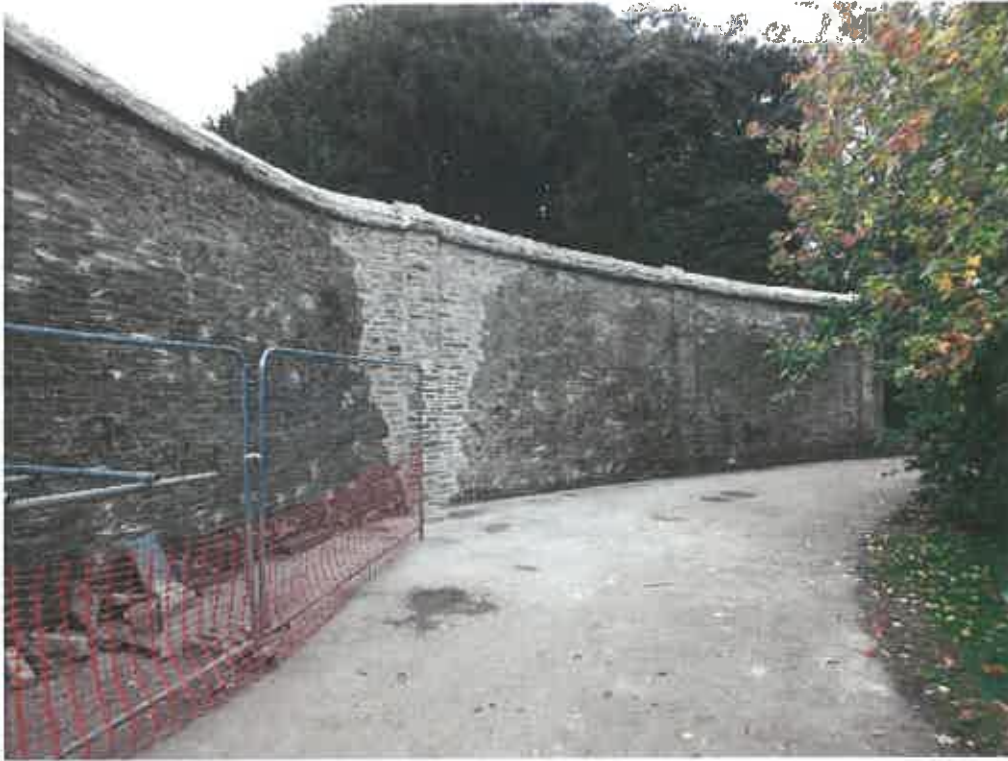
**Completed stitch repair to stone wall Bay 4 and 5**

The crack between Bay 4 and 5 was carefully taken down and it was found that the stonework in itself was in good condition. It was therefore agreed to try and retain as much of the historic fabric of the stone wall as possible and to minimise the amount of wall to be rebuilt. This approach allowed for a larger amount of the wall to be retained than had previously been envisaged. It was also found that at the base of the wall the ground was very soft and that this had probably contributed to the cracking and movement in the wall. A new stone foundation was built at the base of the wall and tied into the adjacent stonework with stainless steel twisted bars. The stone wall was then rebuilt with stainless steel bars inserted into the retained sections of the walls and the bed joints as the work proceeded, using where possible the retained stone work. This has allowed this section of wall to be rebuilt and tied back together, which is clearly shown on the recording drawings.

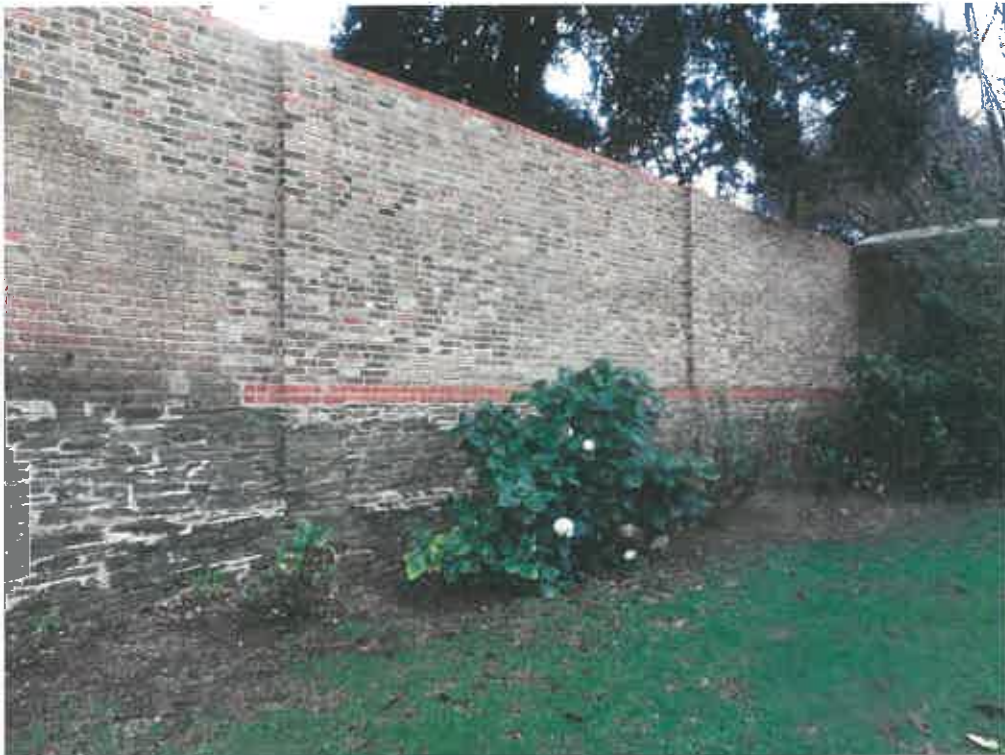
**Completed garden wall Bay 9 to 16**

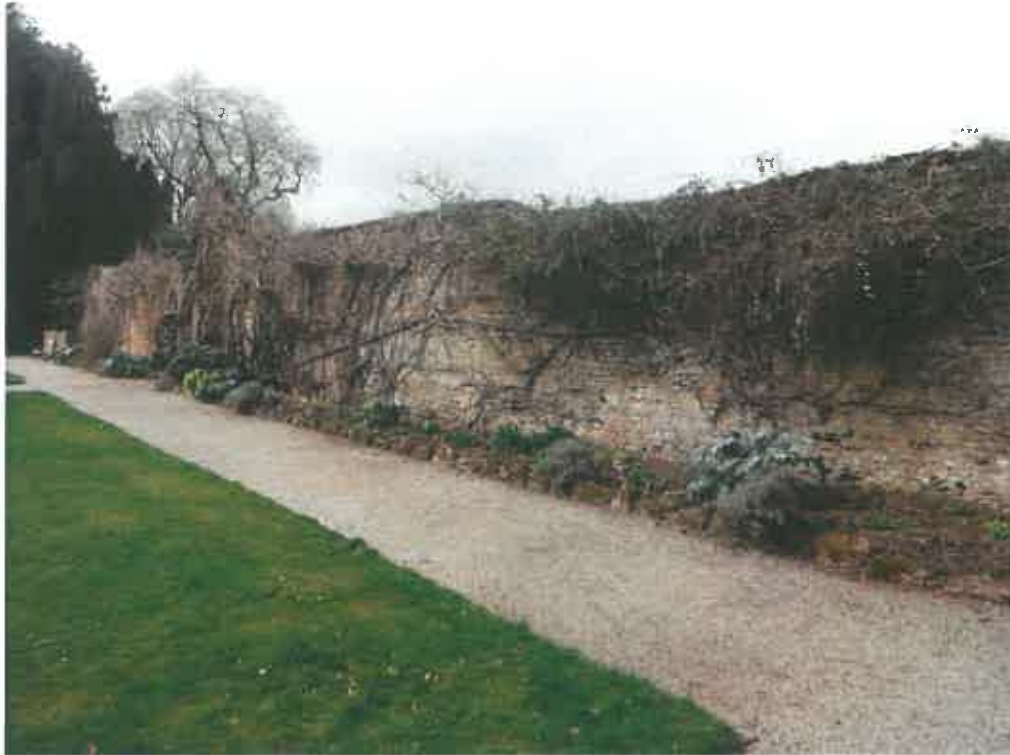
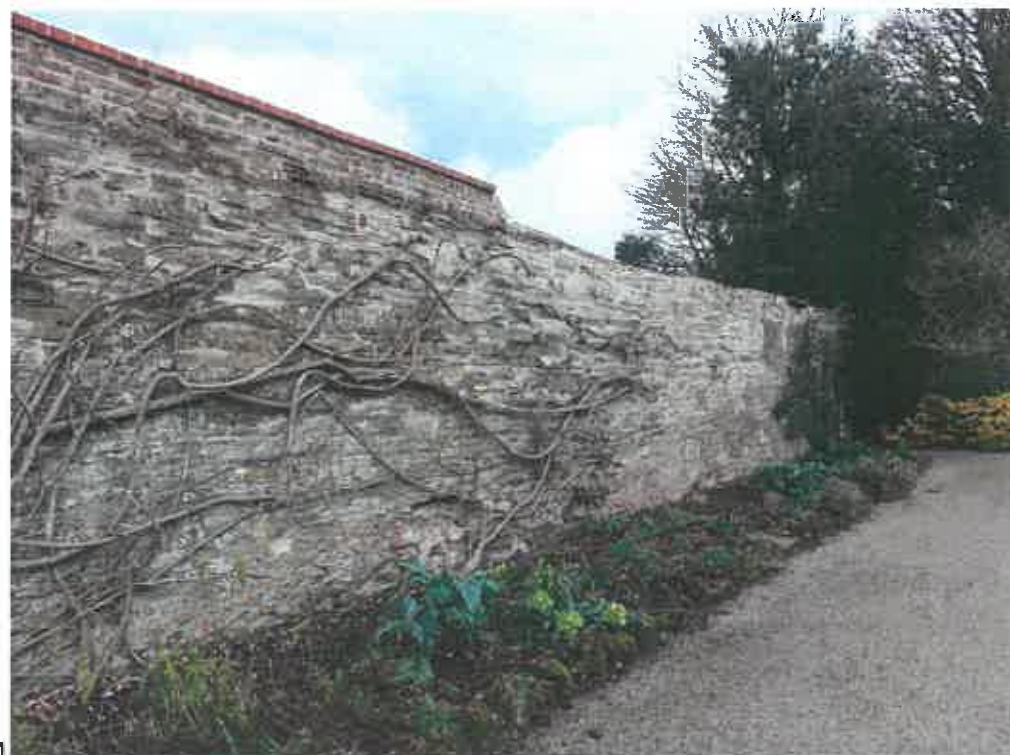
## Hot House Walls

**Hot House walls** – in this area it was clear that a section of the adjacent to the Old Plant shop had been badly affected by the weather and plant growth. It was clear that a section of the brickwork in this area would need to be carefully removed and rebuilt with the reclaimed brickwork to leave the wall in a good and sound condition.

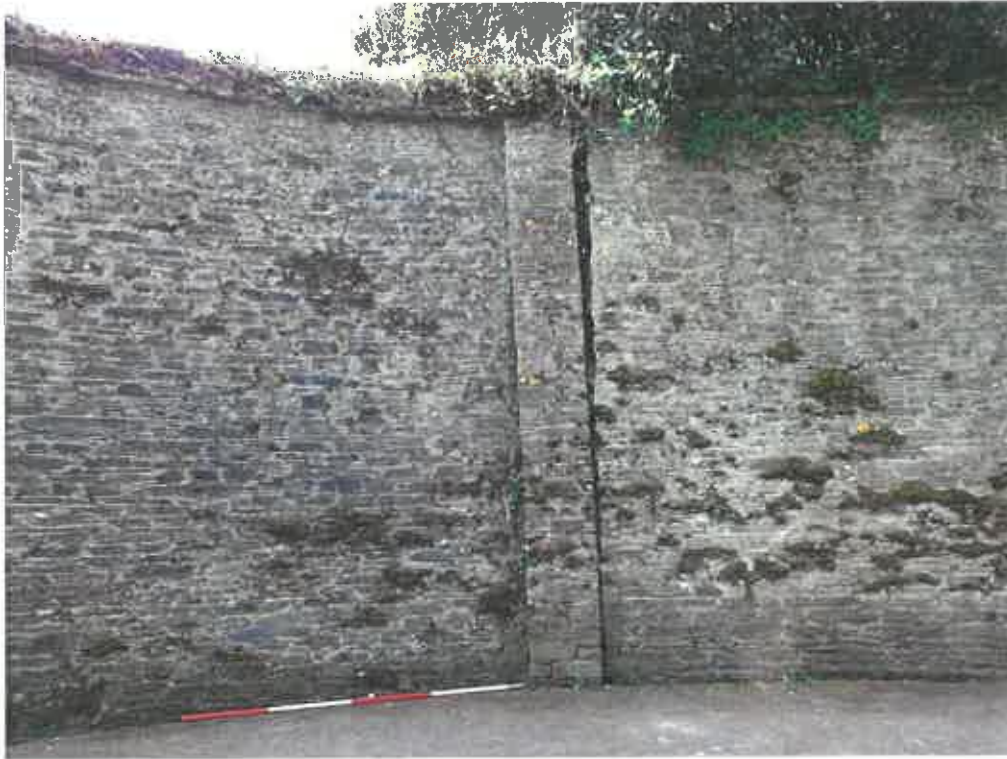
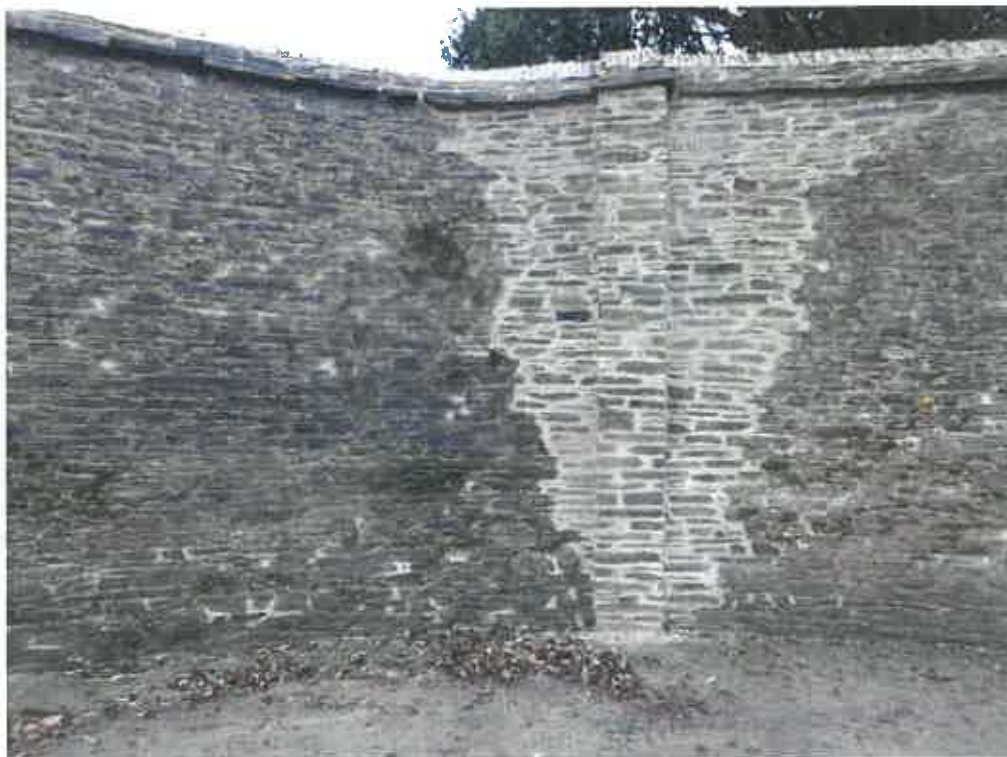
**Crack to Bay 5**

**Stone wall between bay 4 and 5** – it was clear that there was movement out of the vertical plane to this section of the wall. There had been movement which had led to the separation of the stonework on the junction of the wall and stone column, and it was possible that collapse had been prevented due to the buttressing effect of the concrete block structure on the rear of Bay 4. It was clear that there had possibly been some damage to the base of the wall and that careful dismantling of a section of the wall would be needed to allow for the wall to be rebuilt. It had been found on other similar projects that by careful removal of the original wall fabric it was possible to retain as much of the wall as possible and then stitch together the new and retained sections of the wall. The use of stainless steel twisted

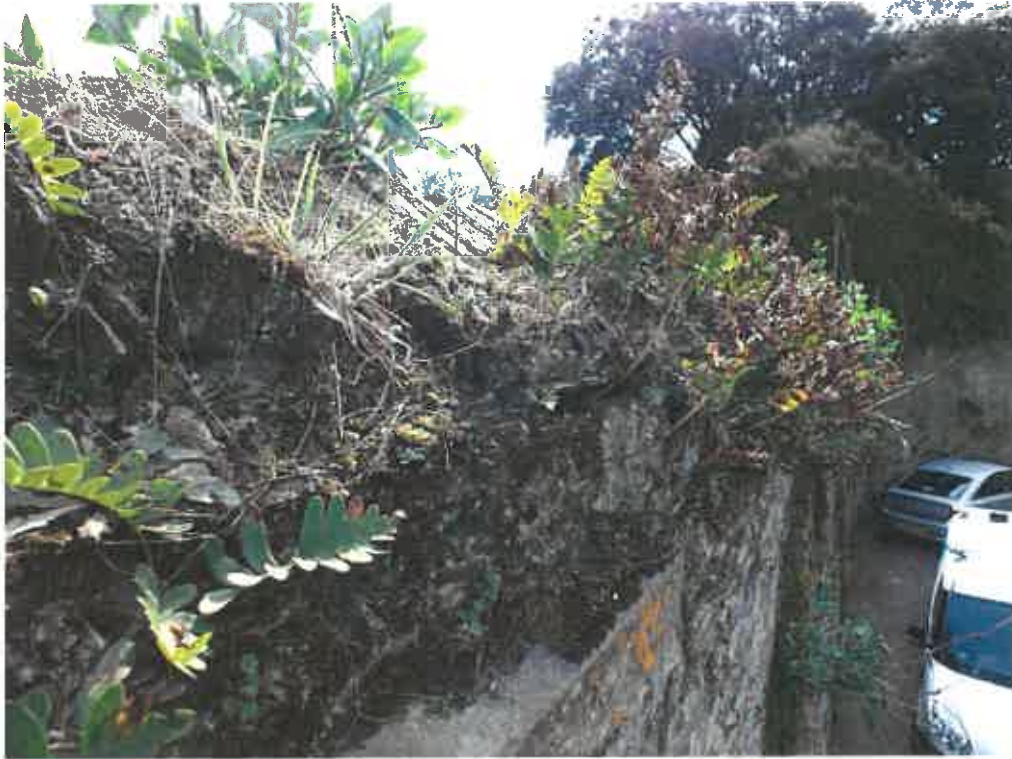
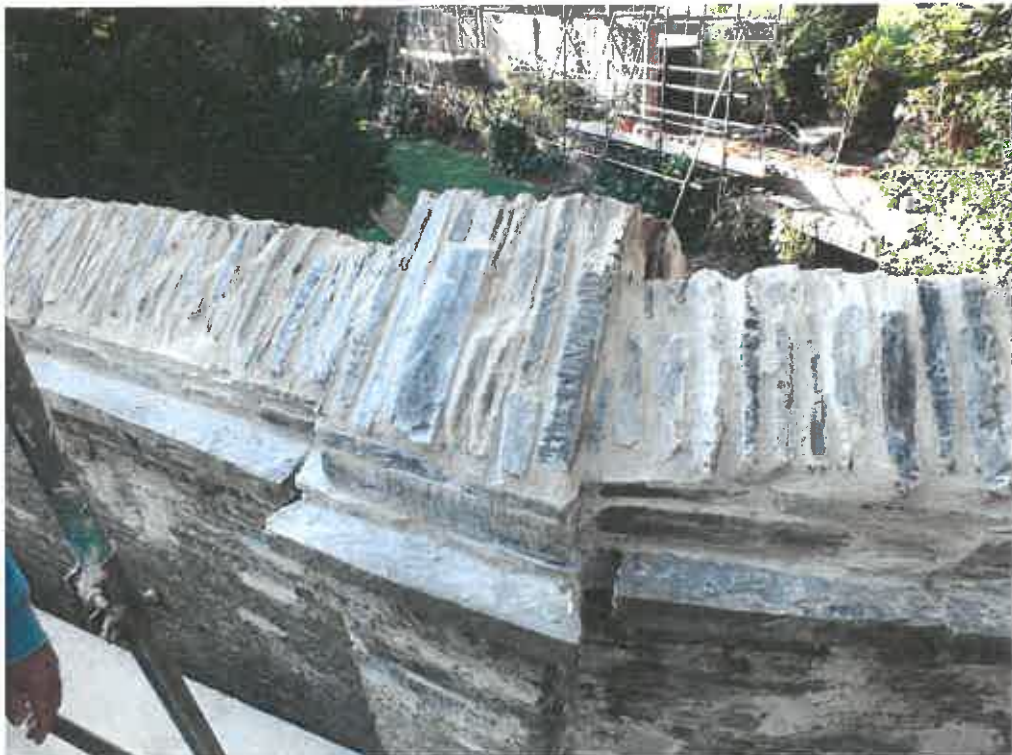
## Head of Stone Wall

The stone walls were found to be in remarkably good condition with limited work required to the walls, with generally the works being restricted to the head of the walls. It was found that the roots from the plants and vegetation on the head of the walls had spread along the top of the walls directly underneath the copings. It was therefore agreed that in the interests of restricting the future plant growth, there would be careful removal of the stone copings and removal of the vegetation with treatment of the heads of the walls before reinstating the stone copings.

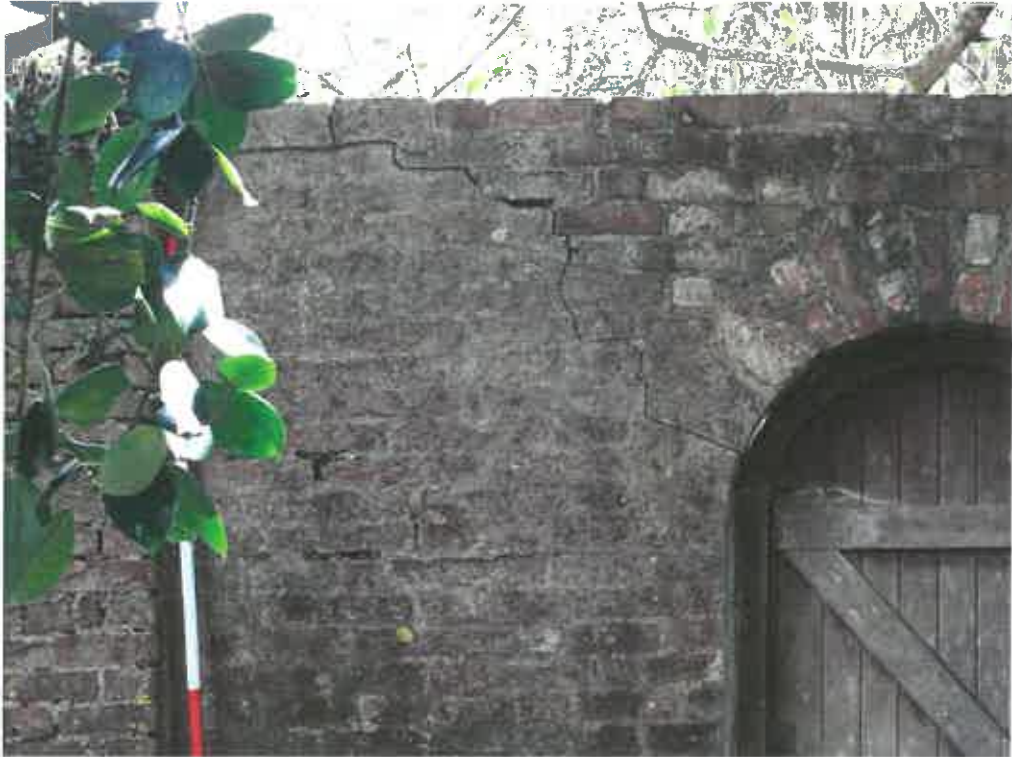
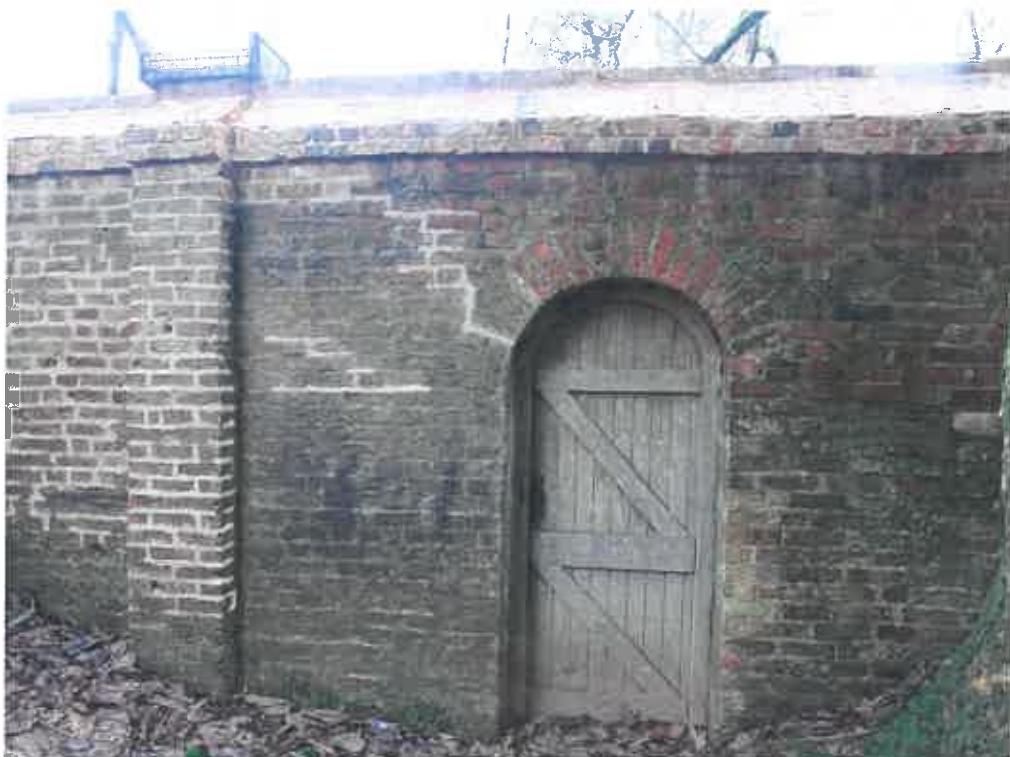
**Bay 16**

The brickwork walls along the run from Bay 9 up to Bay 16 were noticed as having a significant lean in the walls at the time of the survey. The walls however appeared to be stable with no evidence of any movement or cracking at the time of the survey. The lean in the wall did not, in itself, appear to represent a threat to the structural condition of the wall as the centre of gravity of the wall was still within the centre third. The brick bond appeared to be in good condition and it was clear from the visual inspection that there were sufficient stretchers in the wall to form a good bond. The thought process was that as long as the wall was maintained and the plant growth removed from the head of the wall then the integrity of the wall should be maintained.

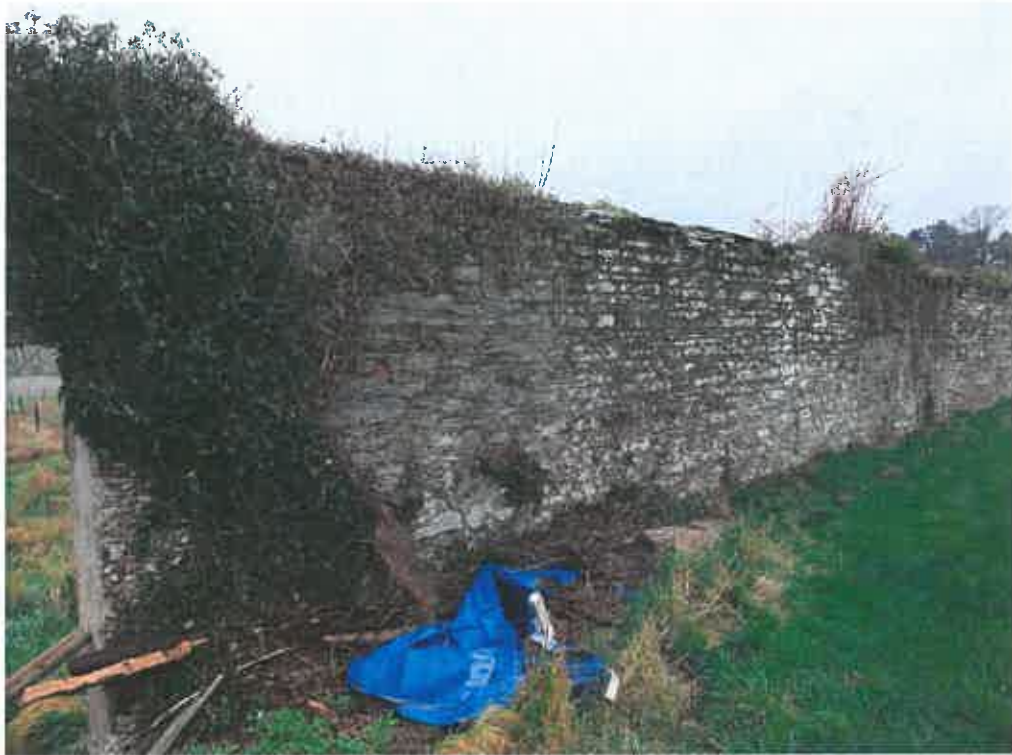
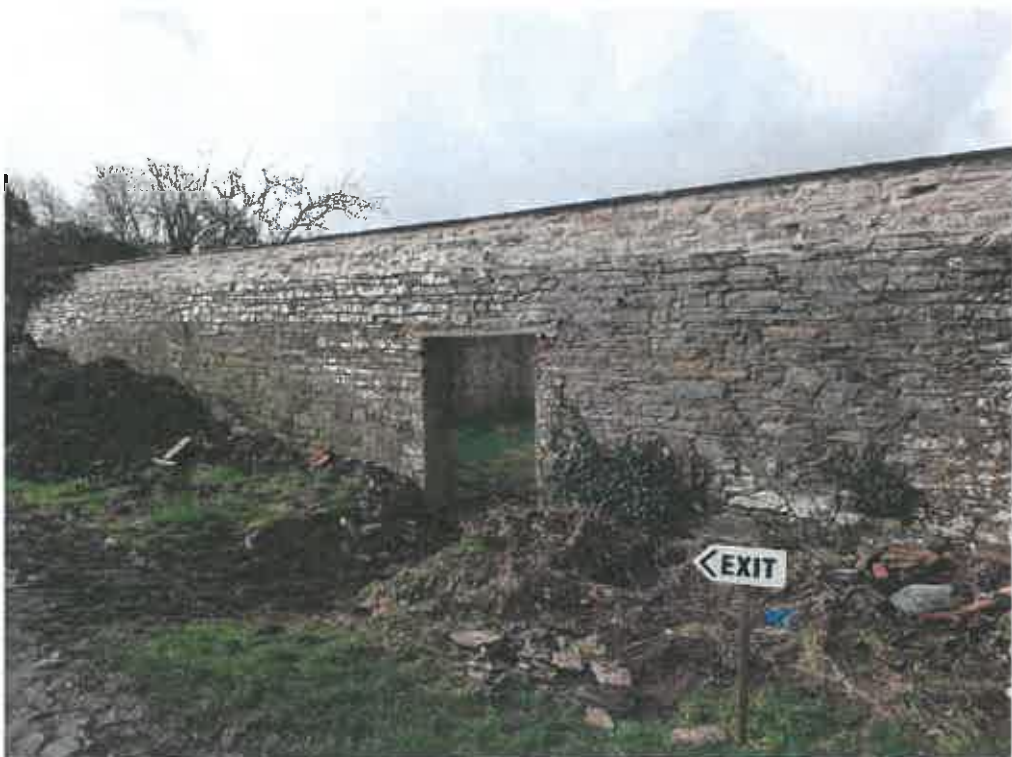
## Kitchen Garden Walls

At the end of the main project works additional funding also allowed for a section of the kitchen garden wall to be consolidated. A brief evaluation of the walls were undertaken and it was agreed that the section that abuts onto the tennis courts was the wall in most need of repair. This section of wall had significant plant and vegetation growth and limited copings to the head of the wall. It was therefore agreed that the wall should be surveyed and that the scope of the works would be limited to the top 400mm of the wall. The brick and stonework should be stabilised the vegetation removed and a slate coping provided to the head of the wall. The slate coping projects at least 40mm past the edge of the wall and ensures that any surface water is taken away from the face of the wall. The head of this section of wall has now been stabilised and protected from further decay from water penetration.
