Thorne Roughets, Anchor Lane, Dedham, Colchester, CO7 6BX

A Level II Historic Building Record

prepared for
Aden Lines and Suzanna Hooper

Colchester HER: ECC4212

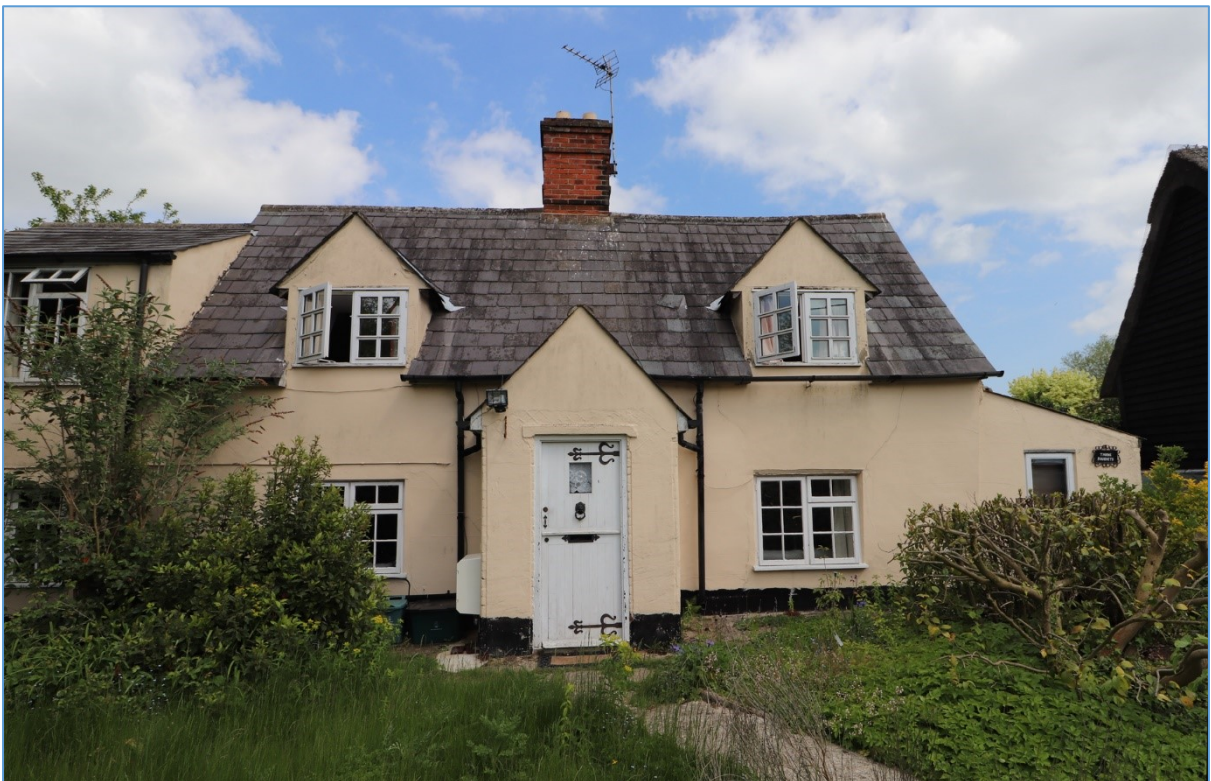
Plate 3. The front of the original core of Thorne Roughets showing later additions, looking east.

A central apex porch, also with a slate roof, contains a white timber stable door and is glazed with small windows to the north and south. Map evidence indicates that the porch was added post-1962 (Plate 3).

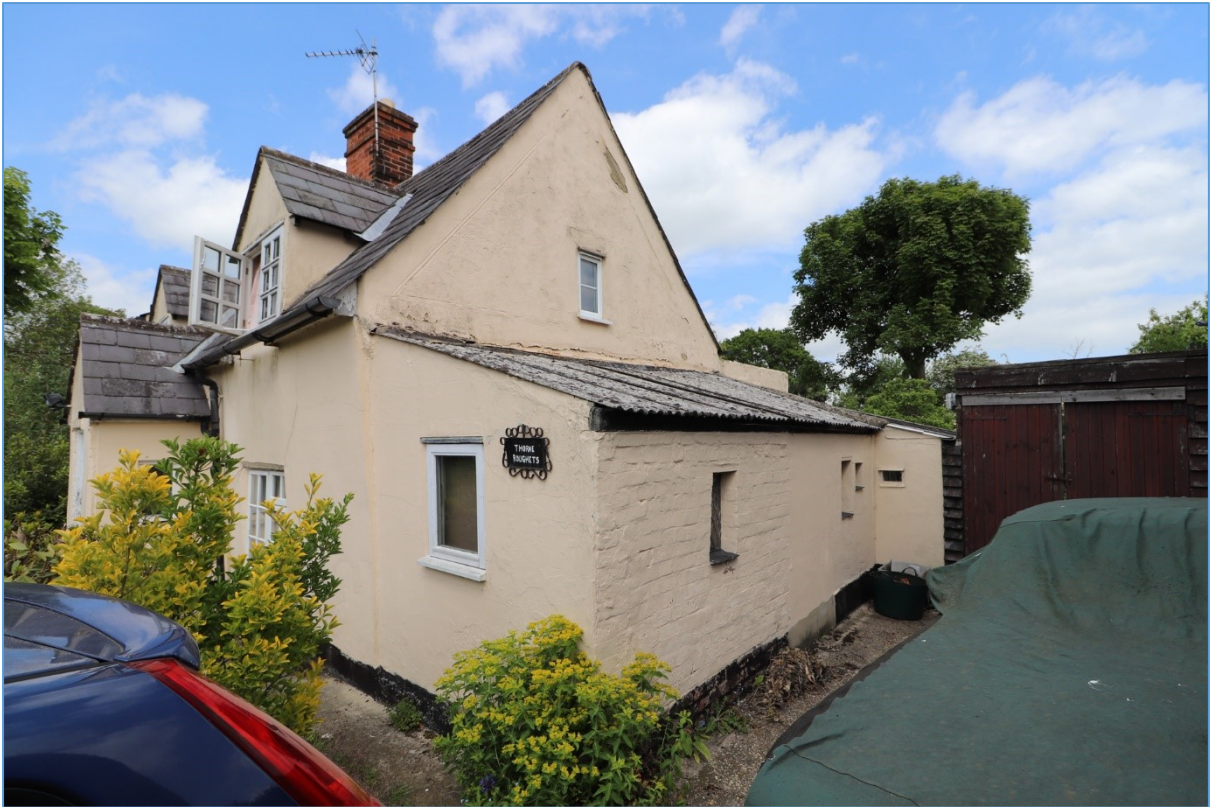
Plate 4. The southern lean-to extension and protruding southern gable, looking north-east.

Southern Elevation: The lean-to extension spans the full width of the ground floor of the southern elevation (Plate 4), before stepping outwards to the south and continuing beyond it to create an additional lean-to extension for the rear kitchen range (Plate 6). Although the western wall of the lean-to is rendered like the western wall of the main house, the exterior of the southern wall comprised painted brickwork laid in a simple stretcher bond. This wall is punctuated by three small rectangular windows glazed with leaded diamonds, and there is the suggestion of a former doorway entering the lean-to from the south, which has now been rendered over (Plate 4).

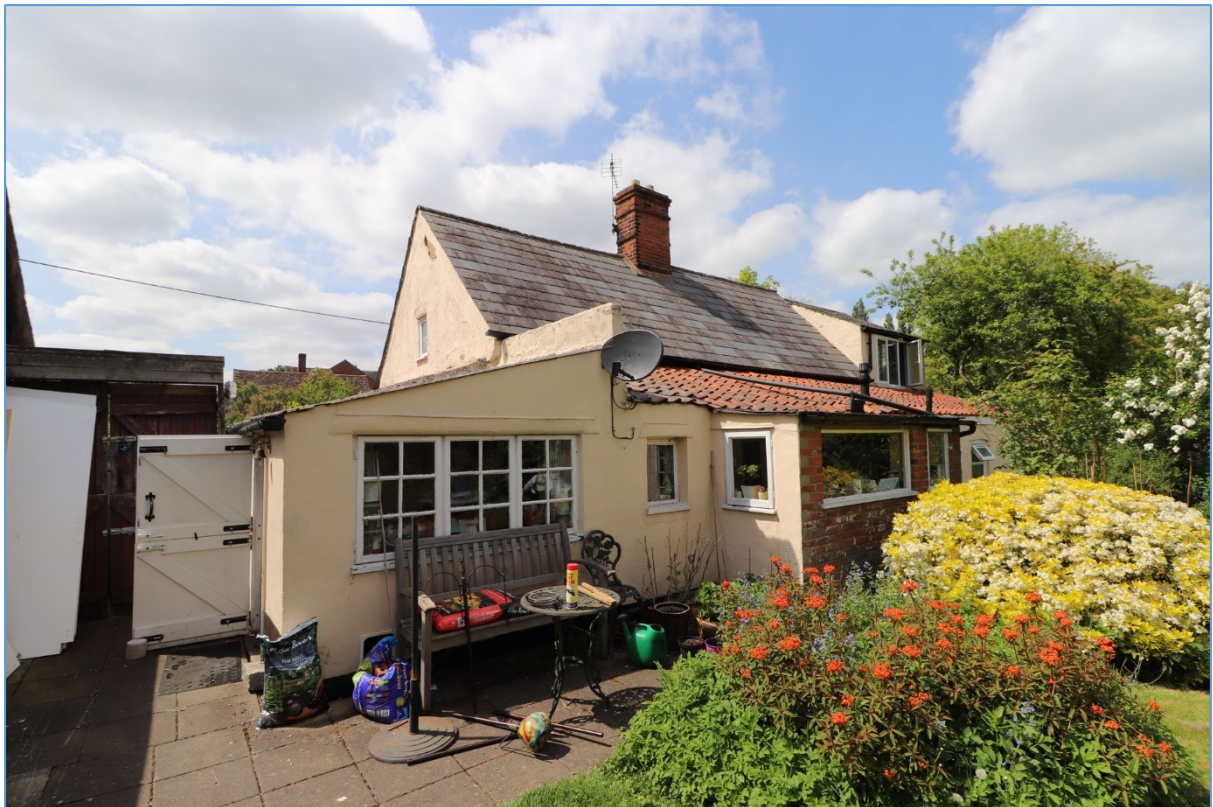
Plate 6. The eastern end of the southern lean-to extension and rear kitchen range, looking north-west.

Towards the southern end of the eastern extension, a small brick out-shut extension has subsequently been constructed to expand the area of the kitchen further eastwards (Plates 6 and 7). This extension is built from stretcher bond and incorporates a small window in its southern elevation, one large and one small window in the eastern elevation, and another small window in the northern elevation, which has subsequently been bricked up again.

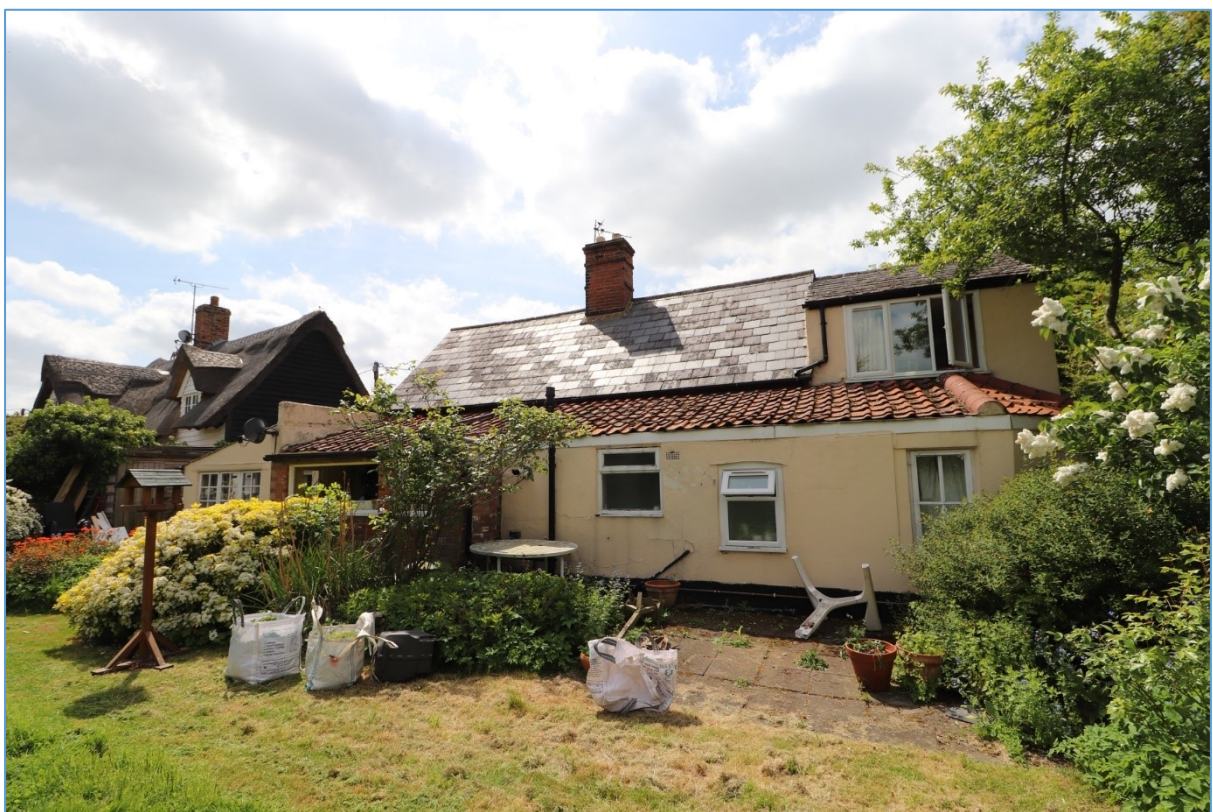
Plate 7. The eastern elevation and rear kitchen range, looking west.

Eastern elevation: The eastern, rear, elevation of the house shows the greatest degree of alteration and extension, all of which has evidently taken place in a piecemeal fashion, without any kind of underlying scheme (Plates 6 and 7). These various episodes of building have been executed in poor quality materials and show signs of no longer being weatherproof.

At its northern end, the rear extension has been continued in front of the northern extension, to create a new downstairs room which links into it via the ground floor (Plate 7). This extension is constructed from breeze blocks and has a cut-off north-eastern corner, giving it an unusual shape. The pantile roof has been extended over the top of it and terminates in an angled roof which slopes to the north. Above the roof of this new extension, a large casement window has been inserted into the upper storey of the northern extension, the sill of which sits above the roofline.

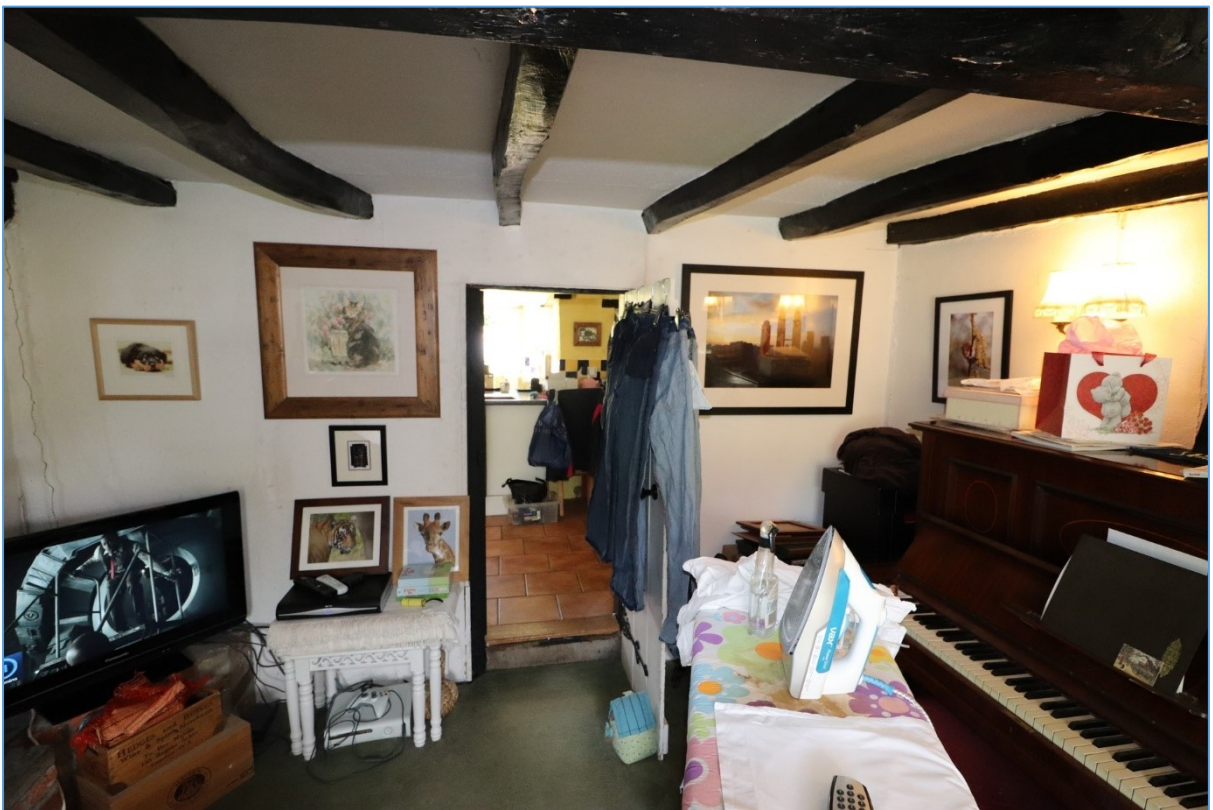
The main evidence of the structure of the building preserved in the lounge is the timber framing of the ceiling, which is exposed, although it shows signs of having been extensively varnished in the past. This ceiling seems to be a later insertion, although it perhaps replaced an earlier ceiling, and was probably made in the 18th century. Its construction comprises a north–south bridging beam, which consists of a half-sectioned length of timber, the eastern face of which is flat and crudely chamfered, and the western face of which is rounded and stripped of bark. Five pairs of west–east joists support the floor above, and some of these show signs of having been replaced with more modern timbers (Plates 10–12).

Plate 12. Interior view of the eastern wall of the lounge.

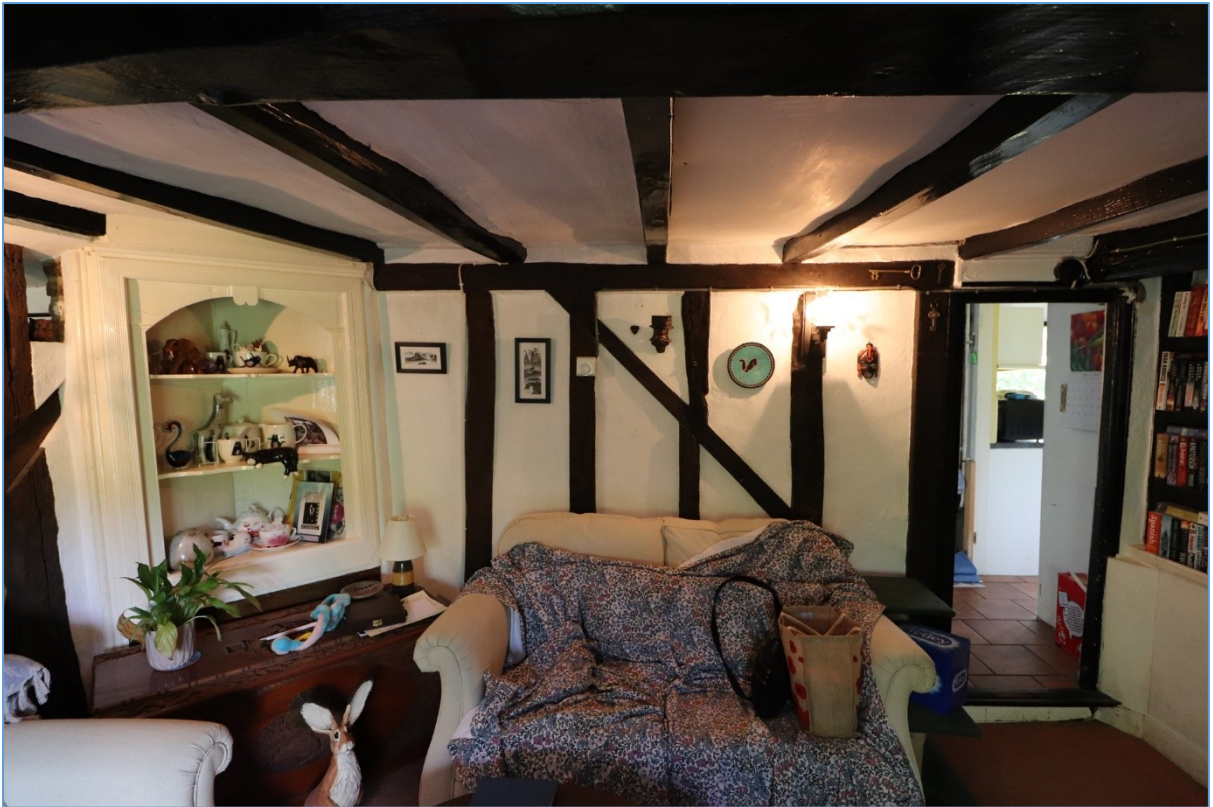
Plate 15. Interior view of the eastern wall of the dining room.

The eastern wall of the dining room (Plate 15) features an exposed panel of timber framing, much of which appears to be original. At the southern end of the wall is the later doorway already referred to, the northern doorpost of which supports the horizontal ledge beam which sits inside the line of the original frame and in turn supports the floor joists. This might be taken to indicate that the upper floor is indeed a later insertion, or may simply reflect the chosen method of construction. The rest of the panel to the north is divided by four vertical studs, braced by a diagonal supporting brace. The framing of the north-eastern corner of the room is obscured by a built-in corner unit, but it is presumed that the framing survives behind this structure.

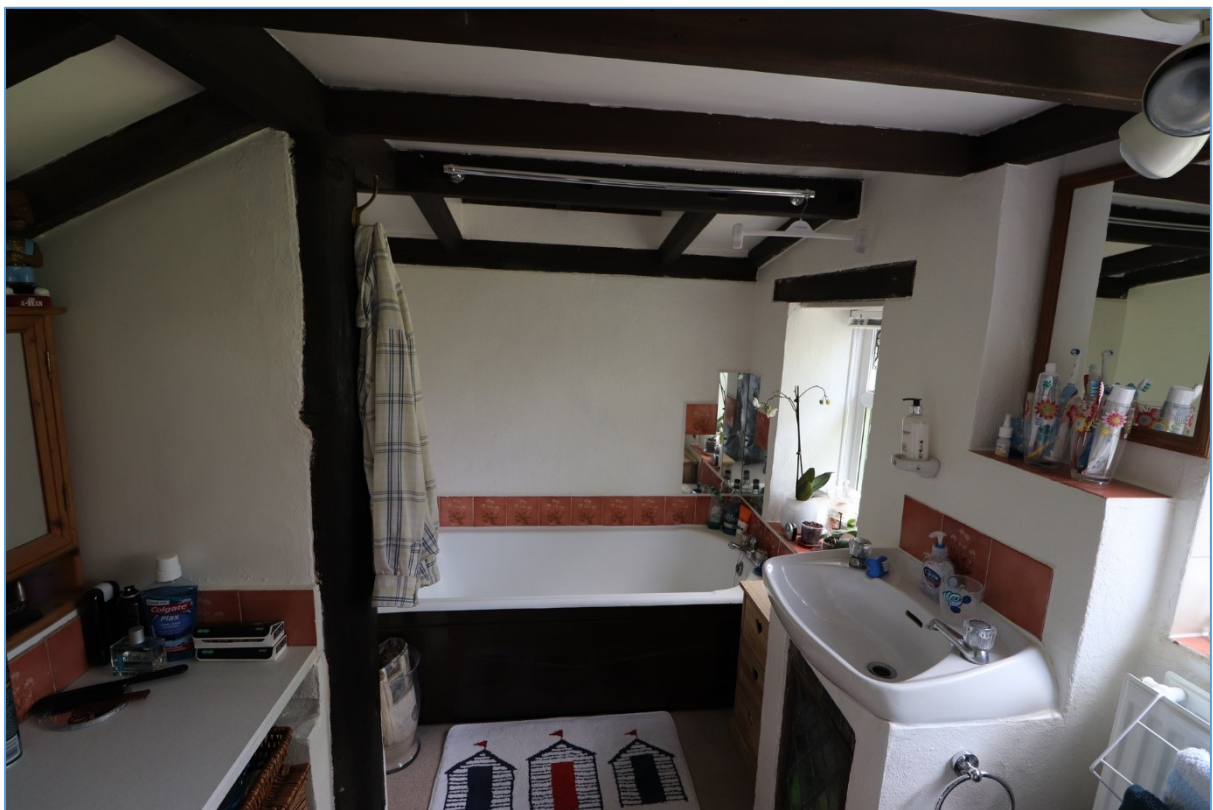
Plate 22. Interior view of the bathroom, looking north.

At the northern end of the range is a bathroom, which features much mock-timber-frame detailing, but which is otherwise architecturally unremarkable (Plate 22). To the south of this is a small lobby connecting with the dining room, which contains a boiler and shows extensive signs of damp and water ingress (Plate 23). To the south of the lobby is a kitchen, which links to the lounge and which, with the lobby, is clearly constructed on a concrete plinth (Plate 24). As was indicated by the historic mapping, the kitchen has clearly been extended to the east with the brick-outshut described above, which contains several large windows.

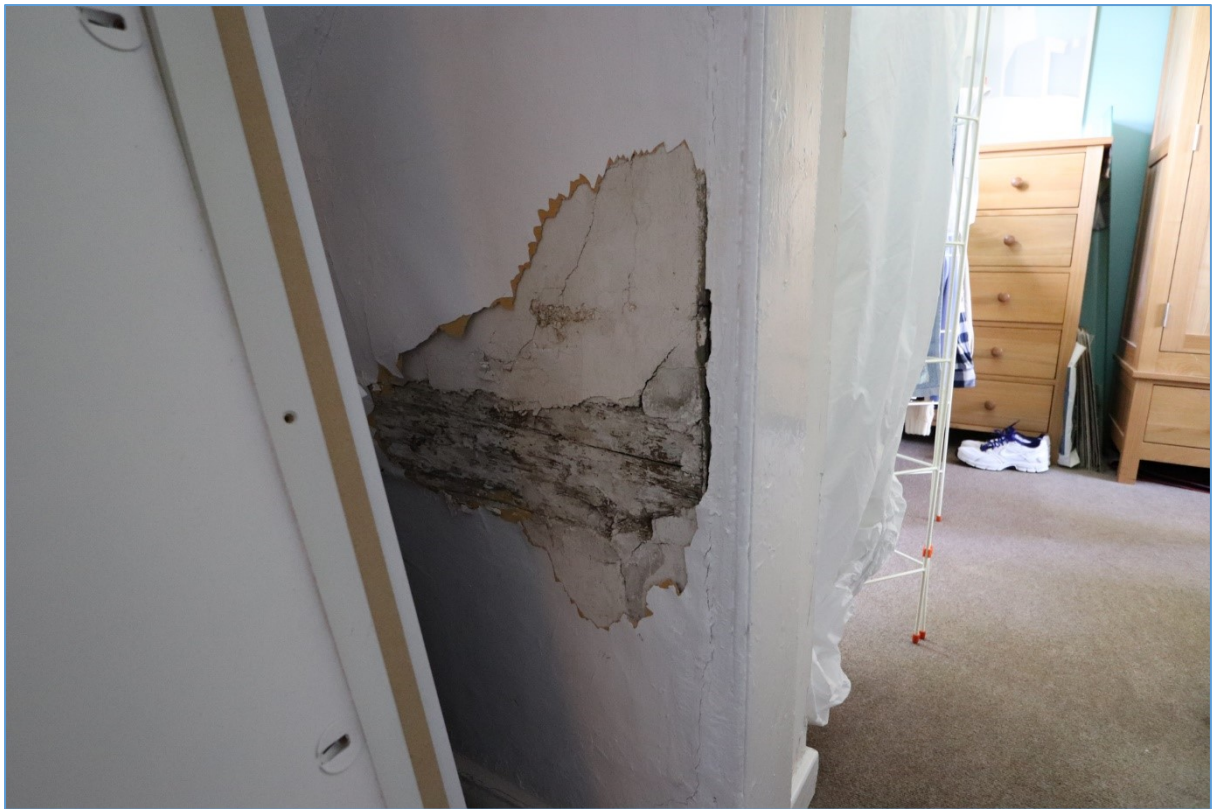
A doorway with an angled corner has been cut through the northern wall of this bedroom to provide access to the upper storey of the northern extension (Plate 33). The creation of this doorway has clearly resulted in the cutting of the tie beam, details of which can be seen behind peeling paintwork to the west of the doorway (Plate 34).

Plate 34. Detail of the exposed beam in the northern wall of Bedroom 2.

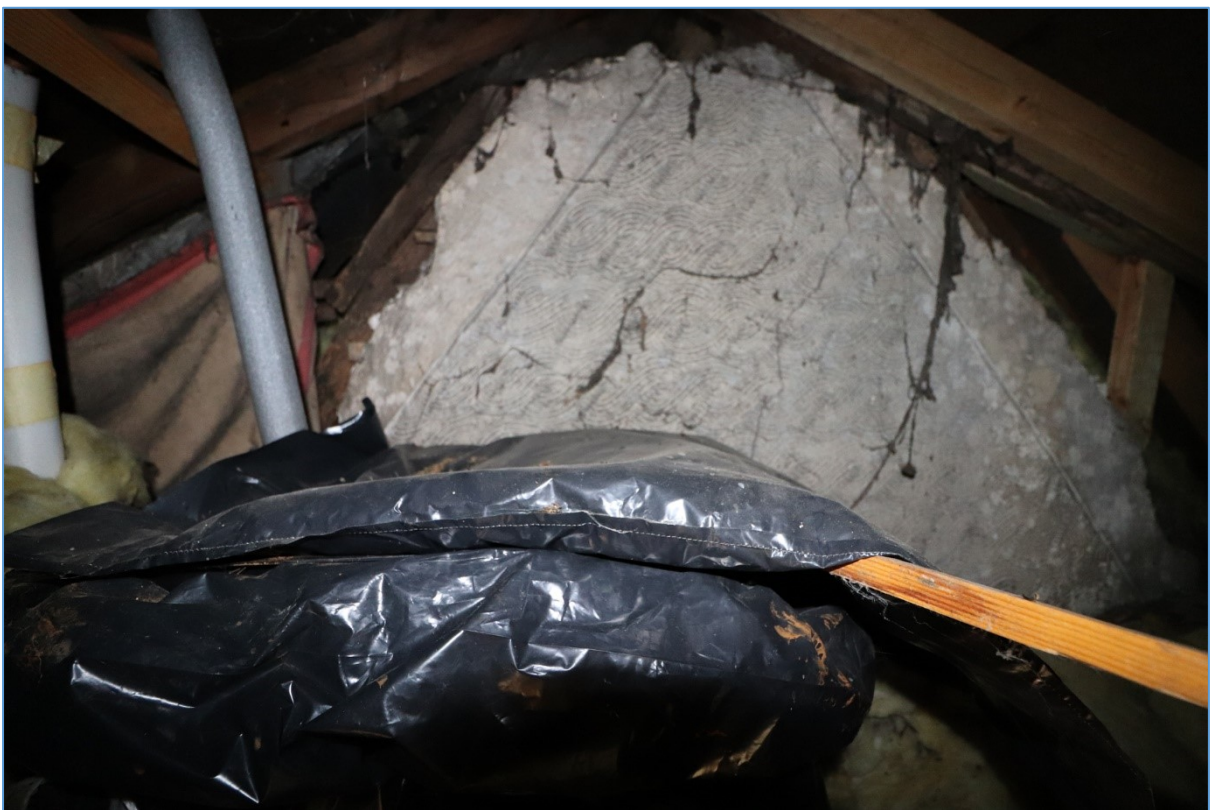
Above the lean-to, the southern gable of the original house is visible, into which has been set a small two-light rectangular window. This lights the southern attic bedroom and must therefore be a later feature. Although the gable has been painted with a thick, impervious paint, it is still possible to discern a triangular border incised into the render of the gable, within which a pattern of overlapping swirls has been incised. Where the paint has peeled away towards the apex of the gable this decoration is still crisply preserved beneath the paint. It is not possible to suggest a date for this decorative scheme, but it must pre-date the erection of the 19th-century extension at the northern end of the property, as similar decoration can be seen on the corresponding gable, which is now inside the roof space of the extension (see below; Plate 38).

Plate 38. Interior view of the southern wall of the loft-space above Bedroom 3.
