# **Little Dale Farm**

Dale Road, Stanton, Suffolk,  
IP21 2DY

## A Level II Historic Building Record

September 2018

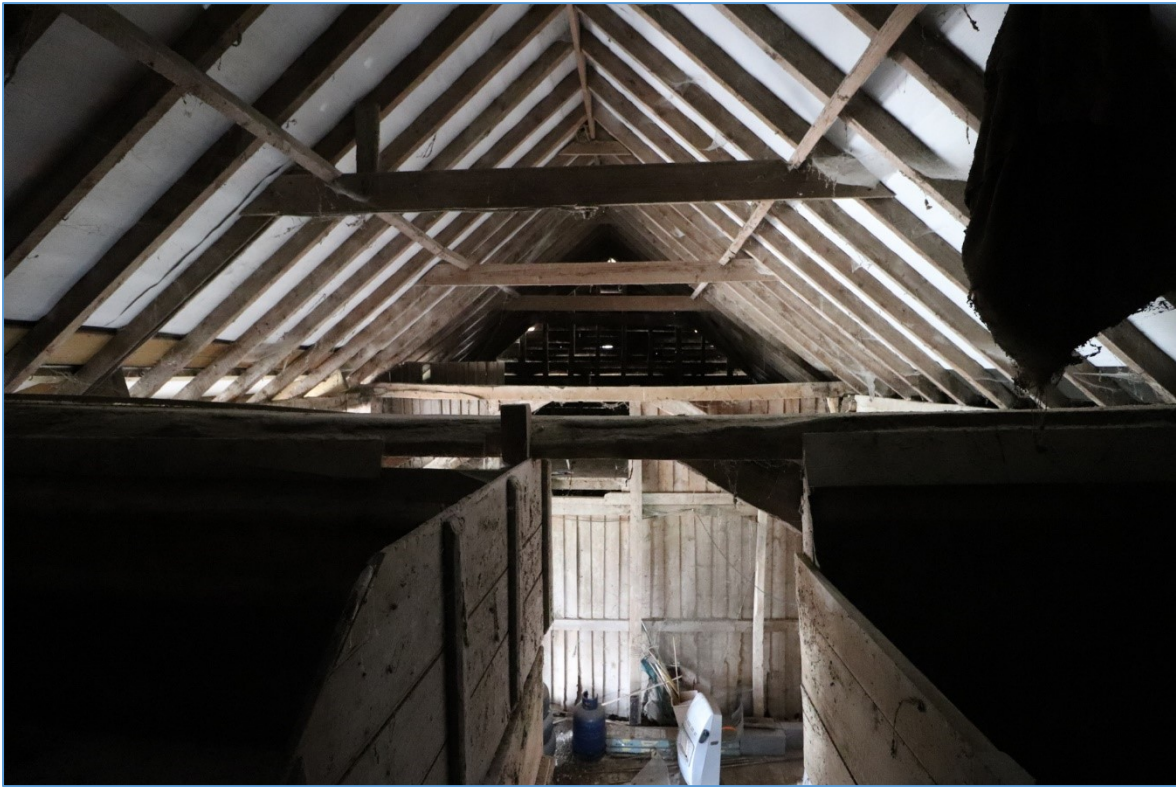
The roof of the barn is neatly tiled with orange clay pantiles (Figures 8–10), and inspection of the interior reveals that the roof structure from the level of the tie beams upwards is constructed from regularly spaced machine-cut timbers, over which is laid a sound weatherproof lining, indicating the wholesale replacement of the roof during the 20<sup>th</sup> century (Figure 12).

Figure 12. The roof of the main barn, looking west, showing the wholesale replacement of the roof structure in modern materials.

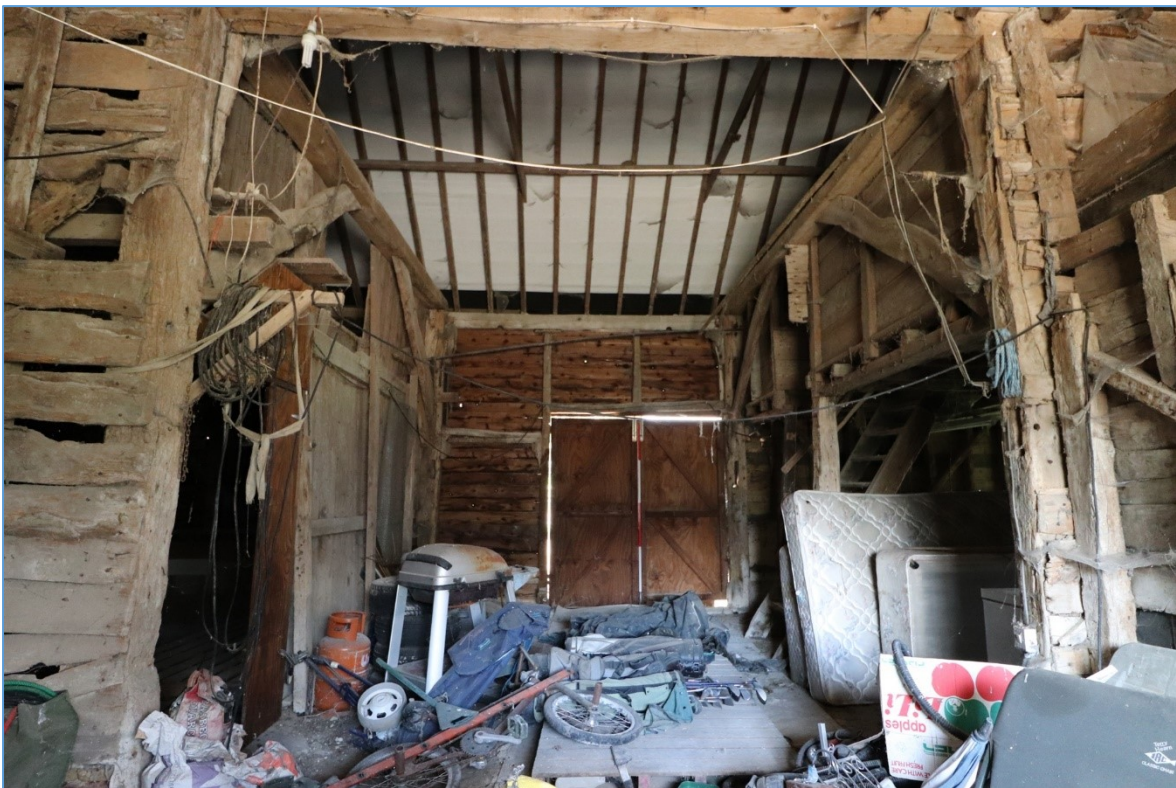
The central bay of the barn is full height and is defined by a pair of simple box cross-frames with simple diagonal braces (Figure 13). The northern face of the central bay would have originally featured a set of full-height double-doors, but this opening has since been infilled with studwork fronted with weatherboarding leaving only a small timber double-door on the eastern side (Figure 14).

Figure 13. The central bay of the main barn, looking north, showing the position of the former double-doors and cross-frames.

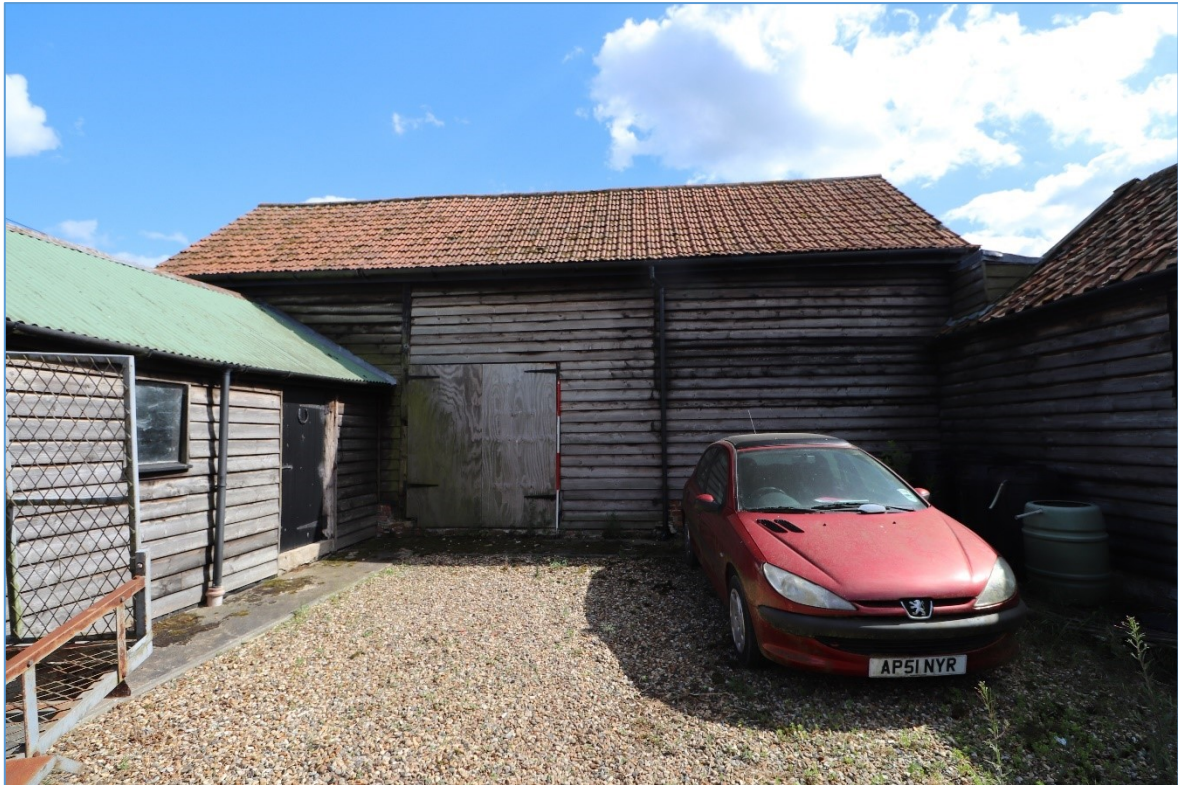
Figure 14. The exterior of the northern elevation of the main barn, showing the blocked former central doorway and modern weatherboarding of the exterior.

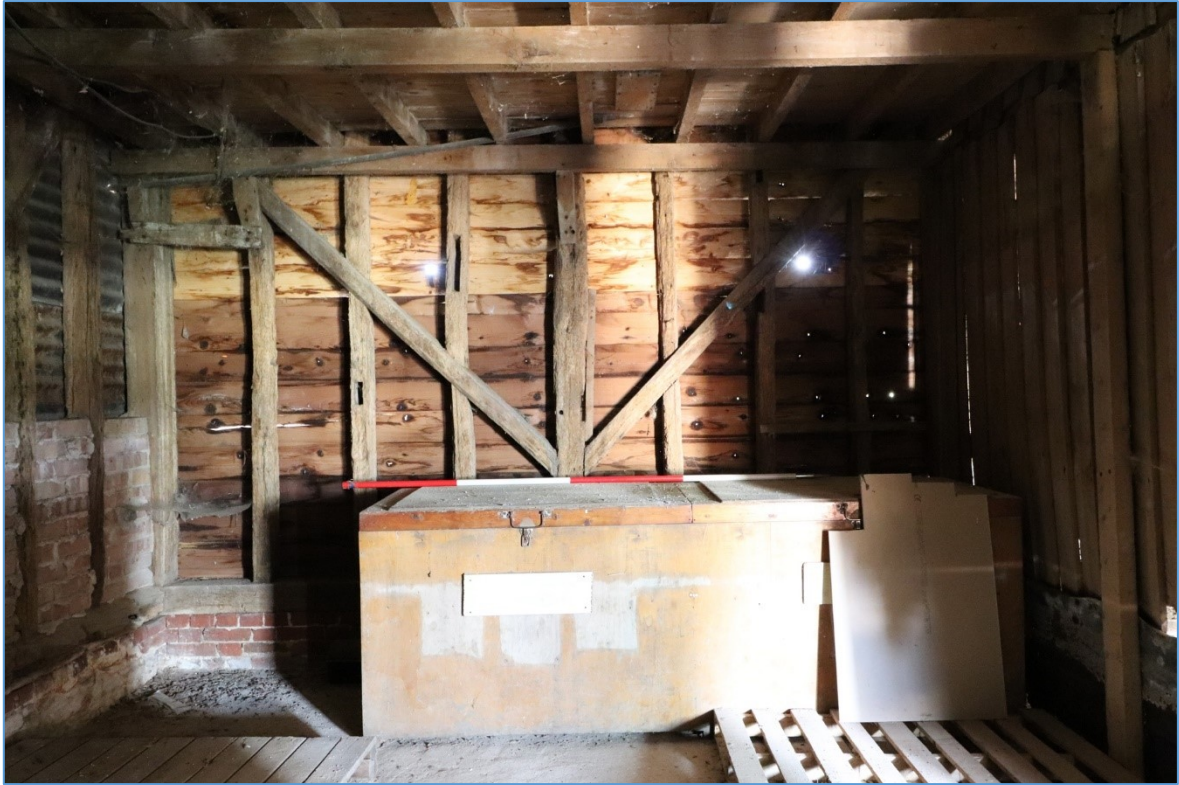
*Figure 18. The northern elevation of the western bay, looking north, showing the surviving timber framing with modern weatherboarding attached.*

The northern wall of the western bay is 3.8m wide and comprises a short plinth of four courses of red bricks on top of which is a horizontal timber sill beam (Figure 18). There are principal posts at each corner of the bay and a central post, with three vertical studs between each pair. A pair of diagonal timber braces are inset into the frame, meeting at the central post. Several of the studs have mortise holes, indicating that they have been reused from elsewhere. Modern weatherboarding has been affixed to the outside of the framing.

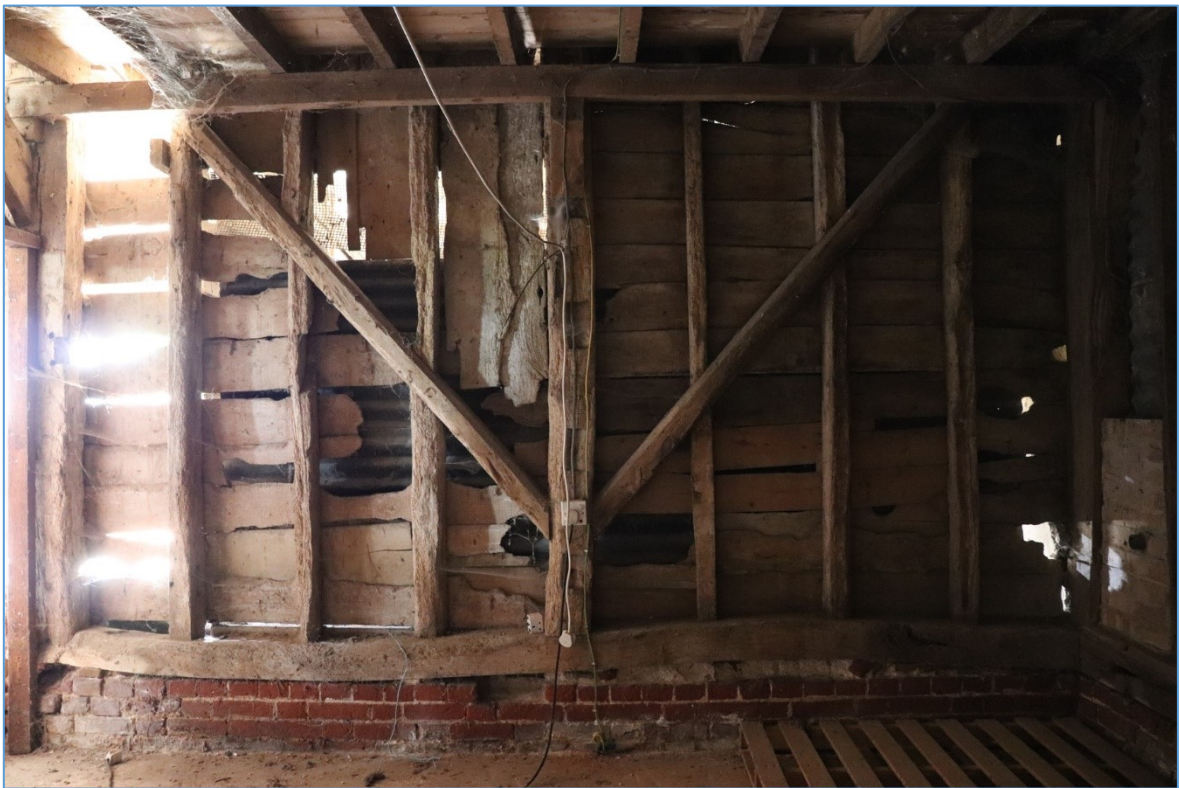
*Figure 19. The southern elevation of the western bay, looking south, showing the surviving timber framing.*

This construction is mirrored on the southern elevation of the western bay, where the same pattern of posts, studs and braces is used (Figure 19). The central post features several mortises, indicating its reuse. As the southern elevation is no longer an external wall, due to the construction of the southern lean-to, the boarding on this wall is considerably older and more decayed than that of the northern elevation.

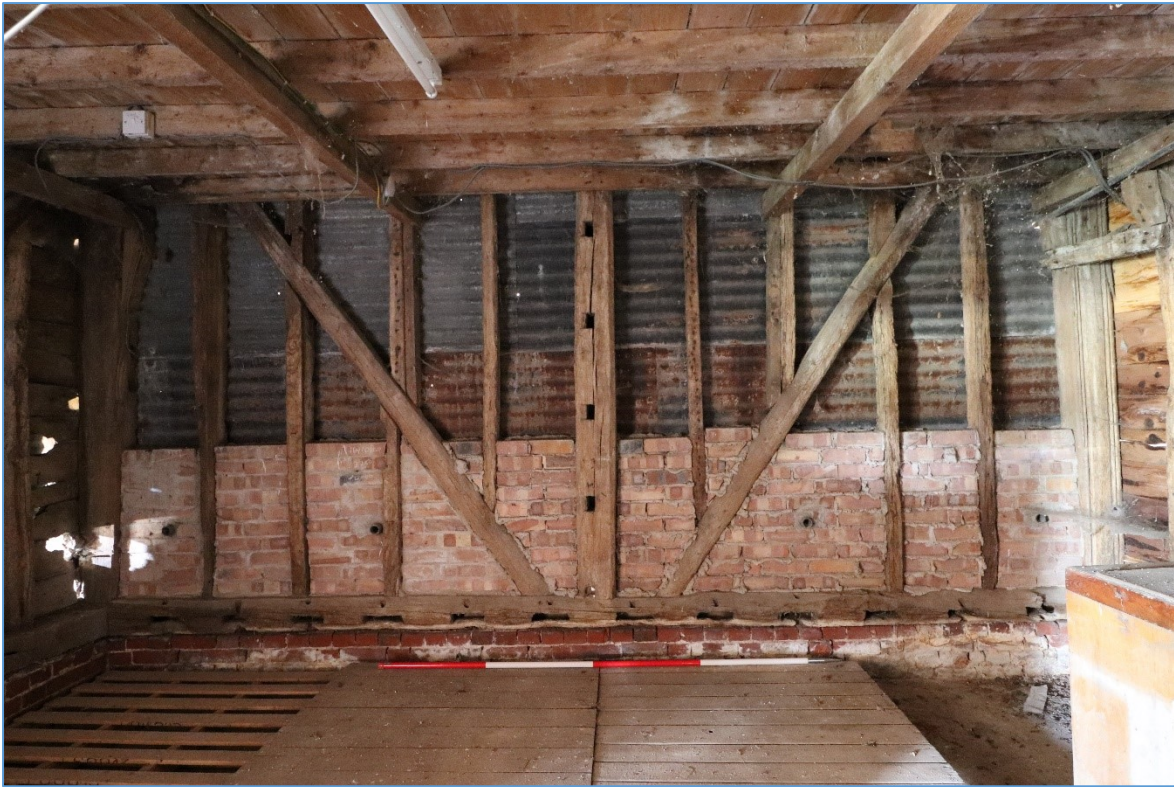
The western wall of the western bay is 5.2m wide and comprises the original gable end of the barn (Figure 20). It follows a similar pattern to the northern and southern elevations, although in this instance there are four studs between each of the principal posts and the diagonal braces do not meet in the centre. The central post has a series of regular mortises, as does the sill beam, suggesting that both of these elements have been reused from elsewhere and indicating that this elevation has been extensively repaired or reconstructed. The gaps between the timbers on the lower part of the wall have been infilled with modern brickwork, and corrugated metal sheeting has been affixed to the outside of the timber frame as this wall now faces into the south-western infill block constructed in the late 1960s or early 1970s.

*Figure 20. The western elevation of the western bay, looking west, showing the surviving timber framing, brickwork and corrugated metal sheeting.*

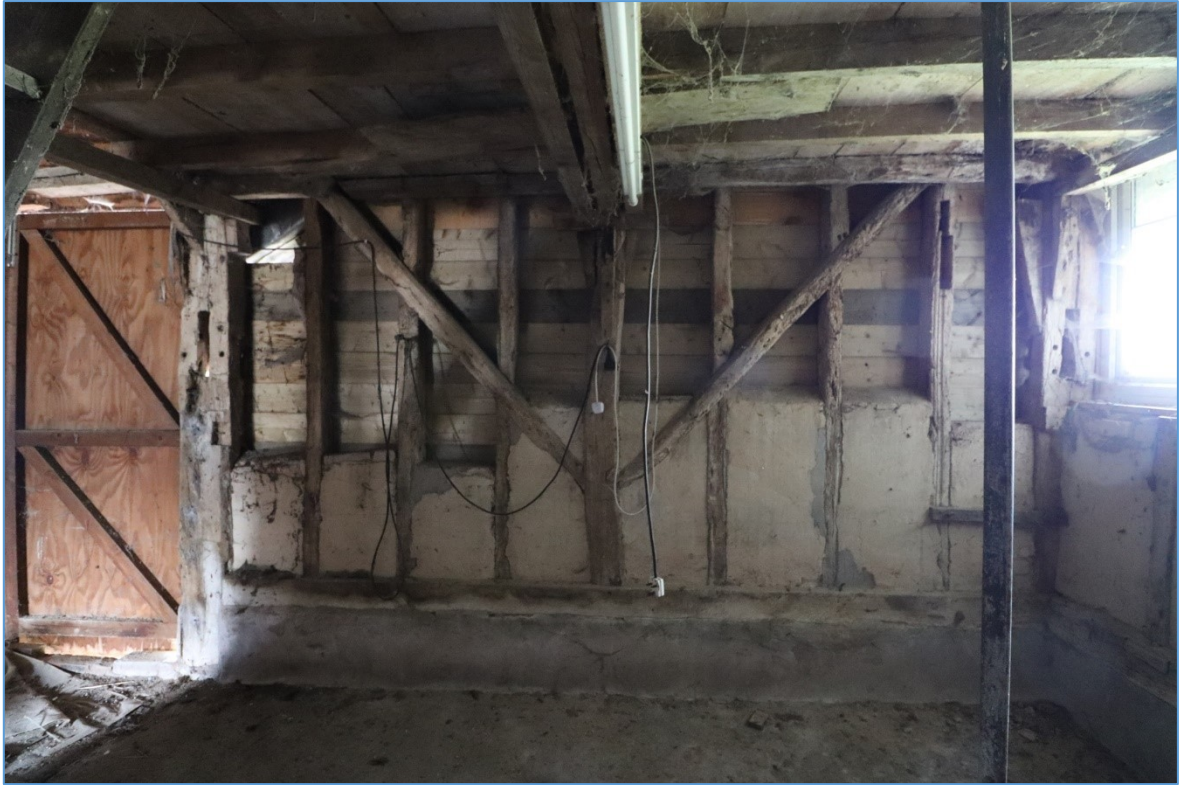
The northern elevation of the ground floor of the eastern bay is 3.8m wide and is constructed with the same combination of principal posts, studs and diagonal bases as its western counterpart (Figure 24). Unlike the western bay, the gaps between the lower half of the studwork are rendered, as is the brick plinth. The weatherboarding on the outside of the frame is well maintained but not as modern as that to the west, and this may reflect the fact that the northern extension is built against the outside of this wall.

Figure 24.. The northern elevation of the eastern bay, looking north, showing the surviving timber framing with render infill.

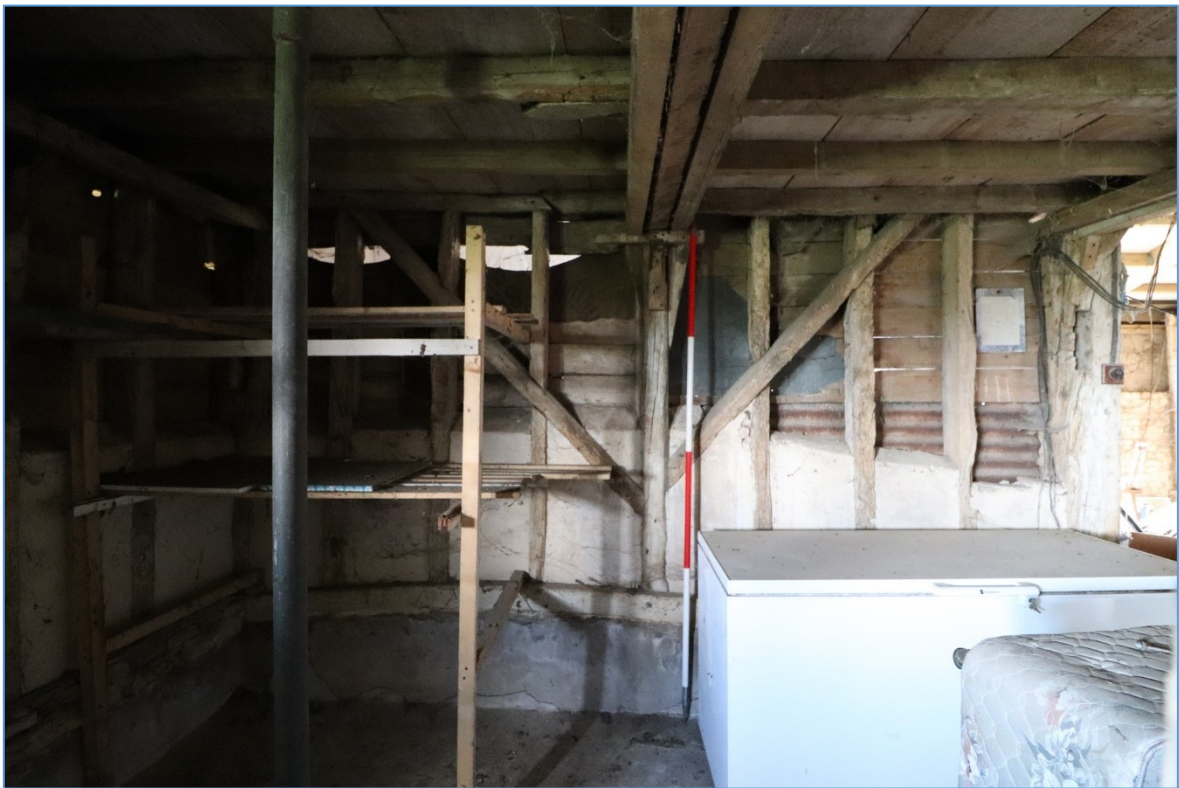
Again, this construction is mirrored on the southern elevation, where the mid-height render infill is continued (Figure 25), indicating that this bay was used for used for livestock in the past. As with the western bay, the southern elevation is now an internal wall, so the weatherboarding is older and of poorer quality as a result.

Figure 25..The southern elevation of the eastern bay, looking south, showing the surviving timber framing with render infill.

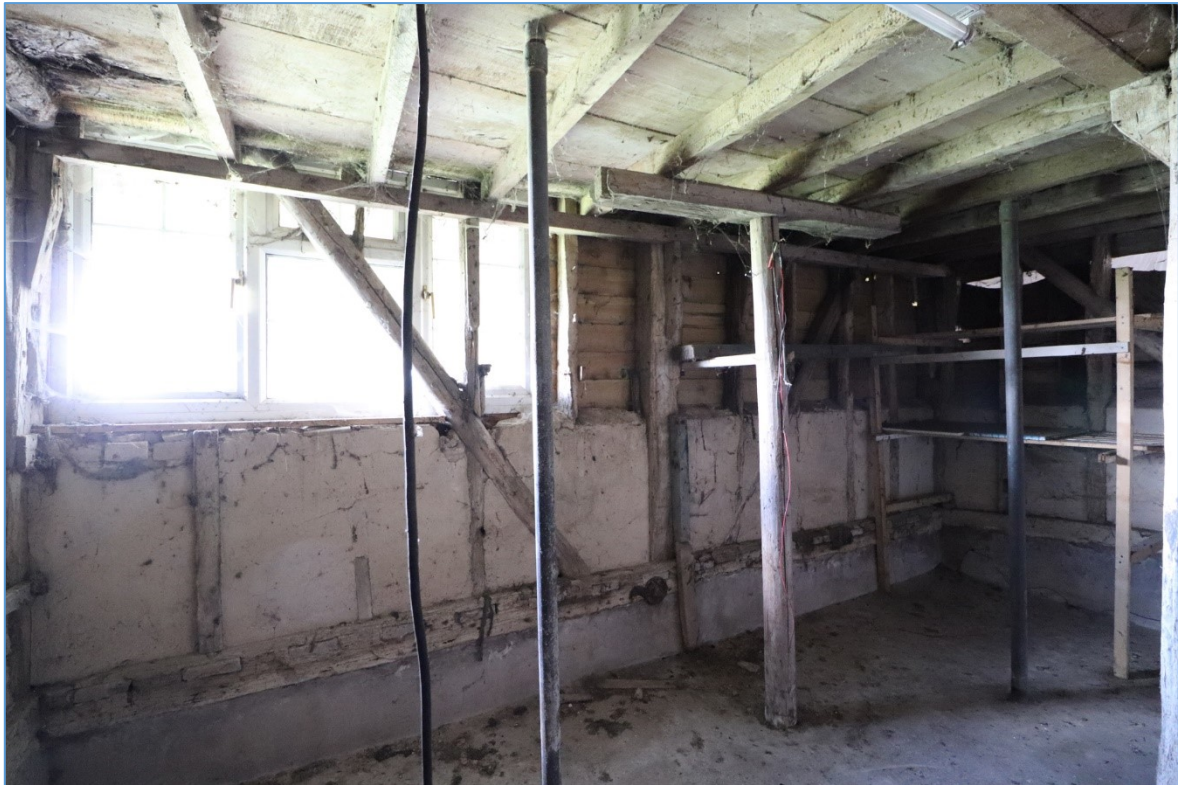
The eastern elevation mirrors that of the western gable end, and again features a sill beam with numerous mortises indicative of reuse. The rendering continues on this wall, but the weatherboarding here is modern, as the external face of this wall is exposed within the eastern lean-to. The northern half of this wall also features and inserted three-light window of relatively modern construction which brings light and air into the space and must be a relatively recent addition.

*Figure 26. The eastern elevation of the eastern bay, looking east, showing the surviving timber framing with render infill and modern window.*

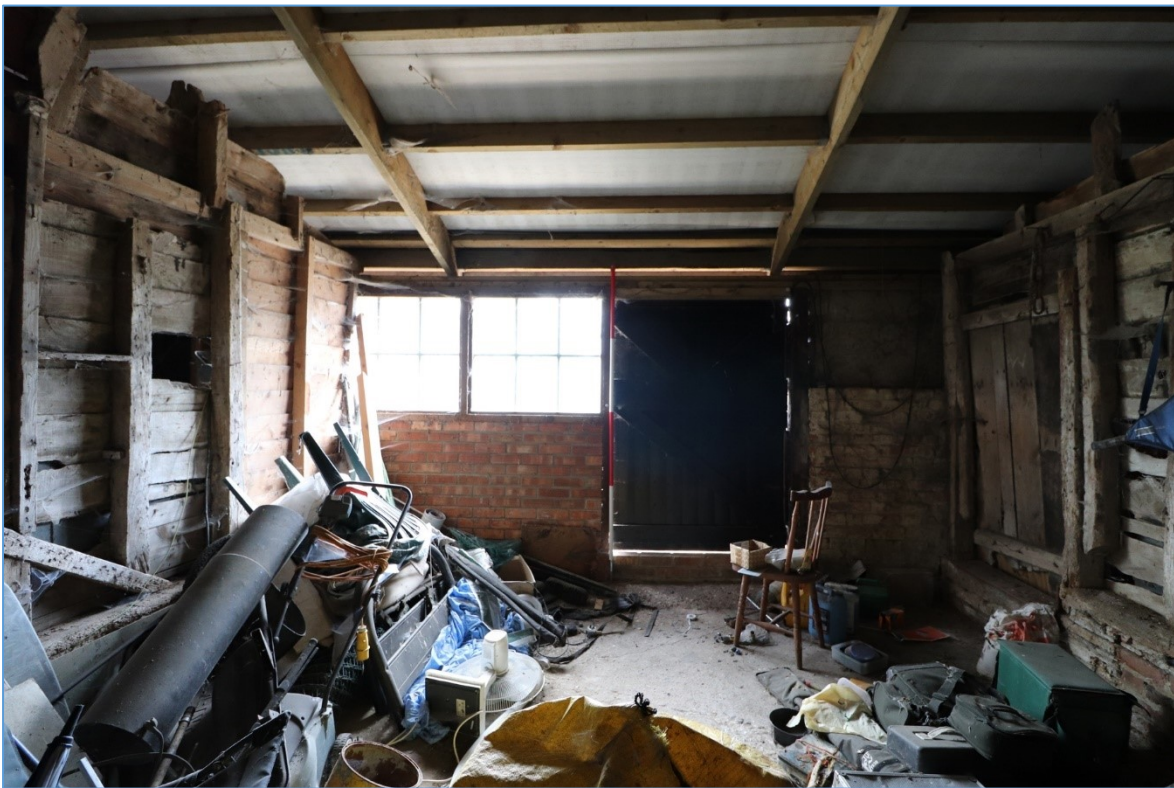
The southern wall of the central bay is punctuated by a wide timber door, with two six-light windows to its east (Figures 27 and 28). The brickwork beneath the door and windows is relatively modern, suggesting the blocking up of a larger opening, while the brickwork to the west of the door is older, and is likely to relate to earlier loose boxes constructed either side of the entrance.

*Figure 28. The southern elevation of the central bay of the southern lean-to, looking south, showing the later bricking up, openings and the new roof.*

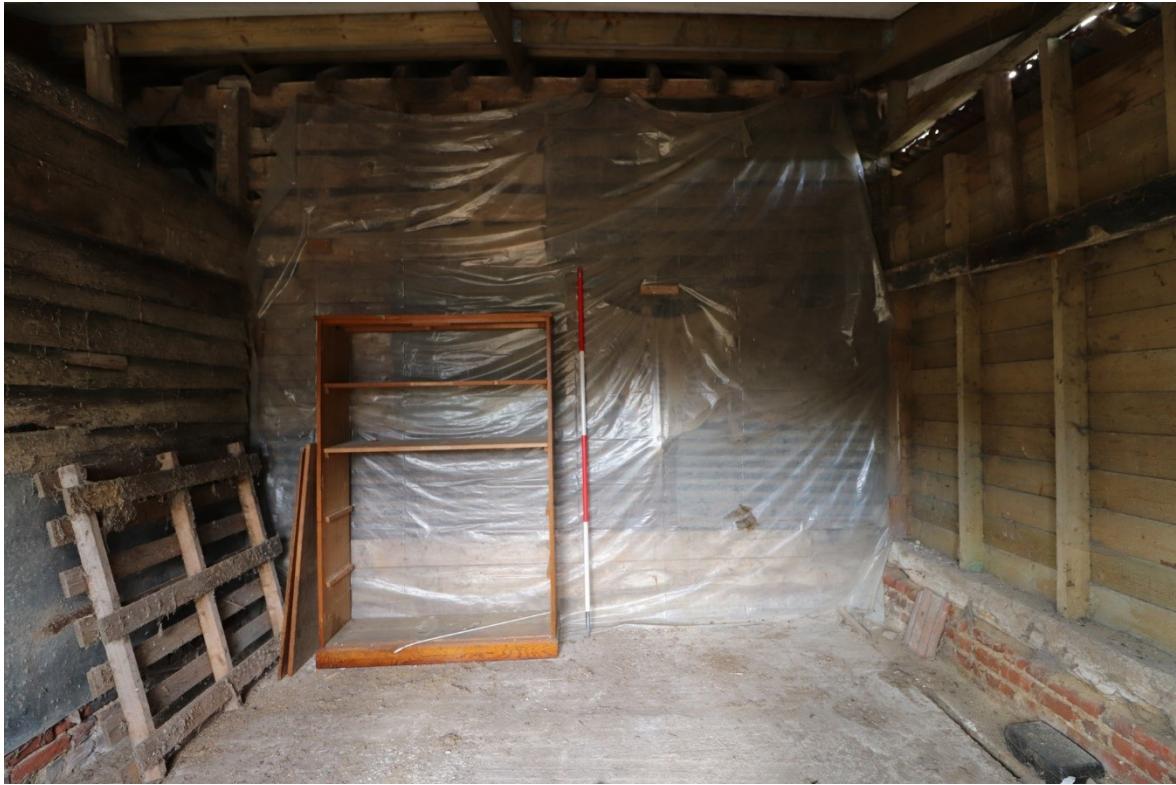
*Figure 36. The northern elevation of the eastern bay of the southern lean-to, looking north, showing the surviving weatherboarding of the barn behind protective coverings.*

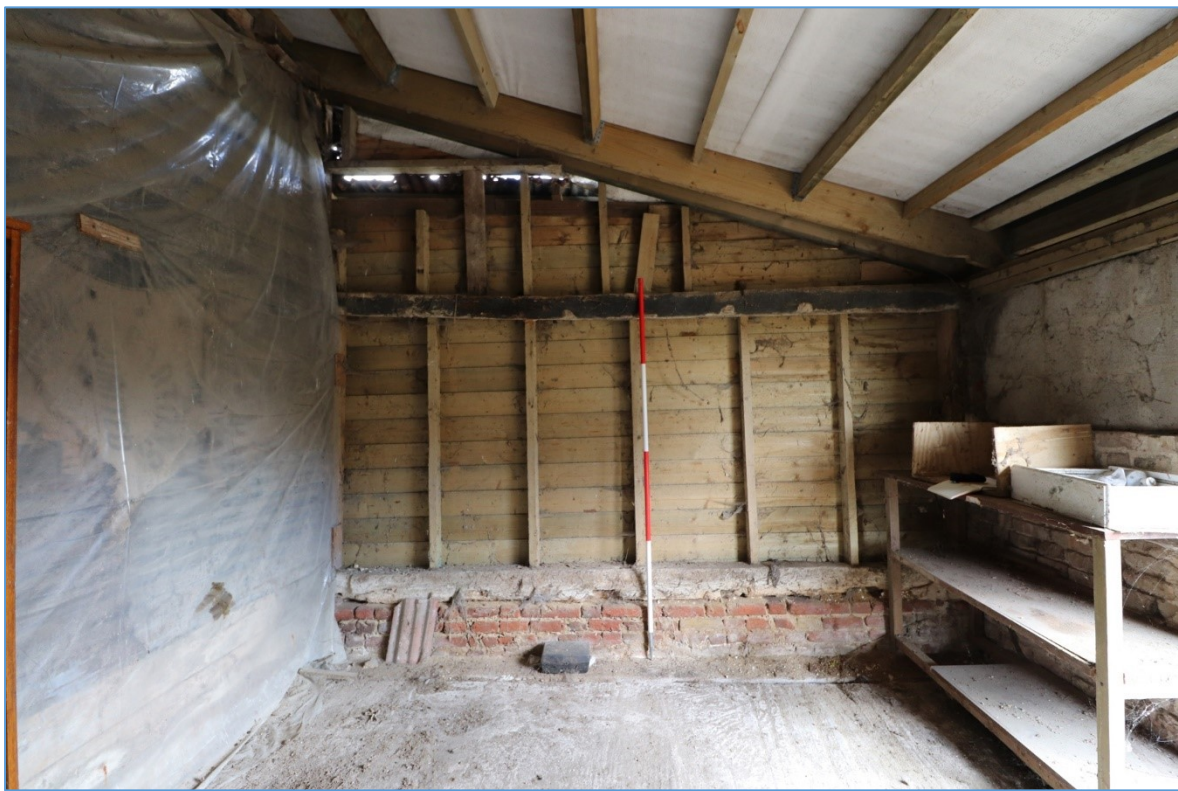
*Figure 37. The eastern elevation of the eastern bay of the southern lean-to, looking east, showing the rebuilt timber walling atop an older sill beam and plinth.*

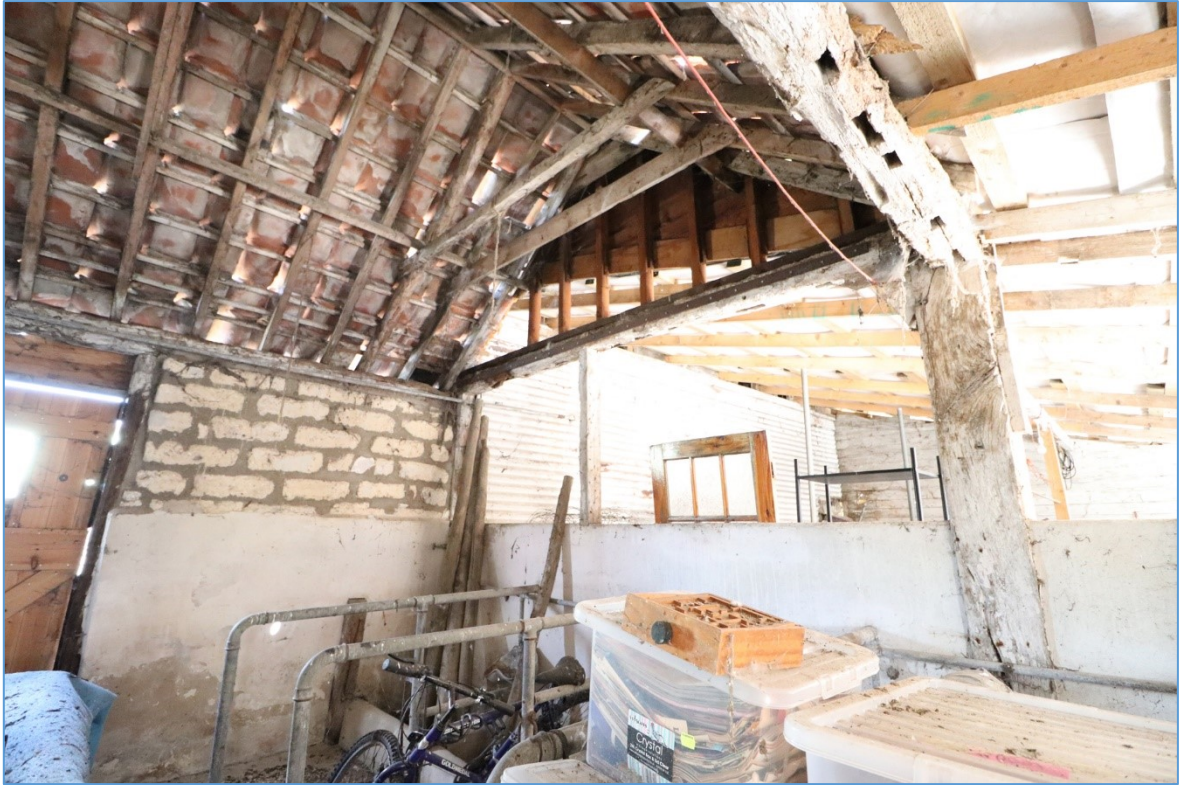
Figure 49. The remnants of the smaller barn within the south-western infill, looking south-east.

Above the tie beam and throughout the whole roof of the barn most of the timbers have been replaced with modern woodwork, although some older timbers have been reused. The roof is not lined above the timbers, and the pantiles sit straight on the rafters, although several tiles are missing (Figure 49, 50, 53 and 54).

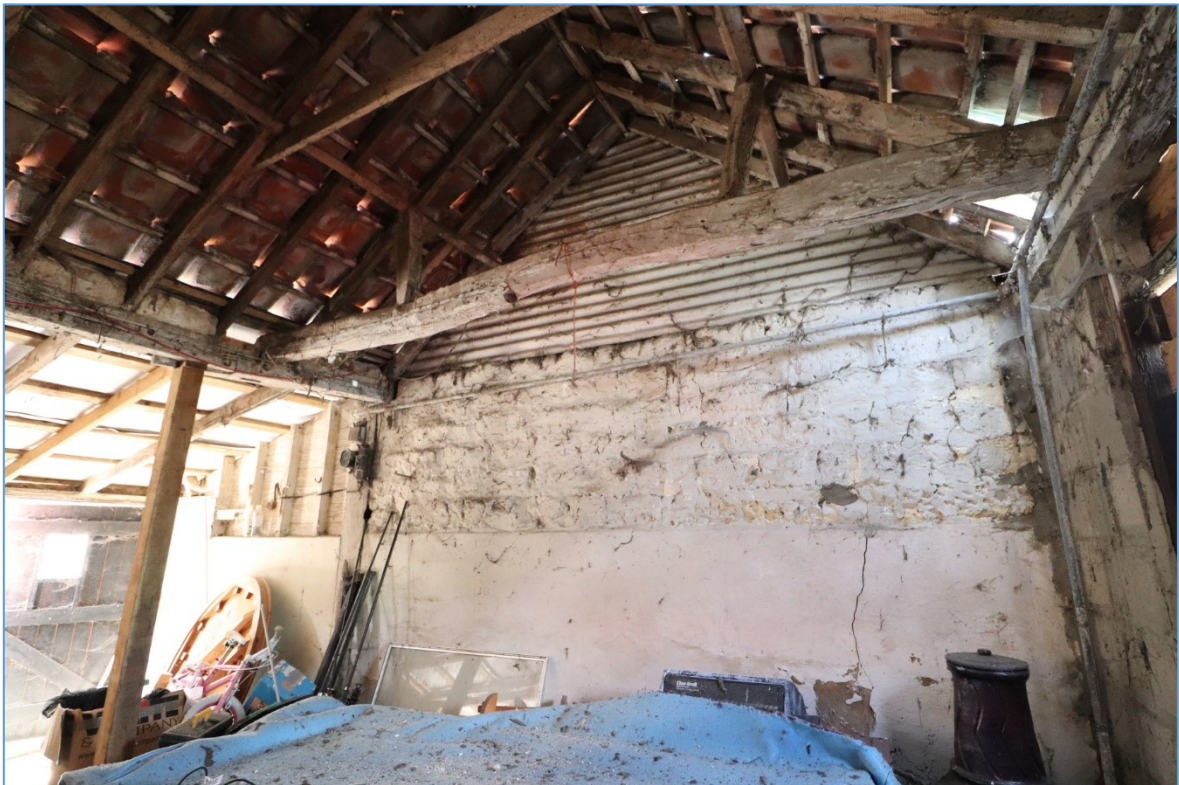
Figure 50. The northern wall of the south-western infill, looking north, showing the remnants of the smaller barn.

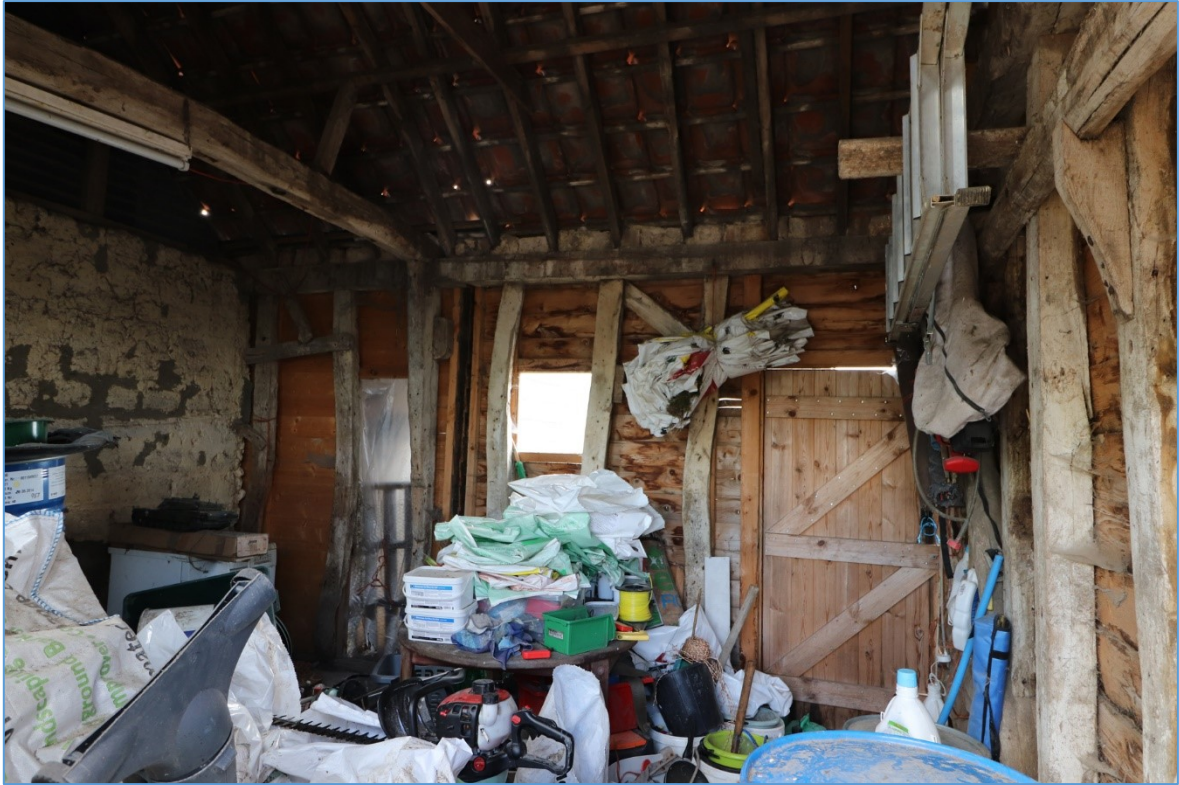
Figure 53. The western wall of the northern half of the smaller barn, looking west, showing the surviving timber framing.

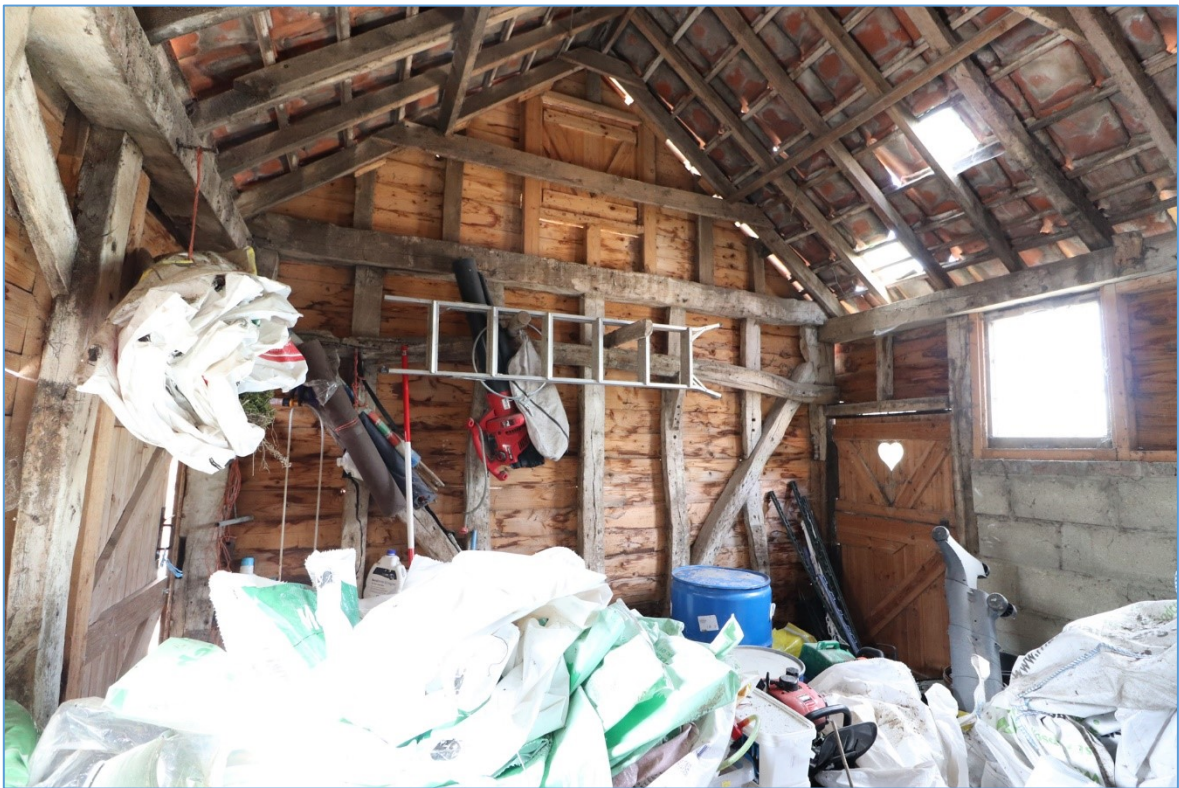
Figure 54. The northern wall of the smaller barn, looking north, showing the surviving timber framing.
