# **8–10 Seckford Street**

## A Level I Historic Building Record

prepared for  
'A' Star Developments Woodbridge Ltd

January 2019

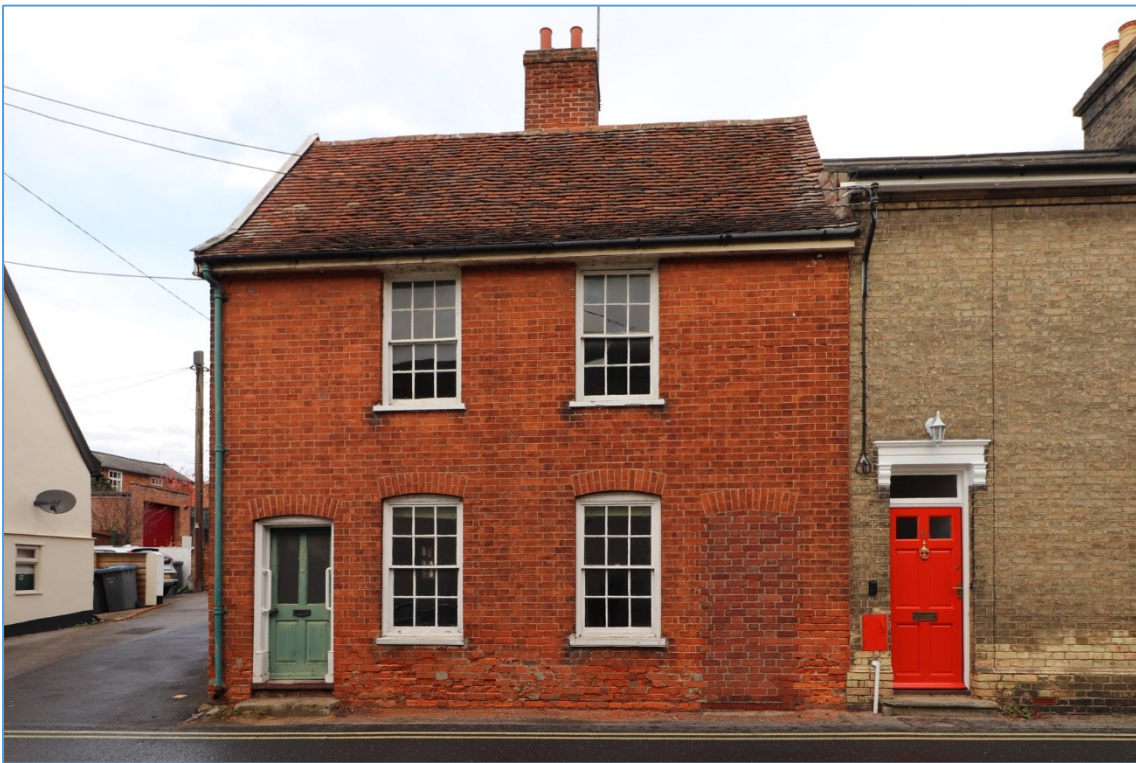
The frontage of the property is of soft red brick laid in a Flemish bond, in contrast to the adjoining property to the east, which is of gault brick (Plate 1). The extant door, with doorstep, is at the western edge of the façade, with an arched brick lintel above, and this provides access to the property. This is mirrored by a blocked doorway at the eastern end of the façade, which would have originally given access to the second cottage, and was presumably blocked following the amalgamation of the properties in the mid-20th century. The ground floor is lit by two twelve-light sash windows, both with arched brick lintels, and the first floor is also lit by two twelve-light sash windows, which are in line above those of the ground floor and built immediately under the eaves.

*Plate 1. The southern façade of the property, showing extant windows and door, and blocked former door.*

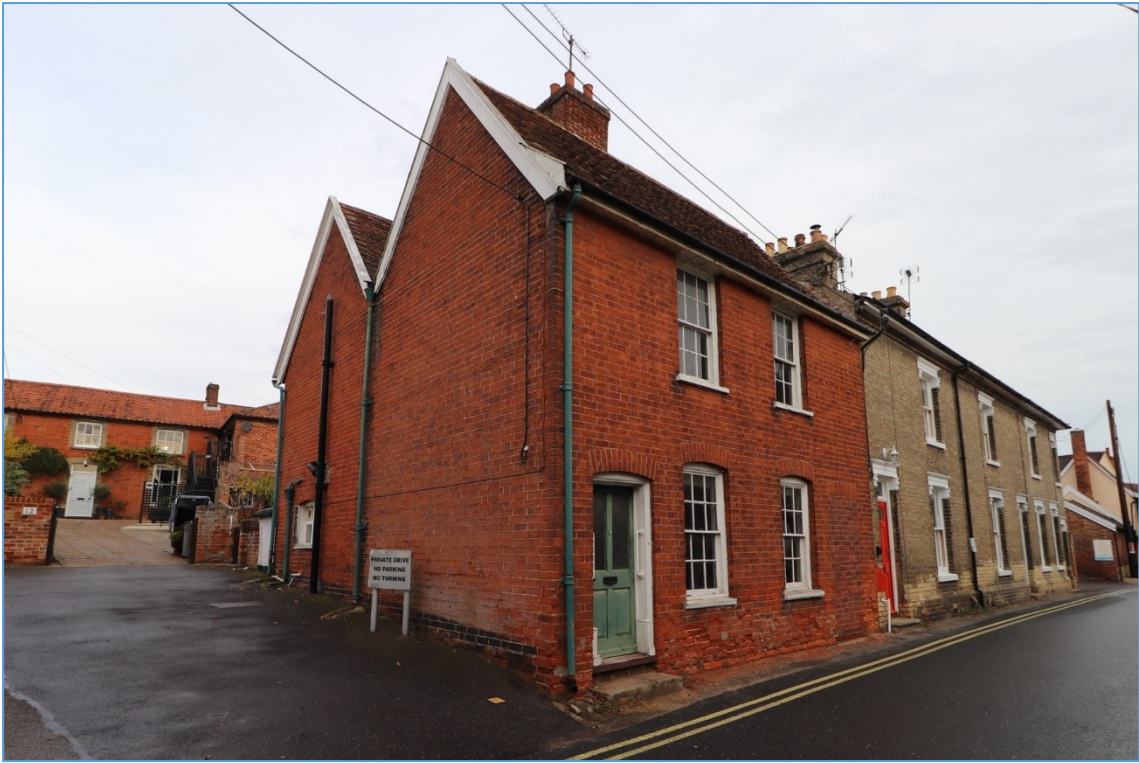
The roof of the building spans the full west–east width of the structure and is of double apex construction (Plates 1 and 2). A tall, red-brick chimneystack rises from the central valley of the roof. The roof is covered with red peg-tiles, and has cast iron rainwater goods. A downpipe runs down the western edge of the façade.

*Plate 2. The property from the south-west, showing southern façade, western gable and double-pitch apex roof.*

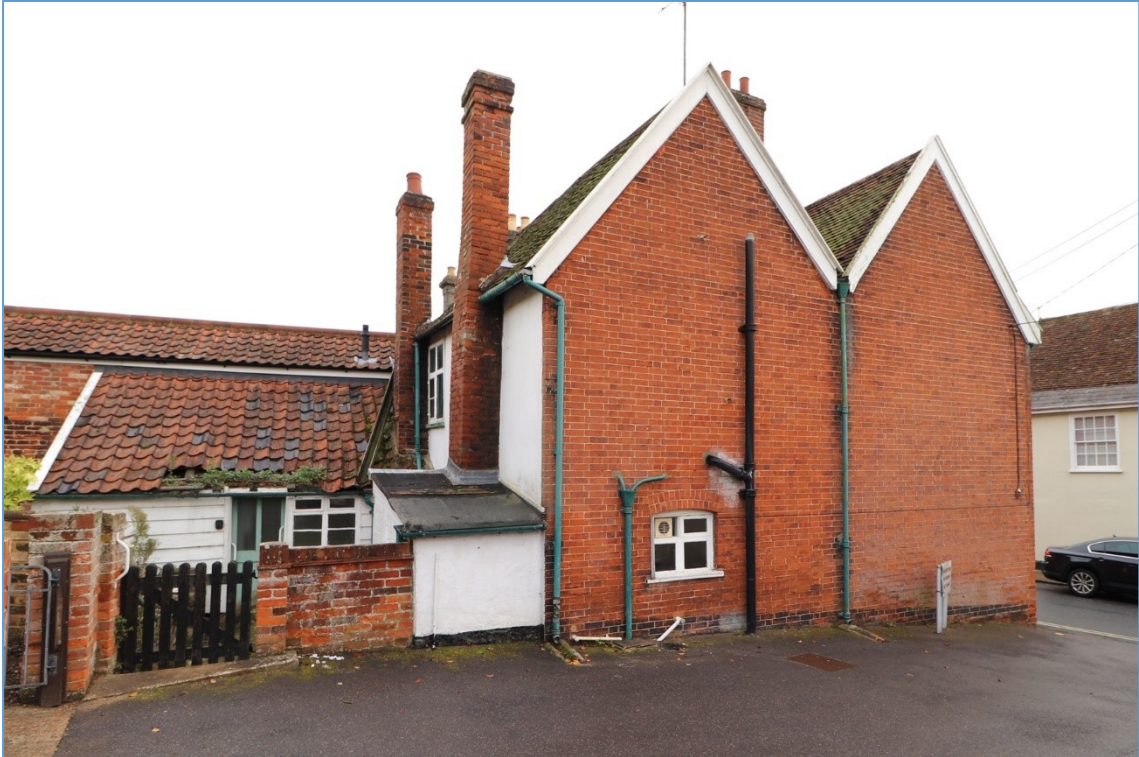
The western gable of the building is also of red brick laid in a Flemish bond, and is largely devoid of features, with the exception of a small four-light window illuminating the kitchen (Plates 2 and 3). This window has an arched brick lintel and its low setting highlights the relative height of the adjacent driveway in relation to the ground floor of the house itself (Plate 3). The gable wall is also adorned with rainwater goods from the central roof valley and the rear of the roof, as well as soil stacks from the bathroom.

*Plate 3. The property from the west, showing western gable, rear chimneystacks and extensions.*

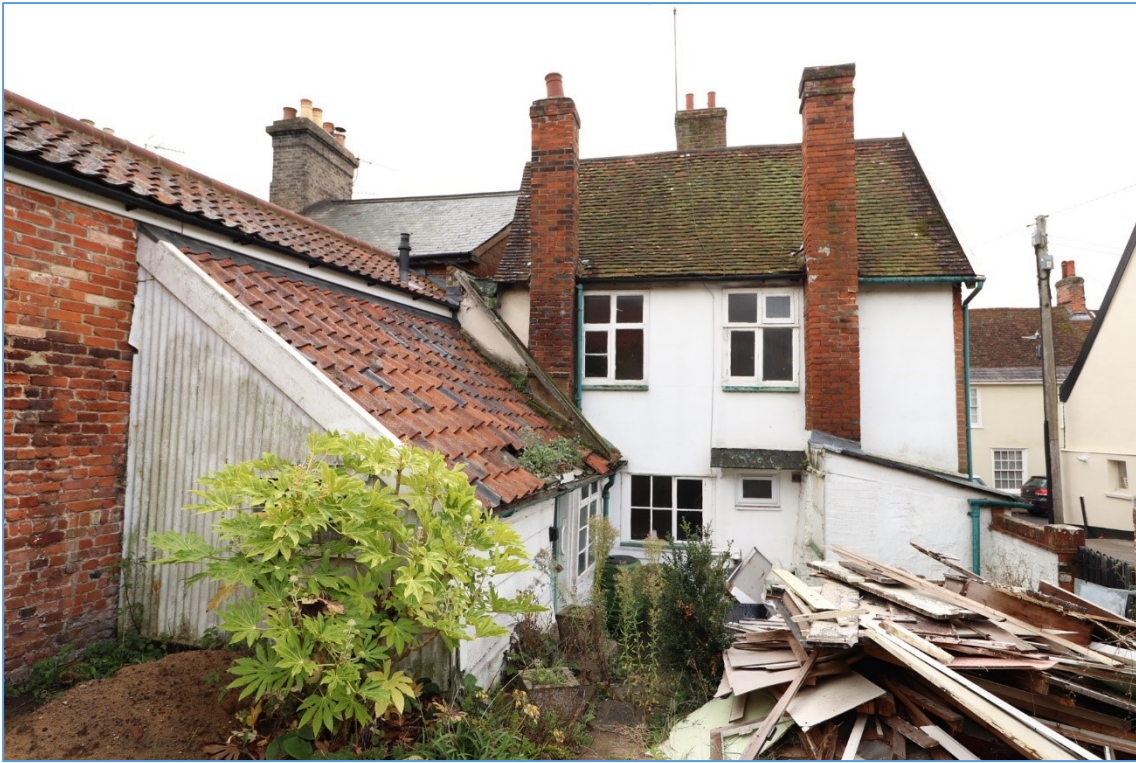
The rear of the property is rendered and painted white (Plates 3 and 4). The rear façade is flanked by two tall, red-brick chimneys which appear to be later additions and presumably served later fireplaces. To the west stands a small outshut with a catslide roof, was not able to be accessed as part of the survey. Historic mapping suggests that this was constructed in the late 19th century.

*Plate 4. The property from the north, showing the rear elevation, with chimneystacks and extensions fronting onto a small yard.*

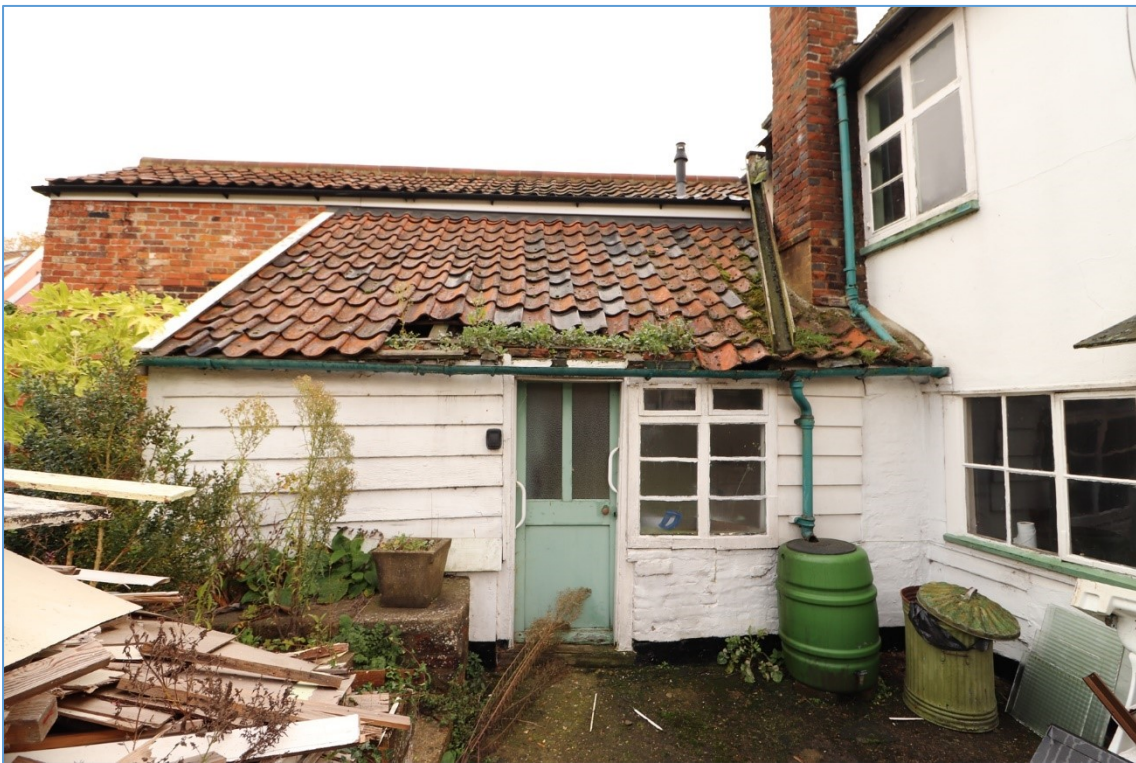
The eastern extension is oriented north–south and its eastern wall is formed by the party wall with the adjacent property, while the base of the eastern chimneystack is incorporated into its fabric. The single-pitch roof is of red pantiles laid over a simple frame, and there are several patches of tiles missing, with vegetation growing through the roof (Plates 4 and 5). The northern gable is of corrugated metal sheeting. The western façade of the extension comprises timber weatherboarding to the north, with a narrow, central, two-light door and an eight-light top-opening window to the south. The wall beneath this window is of rough brickwork laid in an irregular bond, with additional weatherboarding above (Plate 5). A wooden gutter extends from the roof of the main house, across the roof of the extension and feeds into the cast iron rainwater goods attached to the extension itself.

*Plate 5. The western façade of the north-eastern extension, showing weatherboard construction and dilapidated condition of the roof.*

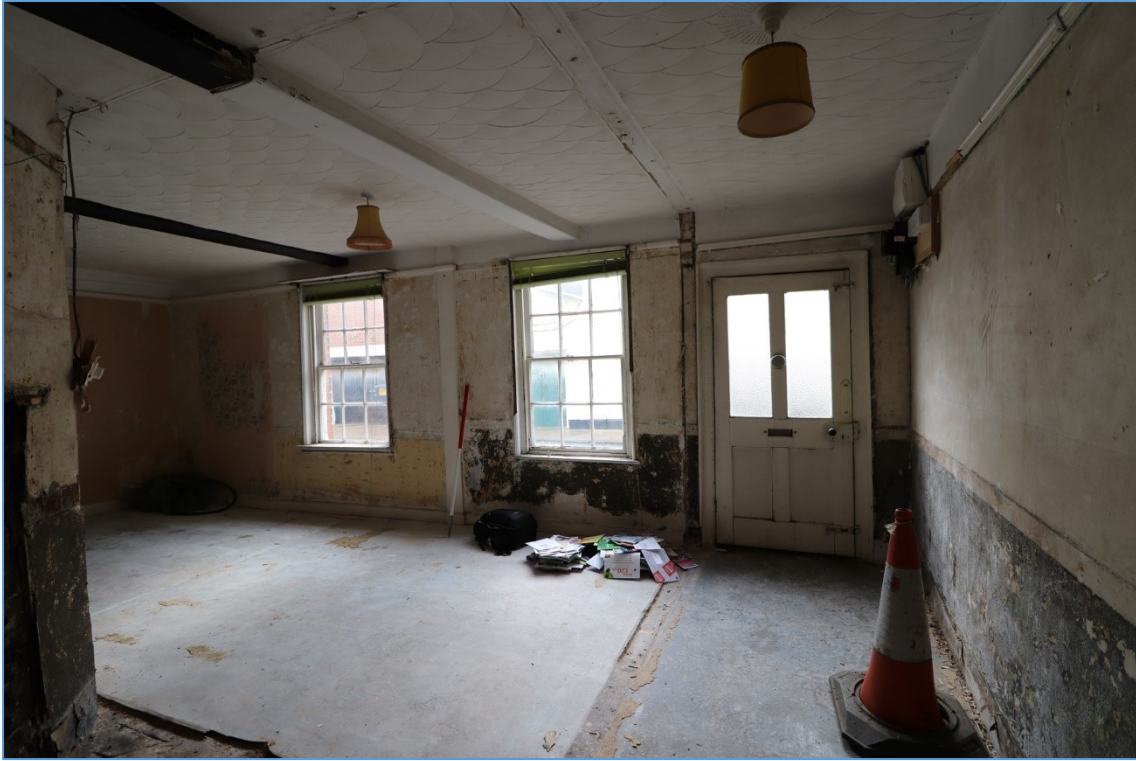
The downstairs front room of the property is now a single expanse, but it is possible to see traces of the partition wall which formerly divided the space into two halves on interior of the front wall, as well as more recent traces of a partition wall which created a hallway immediately inside the extant front door (Plate 6). Traces of the blocking of the eastern front door can be seen in the plasterwork of the front wall.

*Plate 6. The ground-floor front room, looking south, showing front door, and wall and floor scars of former partition walls.*

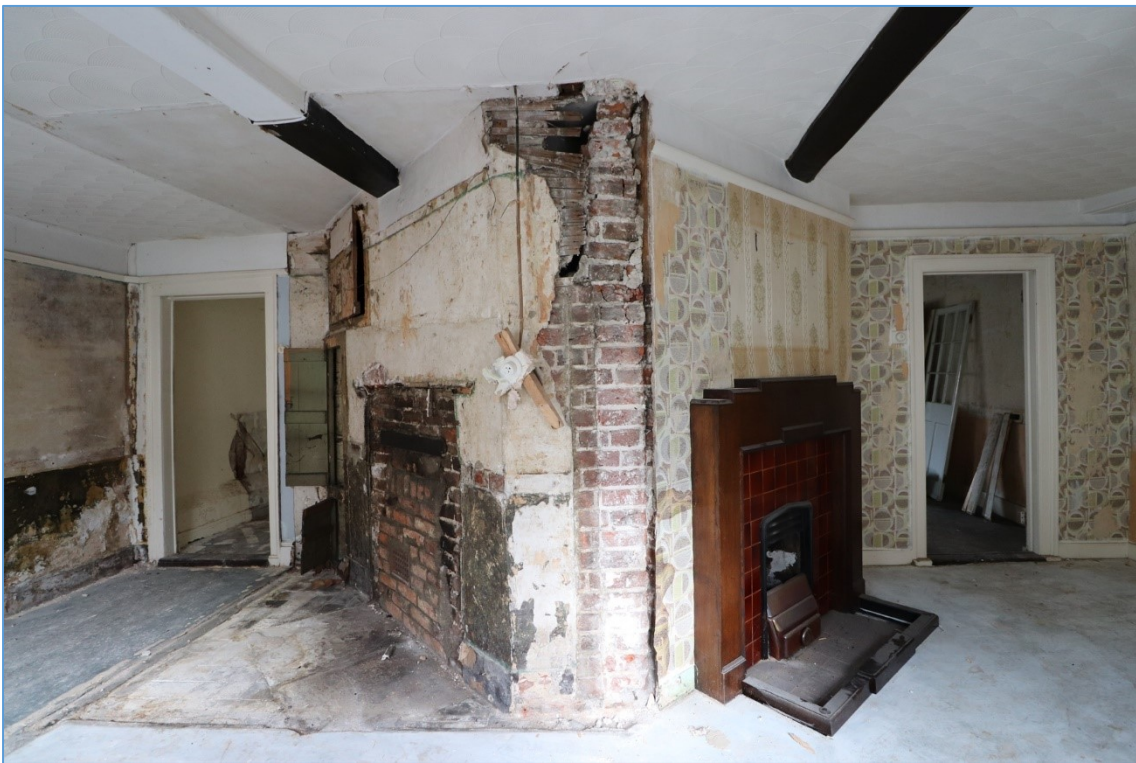
The main architectural feature of note in this space is the pair of fireplaces which formerly served the two properties. These comprise brick façades set at diagonal angles to the rooms, into which two fireplaces are set (Plate 7). The dividing wall of the living room sprang from the southern tip of the fireplaces to the front wall.

*Plate 7. The central chimney stack, looking north along the line of the original partition wall, showing the blocked western fireplace and the open eastern fireplace.*

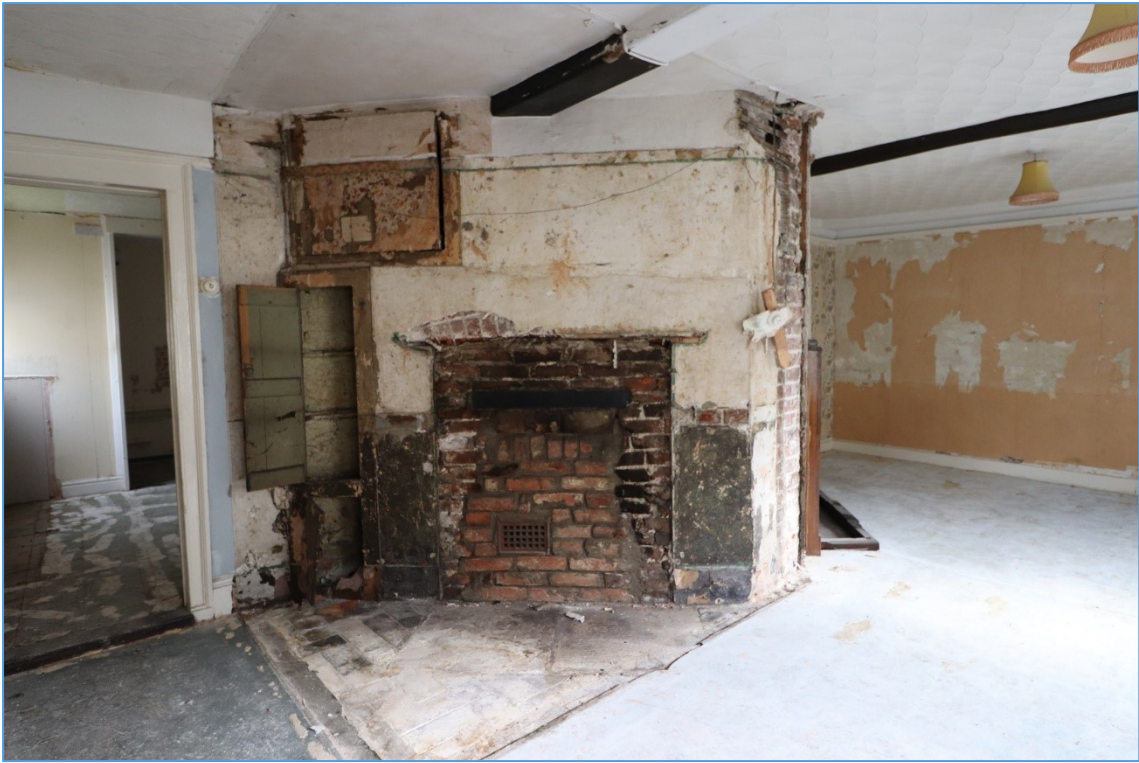
The western fireplace is blocked with bricks, presumably dating from the mid-20th century (Plate 8), and architects' plans and floor scars indicate that until recently this fireplace had been boxed in and squared off alongside the hall (Plates 7 and 8). Traces of older cupboards inserted beside the chimneybreast survive in this area. To the east, the extant fireplace and grate are surmounted by a wooden mantel and glazed tiles (Plates 7 and 9).

*Plate 8. Detail of the blocked western fireplace, looking north-east.*

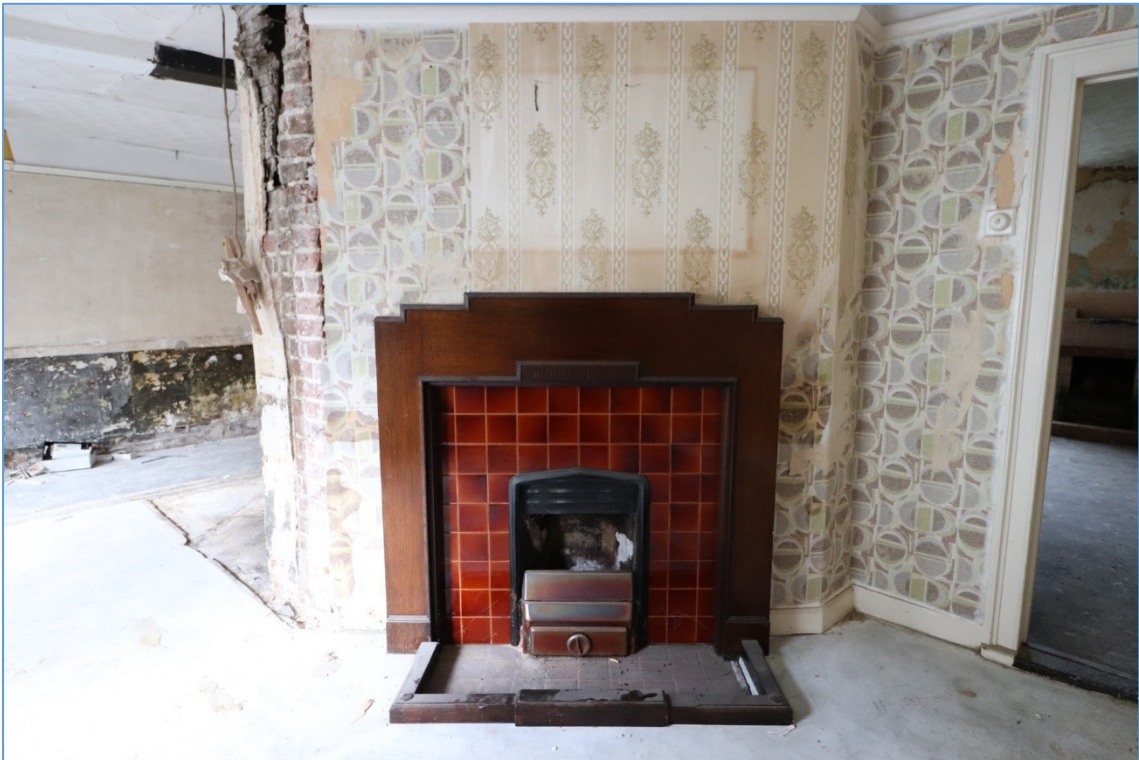
*Plate 9. Detail of the open eastern fireplace, looking north-west.*

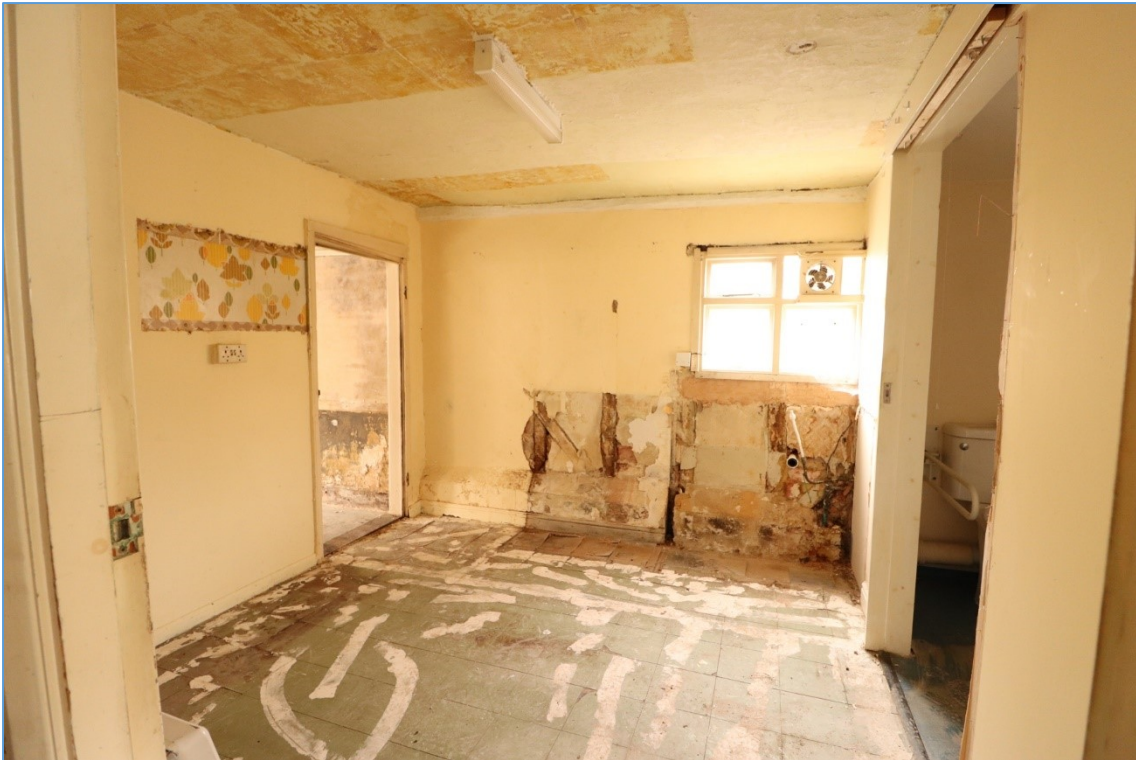
The downstairs rear of the property is still divided into two rooms. The western room was formerly a kitchen, which has now had all of its fixtures and fitting stripped out, beyond which stands a modern accessible shower and toilet room (Plate 10). The stripping out of the kitchen units has revealed evidence of earlier vertical timber beams sat on a plinth which represent the original integral structure of the western gable before it was refaced in brick (Plate 11). This room would also have originally contained a boxed in staircase to the first floor, which was removed and blocked in the mid-20th century. A corresponding staircase still survives within the rear eastern room of the property (Plate 12).

*Plate 10. The north-western former kitchen, looking west, showing exposed timber framing and entrance to the modern bathroom to the north.*

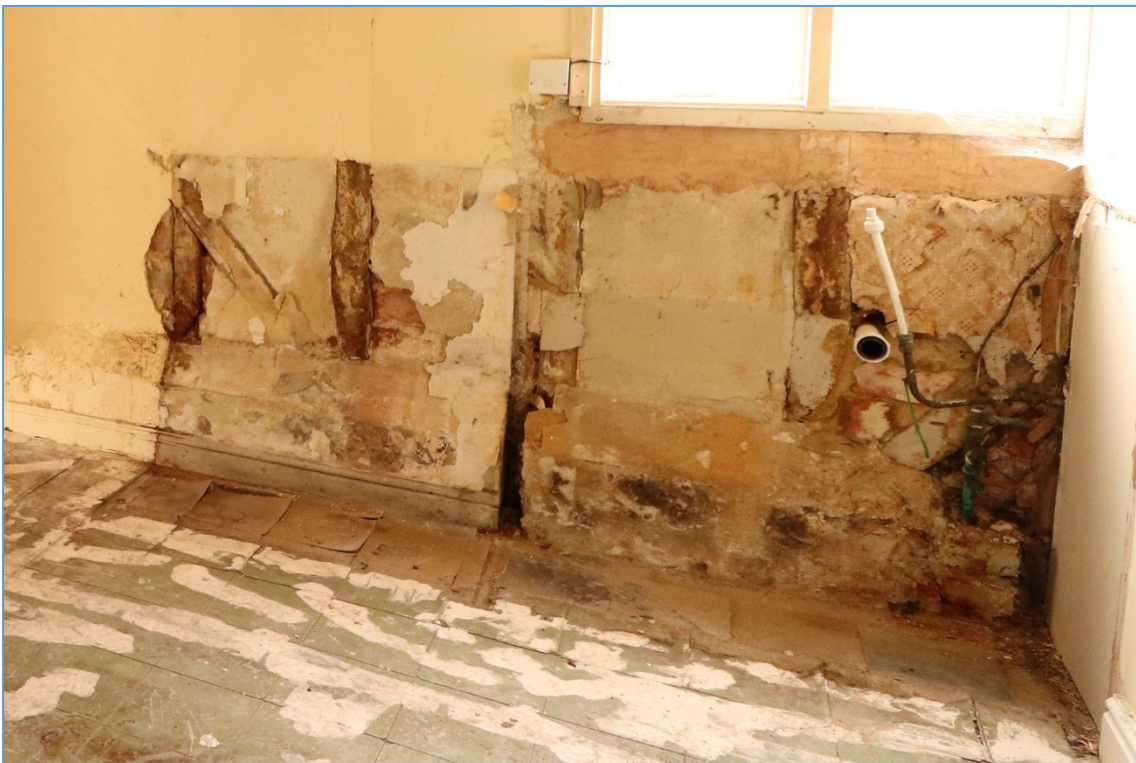
*Plate 11. Detail of the exposed timber framing in the western gable wall of the former kitchen.*

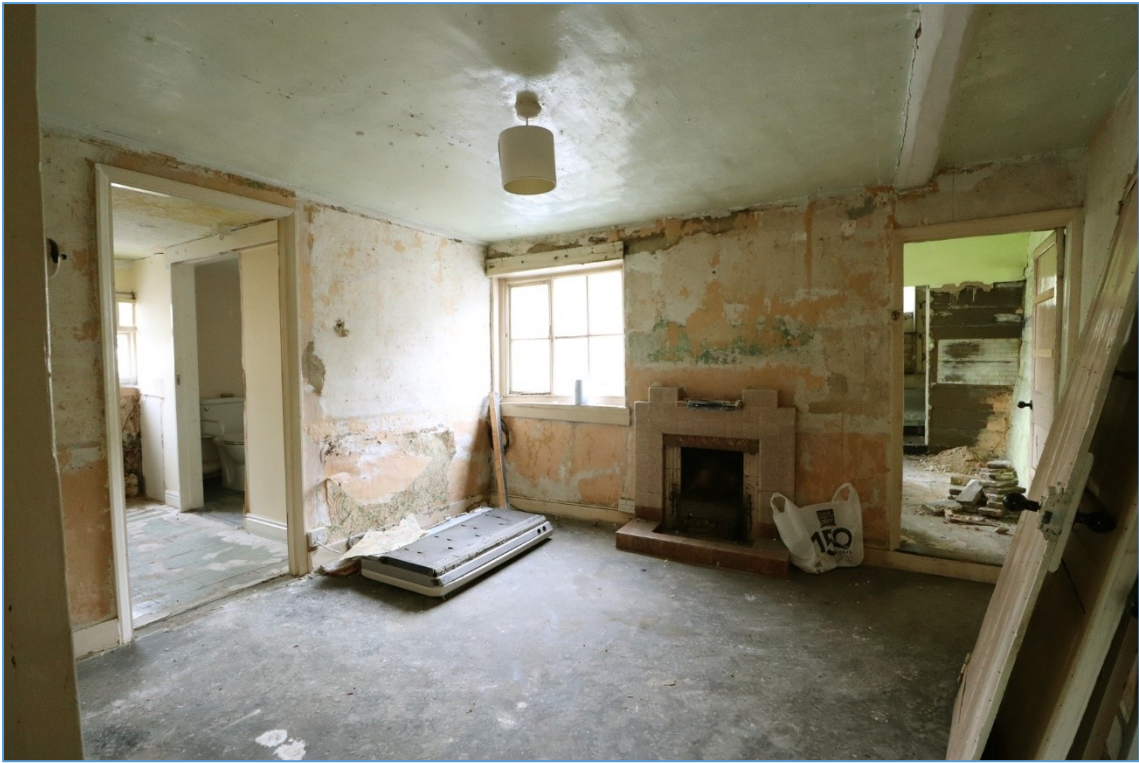
Formerly a dining room, the north-eastern downstairs room has doorways to the front room and to the former kitchen, as well as a doorway to the rear extension (Plate 12). A fireplace on the exterior wall links to the chimney visible from the outside and in the extension. Its grate is surrounded by an elaborate tiled mantel, presumably dating from the first half of the 20th century. The southern side of the room is occupied by the staircase (Plate 13), beneath which is a small cupboard.

*Plate 12. The north-eastern former dining room, showing extant fireplace and doorway to the extension.*

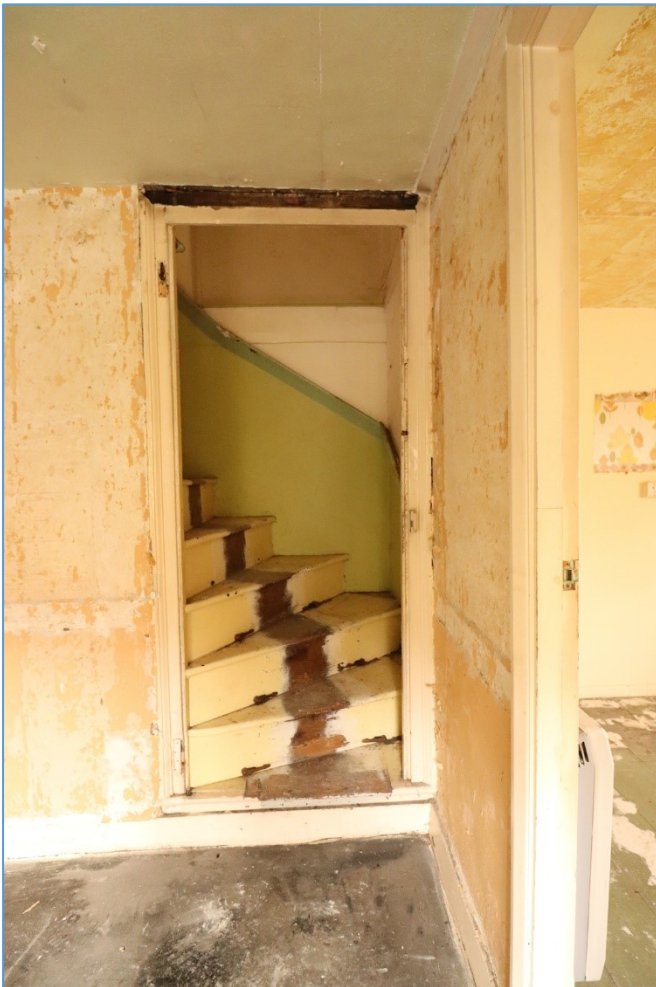
*Plate 13. The entrance to the stairs, looking south.*

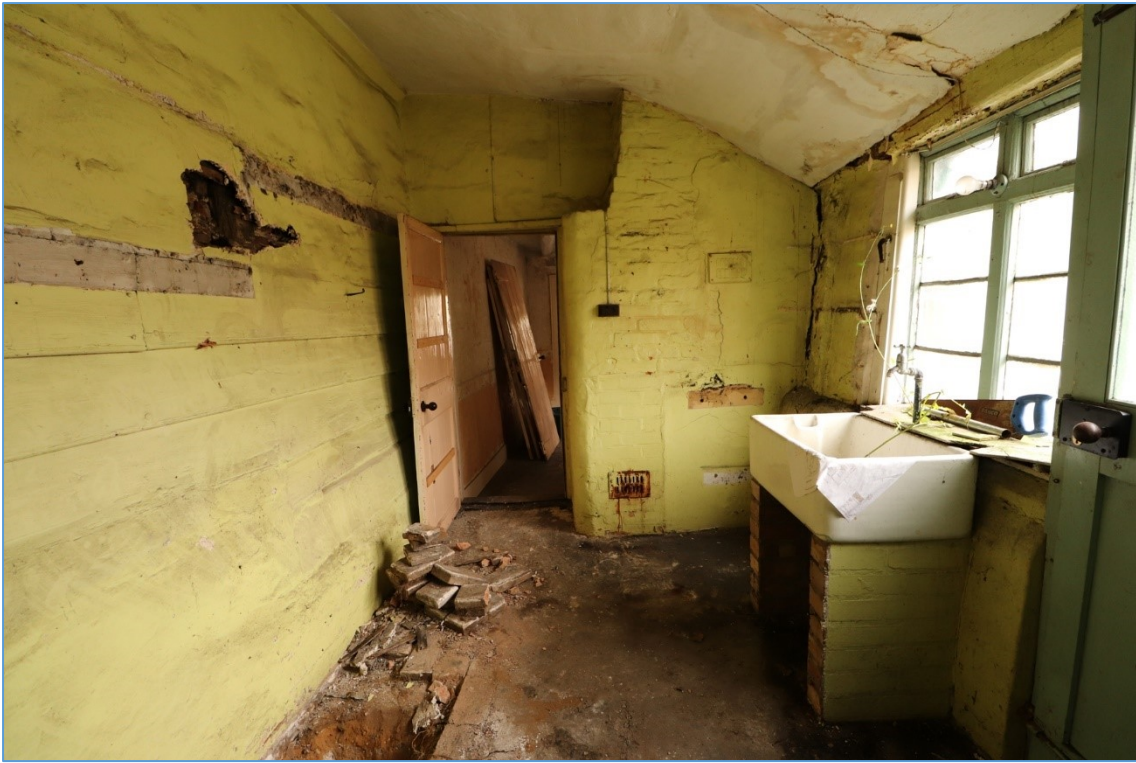
*Plate 14. The interior of the north-eastern extension, looking south, showing encased chimneystack and connecting door to the main body of the property.*

The rear extension is constructed around the footings of the chimney stack (Plate 14) and comprises a floor of thin bricks laid on earth, with a weatherboarded eastern wall and a western wall of brick, set beneath a window and weatherboarding. A Belfast sink stands on two brick piers beneath the window, adjacent to which is the exterior door. The northern end of the extension comprises a weatherboarded partition containing a door, which leads to a small northern room lit by a small two-light window in the north wall (Plate 15). The structure of this room comprises a rough framework of narrow timbers set atop a waist-height brick plinth. Much of the interior is boarded out, although in several places the boarding has rotted, revealing the timbers behind, and a portion of the roof has also fallen in. This extension is due to be demolished as part of the renovation of the property.

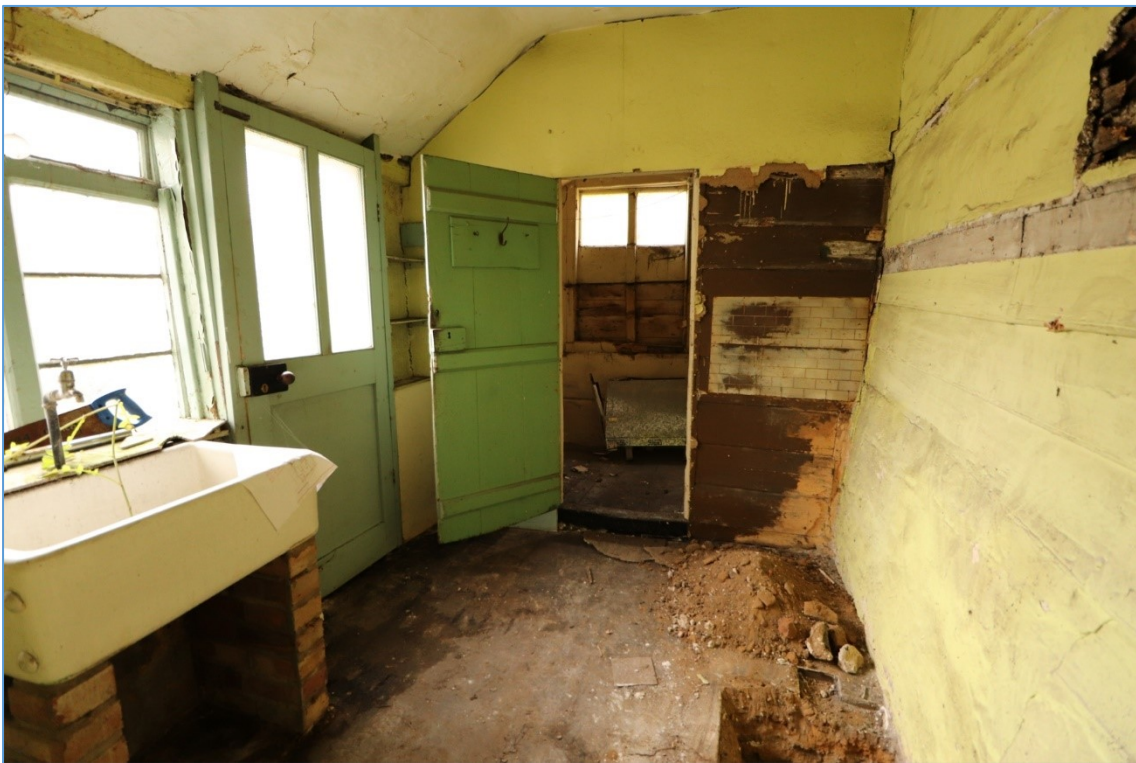
*Plate 15. The interior of the north-eastern extension, looking north, showing the exterior doorway and connecting doorway to the northern cell of the extension.*

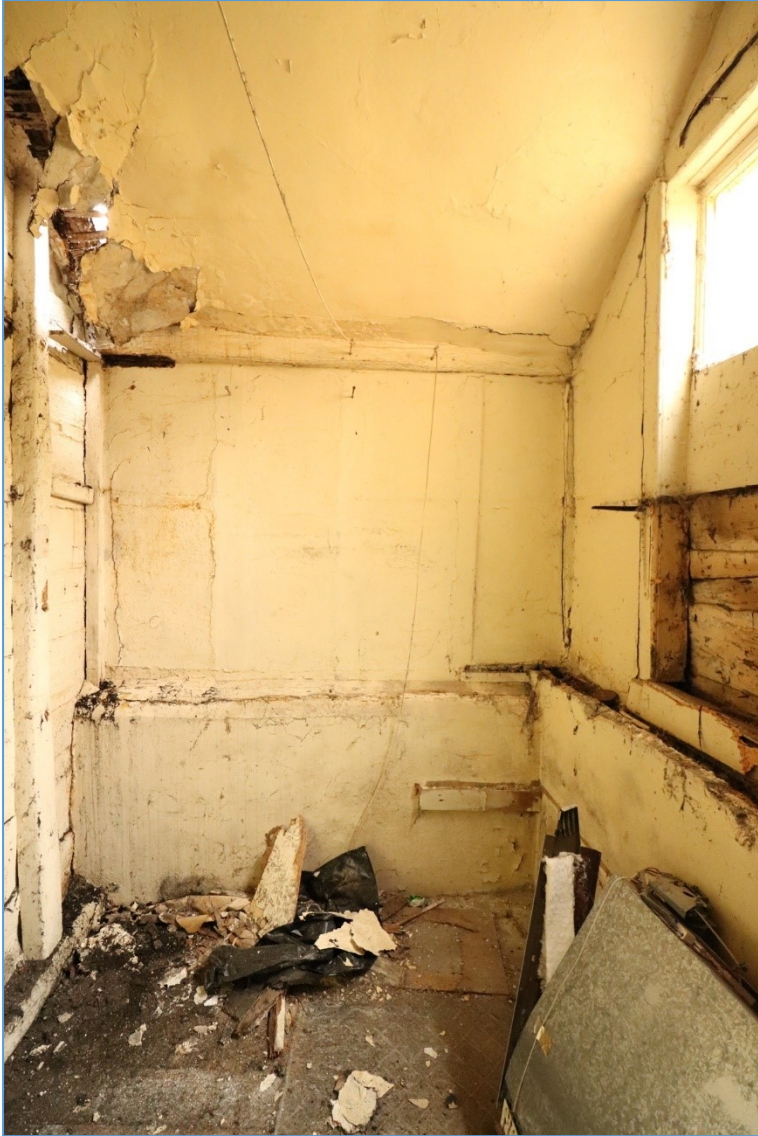
*Plate 16. Interior of the northern cell of the extension, looking west.*

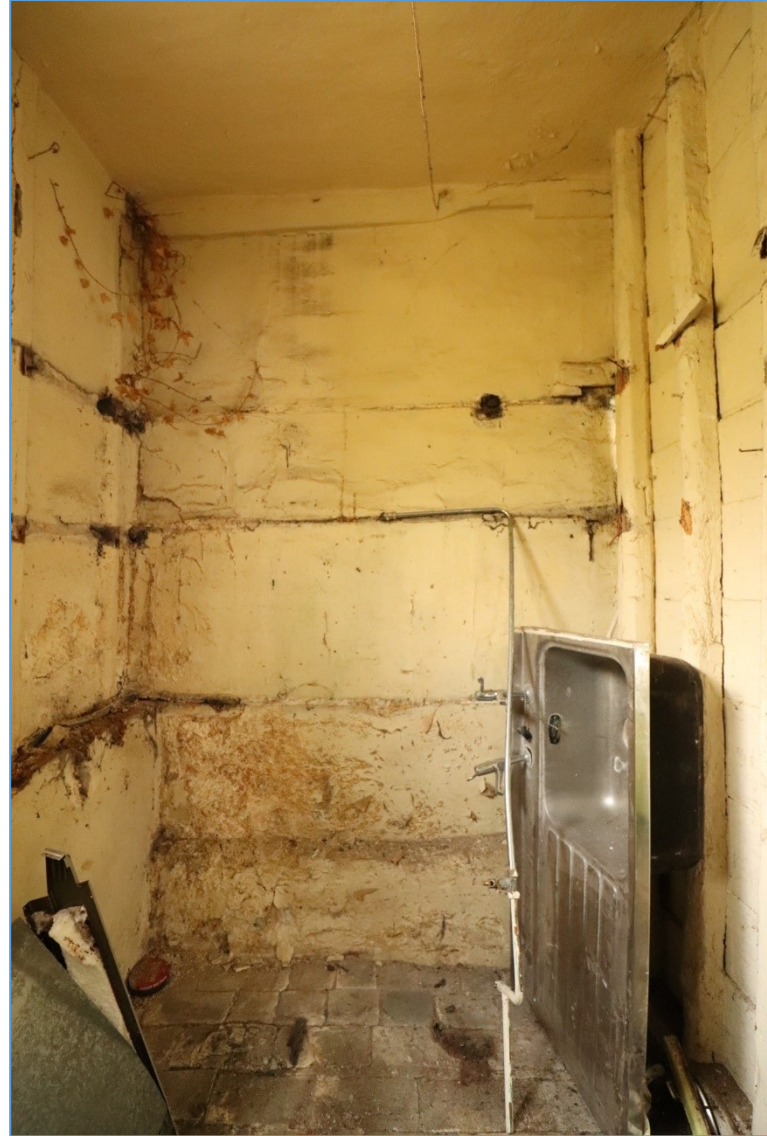
*Plate 17. Interior of the northern cell of the extension, looking east.*

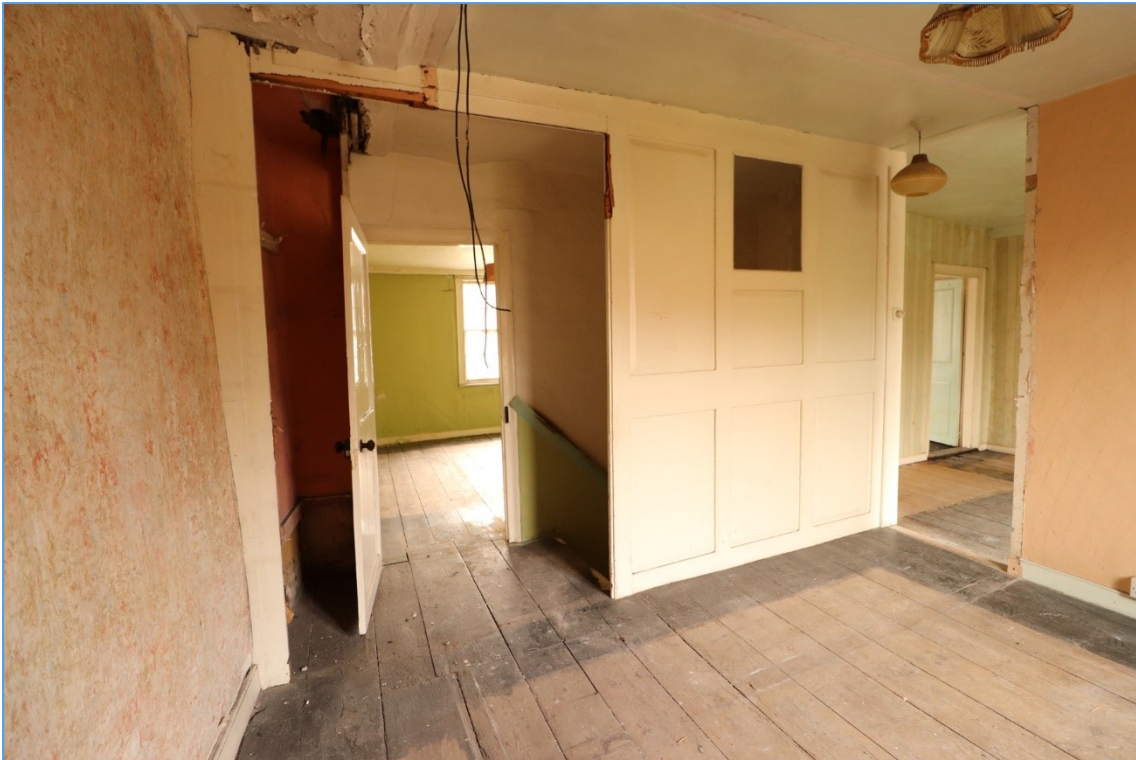
*Plate 18. View of the landing, looking south, showing the scars of former partitions and linking doorway.*

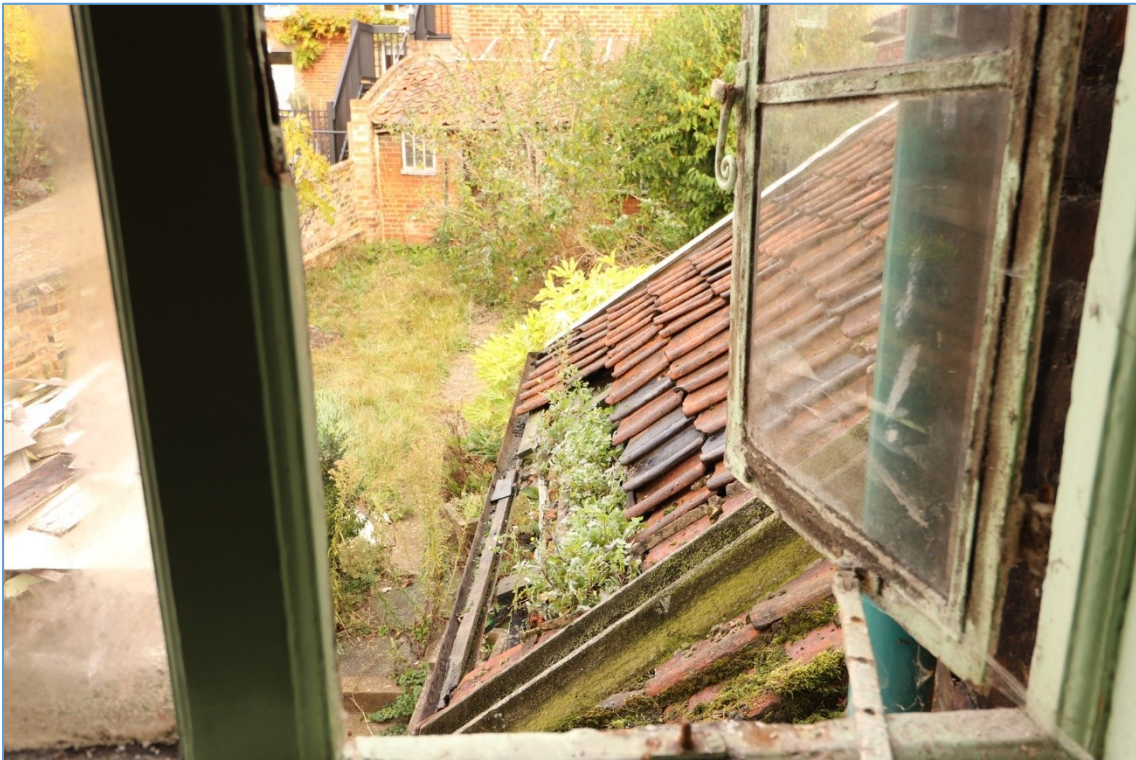
The first floor of the property is accessed via the remaining staircase, which would have originally been mirrored by a second staircase. At the top of the stairs, a doorway leads south into the south-eastern front bedroom, while timber panelling on the northern side of the stairwell and floor-scars indicate the former presence of a landing and corridor cut out of the corresponding bedroom to the north (Plate 18). A doorway was cut through the partition wall between the two upstairs rear bedrooms in the mid-20th century when the two properties were merged into one. The north-eastern bedroom is lit by a Crittall window in the northern external wall, which overlooks the dilapidated roof of the extension (Plate 19).

*Plate 19. View from the rear bedroom window across the roof of the north-eastern extension, with outbuilding beyond.*

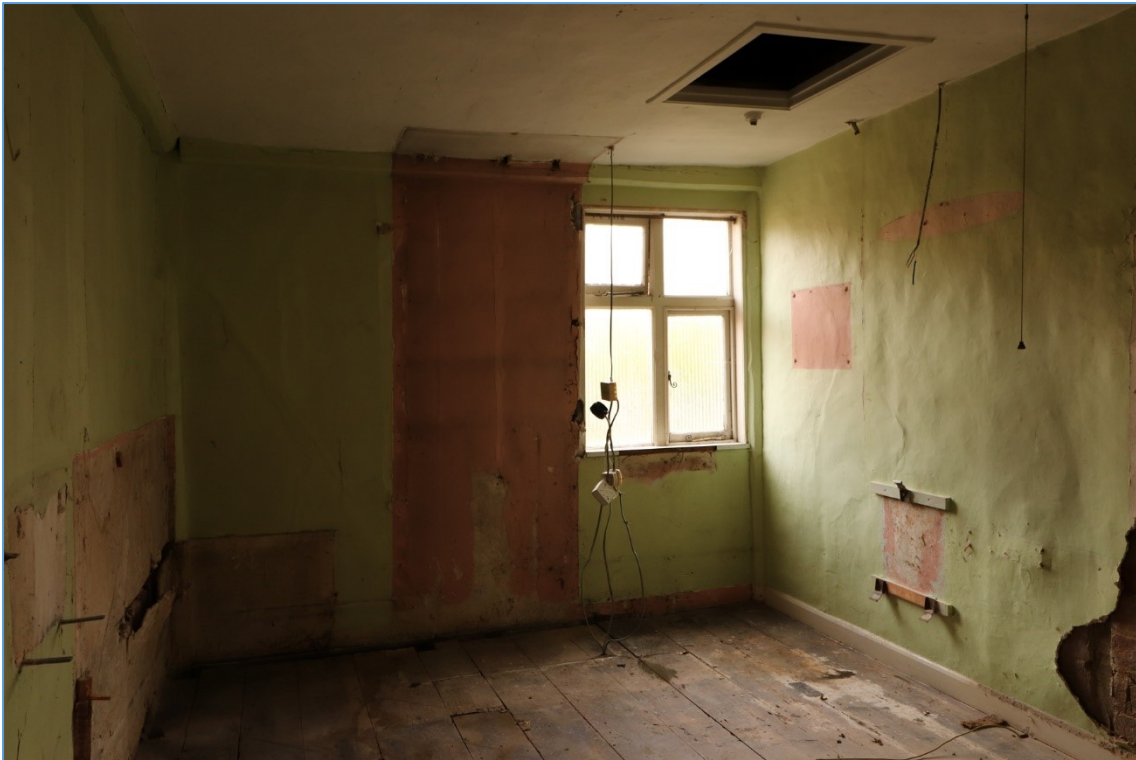
The corresponding north-western first-floor room was formerly a bathroom, and has now been stripped of its fittings (Plate 20). This room was also previously truncated to form a landing corridor, and where the render has come away adjacent to the door cut between the two rooms it is possible to see traces of the construction of the partition wall, which comprises timber studwork infilled with roughly laid bricks (Plate 21).

*Plate 20. The north-western first-floor former bathroom, looking north.*

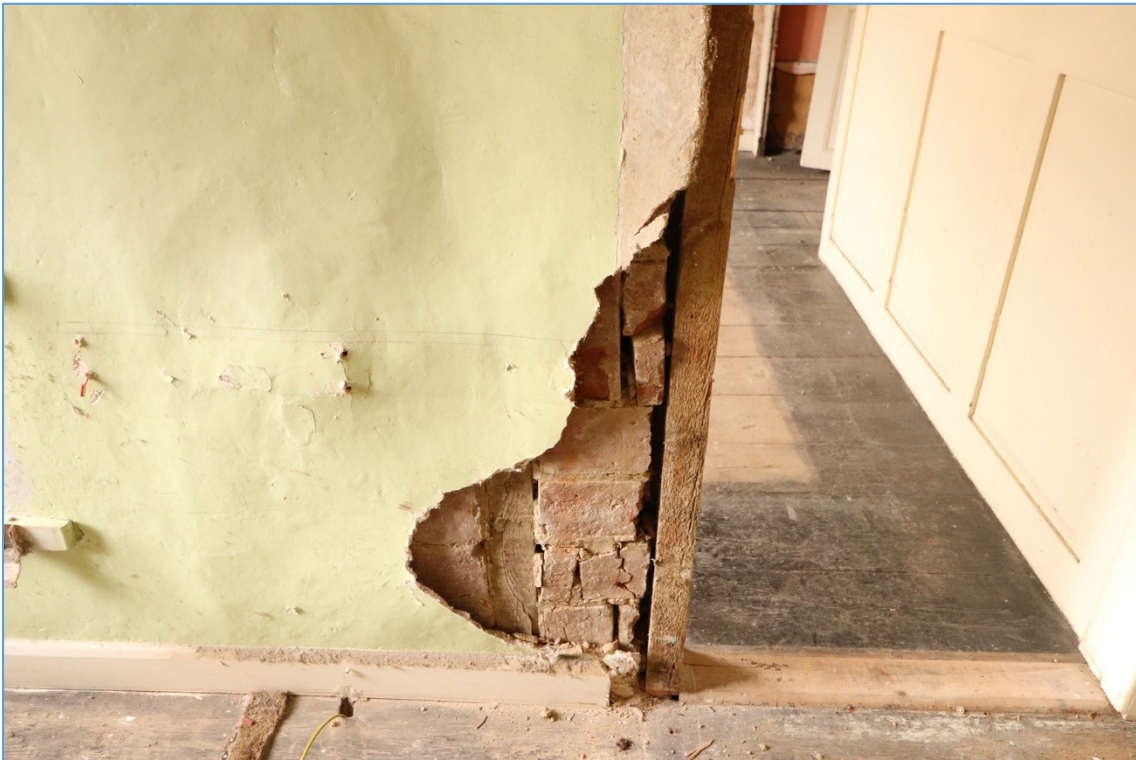
*Plate 21. Detail of the construction of the partition wall between the properties, looking east.*

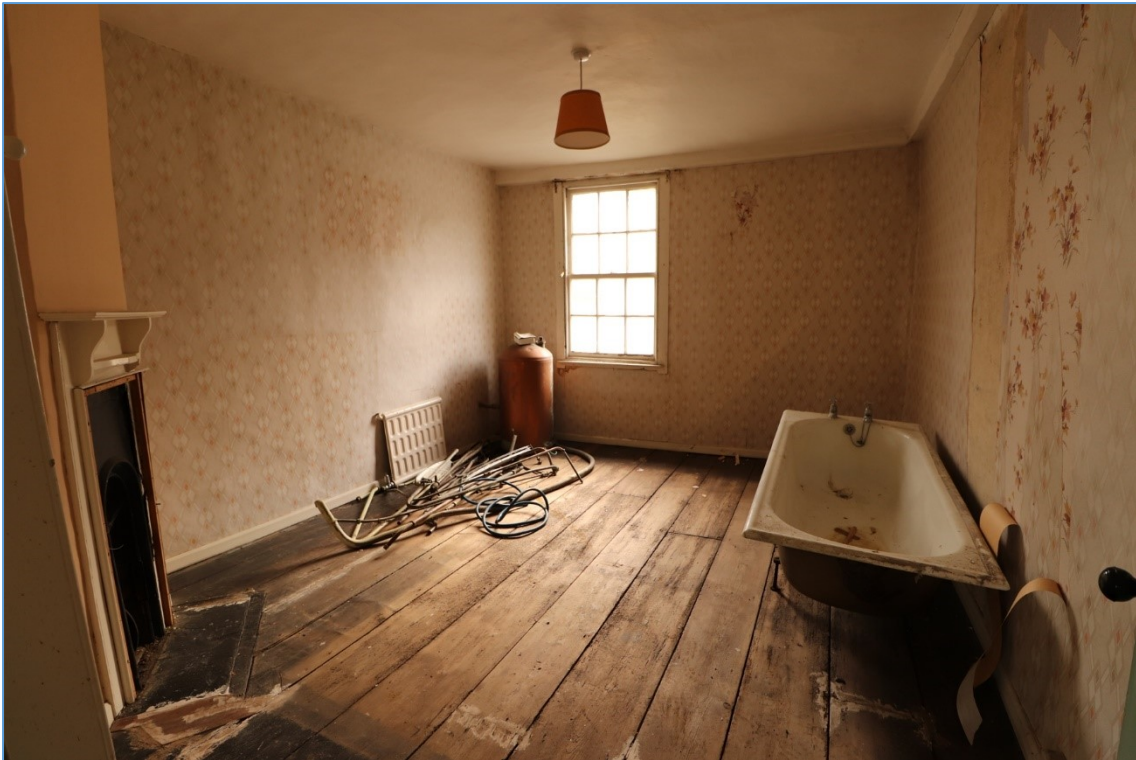
To the front of the property, the south-western bedroom has a sash window overlooking to road (Plate 22), and a small cast-iron fireplace in its north-eastern corner, set into the chimney stack which climbs through the house (Plates 22 and 23).

*Plate 22. The south-western first-floor bedroom, looking south, showing front window and extant fireplace.*

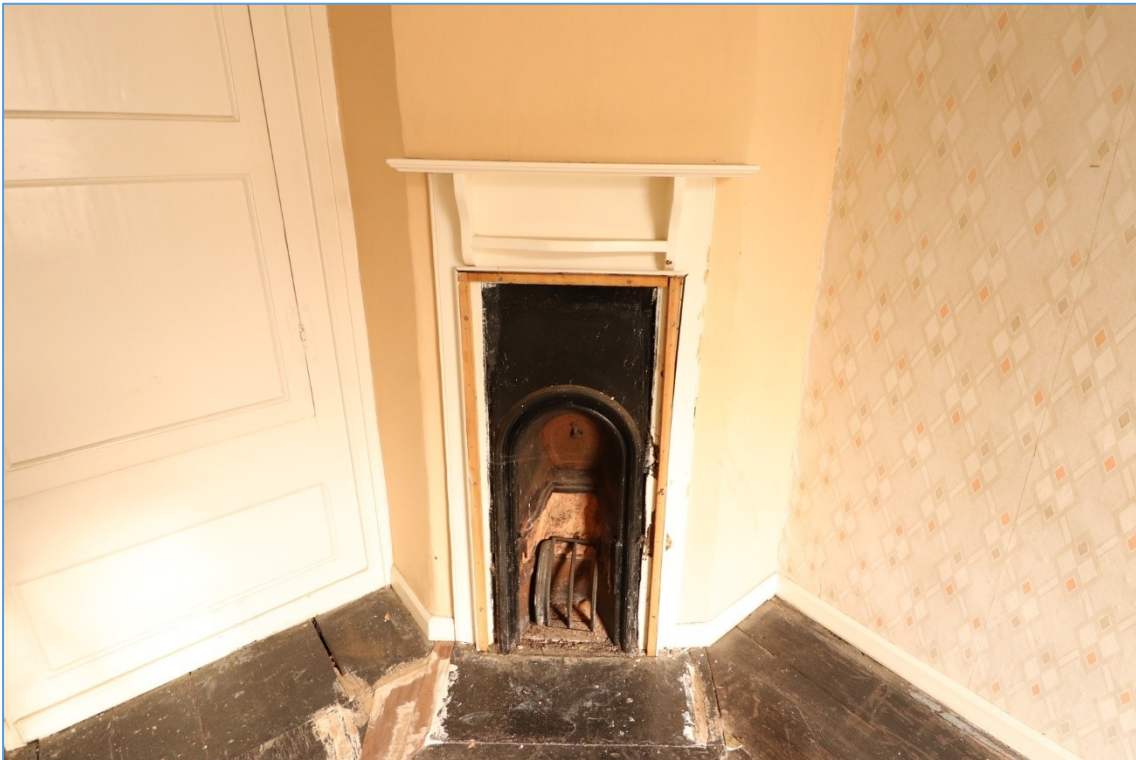
*Plate 23. Detail of extant plain fireplace in the south-western first-floor bedroom, looking north-east.*
