# **8–10 Seckford Street**

## A Level I Historic Building Record

prepared for  
'A' Star Developments Woodbridge Ltd

January 2019

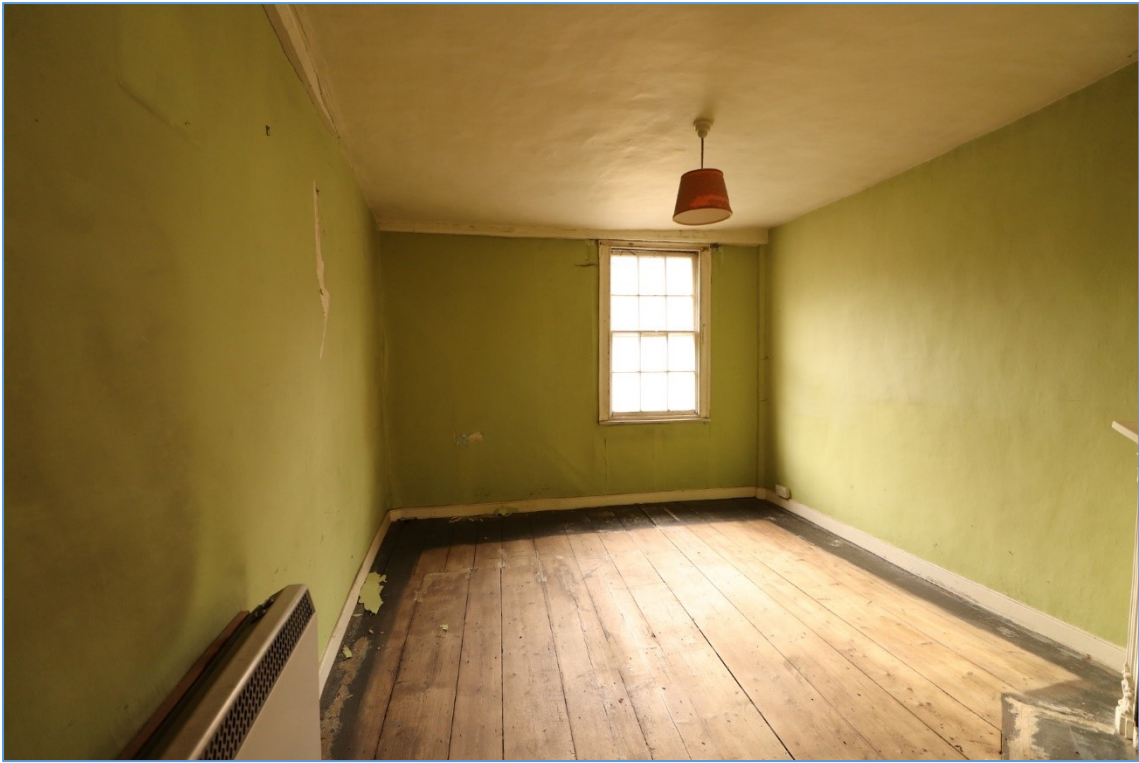
*Plate 24. The south-eastern first-floor bedroom, looking south, showing front window and very edge of extant fireplace.*

Unlike at the rear of the property, no connecting doorway has been created between the two front bedrooms, the south-eastern of which is reached via the landing from the top of the stairs. This room mirrors the other front bedroom, with a sash window and a fireplace (Plates 24 and 25). The fireplace in this room features ornate ironwork decoration and a small cupboard is built into the side of the chimneybreast.

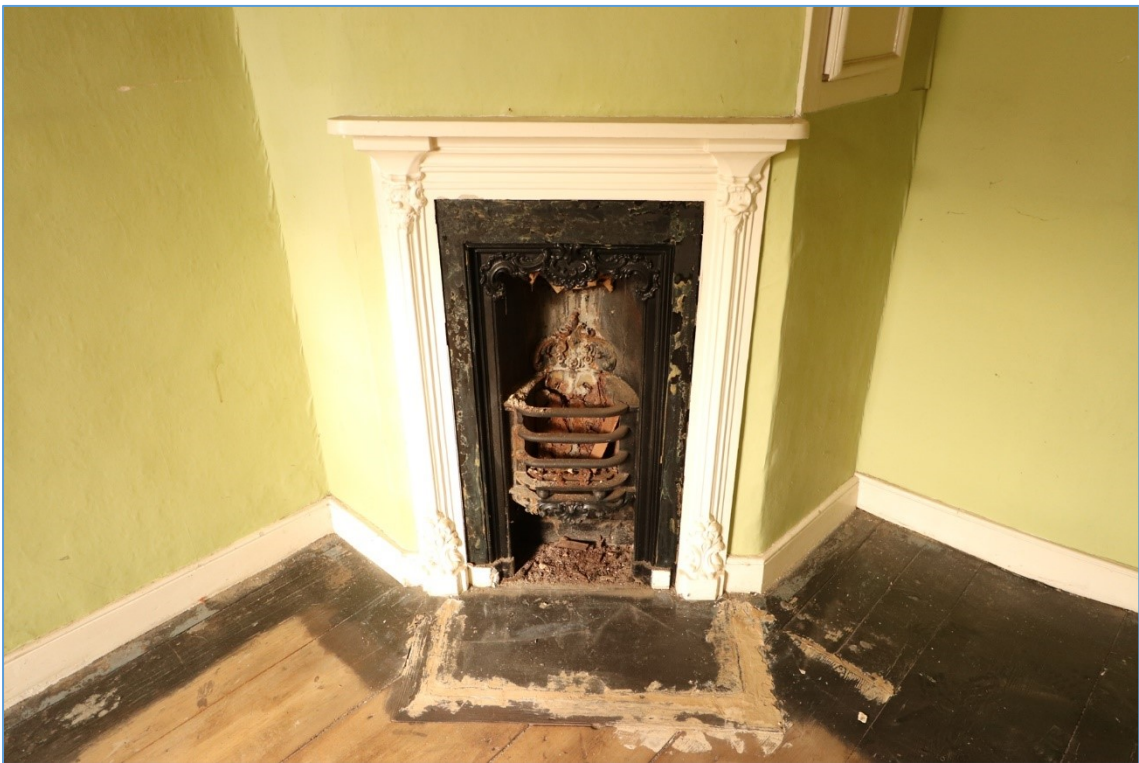
*Plate 25. Detail of extant ornate fireplace in the south-eastern first-floor bedroom, looking north-west.*

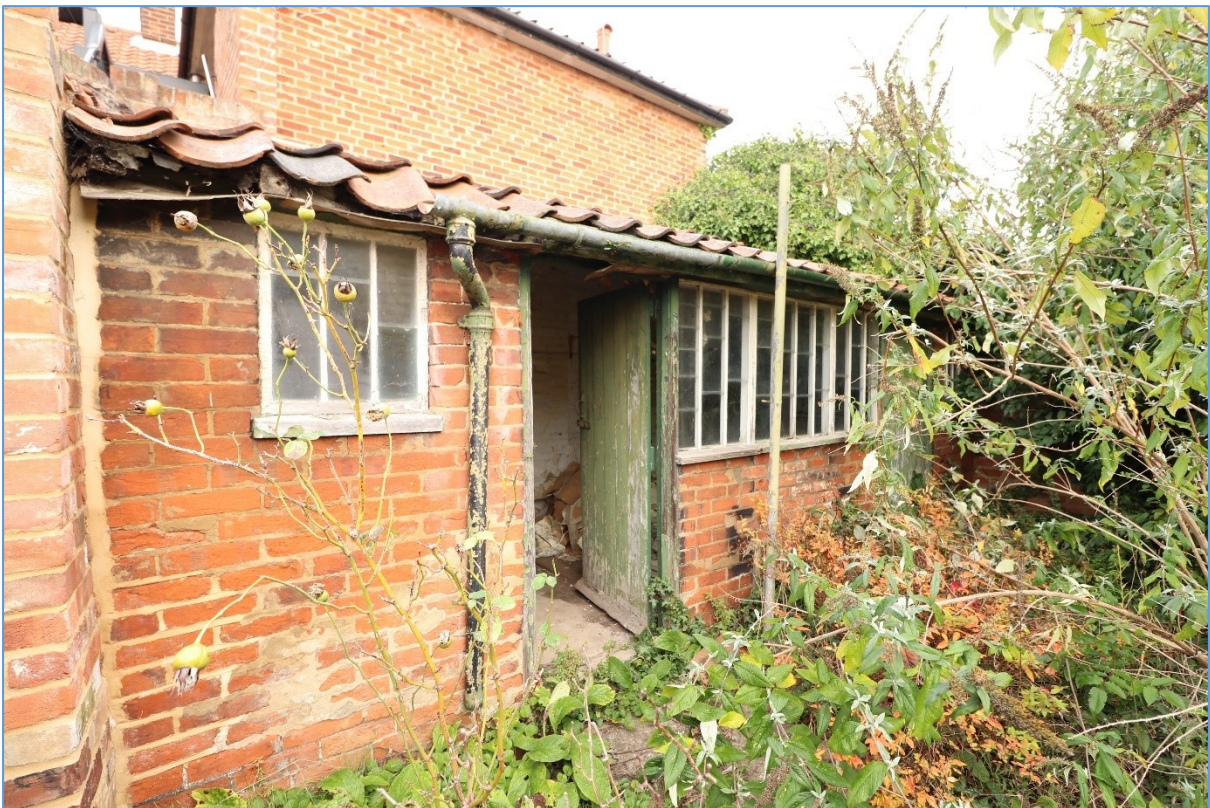
At the northern end of the garden, the plot is spanned by a full-width outbuilding, which had been constructed by 1838 (Plate 26). Constructed from red brick laid in a stretcher bond, with a pantile roof, this building is lit by a series of south-facing windows. Now a single structure, the outbuilding has two timber doors indicating that it was originally constructed to serve the two houses. Architecturally unremarkable, the outbuilding has a simple timber roof structure and has recently been used for storage (Plates 27 and 28).

*Plate 26. The exterior of the full-width outbuilding, looking north-east, showing both doors and glazed front.*

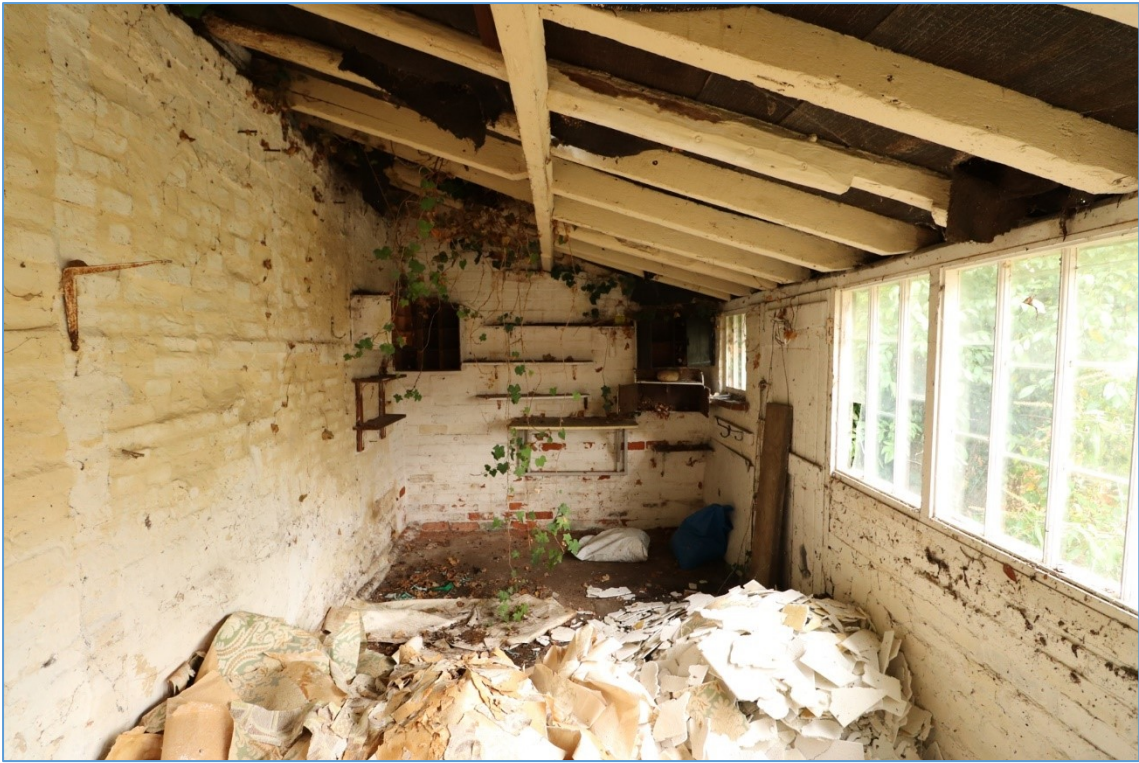
*Plate 27. Interior of the outbuilding, looking east.*

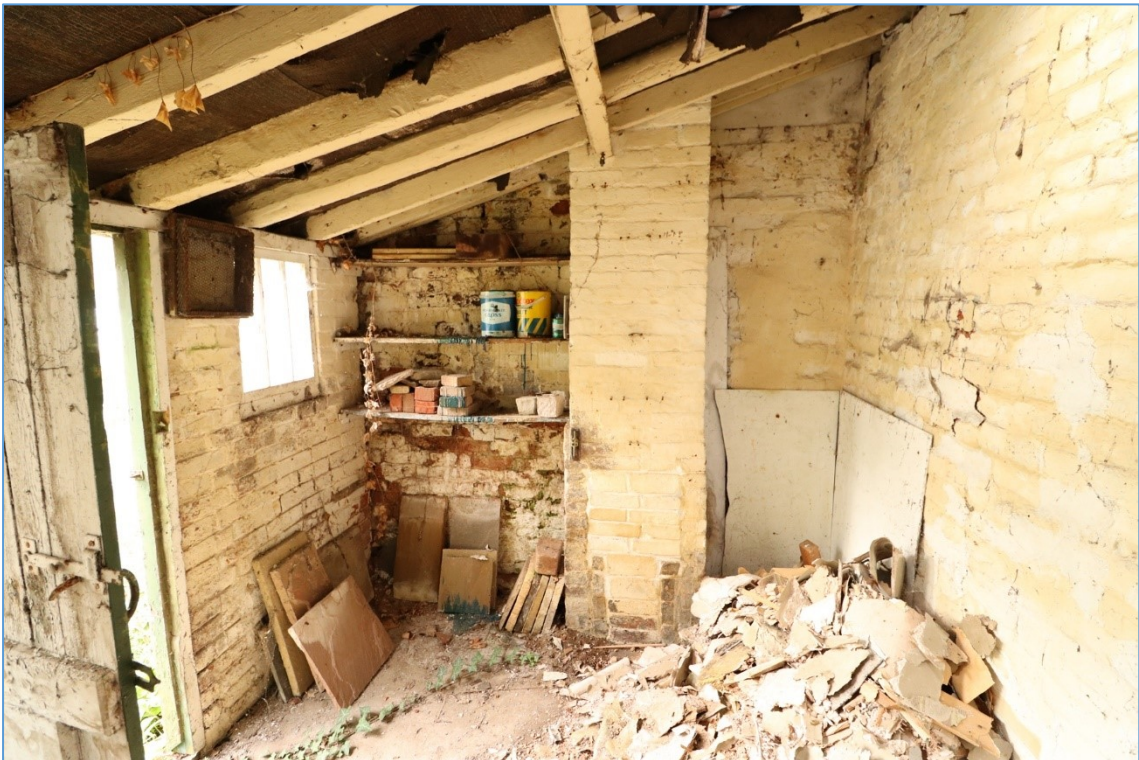
*Plate 28. Interior of the outbuilding, looking west.*
