# Village Farm

Market Weston, Suffolk

## A Level 2 Historic Building Record

August 2021

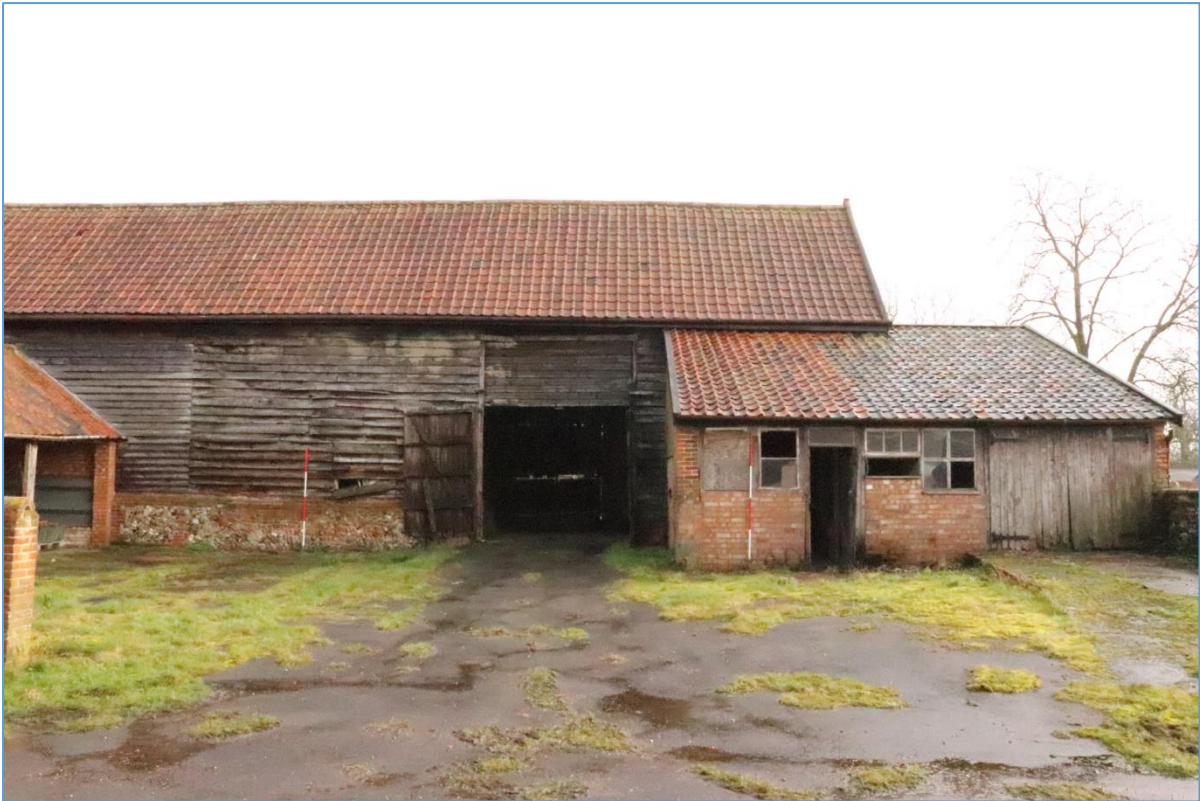
The western elevation of the barn comprises a brick and flint wall with brick capping, approximately 1m high, which carries the cill beam of the timber frame of the barn (Plates 5 and 6). The wall is of black weatherboarding, which is broken in places, and the central doorway is filled with a pair of timber doors, with a weatherboarded panel above (Plates 5 and 7). The southern gable end of the barn is also of black weatherboarding above a brick and flint plinth, with a small opening at the top of the gable and a larger modern casement window at its western end (Plate 3).

*Plate 5. The western elevation of Building A, looking east.*

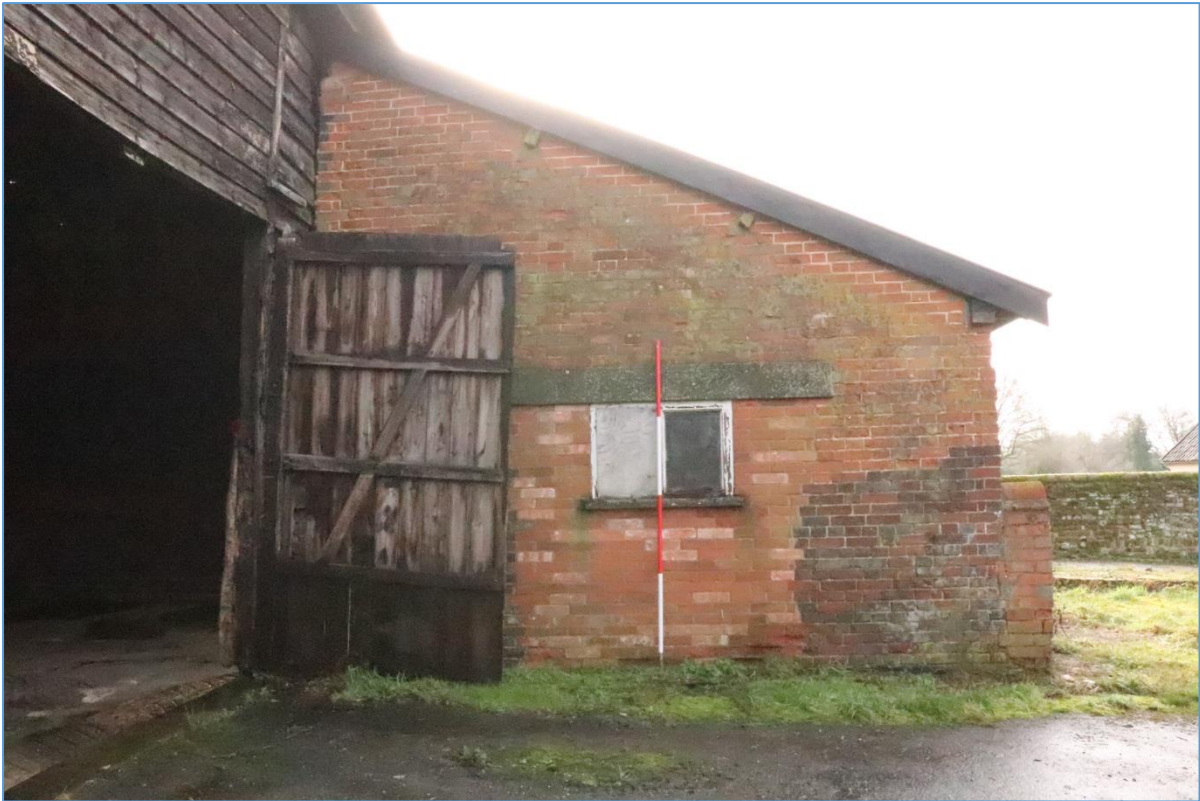
At the southern end of the western elevation is a projecting brick lean-to under a catslide roof, the northern elevation of which shows evidence of its 19th-century origin (Plate 7). This elevation also exhibits many phases of repairs in late 20th-century brick and concrete. The western elevation of this outshut extends beyond the southern elevation of the principal barn and comprises a modern brick infill with timber door and four mis-matched timber windows to the north, with a large pair of timber double-doors served by a concrete access ramp to the south (Plate 8). The southern and western elevations of this building are of relatively modern brickwork. The roof of this lean-to is of modern timber and it currently houses a grain dressing machine (Plates 10 and 11).

*Plate 7. The northern elevation of Building A's southern-western lean-to, looking south.*

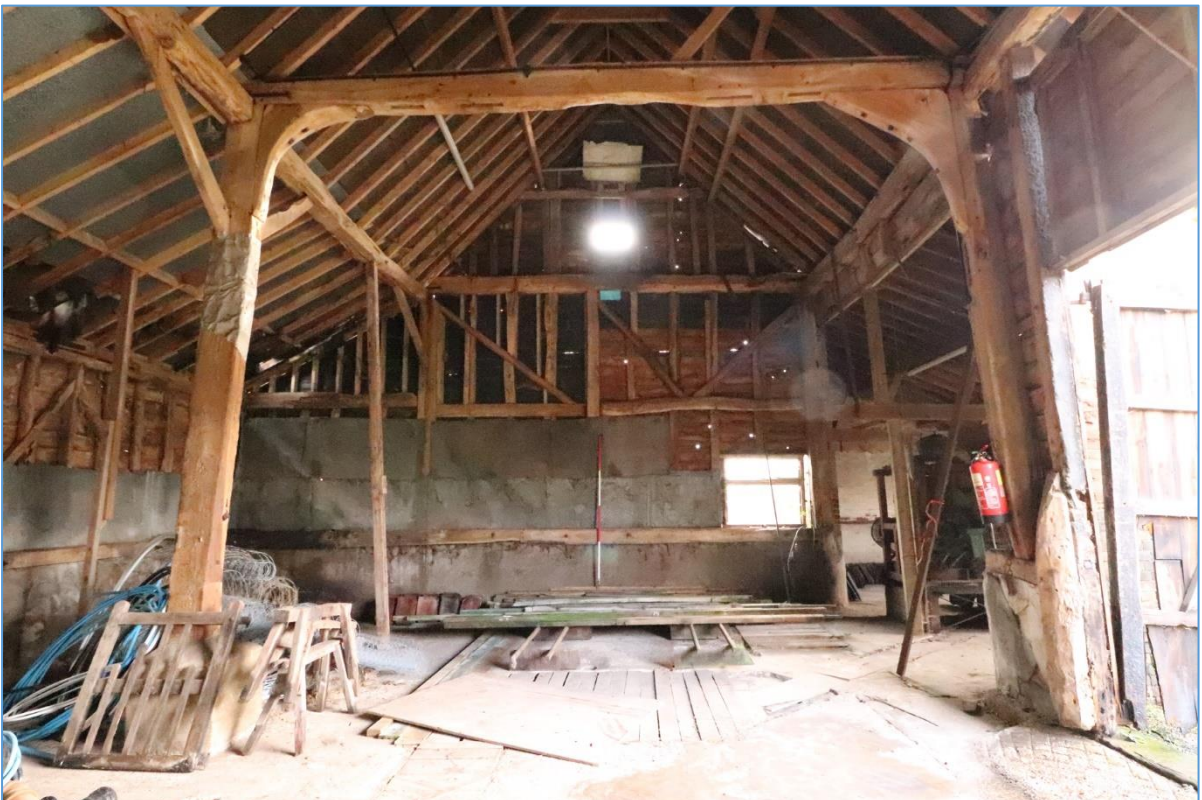
The southern elevation of the barn comprises a cill beam set atop a rendered wall, with a modern casement window at its western end (Plate 14). The lower panels of the wall are covered with protective sheeting, but the corner posts and original tie beam still survive. A horizontal beam divides the wall into four panels, with four vertical studs in each of the western panels and three studs in the eastern panels. The panels are crossed by diagonal cross-braces. Above this, the gable is formed

*Plate 14. The interior of the southern bay of Building A, looking south.*

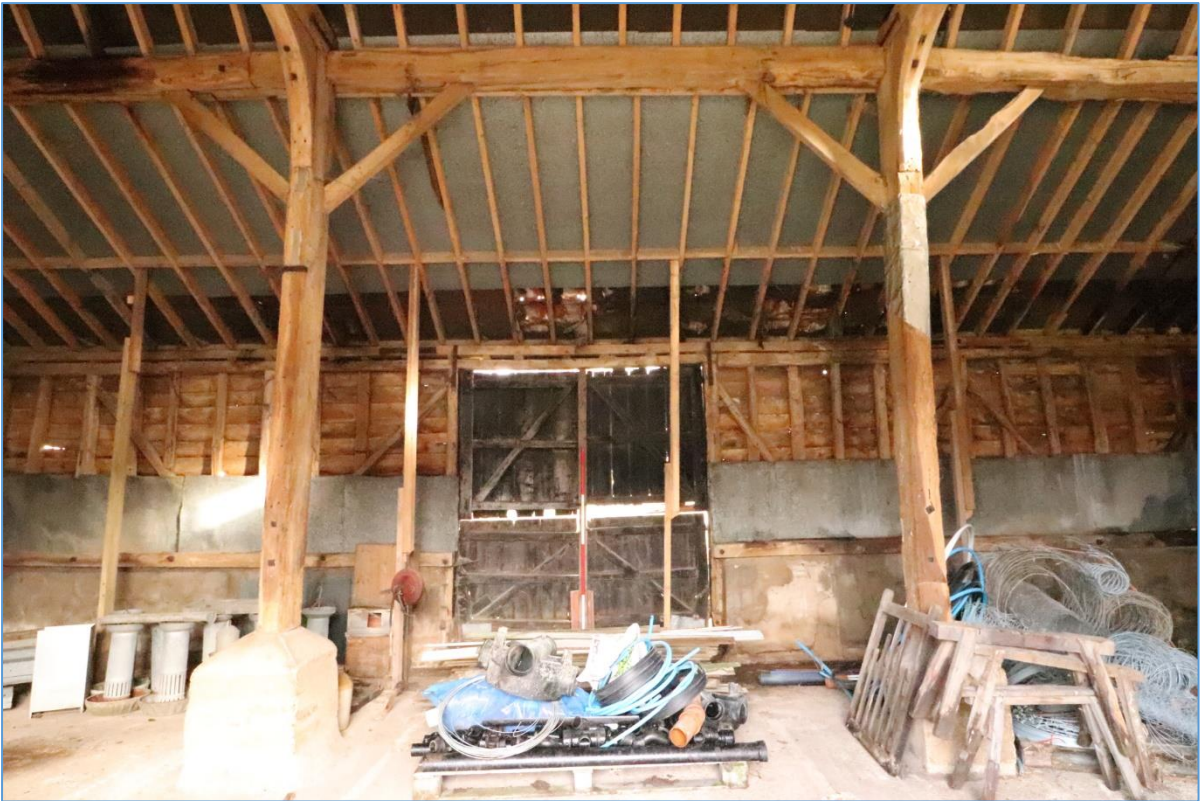
The central bay of the barn is defined by two frames of which the principal posts and tie beams survive, supporting the original wall plates of the barn (Plates 16 and 17). Longitudinally, these beams are supported by simple modern knee braces, while the tie beams are secured by pairs of simple L-shaped timber corner braces. The northern frame of the second bay exhibits empty mortices which indicate the location of former braces. The western elevation of the central bay comprises the double doors described above (Plates 6 and 7), while the eastern elevation comprises a smaller pair of double doors set into the eastern wall of the eastern aisle (Plate 17). To the north of this doorway, the eastern elevation of the northern bay mirrors that of the southern bay and comprises the timber studwork of the exterior wall of the eastern aisle (Plate 18).

*Plate 17. Interior of the central bay of Building A, looking east.*

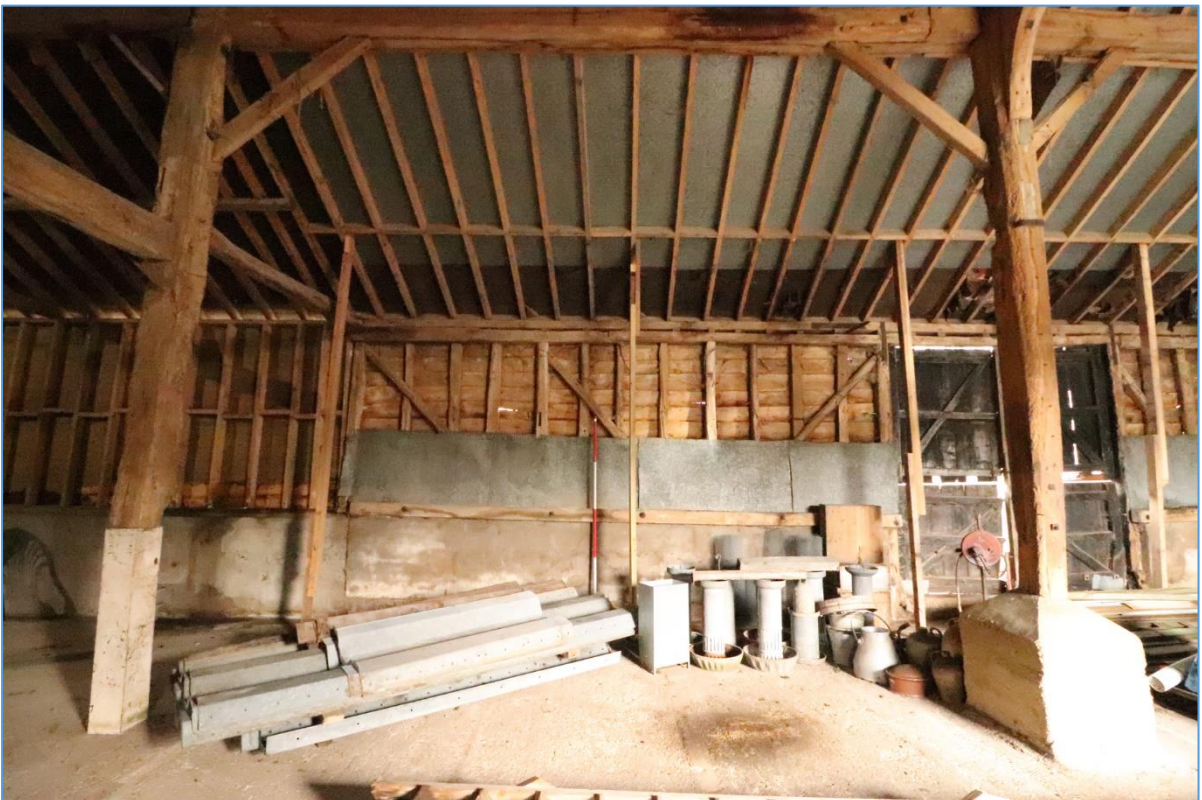
*Plate 18. Interior of the northern bay of Building A, looking east.*

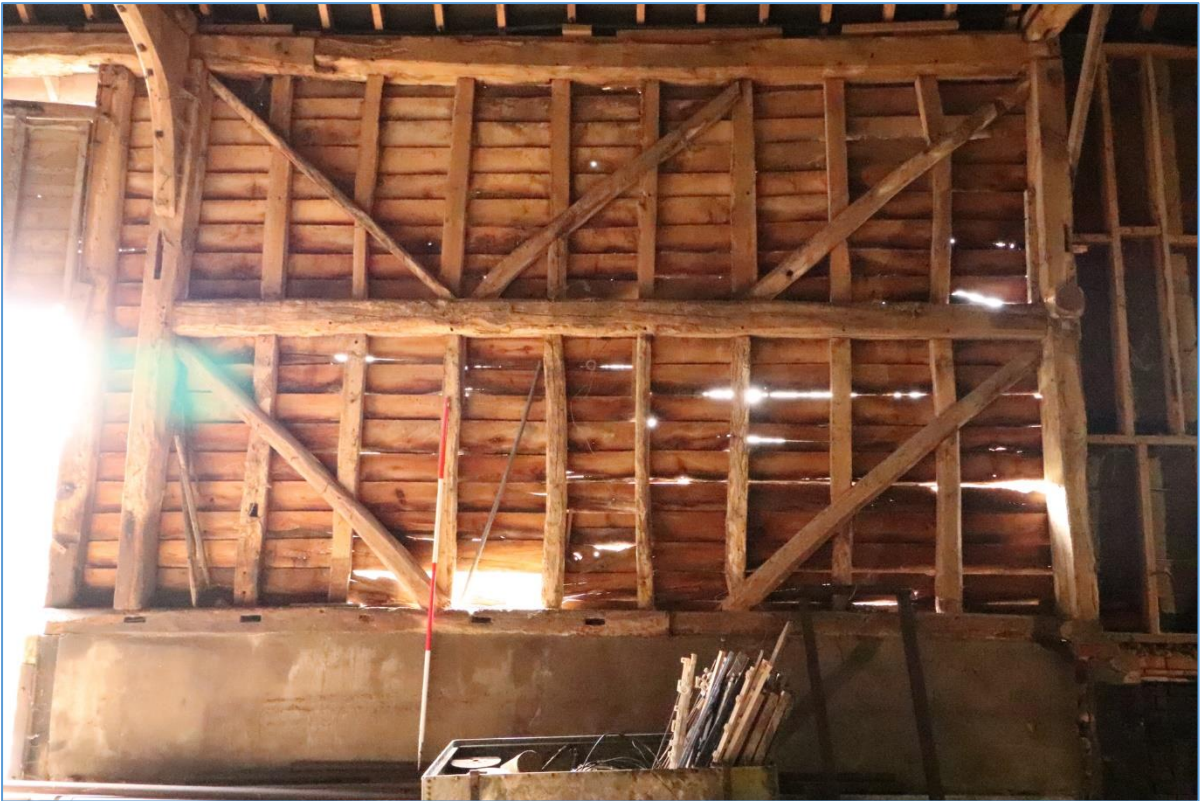
On the opposite side of the bay, the western wall of the northern bay comprises a full-height panel of timber studwork consisting of eight vertical studs sitting above and below a horizontal dividing beam (Plate 19). Several of these timbers are clearly replacements, especially in the upper part of the wall, but those of the lower half appear to be contemporary with the framework of the barn. The cill beam exhibits a number of empty mortices which have no coherence with the current design, indicating that the beam was reused from elsewhere.

*Plate 19. Interior of the northern bay of Building A, looking west.*

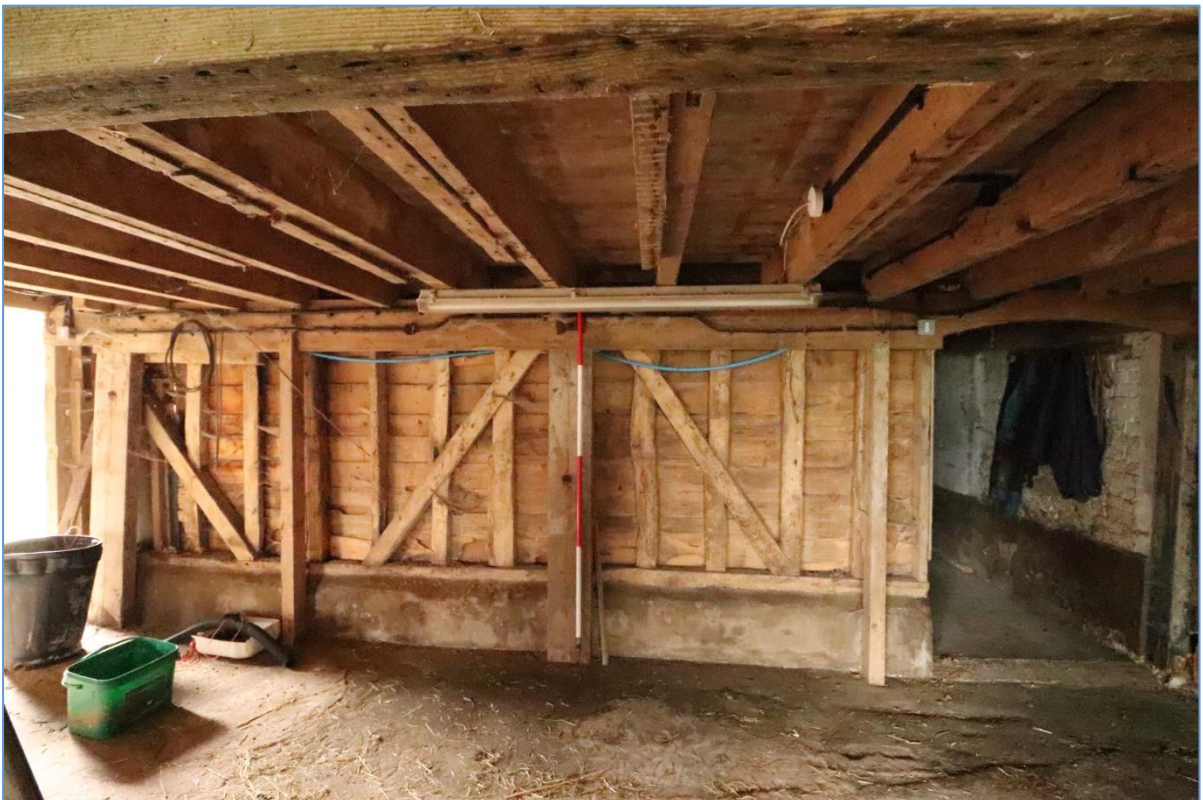
above a rendered brick plinth (Plate 24). Inside this framing, a series of inserted timber uprights support the upper floor, while an arched opening at the northern end of the elevation connects to Building D. The northern wall of the northern bay comprises a heavily modified and repaired panel of timber-framing over a rendered plinth, with wooden doors at its western and eastern ends which connect into the cattle sheds to the north of the gable end (Plate 25).

*Plate 24. Interior of the northern bay of Building B, looking west.*

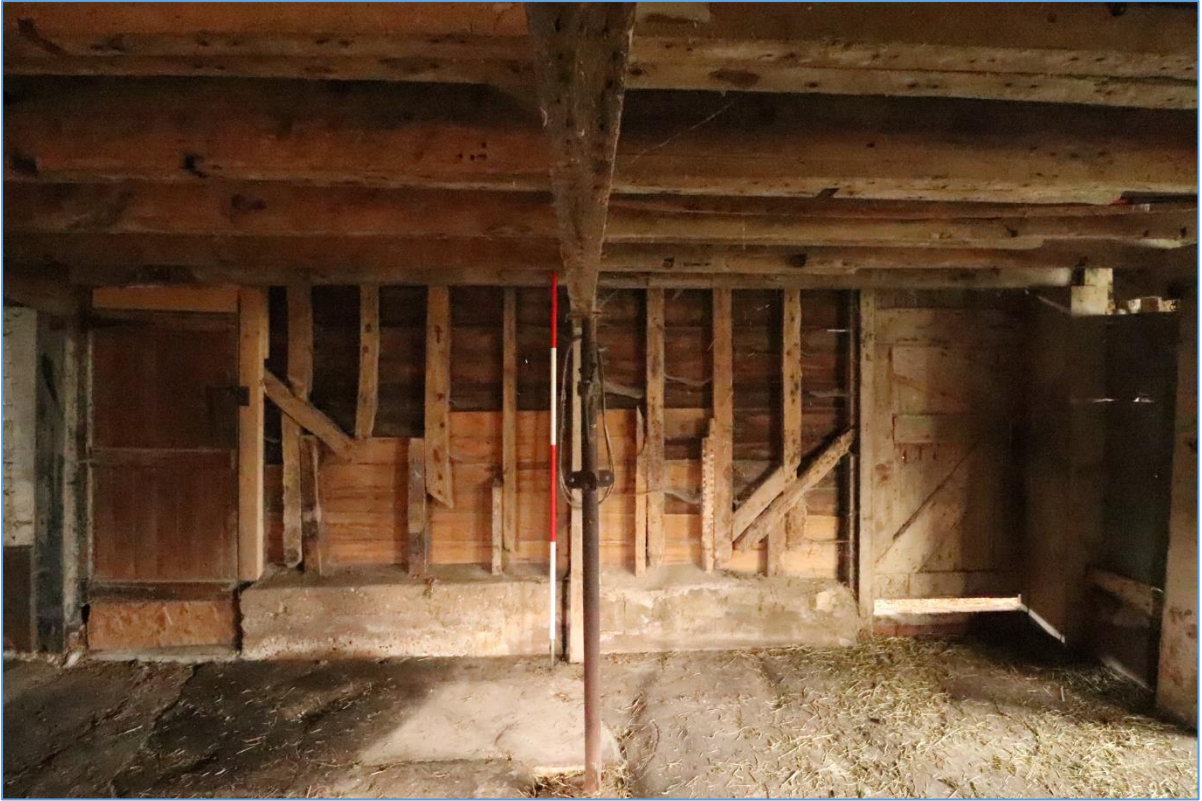
*Plate 25. Interior of the northern bay of Building B, looking north.*

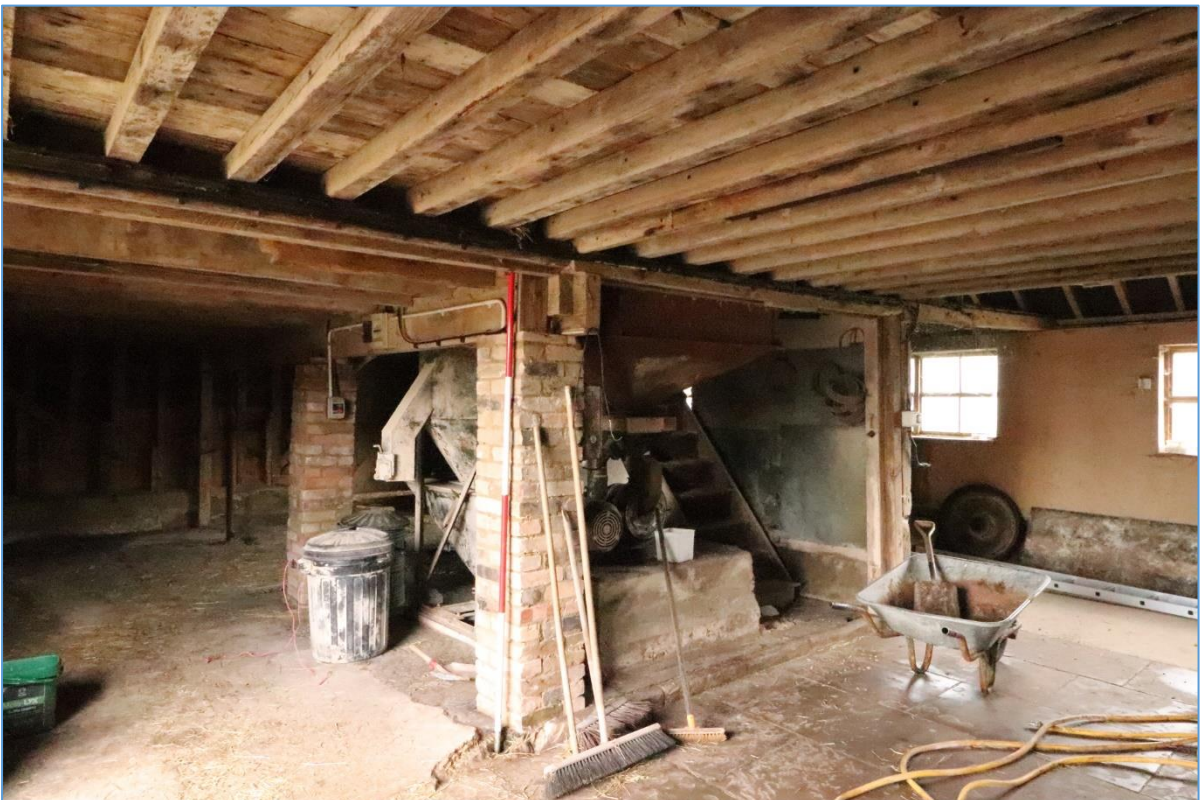
Housed within the northern bay of Building B is a hammer mill which stands between a pair of brick piers and next to which is a short flight of wooden stairs leading to the first floor (Plate 28).

*Plate 28. Interior of the northern bay of Building B, looking north-east.*

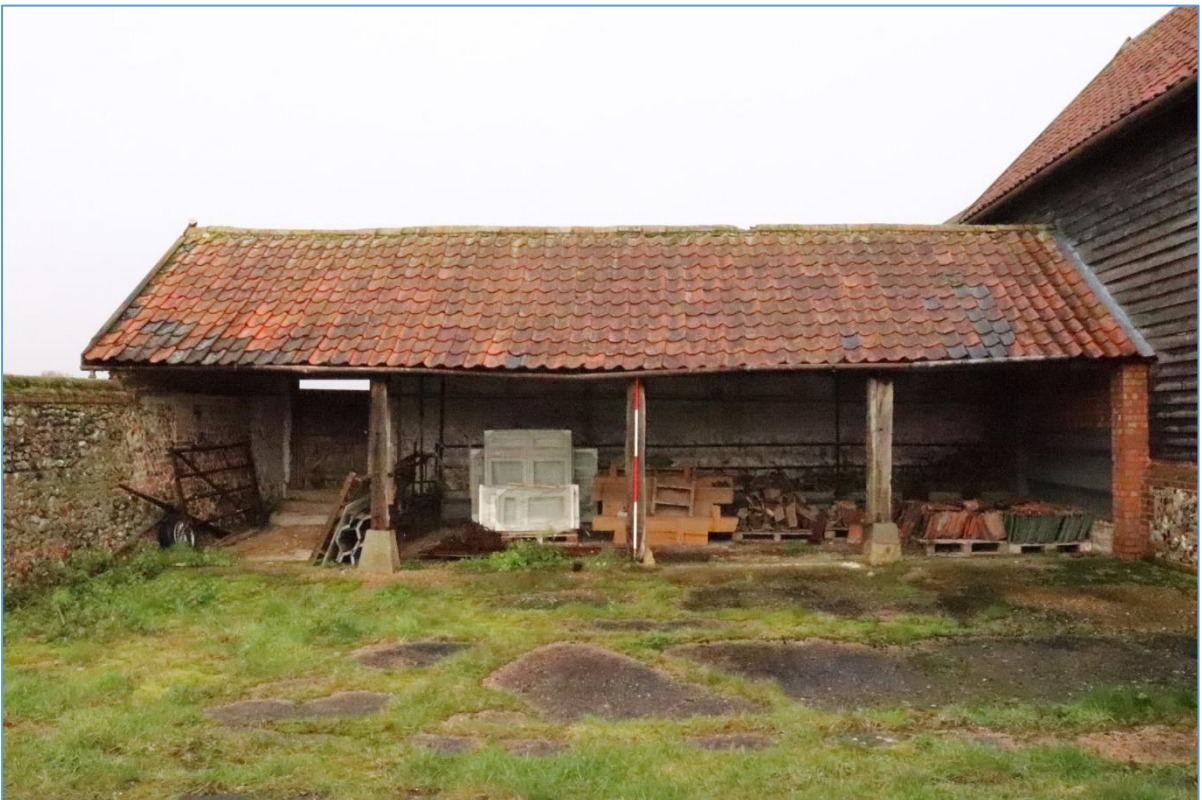
Building C, the 'Calf Shelter' comprises a four-bay open-fronted flint-and-brick range under a pantiled roof which extends westwards from the infilled Building E (Plate 34). It is situated between the southern barn (Building A) and the northern barn (Building B). Historical mapping indicates that this structure dates from the middle decades of the 19th century, although it may replace an earlier structure in a similar location.

*Plate 34. The southern elevation of Building C, looking north.*
