Report on Archaeological Monitoring
St Andrew's Church, Little Glemham, Suffolk

SHES ref. GLL 030

Sarah Bates (Report No. 11)
November 2014

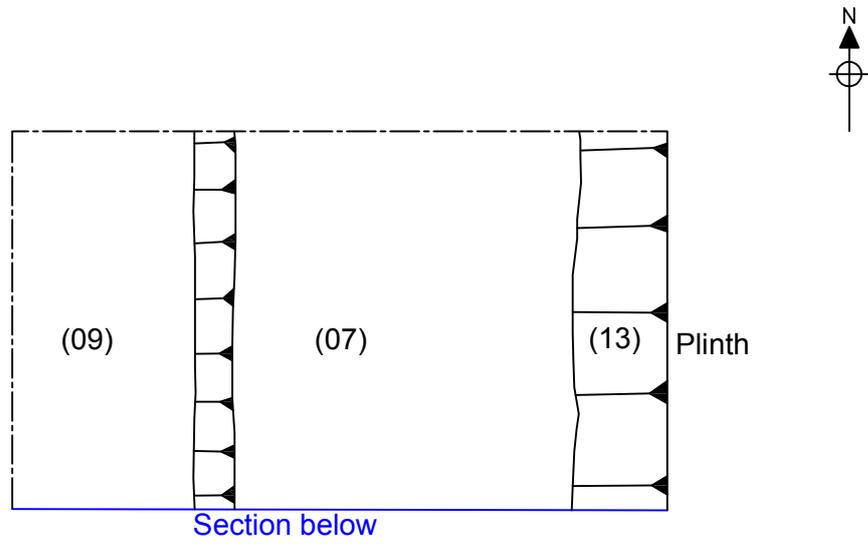
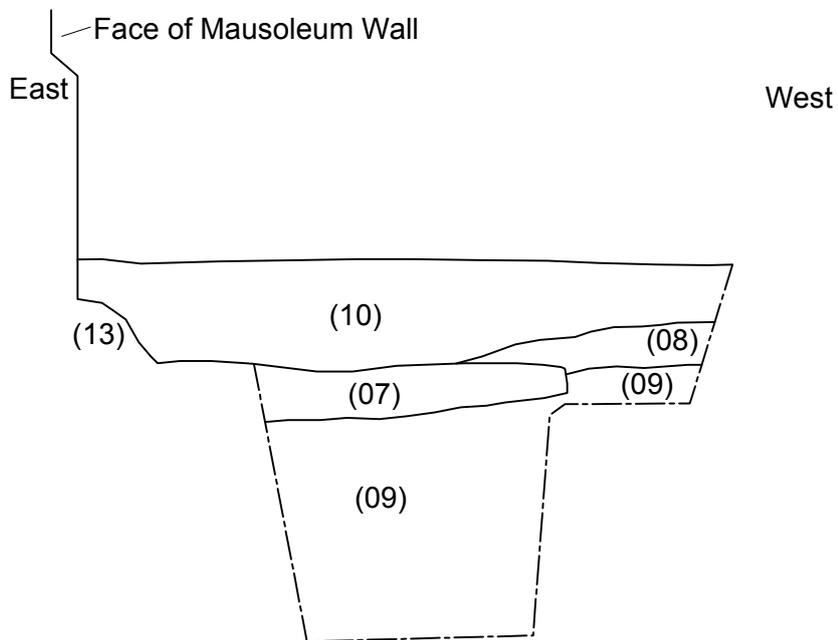
Gully [3] was located towards the north end of the mausoleum on its west side. In the deeper part of the trench brown clayey sand with virtually no inclusions was very similar to (if slightly more sandy than) the soil [12] seen in the lowest parts of gullies [1] and [2]. It was probably undisturbed natural subsoil. It was overlaid by orangey brown clayey sand with occasional flints and quite common mortar flecks [9] above which was a deposit of yellowish cream sandy mortar and flints (mainly small). This extended out from the wall of the mausoleum for about a metre [7] (Fig.3a, Plate 2). It was very compacted and was initially thought possibly to be part of a wall or footing but, after recording, it was partly removed by machine and seen to be only 0.15m thick and sit directly upon the underlying soil [9] (Fig.3b, Plate 3). At the east side of the trench a sloping footing of hard flint and mortar (very similar to that seen in gully [2]) ran along the base of the mausoleum wall. It was harder and the mortar was more whitish in colour than deposit [7] and it appeared to post-date that deposit.

The compacted mortar and flint layer [7] may have been waste material from the demolition of an earlier building which was spread here prior to the building of the 19th-century mausoleum, possibly as some kind of levelling/foundation deposit. Above it was mortar-rich slightly orangey brown sandy clay [8] which was overlaid by topsoil. A sherd of 12th- to 14th-century pottery and two small fragments of roof tile of probable medieval date were found in the deposit [8].

A thick layer of compacted mortar and flint which was recorded in Gully 3 next to the west wall of the mausoleum may have been deliberately spread here to form a level area or broad shallow footing for the construction or reconstruction of the north transept. The date of this deposit is uncertain; although it appears to run underneath the sloping narrower footing at the foot of the mausoleum wall. However, the material itself seems likely to have come from an earlier building in the area. A sherd of pottery of 12th-14th century date and some fragments of tile of likely medieval date were found in mortar rich soil above the compacted layer but, alone, they do not provide sufficient evidence to date the deposition of either layer.

Figure 3a. Plan of Gully 3. Scale 1:20.

Figure 3b. North facing section of Gully 3. Scale 1:20.

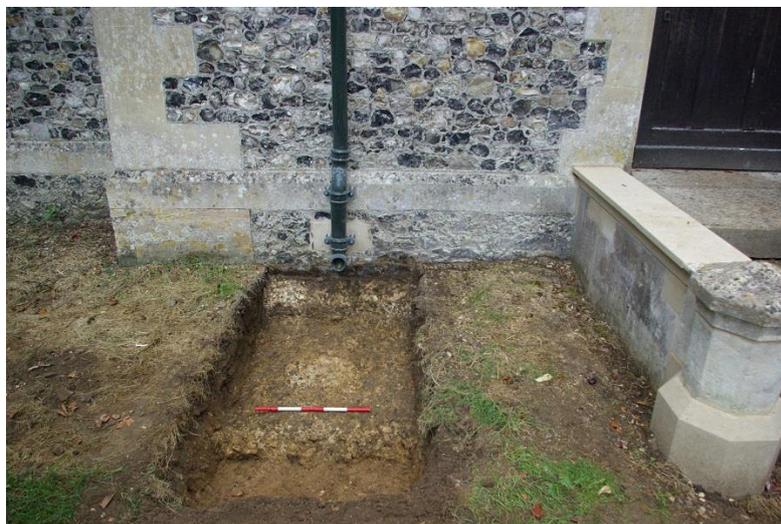
Plate 2: Gully trench 3 with mortar and flint deposit 7, looking east, 0.5m scale

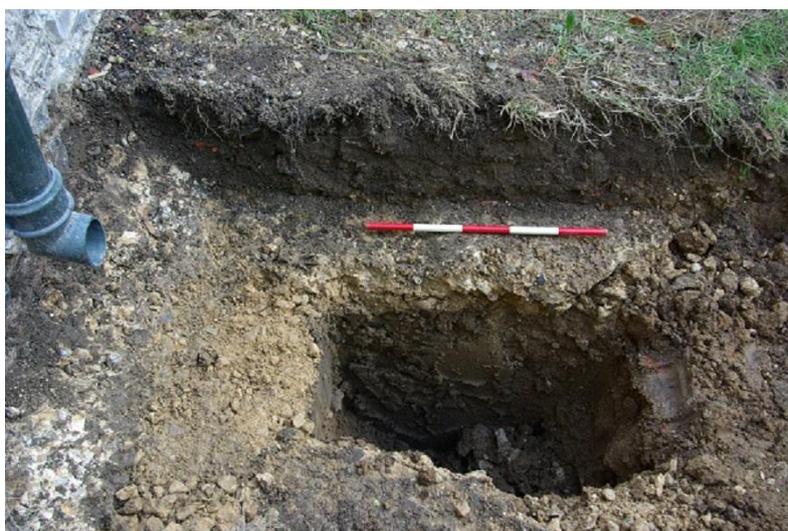
Plate 3: Gully trench 3 with deposit 7 partly removed, footing 13 to left, looking S, 0.5m scale

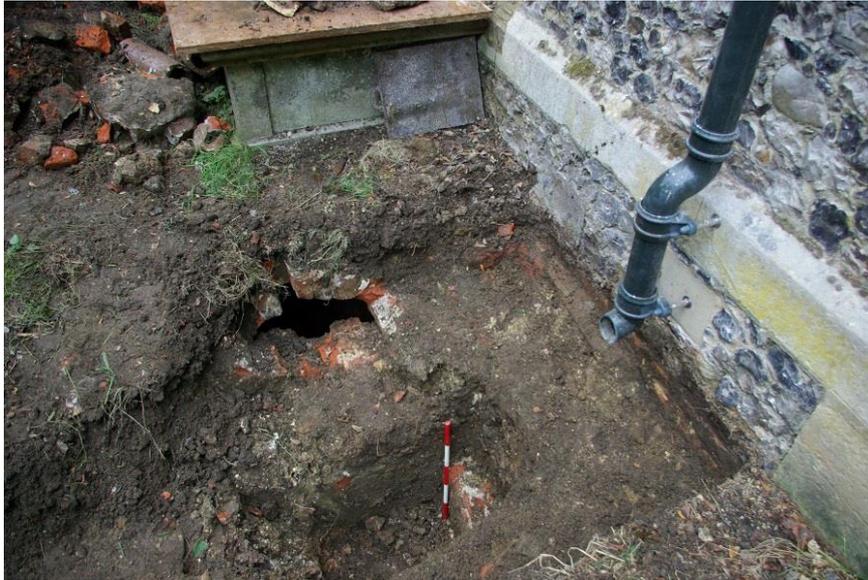
Gully [4] was positioned at the north-east corner of the mausoleum. In its lower part the east side of a red brick feature was seen at a depth of 0.60m below the surface [15] (Fig. 2, Plate 4). Its (east) face, about 0.50m to the east of the mausoleum wall and parallel with it, was rendered. Two courses of bricks were also visible, higher up, at the base of the mausoleum wall. It was unclear what the bricks represented. Perhaps they were part of a previous drainage feature or they may have related to burial vaults. Immediately to the south of gully trench [4], (and at a higher level than the bricks [15]),

the north end of a vaulted brick feature [16] had been damaged by some iron pipes which ran north to south and were cut off and partly removed by the contractors (Fig. 2, Plate 4). These were thought to be disused water pipes which had been laid running through the upper void of a vaulted burial chamber. Flash photographs of the inside of the chamber showed rendered internal wall faces and arched roof, and brick rubble in the bottom with the recently cut iron pipes and some loose soil collapsed onto it.

Plate 4: Gully trench 4 with brick feature 15 (0.5m scale) and showing damage to vaulted structure 16, looking SSW

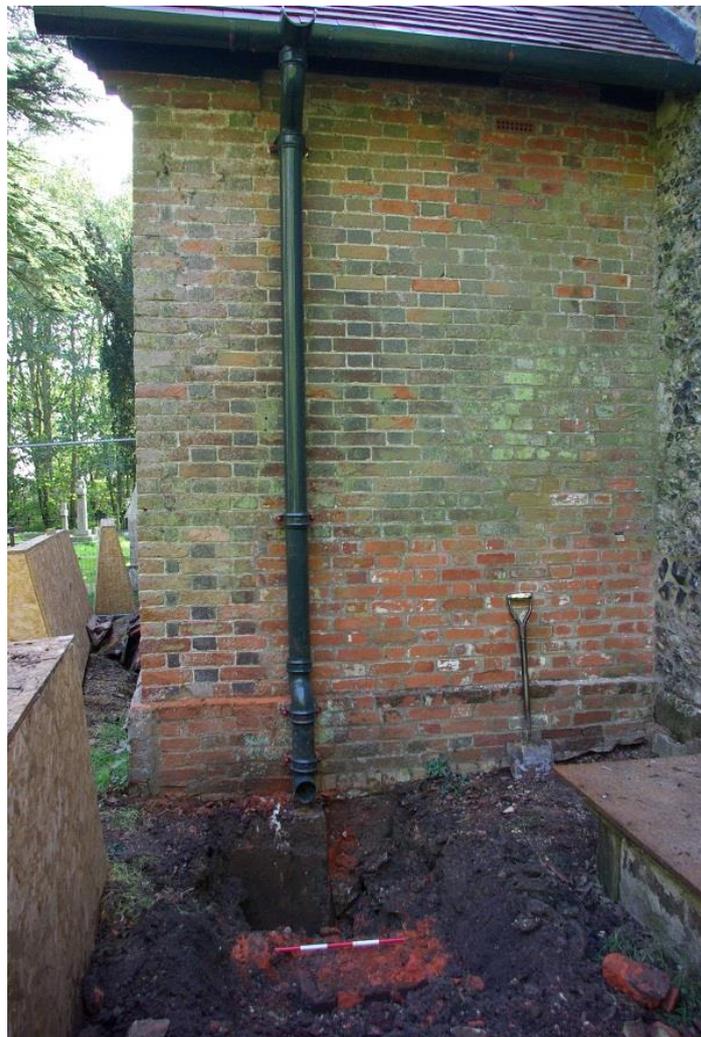
Gully [5] was positioned at the north-east corner of the chancel (Fig. 2, Plate 5). The area had been heavily disturbed by previous construction and demolition work. Part of a red brick construction of likely 19th or 20th-century date was seen running east to west through the area of the gully trench [6]. It may have been part of a former drain or soakaway; the small area between it and the chancel wall was infilled with brick rubble and other disturbance had occurred nearby. It is also possible that the brickwork may have related to some kind of outbuilding. It was noticed that the brickwork in the north wall of the chancel and flintwork in the east wall of the mausoleum has been replaced or repaired in the lower part of the walls in the corner between them and it appeared that some kind of structure may have formerly existed there.

Plate 5: Gully trench 5 with brick wall 6 (0.50m scale), looking S and new brickwork in chancel wall visible
