Report on Archaeological Monitoring
St Andrew's Church, Little Glemham, Suffolk

SHES ref. GLL 030

Prepared on behalf of
Nicholas Warns Architect Ltd for Little Glemham PCC

November 2014

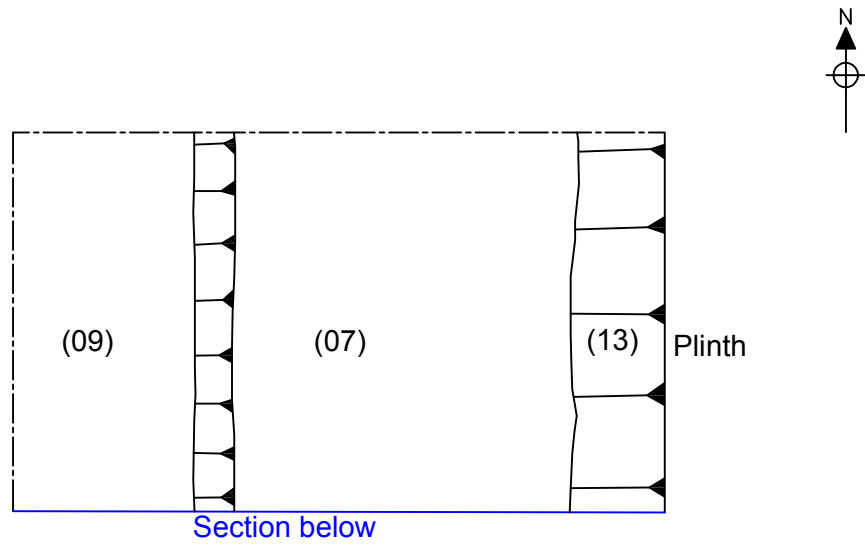
Figure 3a. Plan of Gully 3. Scale 1:20.

Gully [3] was located towards the north end of the mausoleum on its west side. In the deeper part of the trench brown clayey sand with virtually no inclusions was very similar to (if slightly more sandy than) the soil [12] seen in the lowest parts of gullies [1] and [2]. It was probably undisturbed natural subsoil. It was overlaid by orangey brown clayey sand with occasional flints and quite common mortar flecks [9] above which was a deposit of yellowish cream sandy mortar and flints (mainly small). This extended out from the wall of the mausoleum for about a metre [7] (Fig.3a, Plate 2). It was very compacted and was initially thought possibly to be part of a wall or footing but, after recording, it was partly removed by machine and seen to be only 0.15m thick and sit directly upon the underlying soil [9] (Fig.3b, Plate 3). At the east side of the trench a sloping footing of hard flint and mortar (very similar to that seen in gully [2]) ran along the base of the mausoleum wall. It was harder and the mortar was more whitish in colour than deposit [7] and it appeared to post-date that deposit.

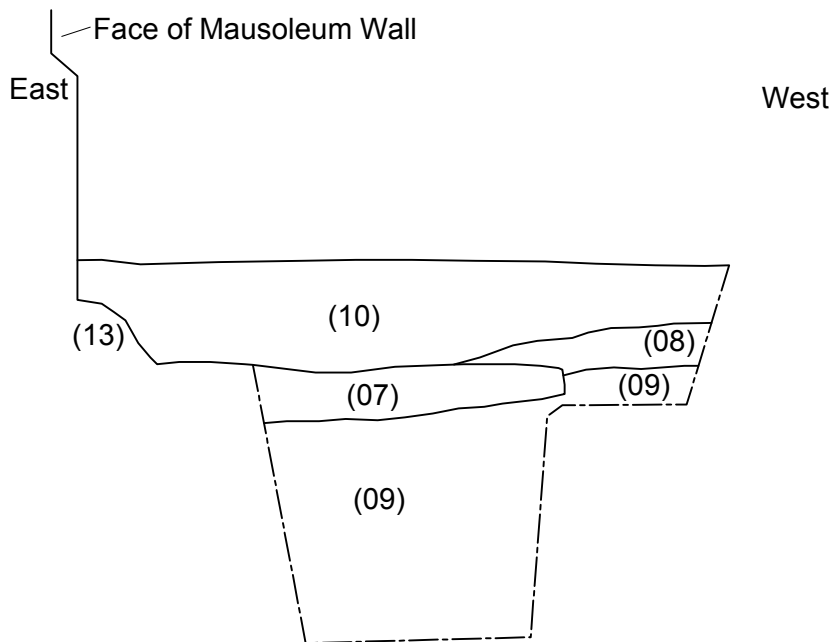
Figure 3b. North facing section of Gully 3. Scale 1:20.

The compacted mortar and flint layer [7] may have been waste material from the demolition of an earlier building which was spread here prior to the building of the 19th-century mausoleum, possibly as some kind of levelling/foundation deposit. Above it was mortar-rich slightly orangey brown sandy clay [8] which was overlaid by topsoil. A sherd of 12th- to 14th-century pottery and two small fragments of roof tile of probable medieval date were found in the deposit [8].

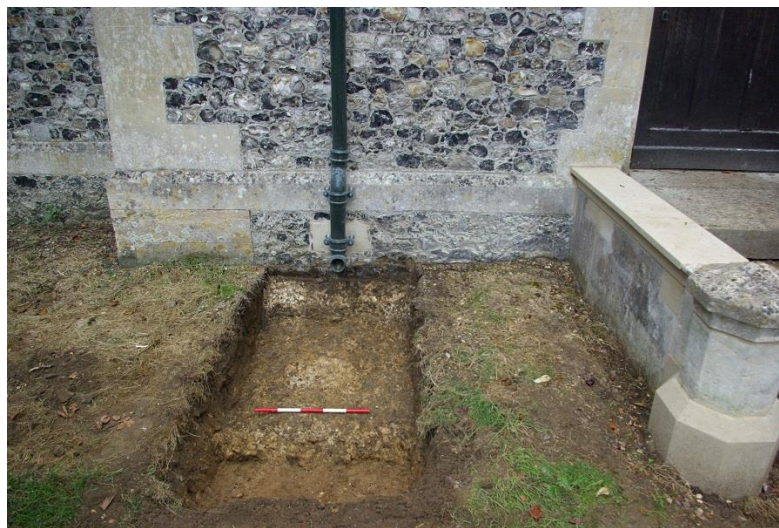
Plate 2: Gully trench 3 with mortar and flint deposit 7, looking east, 0.5m scale

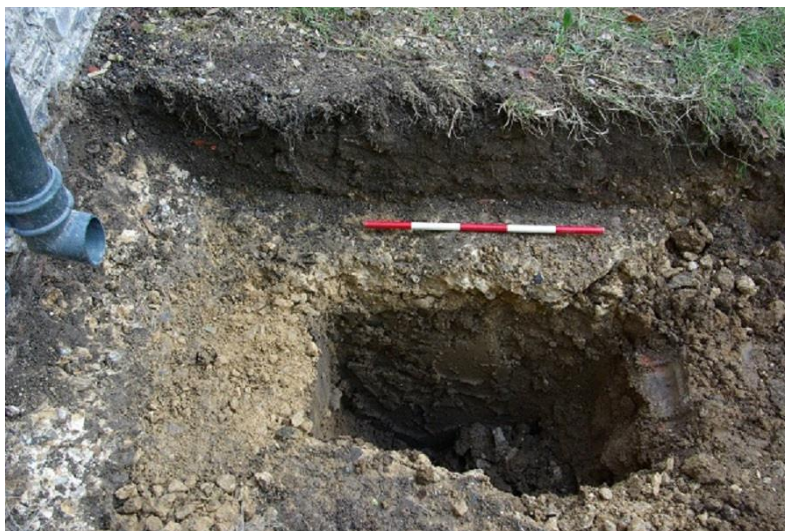
Plate 3: Gully trench 3 with deposit 7 partly removed, footing 13 to left, looking S, 0.5m scale

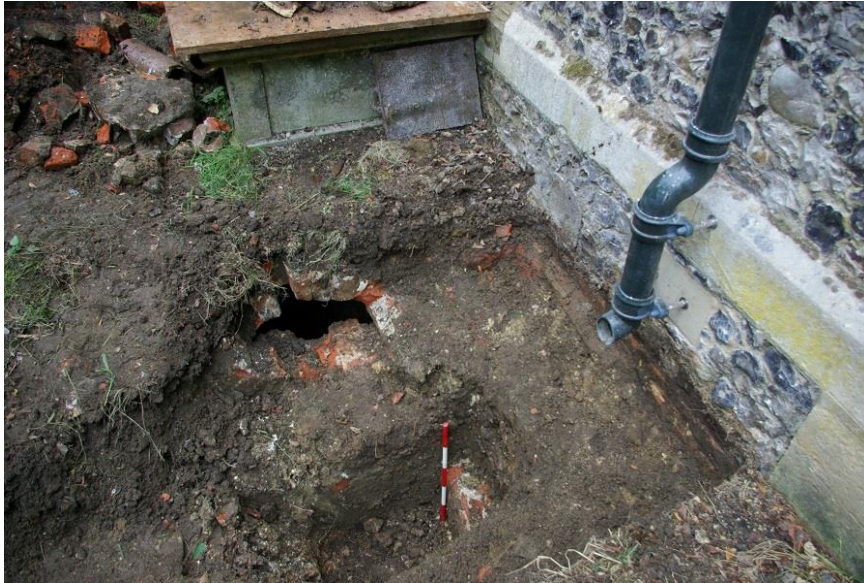
Gully [4] was positioned at the north-east corner of the mausoleum. In its lower part the east side of a red brick feature was seen at a depth of 0.60m below the surface [15] (Fig. 2, Plate 4). Its (east) face, about 0.50m to the east of the mausoleum wall and parallel with it, was rendered. Two courses of bricks were also visible, higher up, at the base of the mausoleum wall. It was unclear what the bricks represented. Perhaps they were part of a previous drainage feature or they may have related to burial vaults. Immediately to the south of gully trench [4], (and at a higher level than the bricks [15]),

the north end of a vaulted brick feature [16] had been damaged by some iron pipes which ran north to south and were cut off and partly removed by the contractors (Fig. 2, Plate 4). These were thought to be disused water pipes which had been laid running through the upper void of a vaulted burial chamber. Flash photographs of the inside of the chamber showed rendered internal wall faces and arched roof, and brick rubble in the bottom with the recently cut iron pipes and some loose soil collapsed onto it.

Plate 4: Gully trench 4 with brick feature 15 (0.5m scale) and showing damage to vaulted structure 16, looking SSW

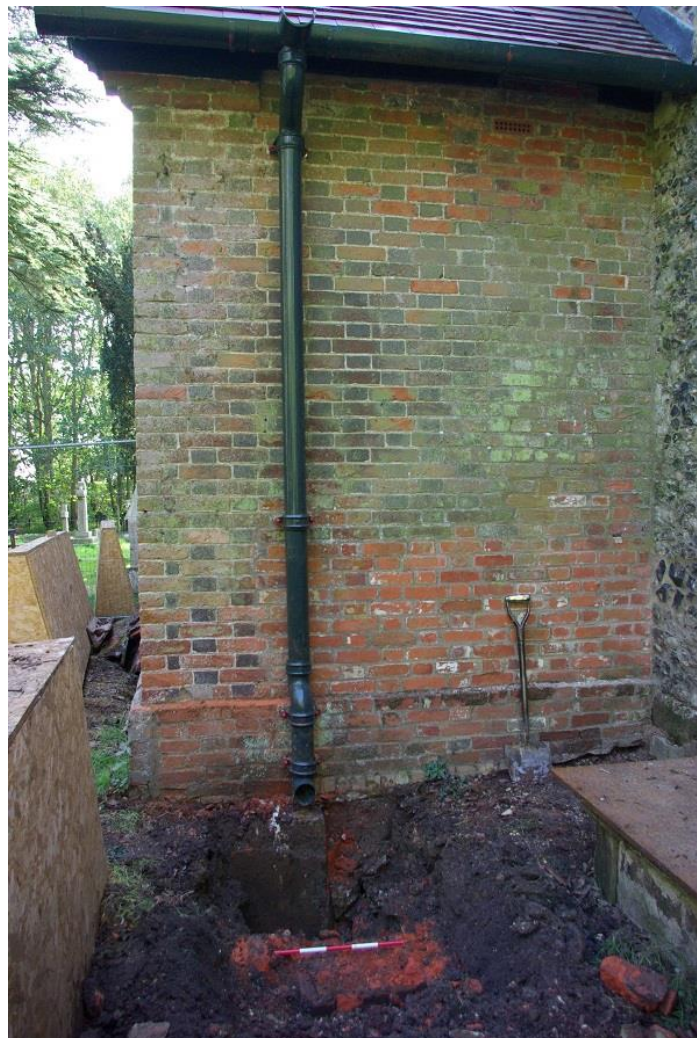
Gully [5] was positioned at the north-east corner of the chancel (Fig. 2, Plate 5). The area had been heavily disturbed by previous construction and demolition work. Part of a red brick construction of likely 19th or 20th-century date was seen running east to west through the area of the gully trench [6]. It may have been part of a former drain or soakaway; the small area between it and the chancel wall was infilled with brick rubble and other disturbance had occurred nearby. It is also possible that the brickwork may have related to some kind of outbuilding. It was noticed that the brickwork in the north wall of the chancel and flintwork in the east wall of the mausoleum has been replaced or repaired in the lower part of the walls in the corner between them and it appeared that some kind of structure may have formerly existed there.

Plate 5: Gully trench 5 with brick wall 6 (0.50m scale), looking S and new brickwork in chancel wall visible
