Report on Archaeological Monitoring
The Church of St Lawrence, Brundish, Suffolk

SHER ref. BUH 016

Prepared for Brundish PCC

May 2016

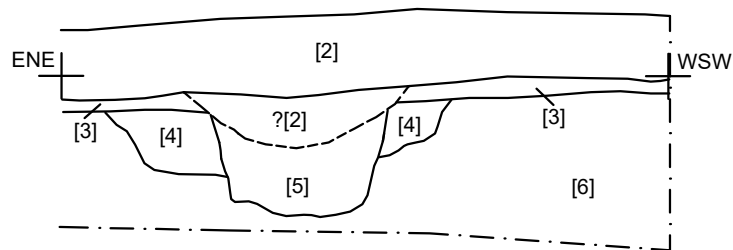
B WSW-facing section, nave N buttress footing [5]

A drain trench ran eastwards from the end of the Fildrain (Fig. 1). In the south side of this trench, immediately north of the first nave buttress, a series of deposits were thought to relate to the construction of the buttress footing (Fig.2B). Within a probable construction cut (not numbered) were deposits of pinkish light brown slightly gritty clay [4] and large irregular flints in cream lime mortar [5]. The clay had small sub-angular fragments of chalk (including small flecks) of chalk. It was firm, wet and quite sticky but was the colour of partly-fired material. The mortared flints formed a hard lump of masonry [5]; almost certainly the northern end of the buttress footing - although it was about a metre north of the buttress. It seems likely that the clay (originating from the natural subsoil at the site) was used as a foundation deposit. Perhaps it was partly-fired waste material of some kind. Overlaying the deposits was a thin layer of mid to light brown sandy silt [3]. Topsoil overlay these deposits and slumped into a depression where some masonry may have been removed. Just to the east the trench turned at a dog-leg and part of a former drain was seen in the north side of the trench just opposite the east end of the nave. The trench here was 0.60m deep. A single spur ran off to a gully at the chancel side buttress (where nothing of archaeological interest was seen) and further east the trench was dug through the undergrowth at the edge of the churchyard to enter the river at a depth of 0.80m (Plate 7).

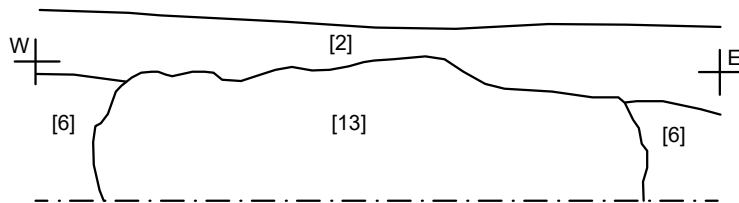
C S-facing section, S nave buttress [13]

The solid footing of the first nave buttress was recorded in the drain trench [13]. (Figs 1 and 2C, Plate 9). It was of medium and large flints in light cream mortar. Its bottom was not reached when the masonry was broken and removed from the (0.50m deep) trench by the contractor to enable pipe-laying.

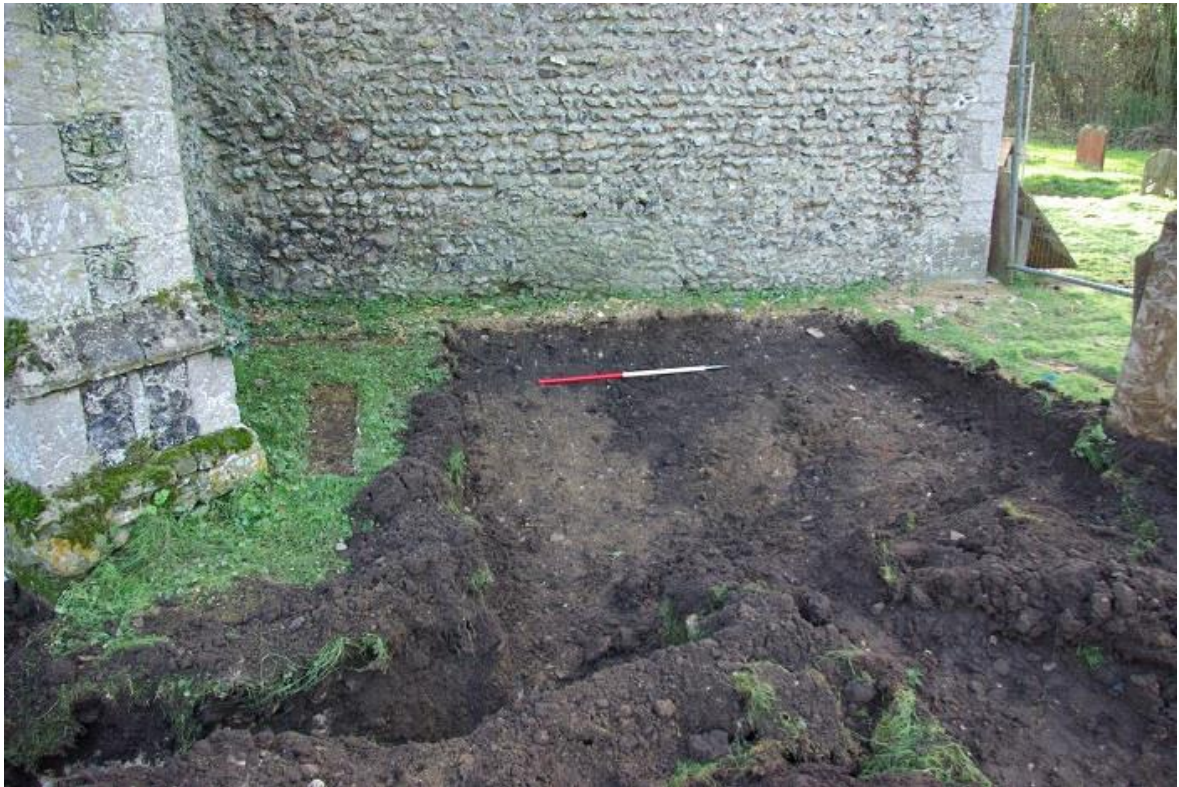
Shallow trenches for water catchpits were dug at the north and south sides of the tower. Neither of the trenches extended right up to the tower wall so the lowest parts of the walls and their footings were not exposed. Trench [10], to the north, was 2.80 x 2.30m in size and sloped down away from the church from 0.25m to 0.40m in depth (Plate 1). Mixed light brown clayey silt churchyard soil with frequent flecks of mortar and moderate numbers of small and medium flints was exposed in the bottom of the trench below the brown slightly clayey sandy loam topsoil. Nothing of archaeological interest was revealed.

Plate 1: N tower catchpit trench [10], looking S, 1m scale

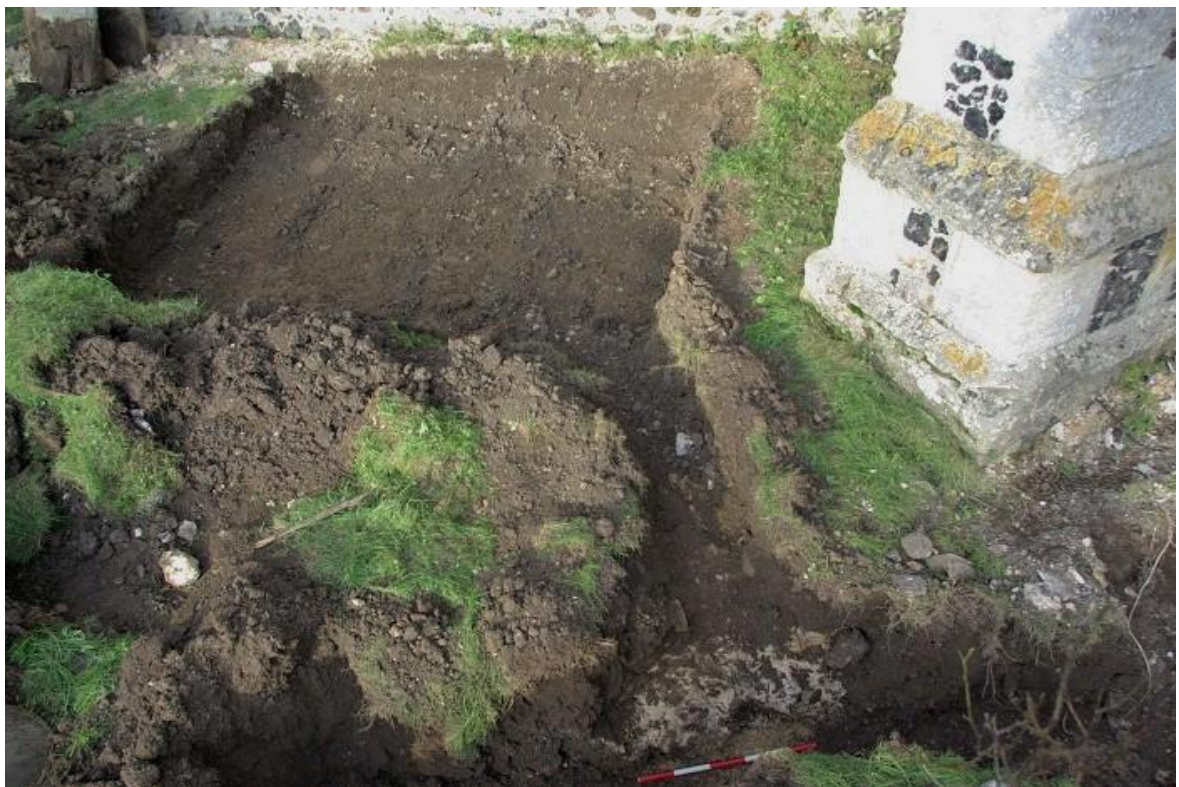
At the south side of the tower three gravestones were temporarily removed by the contractors in order to dig trench [11] (Plate 2). The trench was 2.50 x 2.20m in size and was the same depth as trench [10], sloping down very slightly away from the church. The same deposits were excavated and exposed as to the north and nothing of archaeological interest was seen. The gravestones were reinstated following completion of the site work.

The footing of the south-west corner buttress of the nave was exposed in the drain trench running between the tower and porch catchpits. It was of cream mortar and flints and was solid [15] and was seen beneath the topsoil at a depth of 0.30m from the surface (Fig. 1, Plate 2).

Plate 2: S tower catchpit trench [11], footing [15], looking N, scale 0.5m

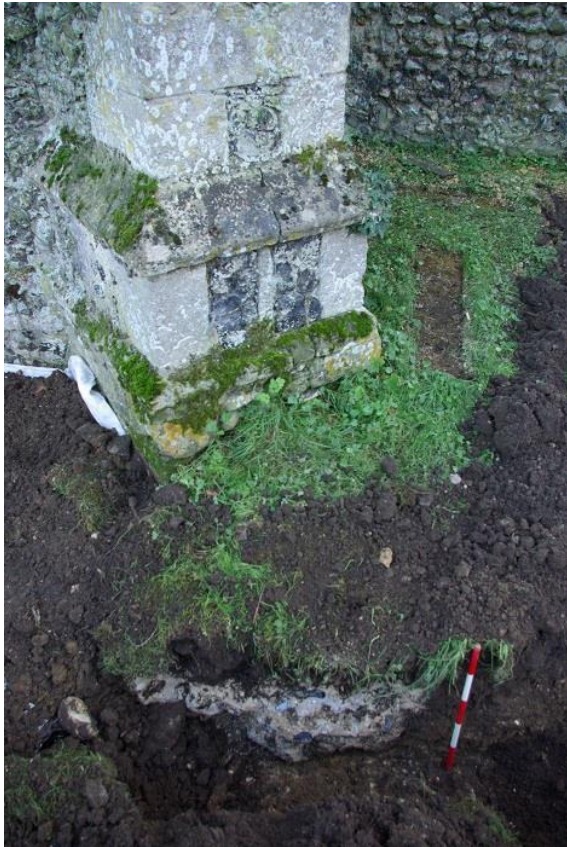
A short length of drain ran eastwards from the north tower catchpit. The end of the flint footing of the northwest corner buttress of the nave was exposed in the lower side of the drain trench [17] (Figs 1 and 2A, Plate 3). It comprised medium and large flints in a hard cream lime mortar. The footing was not exposed as far south as the buttress itself.

Plate 3: NW nave corner buttress and footing [17], looking S, 0.5m scale

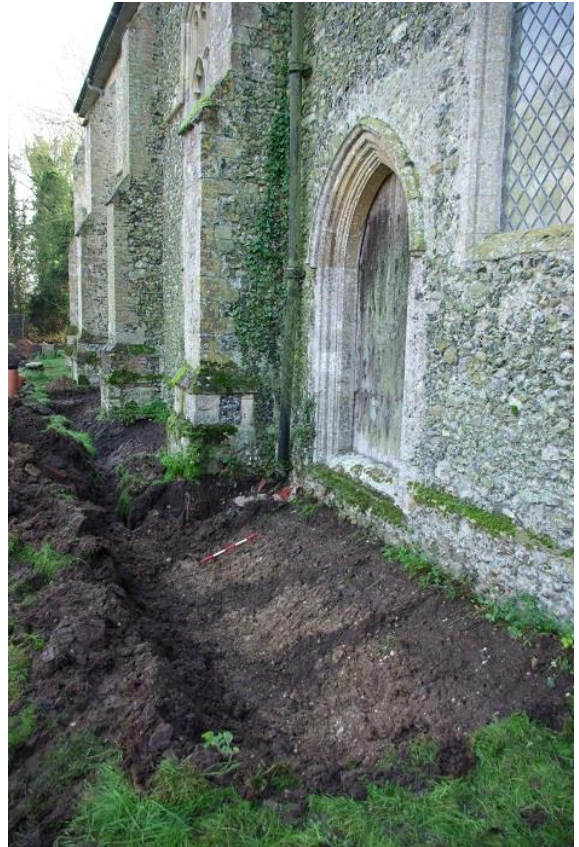
A ground drain of Fildrain type was installed along the north side of the nave from its west corner to the first side buttress (from the east end) [1] (Fig. 1, Plate 4). It was about 0.80m wide (at the top) with the south side sloping away from the church wall at forty-five degrees to a depth of 0.65m. Light brown sandy clay with occasional small 'grits' of chalk was exposed in the bottom and sides of the trench [6]. It seemed likely that at least

Plate 4: N nave, drain trench [1], looking E, 0.5m scale

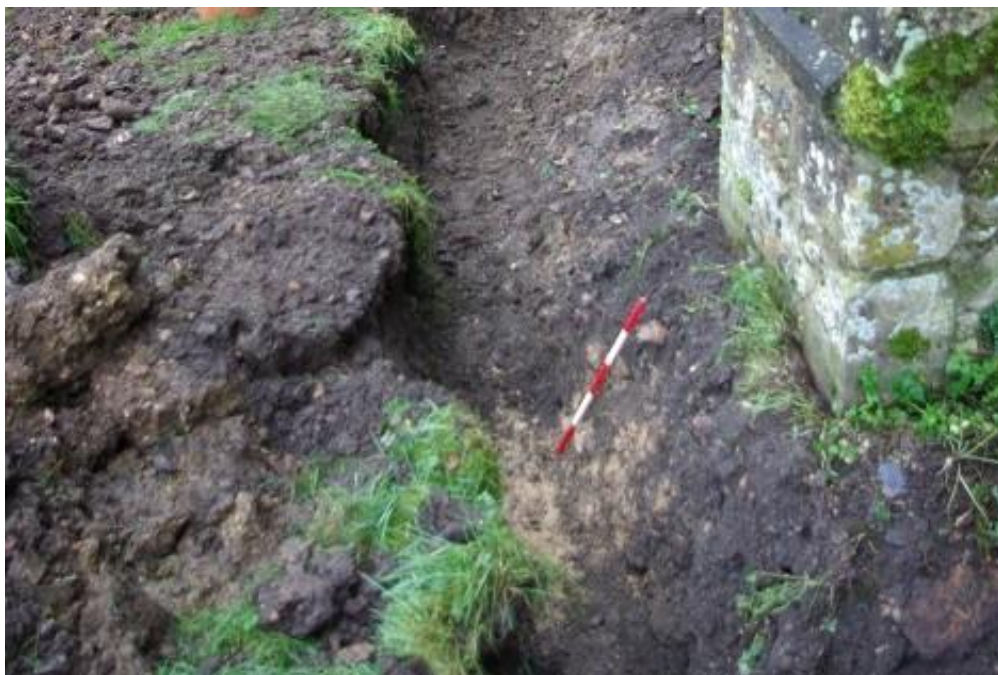
some disturbance by grave-digging would have occurred here and the deposit was a mix of natural subsoil and churchyard soil. It was overlaid by the dark brown slightly clayey sandy loam topsoil [2]. Part of the footing of the nave's second side buttress was exposed in the trench [7] (Fig. 1, Plate 5). It consisted of cream mortar with occasional mostly medium-sized, flint set within it. It appeared to have sloped down away from the buttress; not much of it was removed during machining and it did not appear in the north side of the drain trench although it continued downwards below its base. At the east end of the Fildrain trench part of the footing of the first side buttress was seen in the small deep hole dug to install the downpipe gully pot [8] (Fig. 1). It comprised flints in a hard cream lime mortar and continued down beneath the bottom of the excavated hole (depth approximately 0.75m from the ground surface (Plate 6). Nothing else of archaeological interest was seen.

Plate 5: N nave footing [7], looking E, 0.5m scale

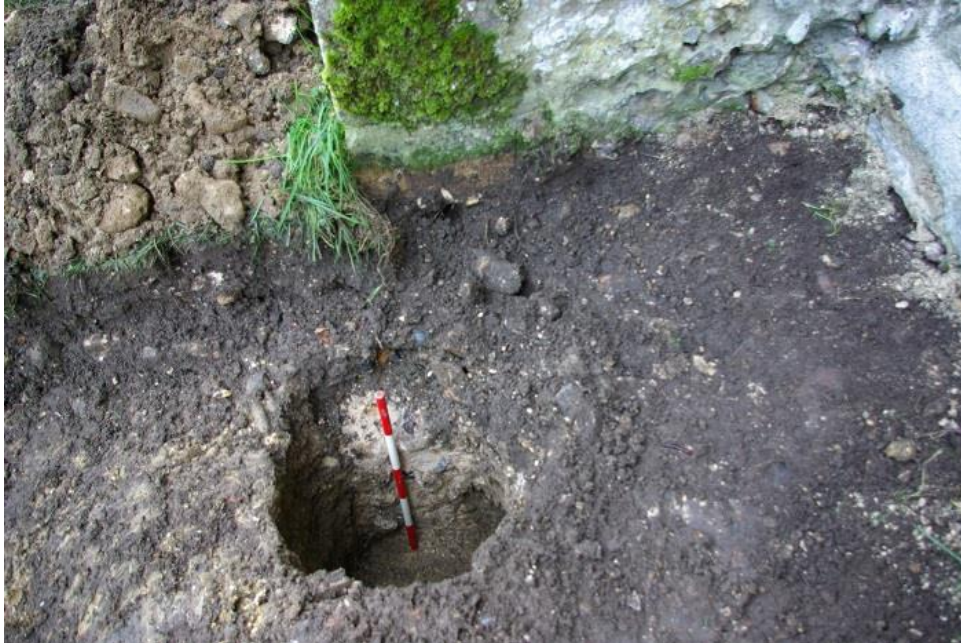
Plate 6: N nave buttress footing, [8], looking E, 0.5m scale

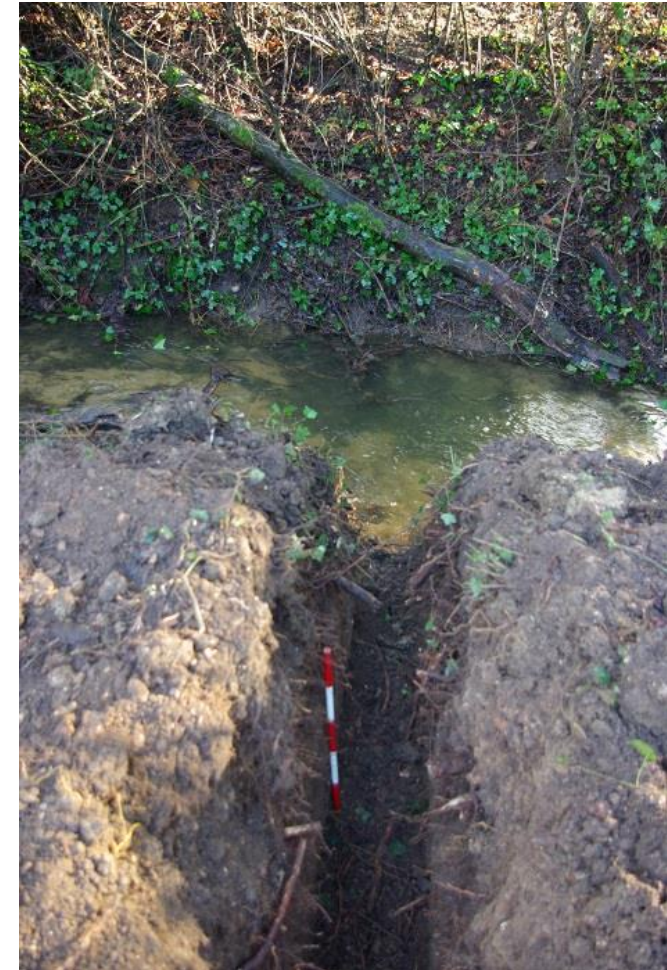
Plate 7: Drain trench [1] enters River Alde, looking E,
0.5m scale

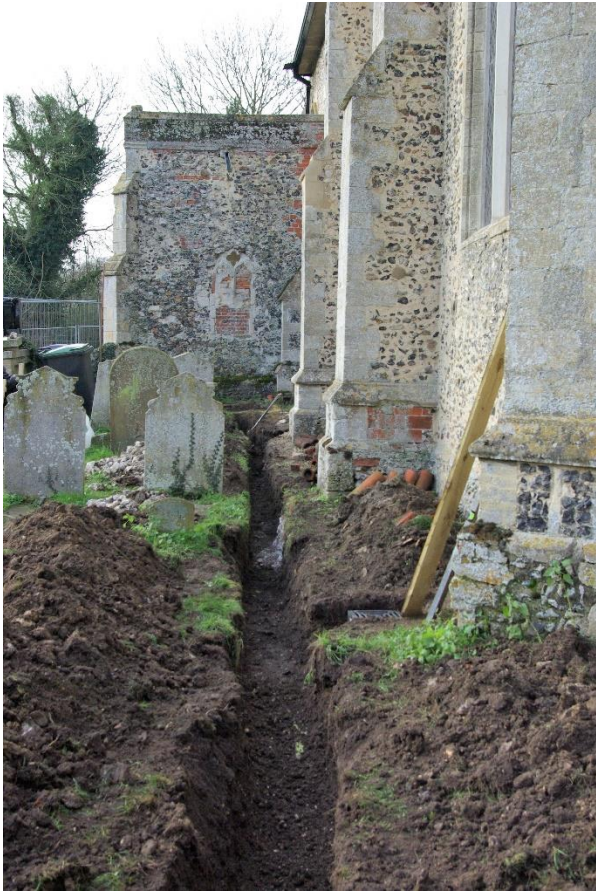
A drain trench ran west to east along the south side of the nave and chancel [9] (Plate 8). A spur ran to a gully at the chancel side buttress (where nothing of archaeological interest was seen). The trench was 0.35m deep at its west end, 0.55m deep opposite the chancel's south door and 0.80m deep opposite the east end of the chancel. It entered the river at a depth of 0.75m.

Plate 8: Drain [9], S of nave, looking W

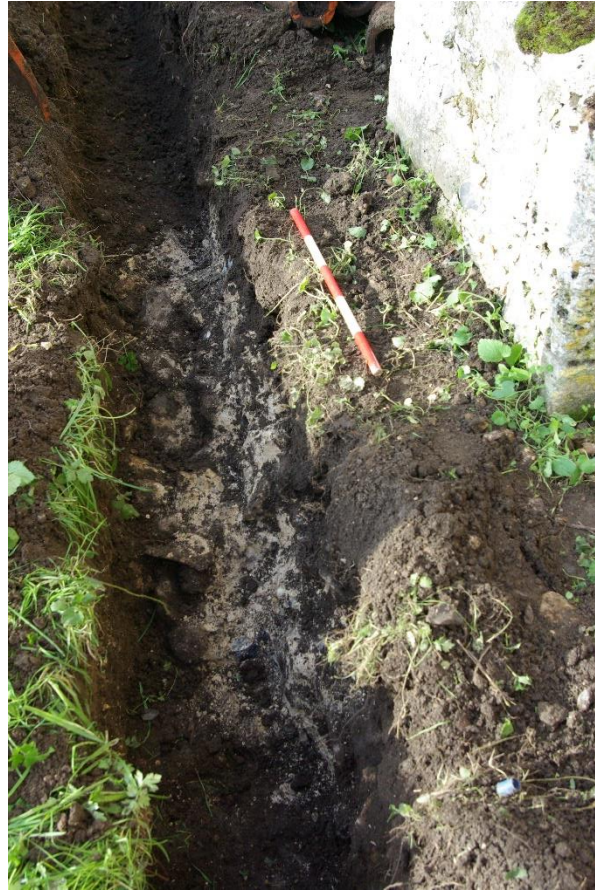
Plate 9: S nave buttress footing [13], looking W,
0.5m scale

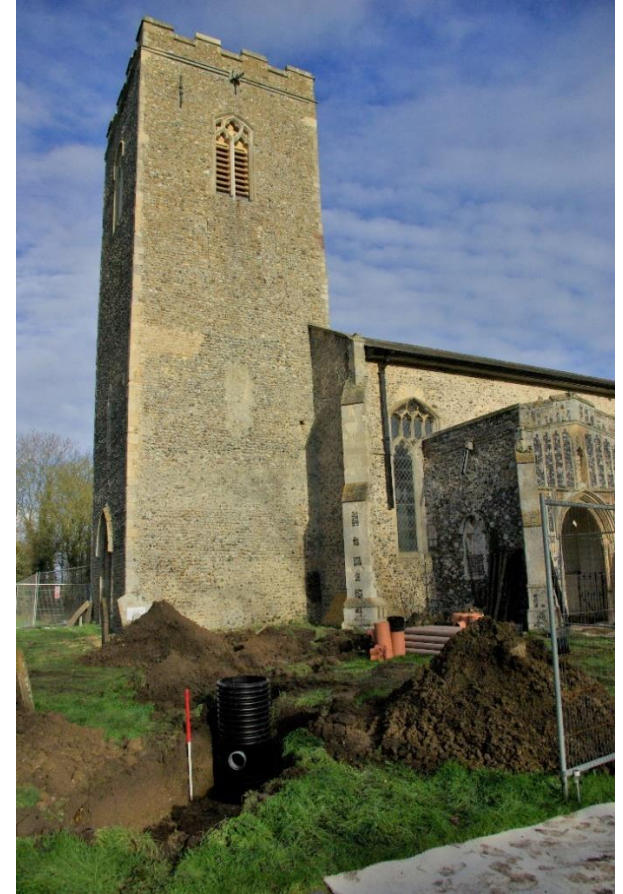
A trench for a new soakaway was excavated about nine metres to the south-west of the church [14] (Fig. 2, Plate 10). It was 3.70 x 1.30m in size and 0.60m deep with a deeper area (0.90m) at its north end where an inspection chamber was to be installed.

In this deeper area gritty chalk-flecked grey clay was revealed and thought to represent the undisturbed subsoil. Elsewhere mid to light brown clayey silt with some chalk-flecked grey clay patches was exposed. This was mixed churchyard soil; no graves were identified in the area of the soakaway but the fact that the mixed soil continued across the base of the trench suggested that some, at least, probably occurred at a greater depth – the patches of grey clay suggested that the natural subsoil had been dug into and redeposited. Two or three very small fragments of human bone were found in the mixed soils (again suggesting disturbance by repeated grave-digging in the area). Following consultation with a church official, the bone fragments were reburied in the bottom of the trench.

Plate 10: Soakaway trench [14], looking NNE,.....
1m scale
