**Report on Archaeological Monitoring
St Andrew's Church, Northwold, Norfolk**

NHER ENF 134700

Prepared for Northwold PCC

February 2015

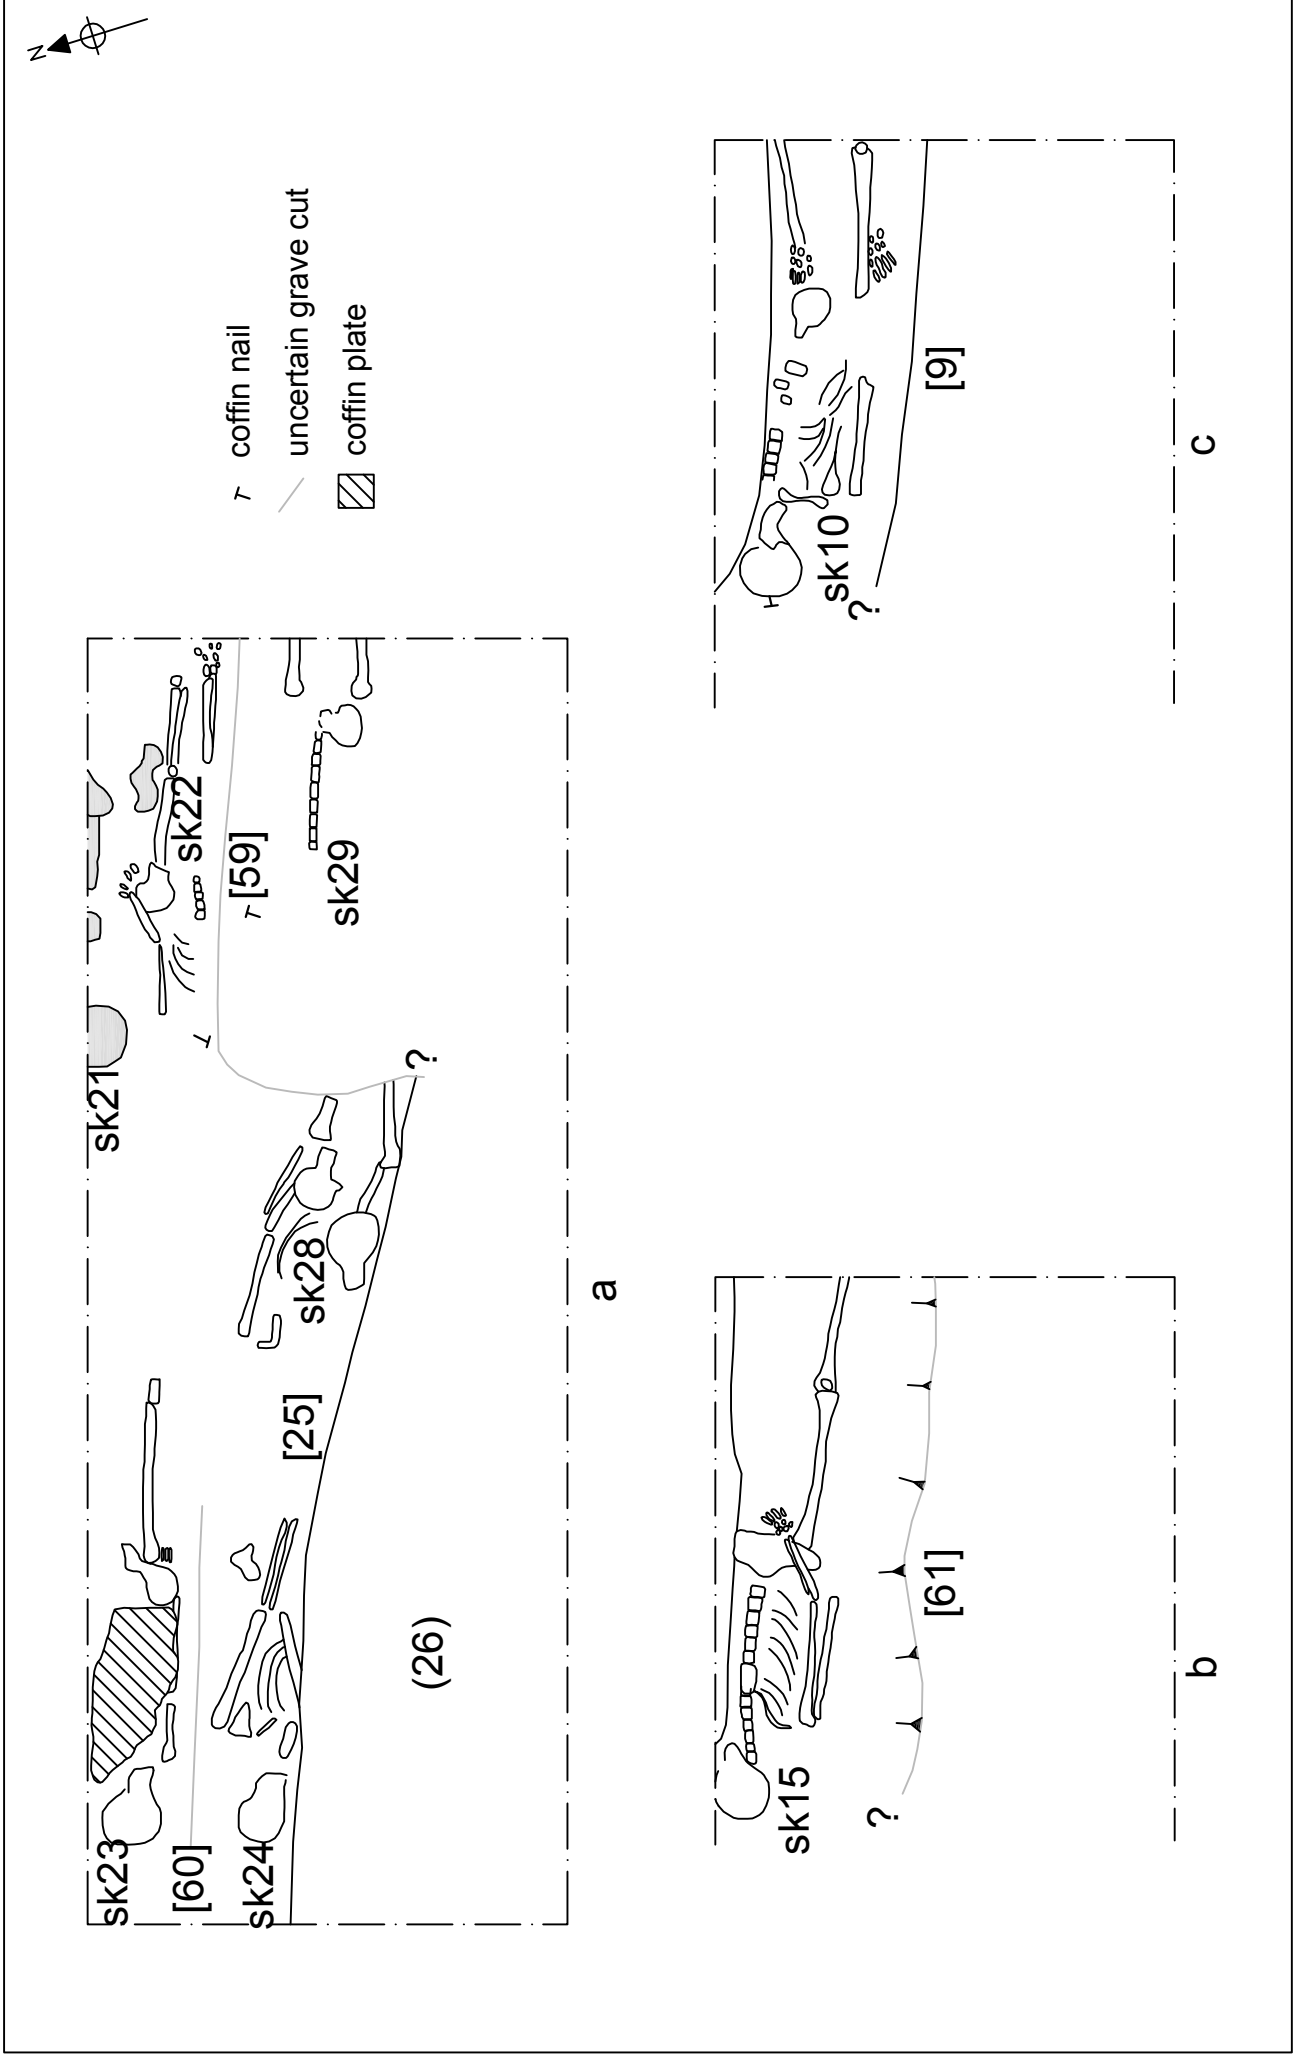
In the central part of the trench at a depth of 1.15m-1.20m was skeleton [28] (Fig. 3a, Plate 3). Surviving *in situ* were the left arm and parts of left ribs and pelvis, part of right arm, the upper parts of the femurs and the mandible. The cranium may have been that seen, displaced, in the region of its pelvis. The skeleton was truncated to the east and south (by grave [59] and feature [25] respectively). To the west and north no edges of a grave were discernible. Some of the bones from skeleton [28] were not fully fused; it was probably a juvenile or young adult.

At the west end of the trench were two adult burials [23] and [24] which lay close together at a depth from the surface of 1.15m- 1.25m (Fig. 3a, Plate 3). The stratigraphic

In the north-east corner of the trench was a series of burials the earliest of which was probably represented by the skull and a few bones of skeleton [21] (shaded grey in Fig. 3a). Most of this skeleton to the north, outside the trench. The skull seemed quite small and might have been from a juvenile although this is uncertain. Immediately to the south of skeleton [21] was skeleton [22] the skull of which was missing and the right side of which was truncated to the south by grave [59]. Coffin nails were associated with burial [22]. Skeletons [21] and [22] were recorded at the same depth from the surface (1.05m-1.12m) but during excavation it was felt that burial [22] post-dated [21].

At a higher level in the north-east corner of the trench were two more burials. Adult skeleton [15] was within putative grave cut [61] (Fig. 3b, Plate 4). The skeleton, at a depth of 0.90m-1.05m, appeared to be truncated by another grave to the north of the trench; its right leg and, probably, its upper right part was missing. One oddity was a ?left humerus which was the same length as, and lay neatly beside, the *in situ* right humerus. It is uncertain whether it was from the same skeleton and, if so, how it became placed so neatly where it was found. It is probably more likely to have belonged to one of the underlying burials which had been disturbed by the burial of [15] - it is not uncommon to find, even articulated, 'odd' bones, which have been disturbed by later burials, seemingly quite carefully placed beside a skeleton (Rodwell 2012, 313).

Directly above skeleton [15], and within grave [9], was skeleton [10] (Fig. 3c, Plate 5). The skull, vertebrae, much of the right side and part of the left leg of the skeleton remained in place at a depth of 0.75m-0.80m. The upper left side was missing, truncated in the same way, although further southwards, as skeleton [15] below it. This supports the suggestion that another grave existed to the north and another grave was seen in section [16] (Fig. 4). It was filled with brown sandy silt [17] with occasional small flints and pieces of disarticulated bone and the corner of a decayed coffin [18] which just extended into the corner of the trench. It was probably this grave that had truncated the earlier burials.

In the south-west part of soakaway [1] a large feature [25] had truncated the burials recorded to its north (and possibly to its east) and was thought likely to be another burial feature of some kind (Fig. 3a). Its fill was a quite light brown sandy loam which was fairly loose with some voids within it. It included chalk flecks and occasional flecks of brick or

Figure 3. Soakaway 1 plans. a) Skeletons at base of trench. b) and c): Overlying skeletons.

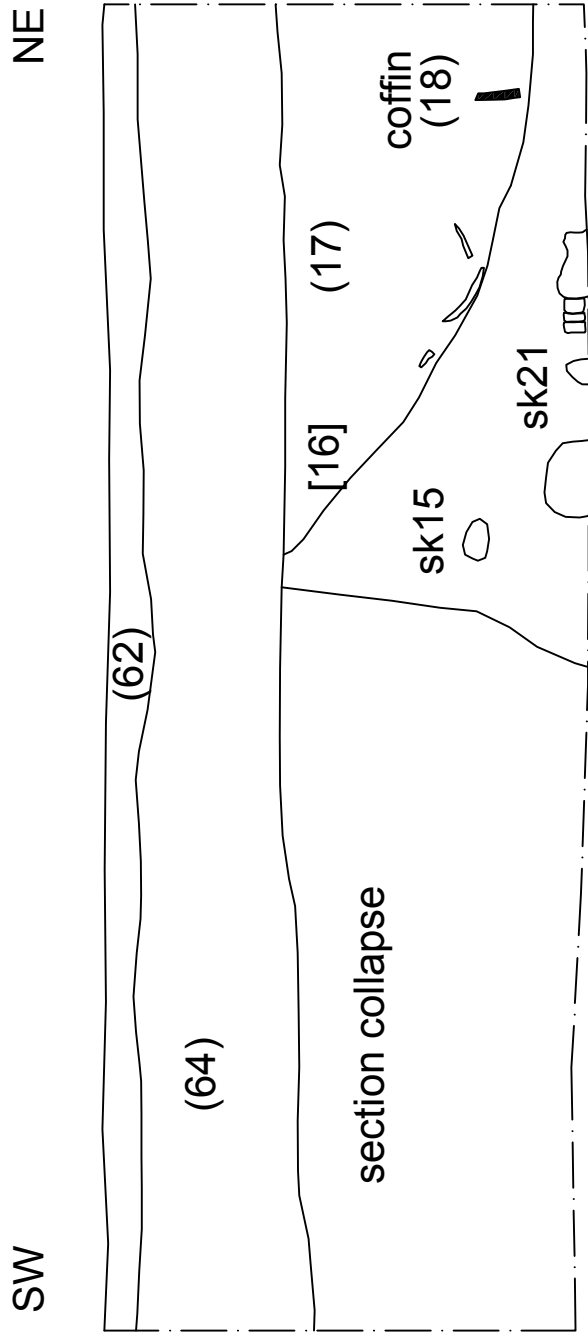
tile. The north-west side of trench (above skeleton [23]) collapsed after machining (Fig. 4) and it seemed likely that collapsed soil was the upper fill of this large feature.

Figure 4. Soakaway 1 South-east facing section. Scale 1:20.

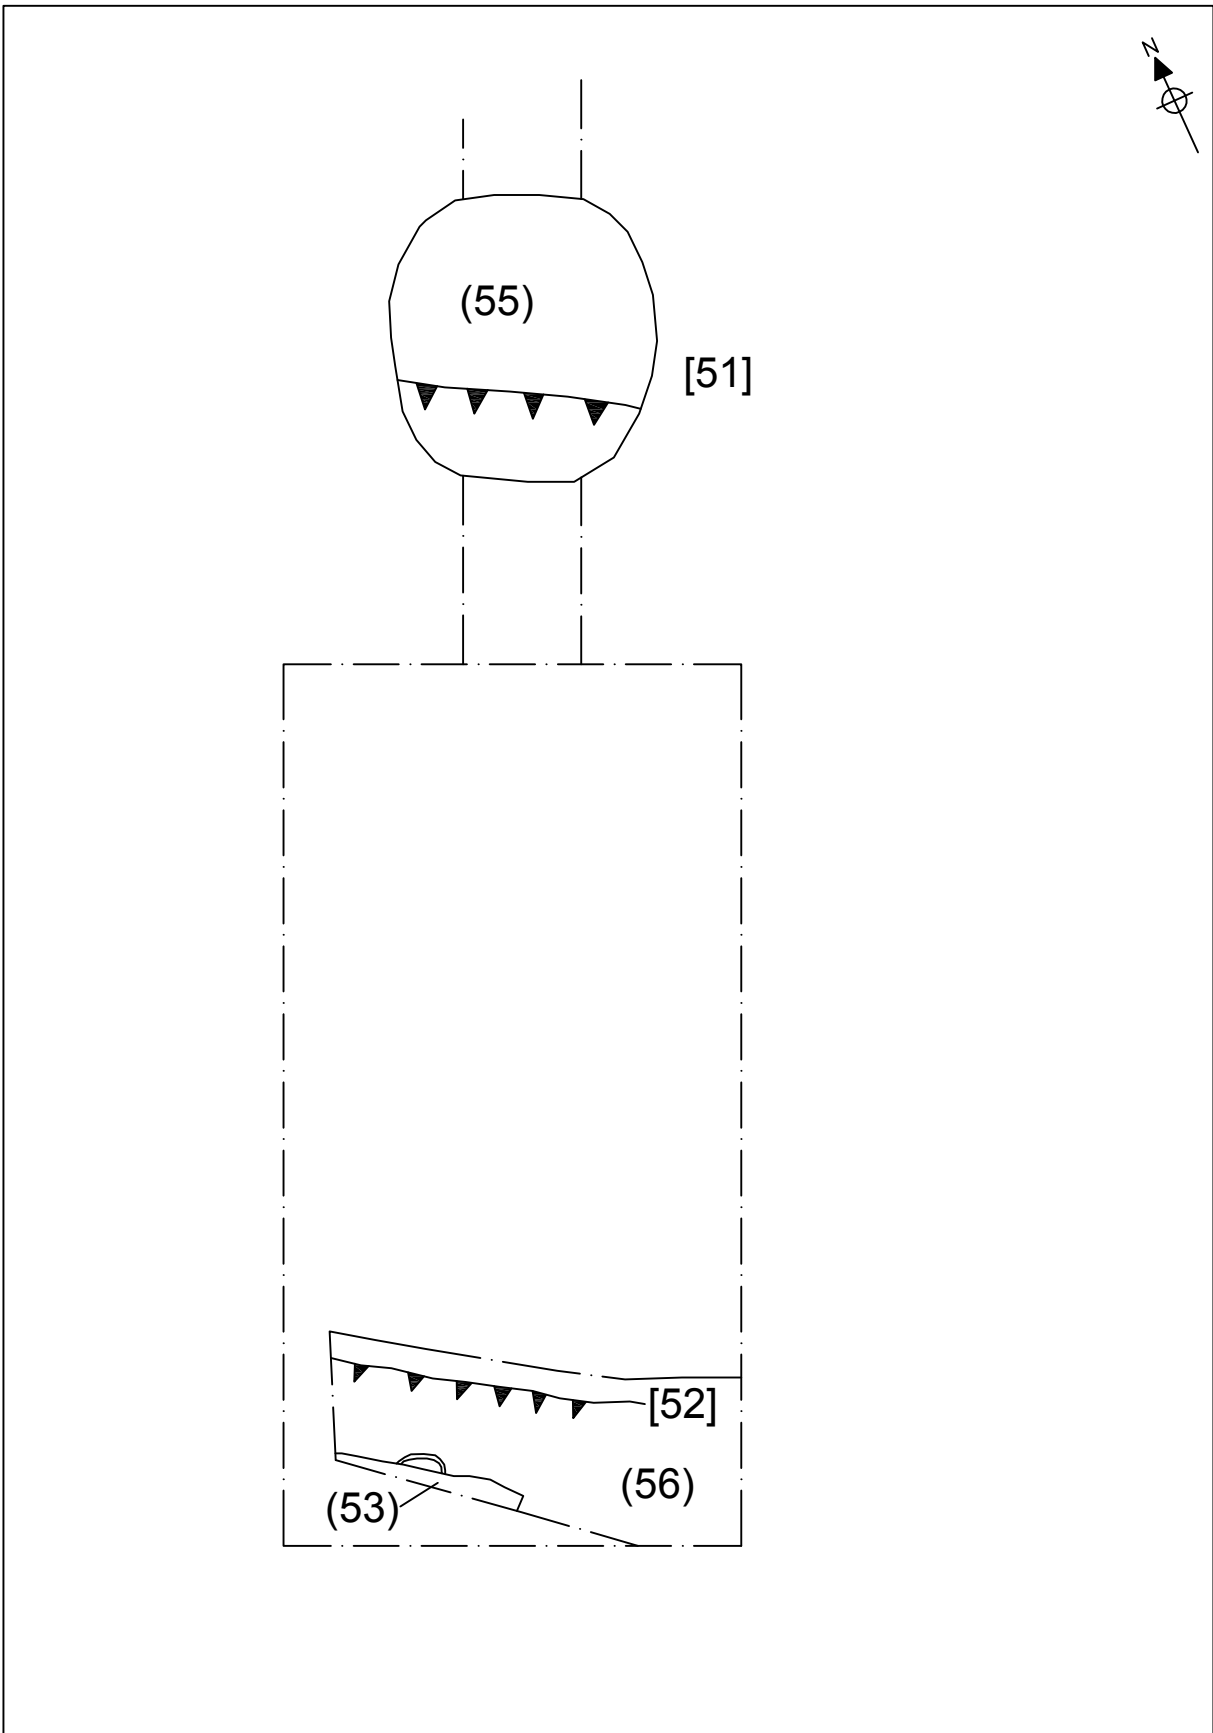
The earliest deposit seen in the soakaway trench was an area of cream sandy lime mortar with chalk flecks and occasional small flints [56] (Fig. 5). This was exposed at a depth of 1.10m in a small area at the south end of the trench. Very similar material [55] was seen at a depth of 1.0m in trench [51] to the north. A small sample of the material was retained and identified as probable mortar, possibly of medieval date. It seems most likely that these deposits represent building waste which was dumped in the churchyard either during or following construction work. Deposit [56] was cut by the bottom of a grave [52]. On the south side of grave cut [52] were the *in situ* traces of a wooden coffin and an iron coffin handle (Fig. 5).

Figure 5. Plan of Soakawy 2. Scale 1:20.

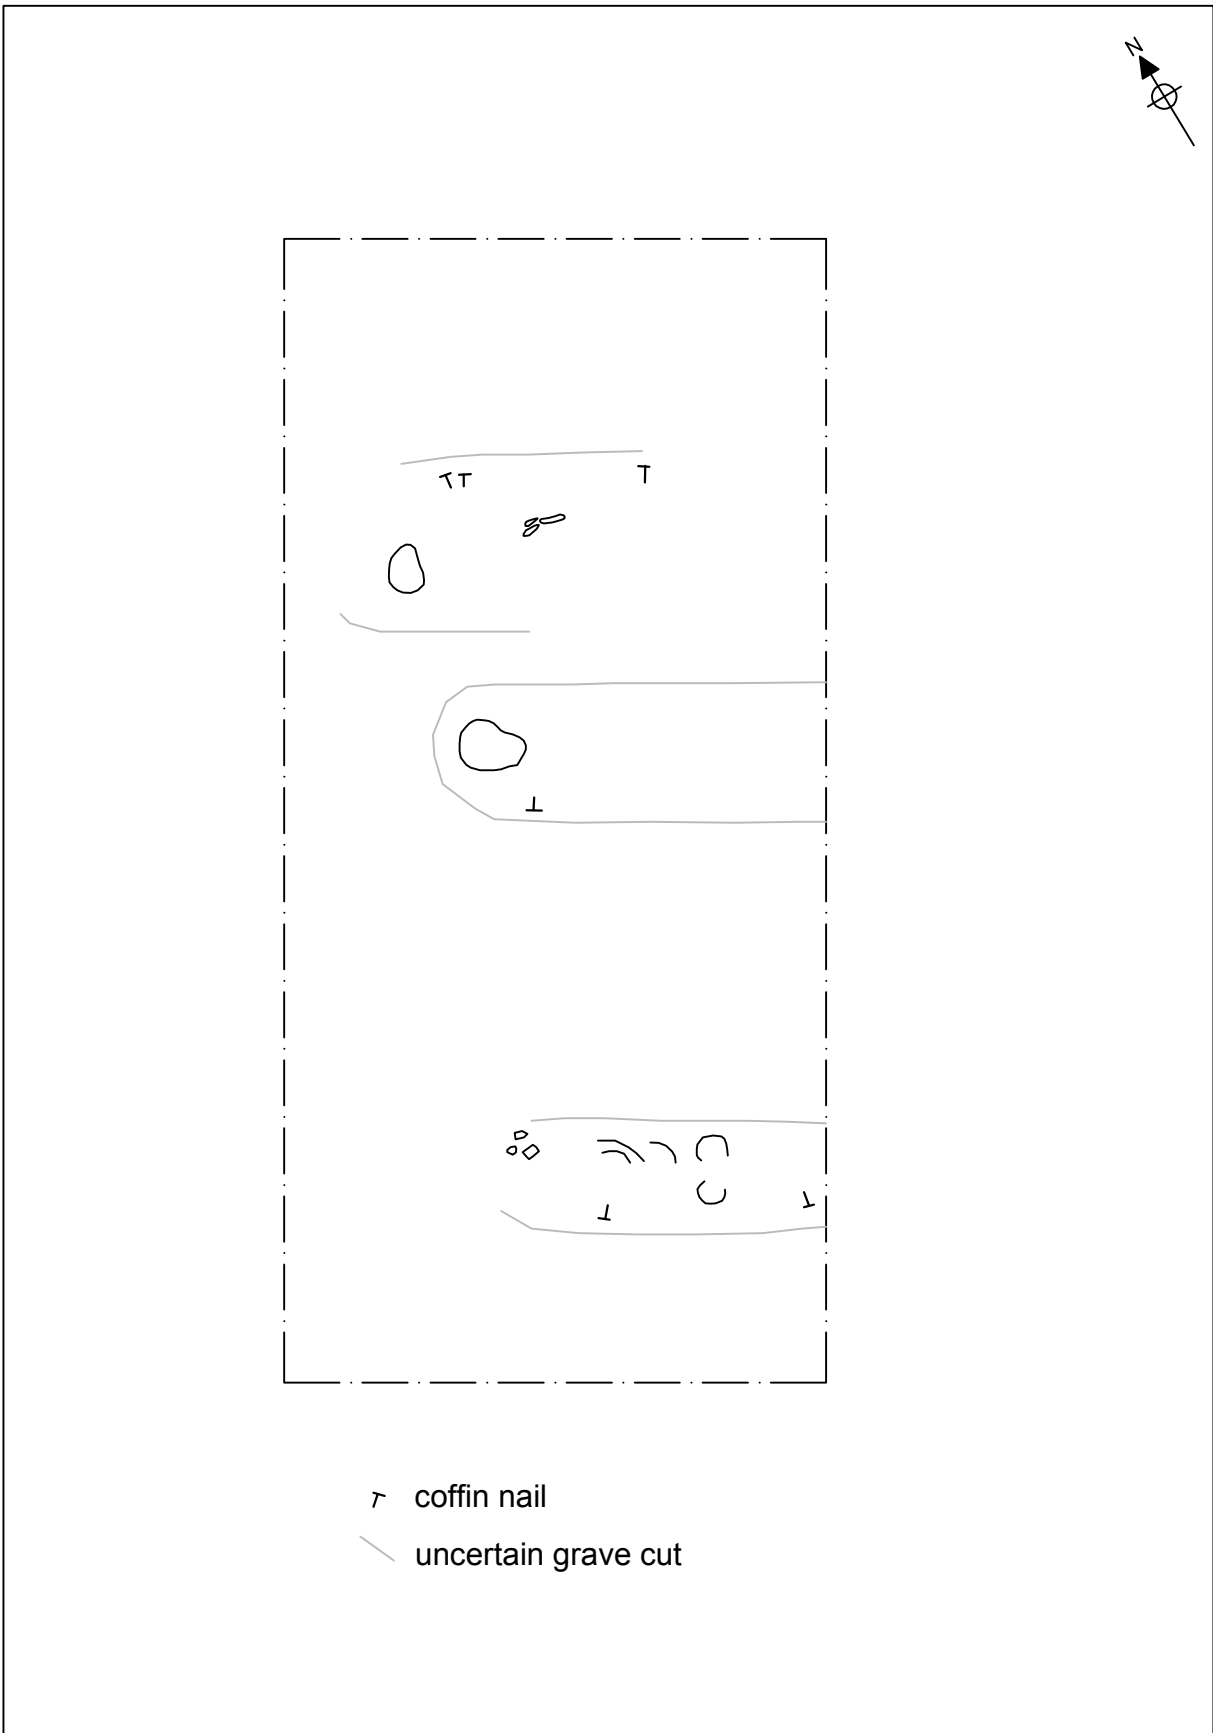
In the bottom of the trench three east-facing burials were identified although none of them were fully exposed by excavation as they lay below the depth required for the soakaway. Parts of skulls, ribs, and the pelvis of one skeleton were identified as well as the outlines of the grave cuts (Fig. 6). The burials were left *in situ* and re-covered with a layer of soil.

Figure 6. Plan of Soakaway 3. Scale 1:20.

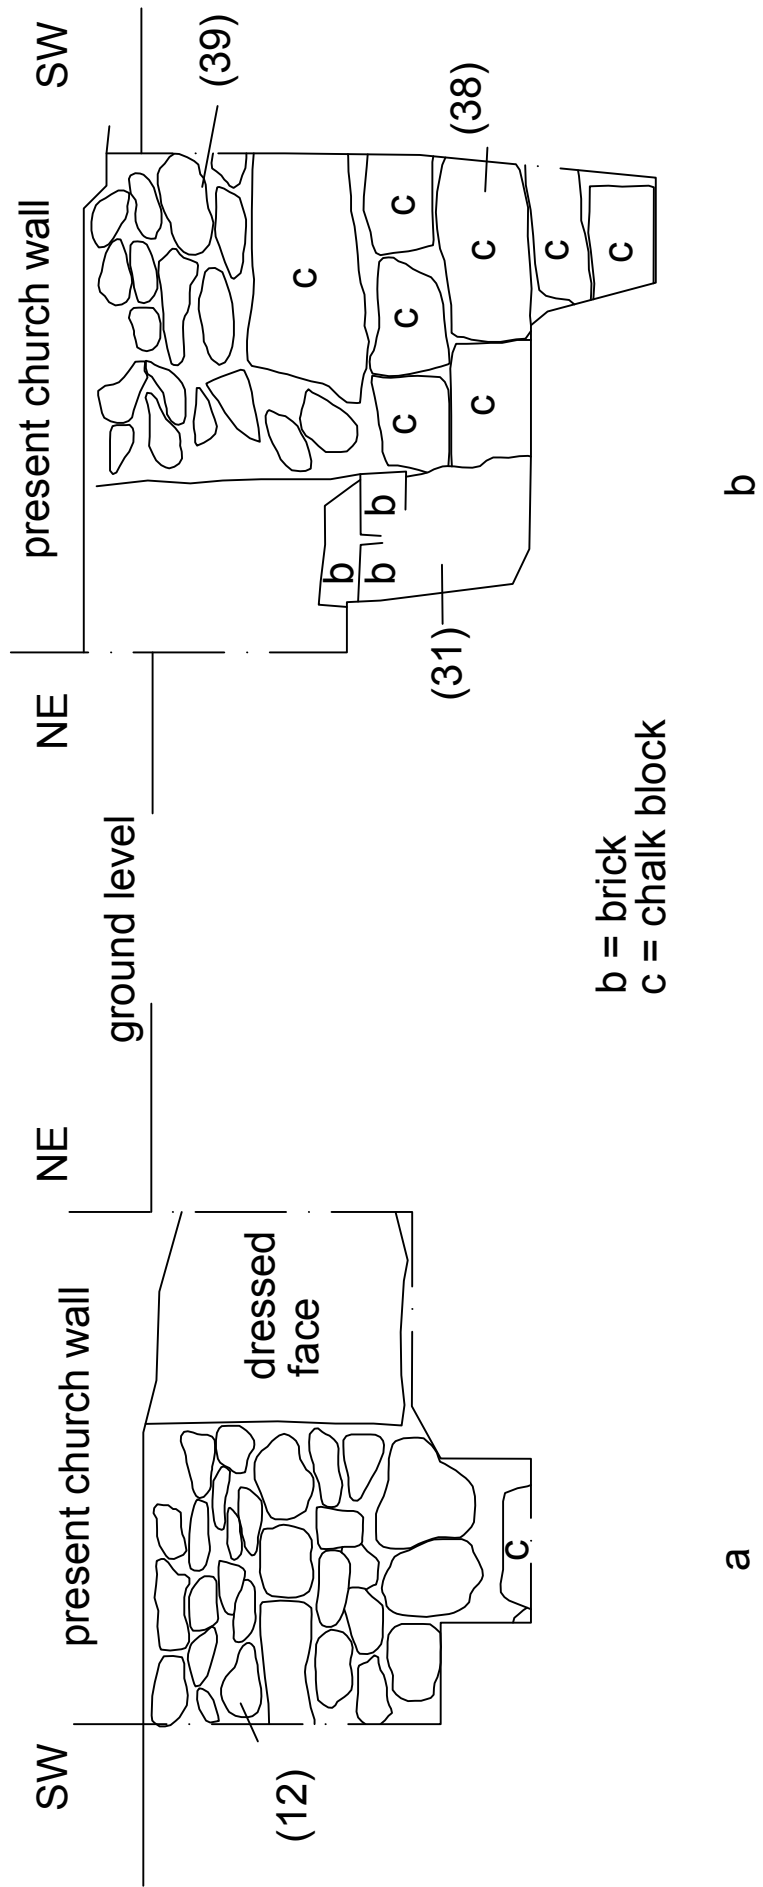
This downpipe gully was immediately to the east of the south porch. The church footing [12] was revealed beneath the south aisle wall. A very small area was hand-excavated by the archaeologist to reveal the top of a chalk block (Fig. 7a). Above that, and just below the bottom of the existing downpipe a change in the footing was seen. To the west roughly coursed medium to large flints with degraded lime mortar and soil between them were exposed with some slightly smaller more angular flints higher up. To the east was a single large stone block with a dressed face. The position of this block does not appear to be of significance in relation to the building. It was probably a convenient fragment, reused in, and offering a degree of structure to, the footing.

In the east side of this gully trench a brick feature was recorded [31] (Fig. 7b). It extended about 0.80m from the wall of the north aisle and appeared to be the north-west corner of something. The south to north length was two bricks wide but it was more substantial (although only partly revealed) at its north end where it turned at a right angle (Fig. 8a, Plate 7). The bricks were light yellow/cream coloured, but, unfortunately, a brick was not retained for dating. Beneath the coursed bricks was a slight flint footing. Although it was too close to the church wall to represent a porch it is possible that it may have supported, a simple (?timber) shelter around the doorway. The more substantial part may have supported a corner post for such a structure around the door. Alternatively the bricks may represent some other kind of structure. (The feature remained *in situ*; the gully pot was placed immediately to its west).

Figure 7. a) Trench 11 South-east facing section. Scale 1:20.
 b) Trench 30 North-west facing section. Scale 1:20.

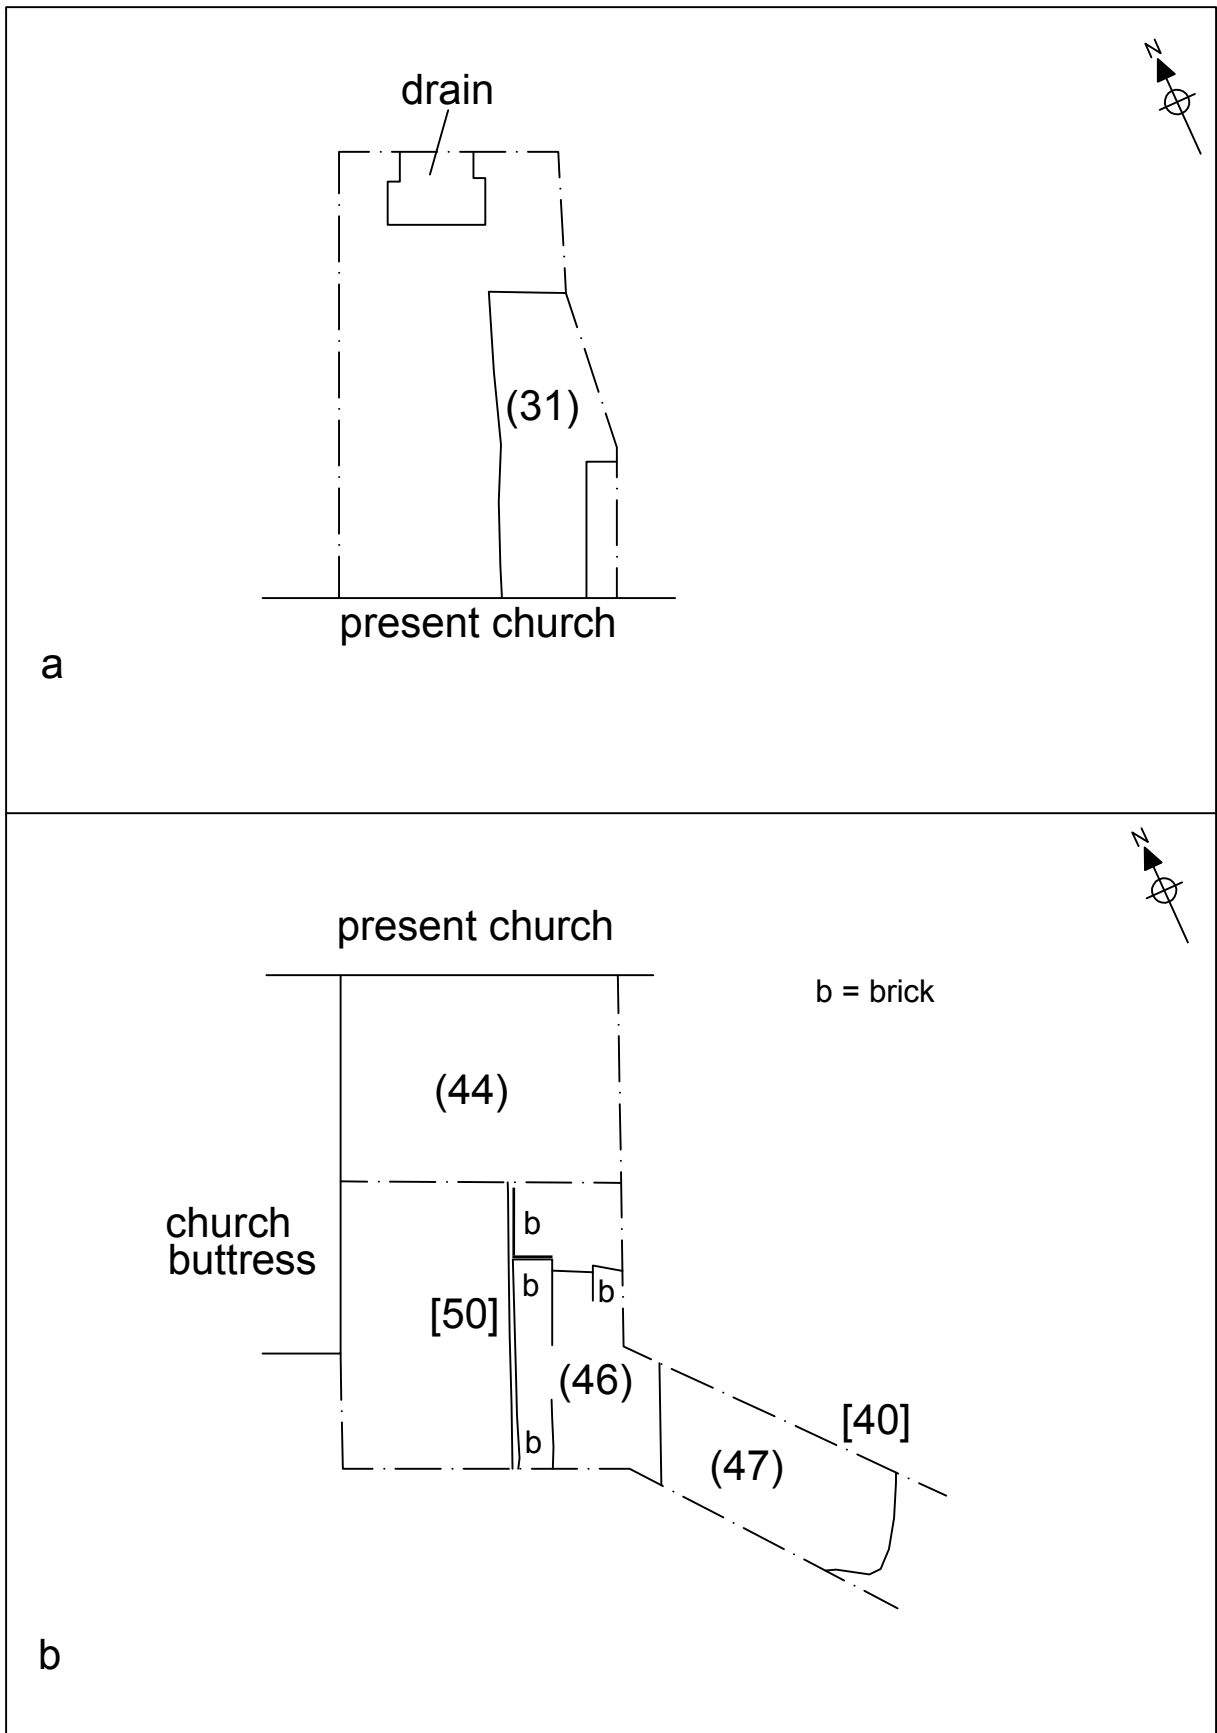
Trench [30] was located just to the west of the doorway in the wall of the north aisle. At a depth of 0.15m below the existing ground surface were some large chalk blocks which were neatly 'coursed' and extended downwards to a depth of 0.55m [38]. (Plate 7 shows only the upper chalk blocks while Fig. 7b shows the blocks exposed to what was almost certainly their full depth). The chalk blocks protruded very slightly from the face of the above footing and wall. On top of the chalk blocks some roughly coursed medium-sized flints [39] (some cobble-like and some more angular, within soil and degraded lime mortar) formed the upper part of the wall footing.

Trench [43] was located immediately east of the central buttress on the south side of the chancel. In the bottom of the deeper hole dug for the gully pot was a deposit of mid to light brown silty [49] in which was found a sherd of Late Saxon pottery. The deposit ran underneath the bottom of the buttress footing (at a depth of 0.70m from the bottom of the chamfer of the buttress plinth). Above this a layer of light brown silty sand with common mortar rubble [48] overlaid by brown silty sand with occasional flecks of mortar [45] was seen to the east of the buttress footing. Both deposits were fairly uncompacted and two fragments of medieval window glass came from [48]. These deposits were cut to their east by [50] which was the construction cut for a footing of some kind (Fig. 8b, Plate 9). At its west side some bricks formed a regular north to south 'wall' [46] only part of which was exposed - it probably continued northwards as far as the chancel wall. Immediately to the east of the bricks (seemingly part of the same 'structure') was a mass of very solid brick and chalk rubble in a hard whitish mortar [47] which continued to the south-east where a probable 'corner' seen in drain trench [40] appeared to represent the southern end of the feature. Part of a medieval brick came from near the bottom of 'footing' [47] and a fragment of chalk with tooling from a rounded chisel also came from the footing. Other bricks, from [46], were of medieval and probable post-medieval date. It seems likely that the bricks formed the face, and the rubble represented the core of a former buttress.

Figure 8. a) Plan of Trench 30. Scale 1:20.
 b) Plan of Trench 43. Scale 1:20.

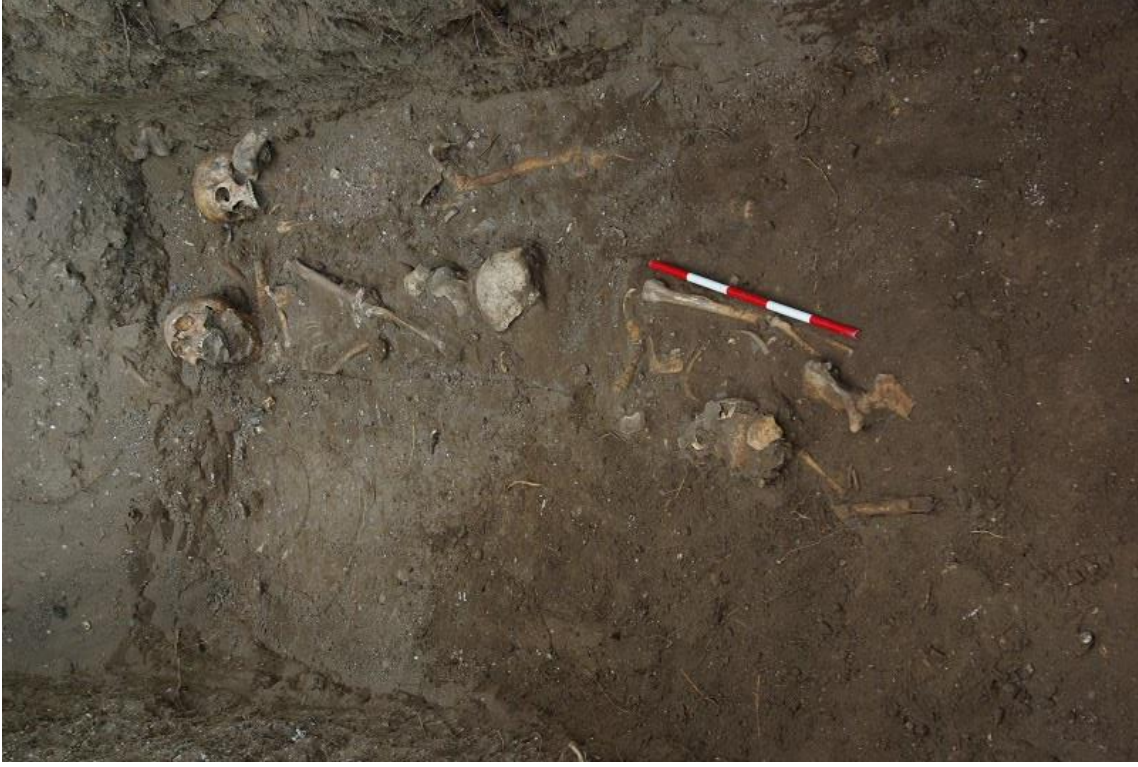
Plate 3: Soakaway 1, skeletons 23, 24 and 28, looking SW, 0.5m scale

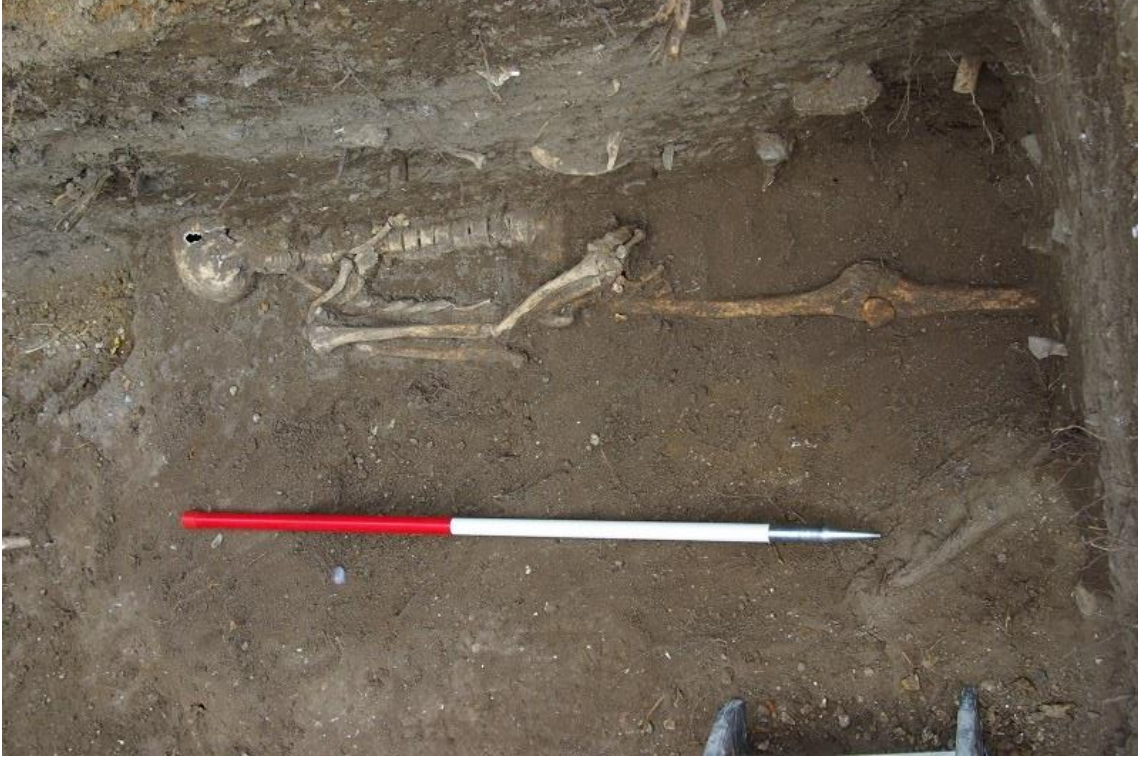
Plate 4: Soakaway 1, skeleton 15, looking SW, 1m scale

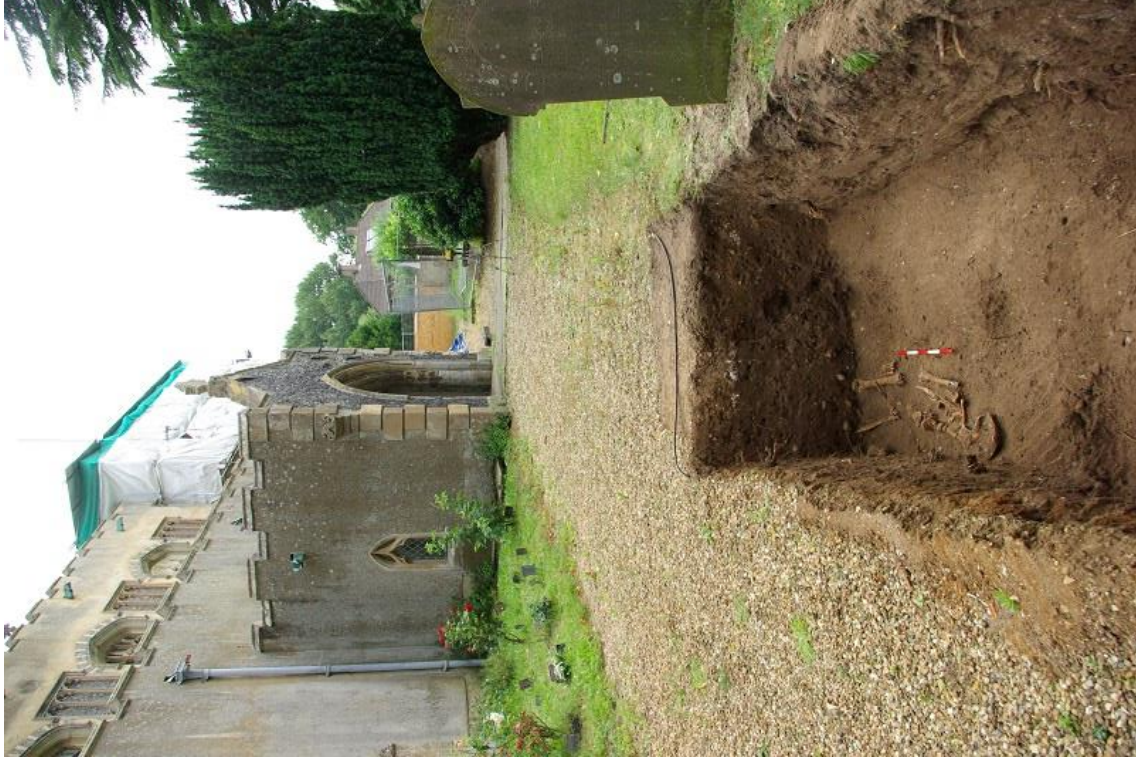
Plate 5: Soakaway 1, skeleton 10, looking NE, 0.5m scale

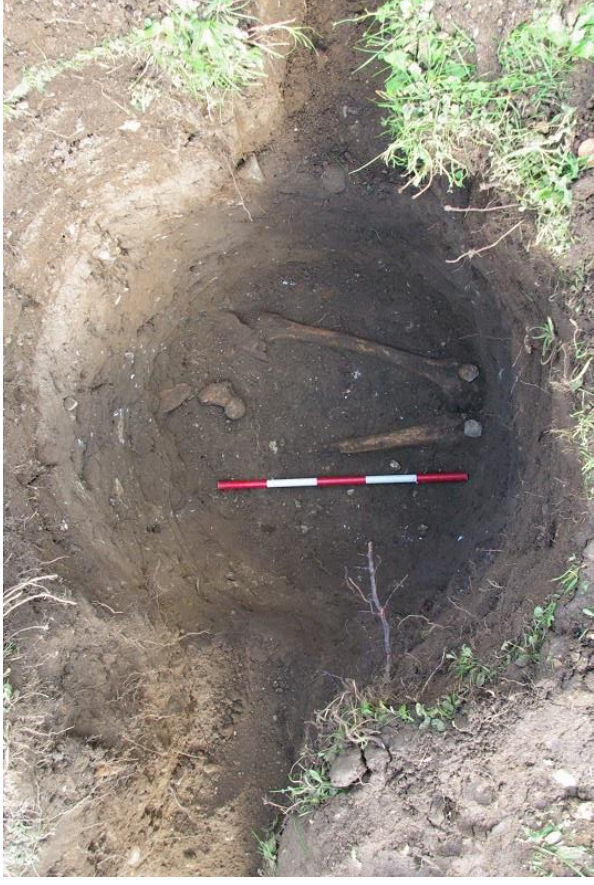
In trench [51] legs bones of an articulated skeleton were recorded at a depth of 0.90m (Plate 6). They were removed from the trench for reburial. Two sherds of Late Saxon pottery, a fragment of medieval roof tile and a small piece of limestone with a flat surface were found in the soil excavated beneath the bones.

Plate 6: Trench 51, human remains, from above, facing S, 0.5m scale

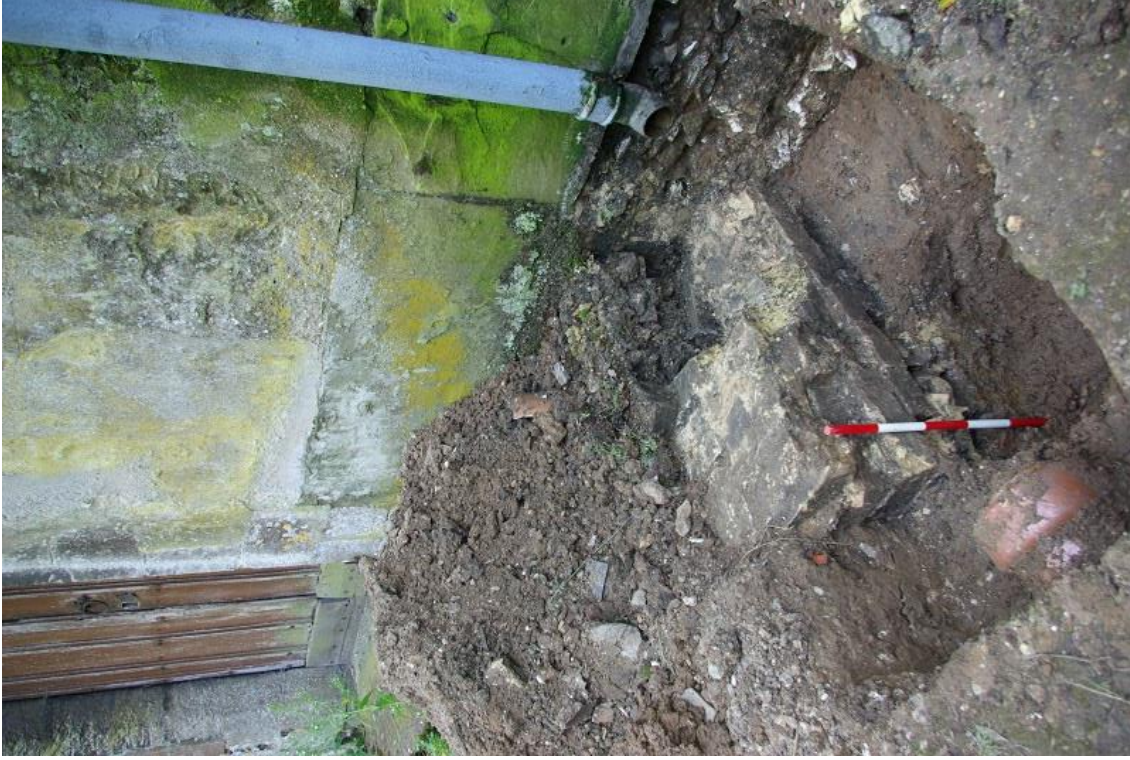
Plate 7: Trench 30, footing [31], looking S, 0.5m scale

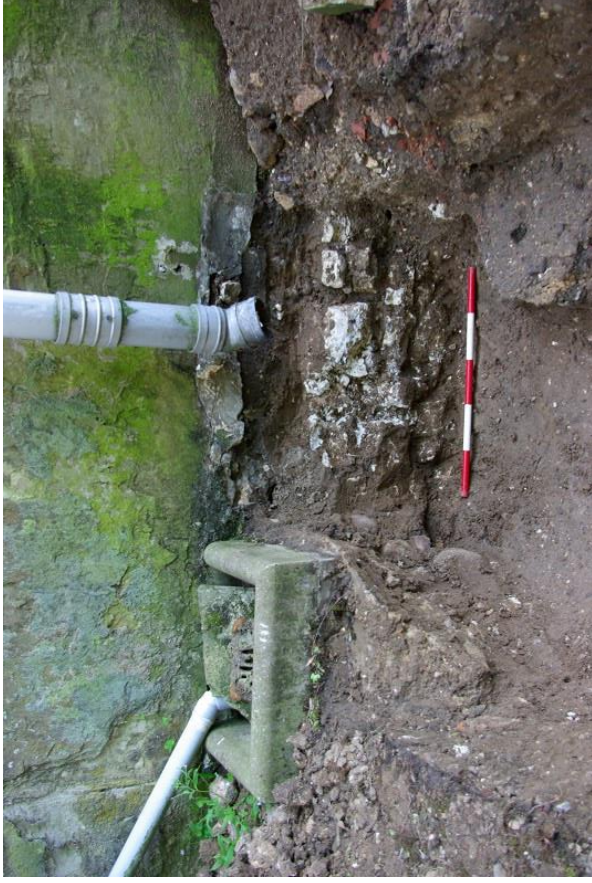
Trench [35] was located close to the east end of the north aisle. The wall footings revealed were very similar to those seen in trench [34]. The chalk blocks were revealed to a greater depth (0.35m) and protruded slightly further (0.12m) from the bottom of the wall and flints above them (Plate 8). The blocks were obscured to the east by an existing drain gully.

Plate 8: Trench 35, church footing [38], looking SSW, 0.5m scale

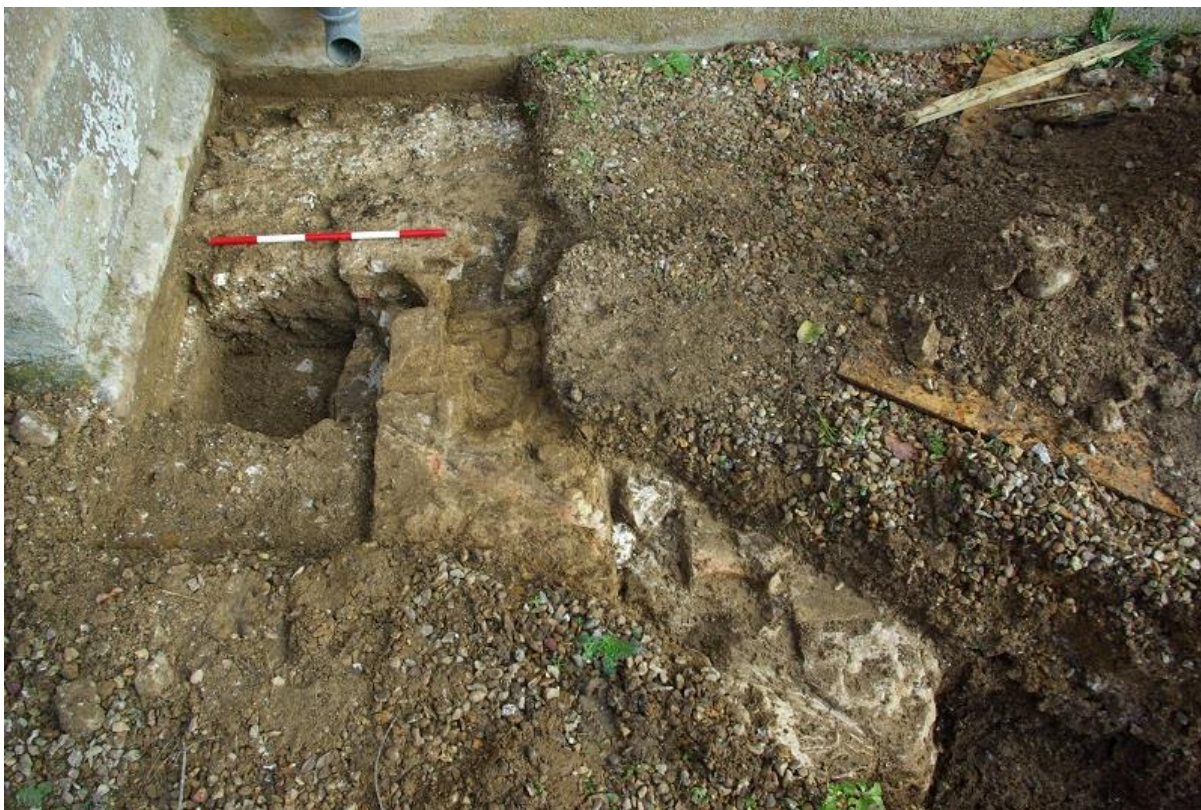
The footing of the existing chancel buttress was 0.50m deep and comprised three 'layers' of mortared flints (which became progressively more regular towards the top) above which the face of the chamfered plinth was (mostly) below the present ground level. No clear construction cut for the lower footing of the existing buttress was identified (although a deposit of mortar-rich debris [44] may have related to the construction of the buttress (see Fig. 8c and Plate 9)

Plate 9: Trench 44/40, footing [46]/[47], looking NE, 0.5m scale

After it had been archaeologically recorded, the masonry was removed by the contractors to the 0.40m depth required for the drain.

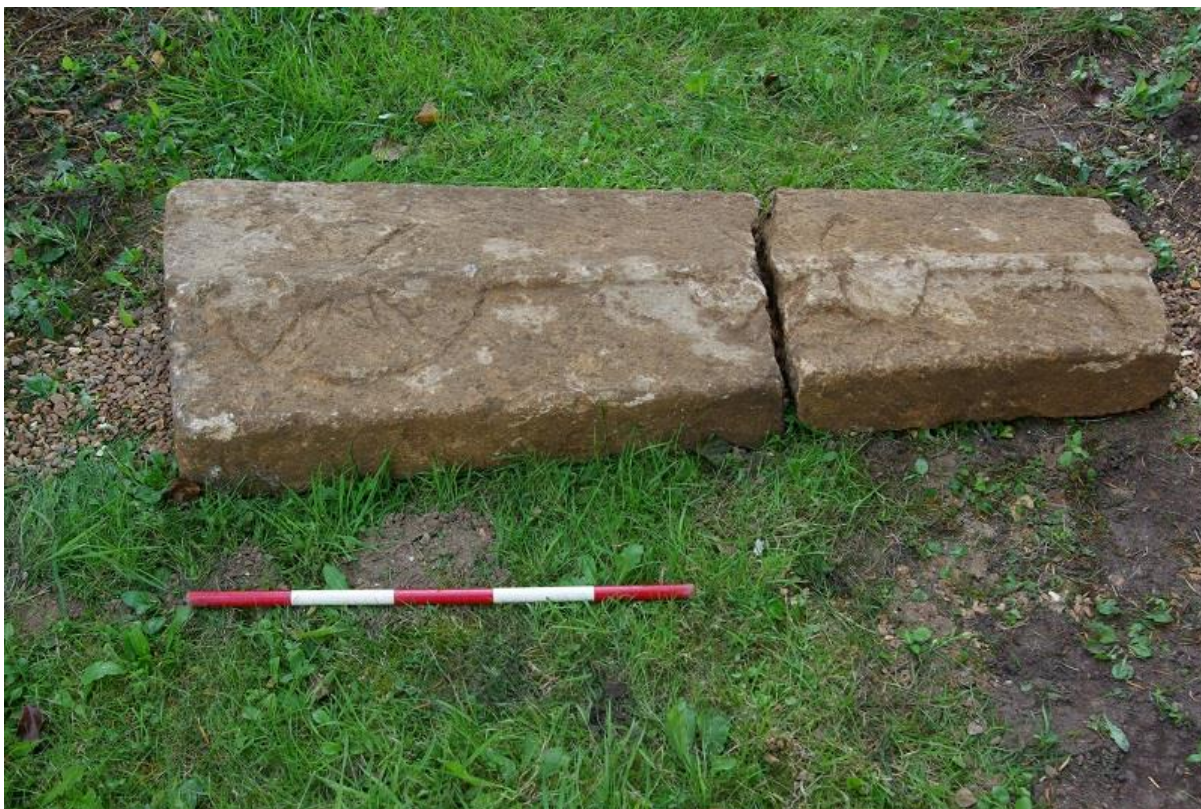
The coffin lid (in two pieces and with its bottom missing) is approximately 300mm wide at its narrowest and 400mm wide at the top (Plate 10). Its minimum length is 1200mm and it is 95mm thick at the edges, its upper face sloping very slightly up to its raised central decoration. The top edge slopes very slightly up from left to right giving the whole slab a slightly asymmetrical shape. The upper surface is decorated with a central shaft and, at the top, a cross *paté* (with wide concave-sided arms). The cross has convex ends to its arms (known as an *alésée* type) so that the whole design forms a circular motif. Another probable (?similar) cross can be seen in the lower central area (but is at the break and is damaged). The central shaft runs the entire surviving length of the slab appearing above and below the crosses. The coffin lid is of limestone which is likely to have come from the Barnack quarries (near Peterborough) and the narrow 'leaf' areas between the arms of the cross are in keeping with designs from there (Butler 1965) – (although a double omega also typically seen on the Barnack products is absent).

A carved coffin slab of probable 13th-century date was found in the drain trench close to the south porch. Such slabs are more common in areas with locally occurring stone so its presence at Northwold is of interest. Its style and location suggest it is likely to have been made at Barnack in Cambridgeshire (Butler 1965) and it may have been brought to the site via the Nene, Great Ouse and Wissey rivers. Such coffin slabs were usually used inside churches and would have covered quite shallow graves (Rodwell 2012, 312, 321). In the later in the medieval period indoor graves were often deeper and without such slabs which were often lifted and reused in the church (or other) buildings. Slabs may have sometimes been moved due to the inconvenience of their raised surface in the floor (Butler 1957). At Northwold it appears the slab may have been reused (upside-down?) in a path in the churchyard.

Plate 10: Coffin lid found in trench 20, 0.5m scale

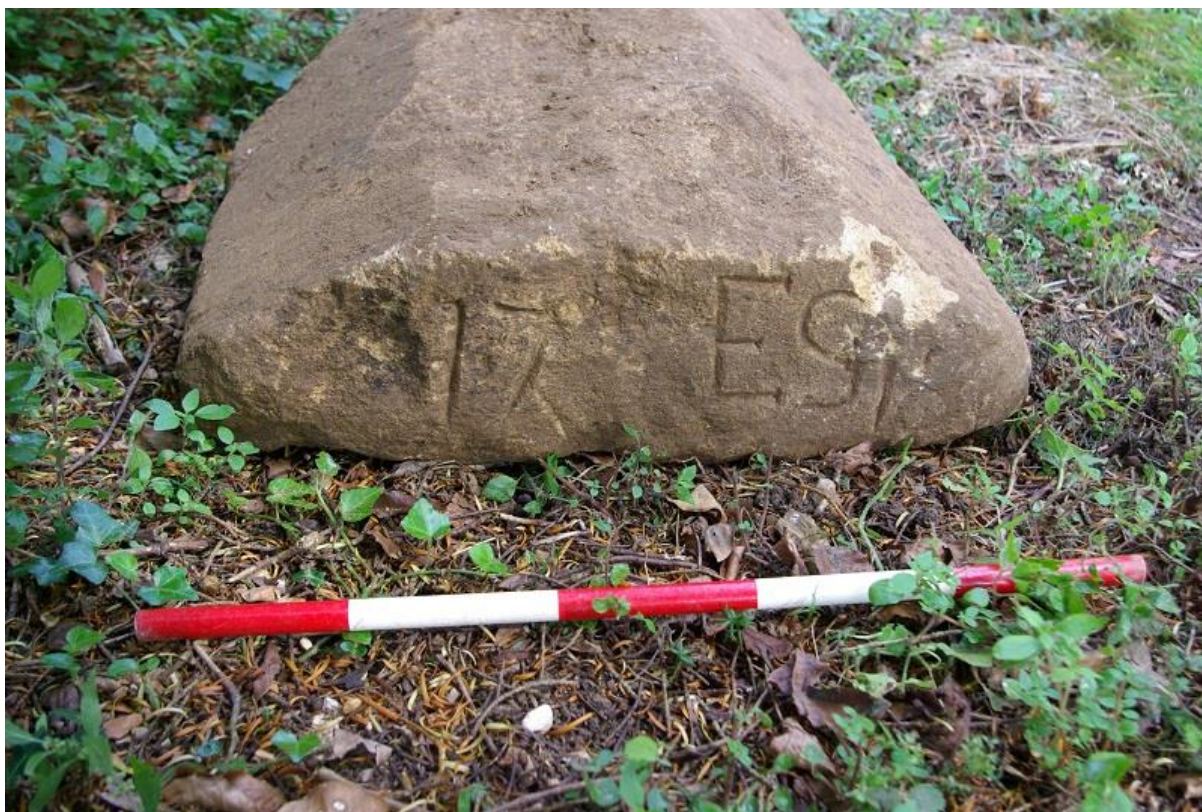
Also found in trench [20] was a large block of limestone with sloping upper surfaces [37] (See Plate 11). It was 750mm long (with part of one end missing), 490mm wide, 60mm thick at the sides and a 280mm maximum thickness at the centre (with some damage to the top). Although partly illegible, one end was inscribed '..17 ES..'. The piece is probably a large coping stone and of post-medieval date.

Plate 11: Inscribed architectural fragment from trench 20, 0.5m scale
